INFLUENCES ON THE MECHANICAL PROPERTIES OF ELECTROLESS
COPPER DEPOSITS IN MULTILAYER INTERCONNECTION BOARD (MIB)-
PLATED THROUGH HOLE (PTH) APPLICATIONS

A Thesis

Metallurgy and Materials Engineering

Lehigh University

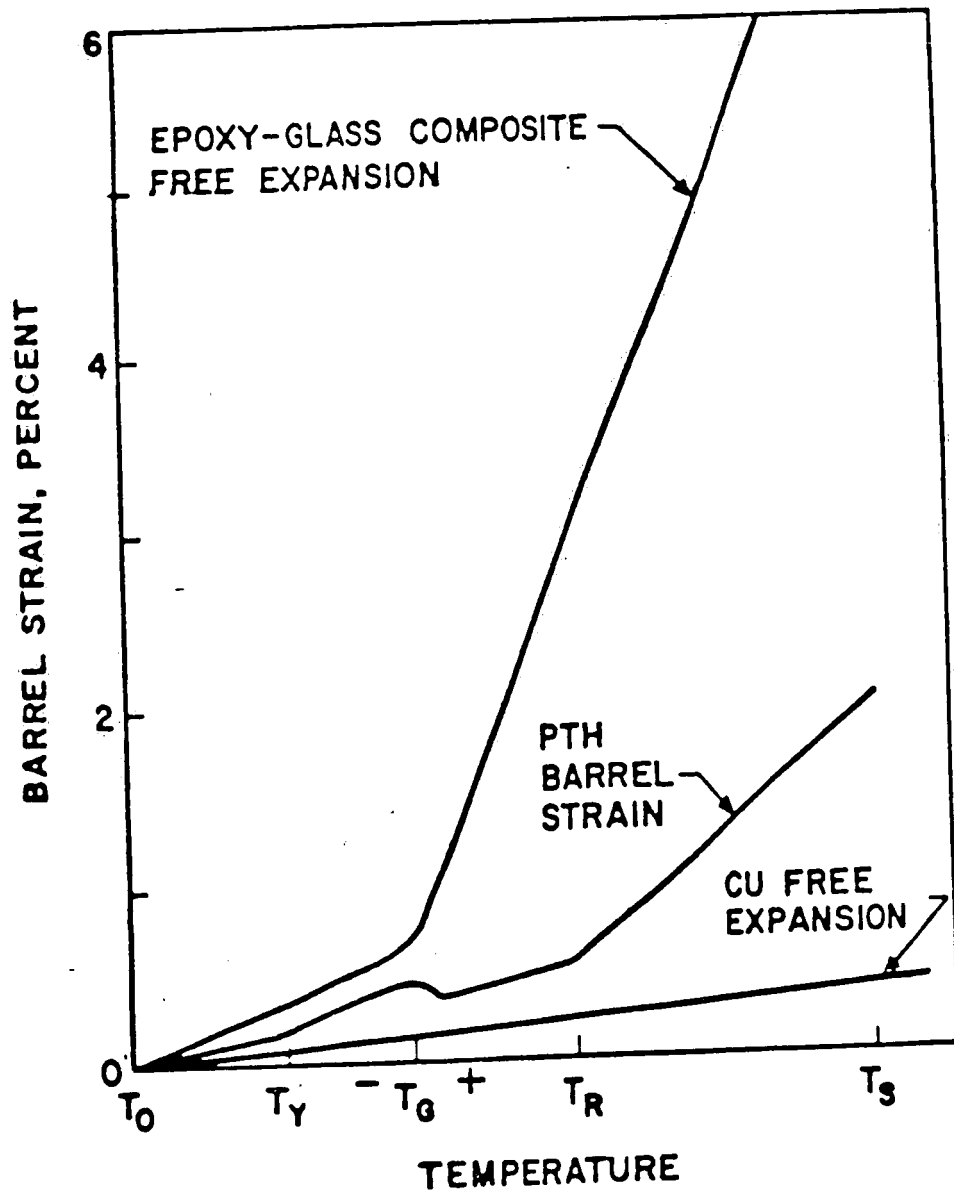
Figure 4: PTH barrel strain versus temperature based on the simple piece-wise linear model of Oien [3].

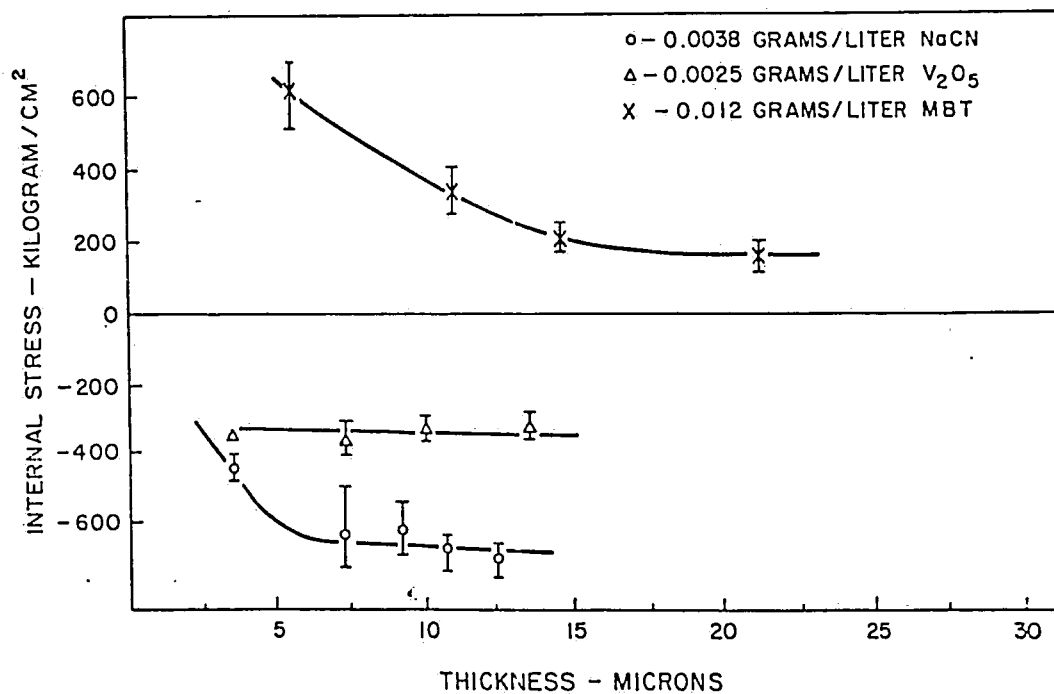
Figure 5: Internal stress versus thickness of Cu deposits from NaCN, V₂O₅ and MBT stabilized electroless baths (after Aycocock et al. [9]).

Aycock et al. [9] have used a spiral contractometer to measure the internal stresses in electroless copper. When certain additives were used in the plating bath, either a residual compressive or tensile stress was observed in the copper foils (Figure 5). The residual stresses were found to become more compressive with increasing foil thickness. Aycock suggests that residual tensile stresses could contribute to the lower ductility of the deposits. Others [10,11] have suggested that the presence of internal stresses cause pores to develop in the channels between the growing grains, thereby entrapping gases. However, no clear understanding of the interrelations of internal stresses and pores is currently available.

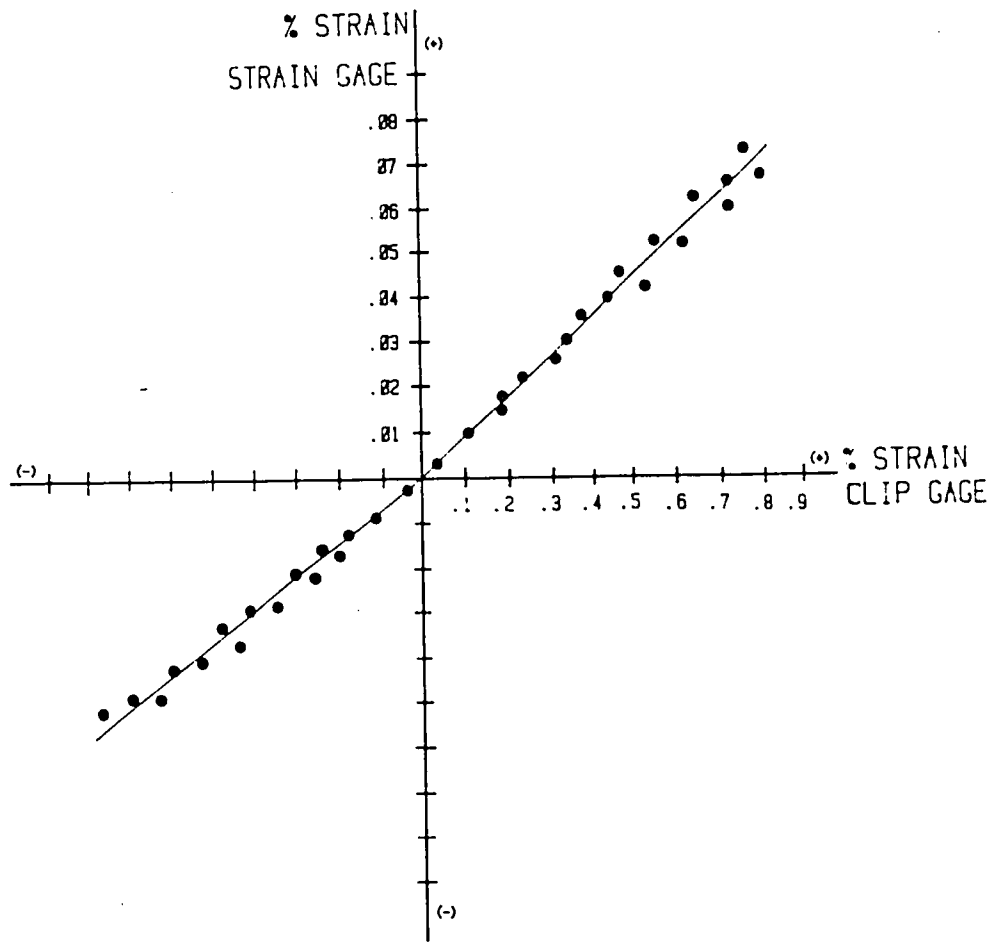
Figure 13: Calibration curve showing clip-in gage strain versus strain gage strain.

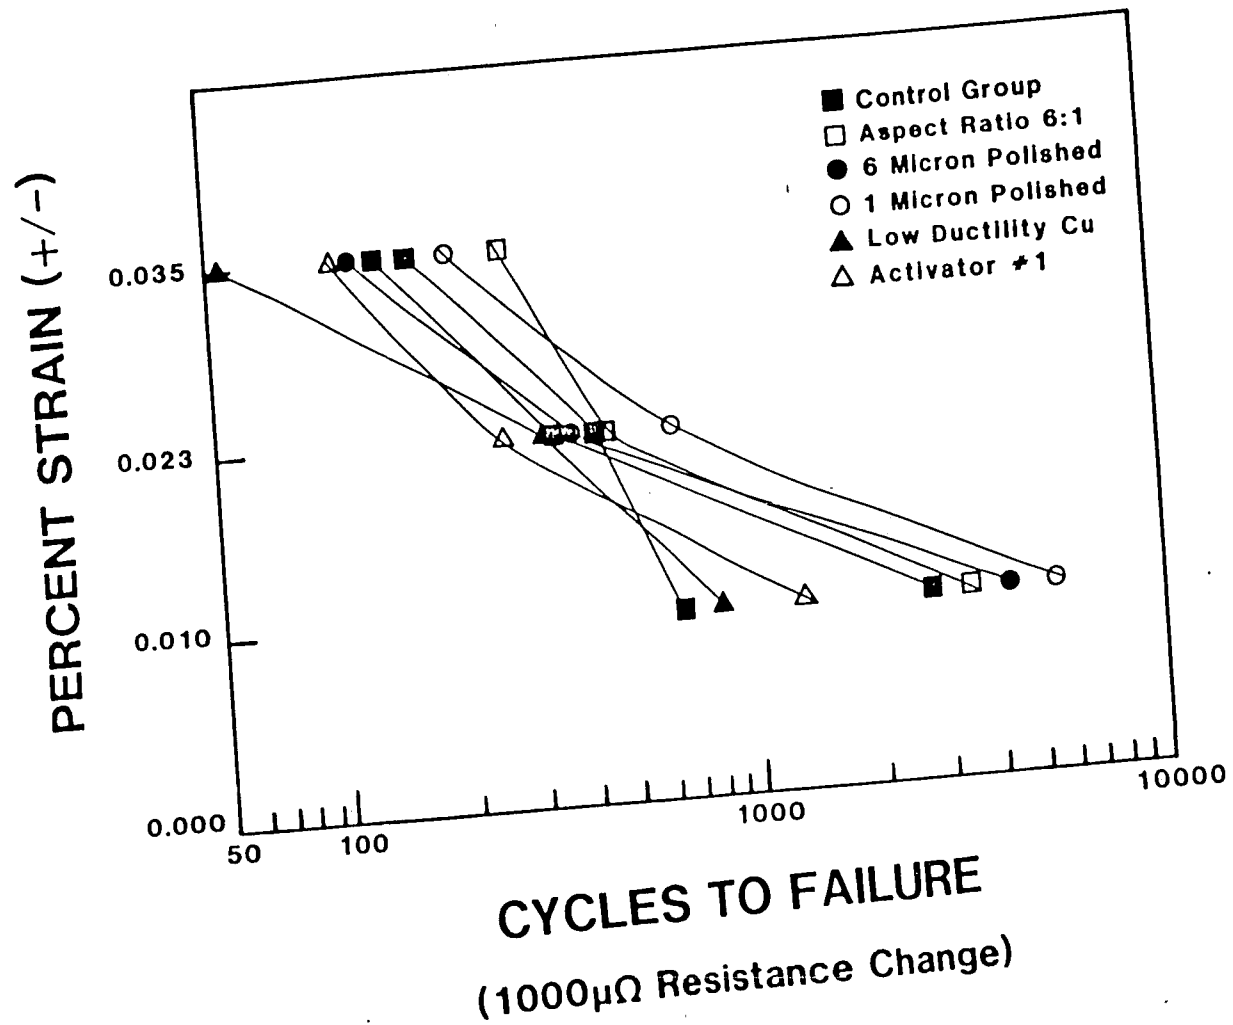
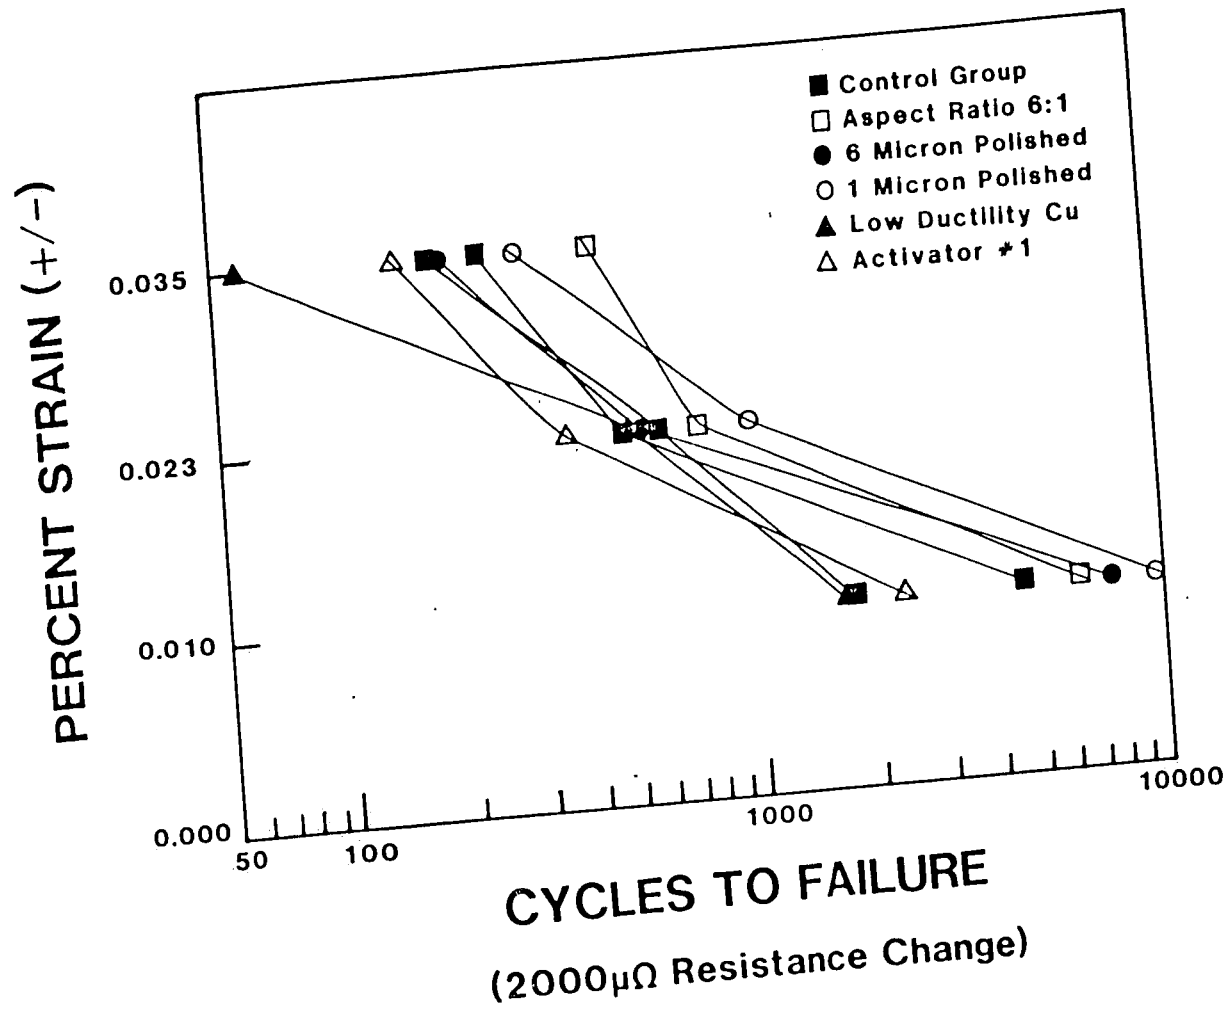
Figure 30: Plot of the cyclic strain versus cycles to failure for each of the four failure criterion (a) 200 $\mu\Omega$, (b) 500 $\mu\Omega$, (c) 1000 $\mu\Omega$, and (d) 2000 $\mu\Omega$.

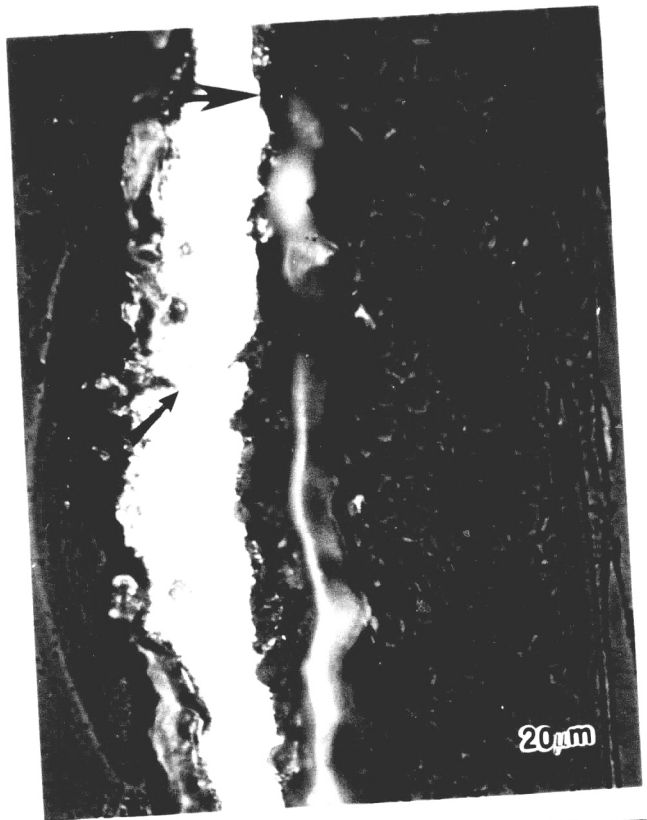
Figure 38: Optical photomicrograph of the gage section of the 0.035% strain 1 micron polished specimen. Note the good adhesion along the copper/epoxy-glass interface along with the copper barrel crack.

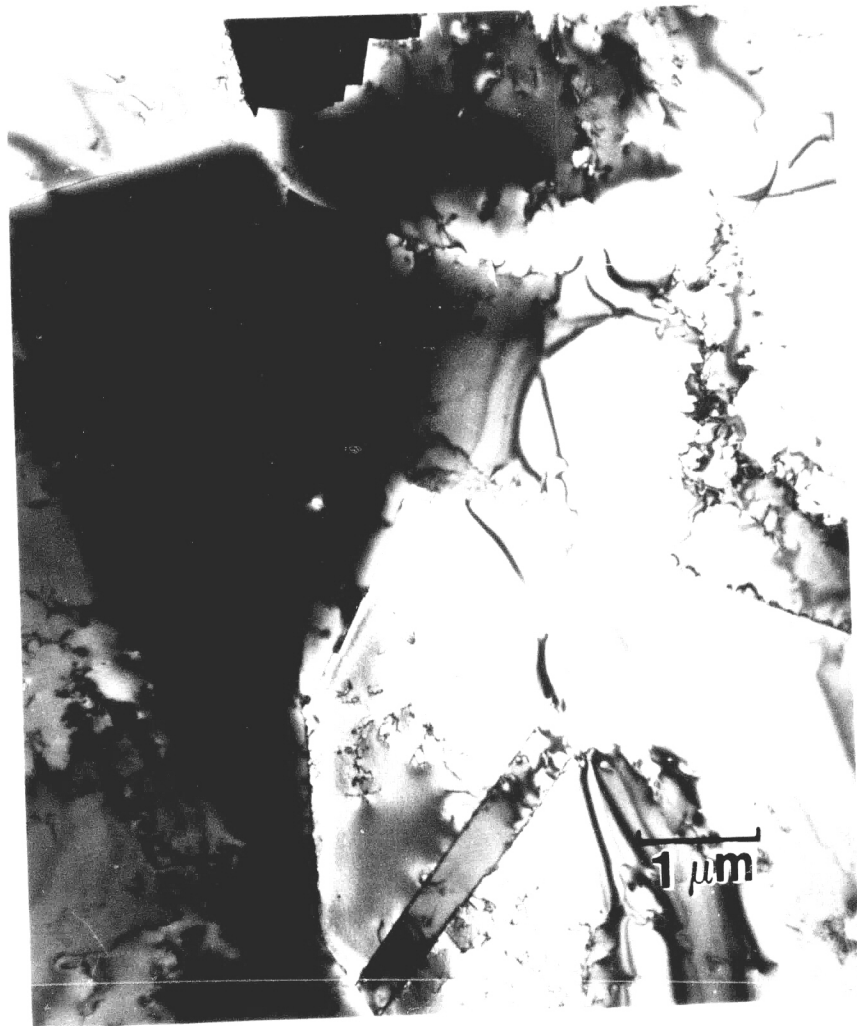
Figure 43: TEM micrograph of electroless copper showing dislocation arrangement after 10 tension-tension fatigue cycles.

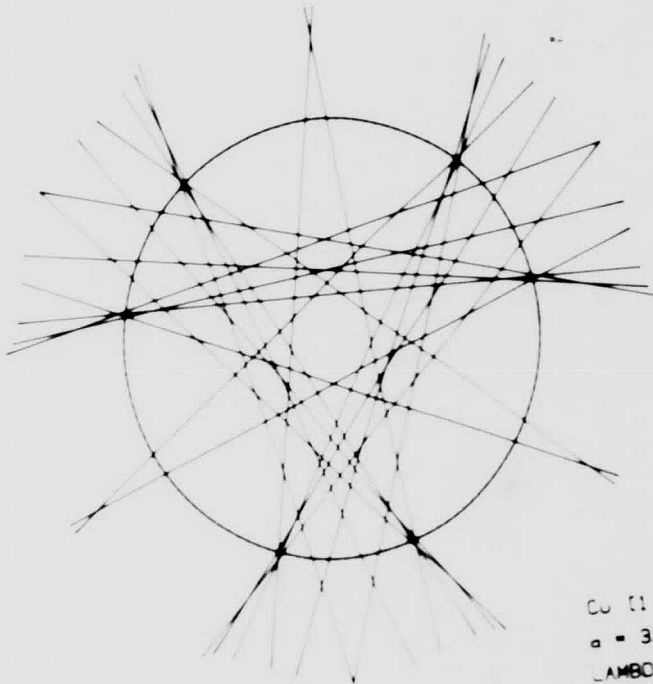
Figure 57a-b: (a) [111] HOLZ pattern taken from as-received electroless copper representative of 80% of the examined grains. (b) A computer simulation [111] pattern showing good matching to (a) achieved through a cubic lattice parameter of 0.3615 nm.
