A statistical analysis of reliability for vapor grown planar InGaAs/InP photodiodes

**A STATISTICAL ANALYSIS OF RELIABILITY
FOR VAPOR GROWN PLANAR InGaAs/InP PHOTODIODES**

A Thesis

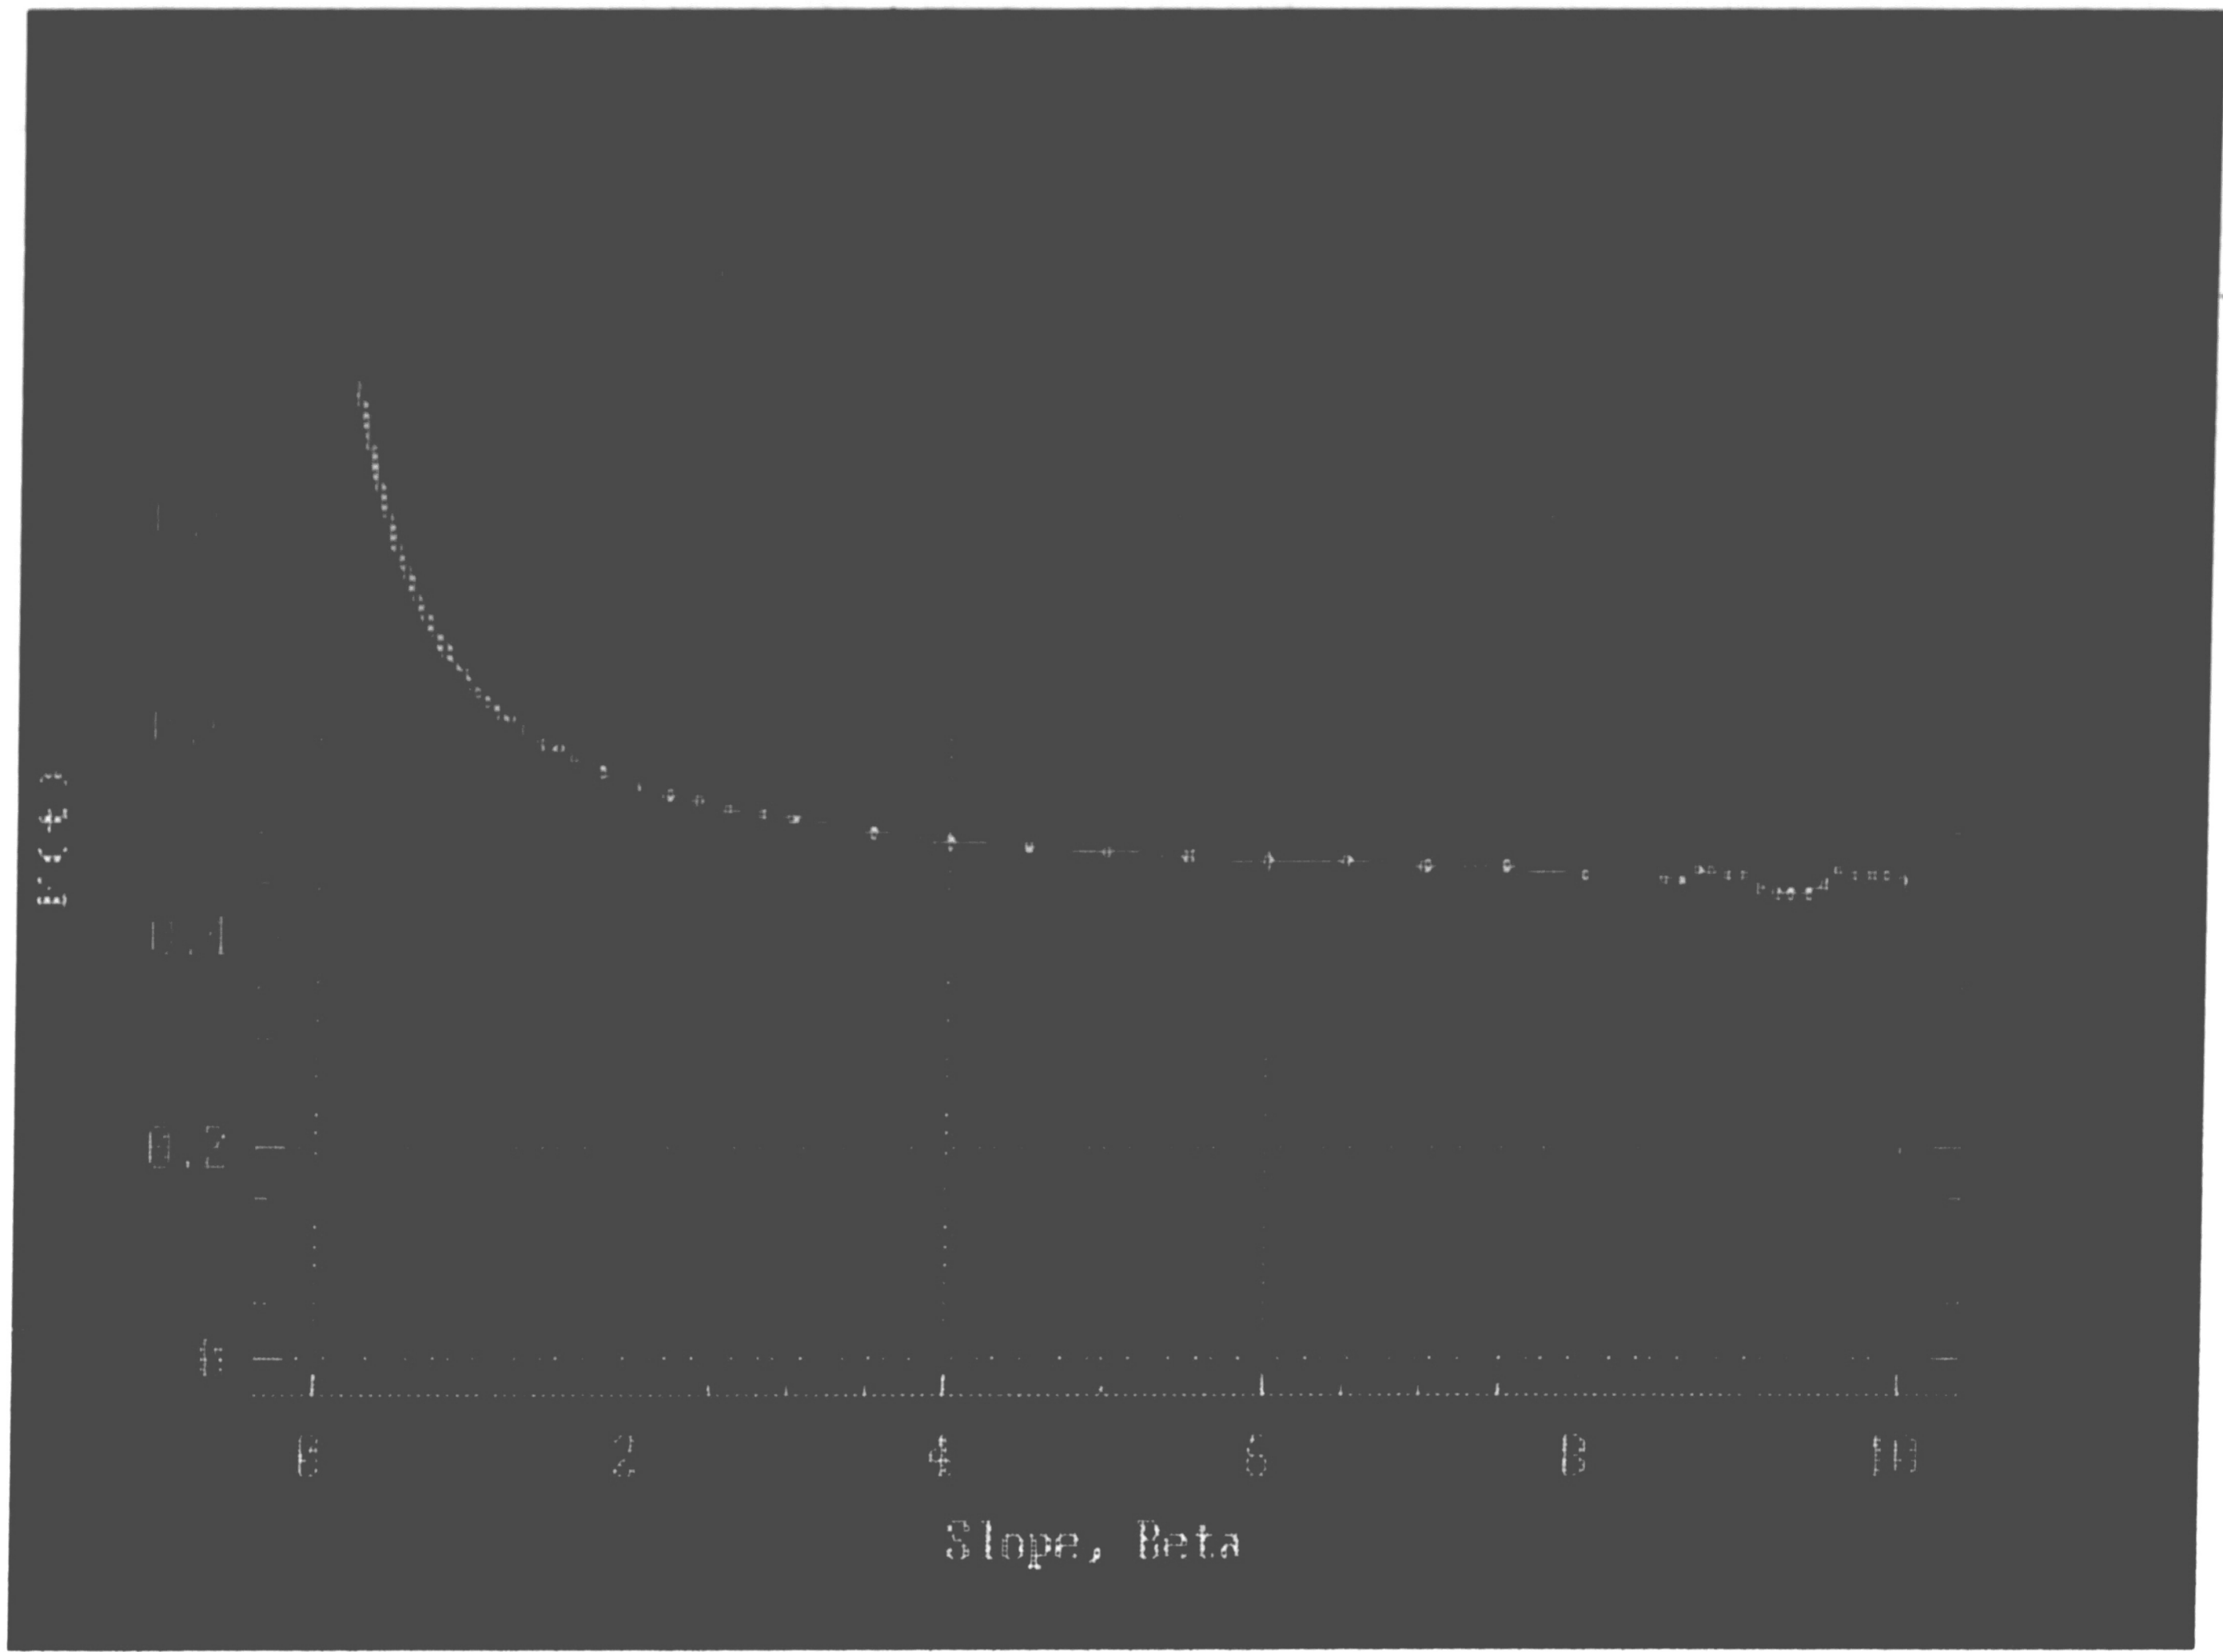
Using equations (6) & (7), $F(t)$ can also be plotted, see Figure 4.

Figure 4. Cumulative Failure, F_{MTTF} , Plot

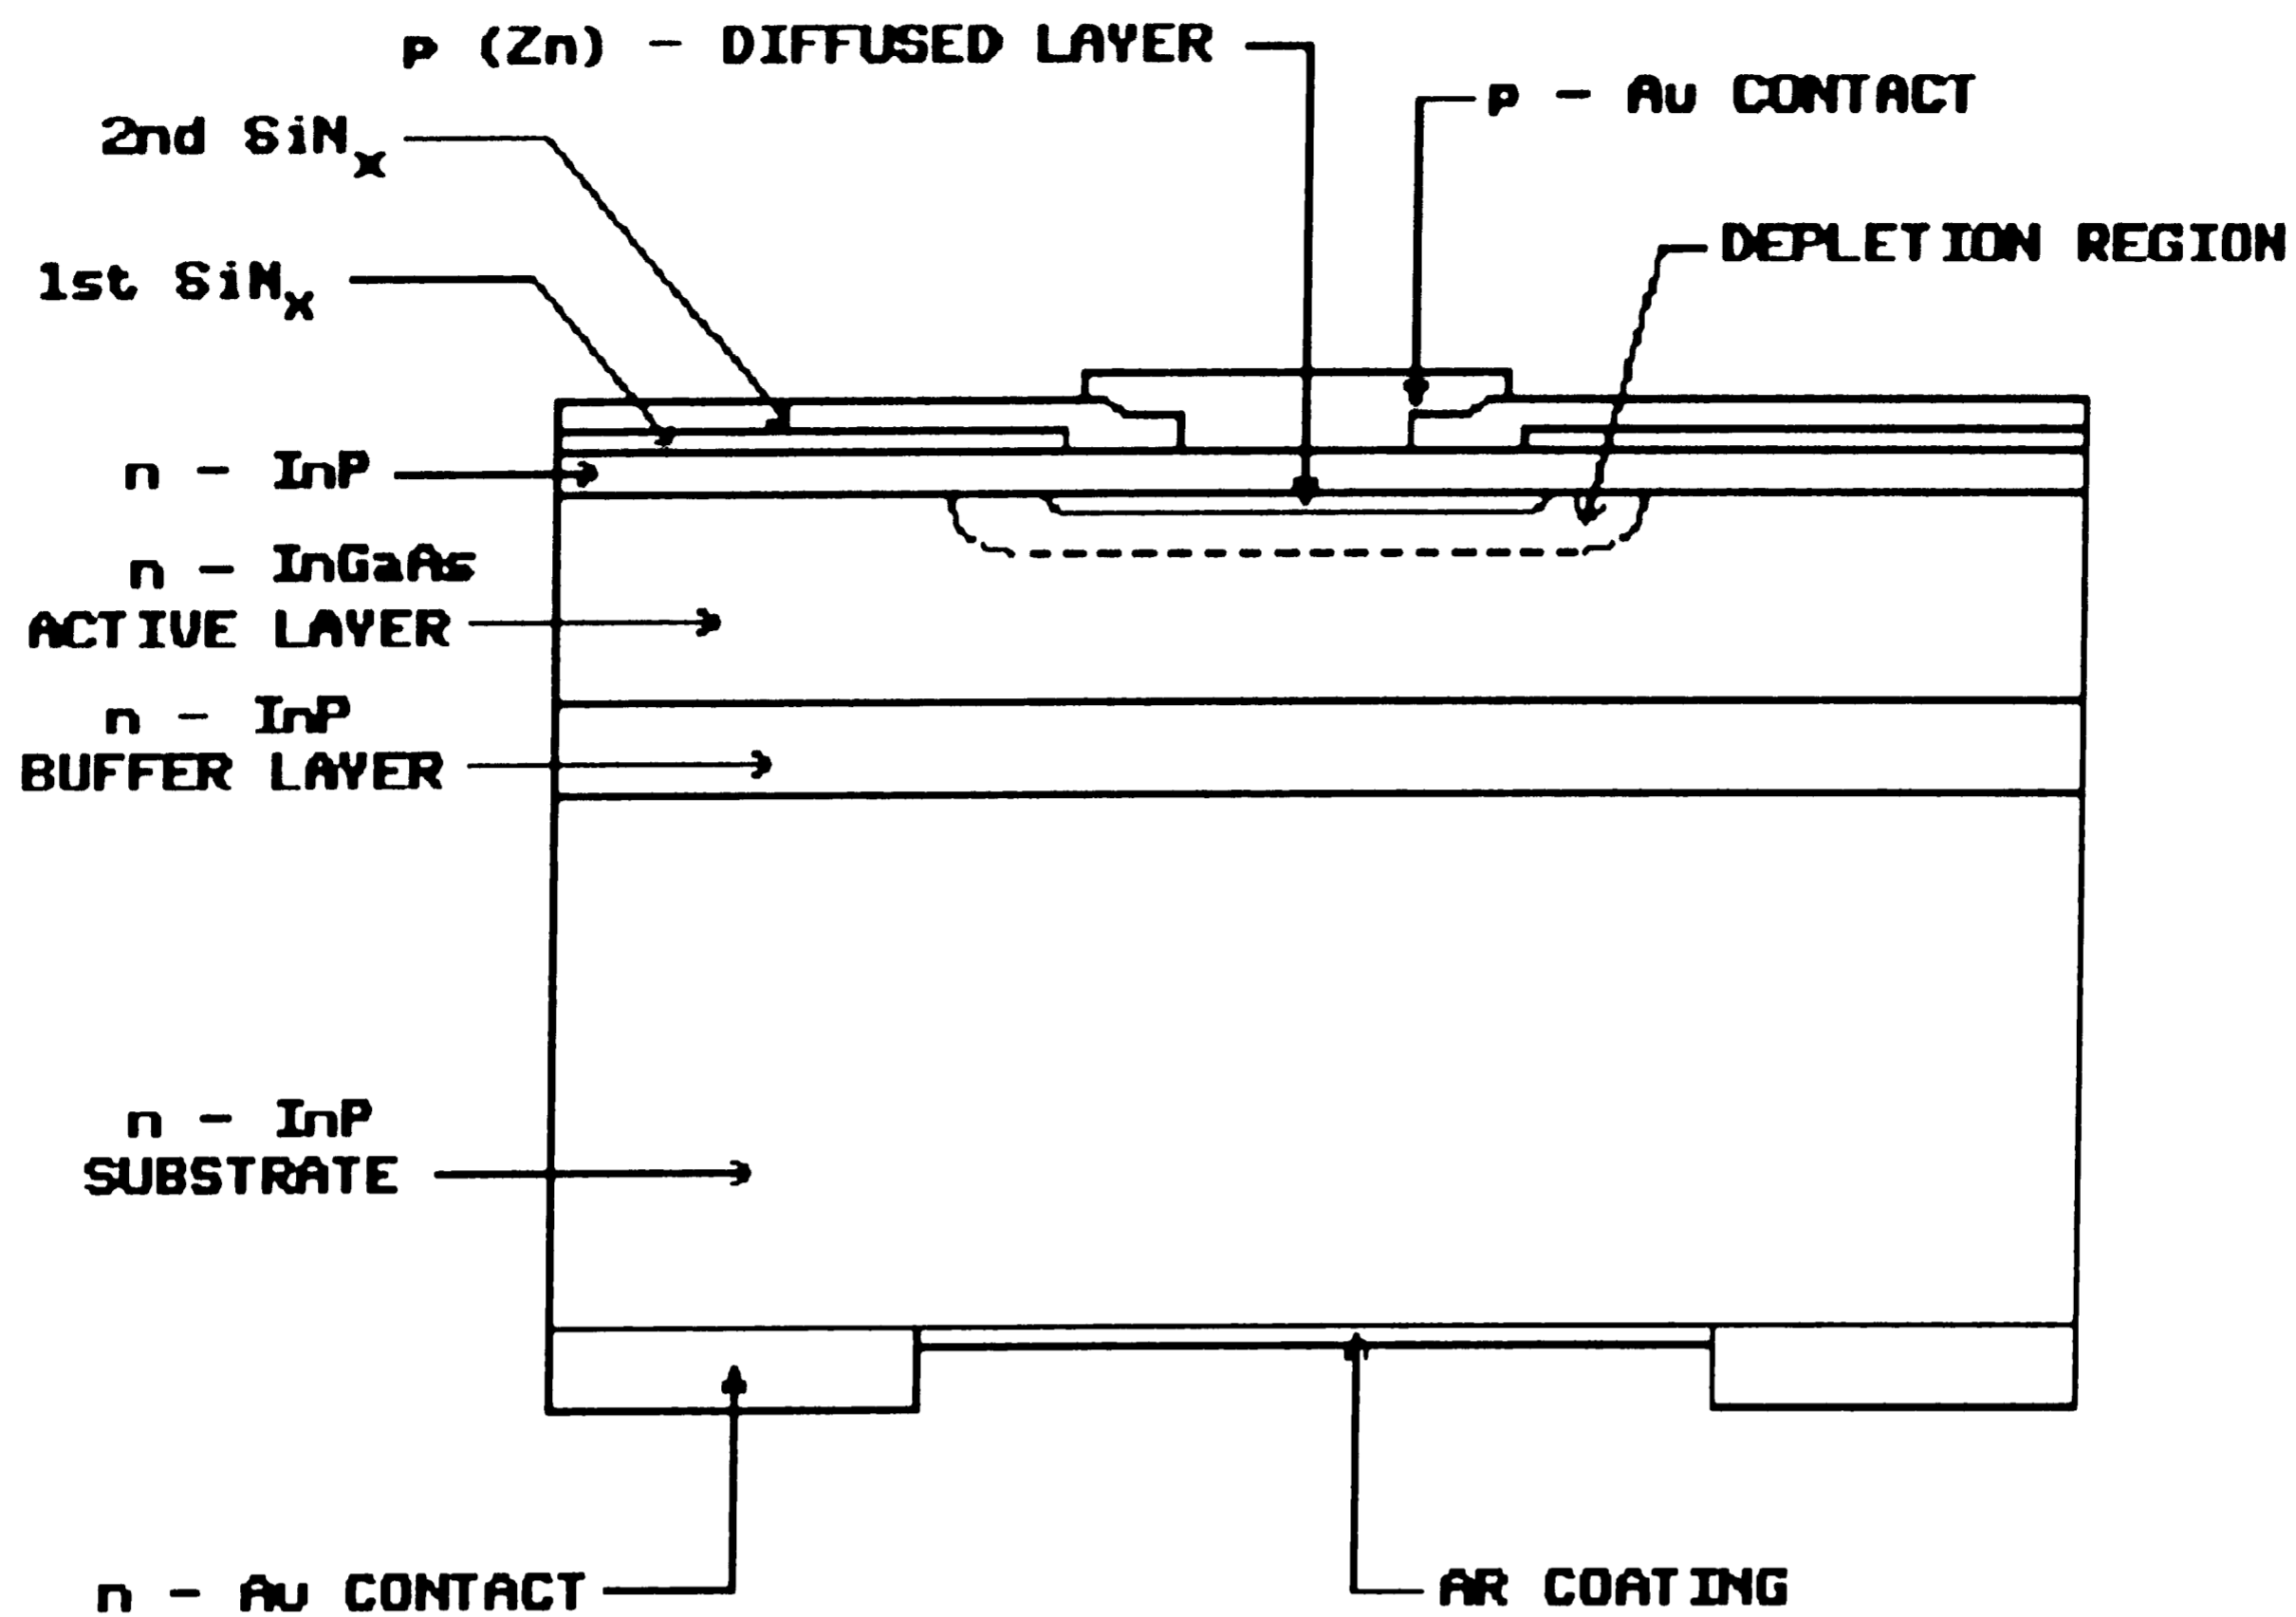
All InGaAsP pin photodetectors manufactured at AT&T have the same basic device structure. As can be seen in Figure 5 it is composed of a n doped InP substrate. The epitaxial layers are grown on top of the substrate using an Vapor Phase Epitaxial, VPE, growth technique composed of a slightly less n doped InP buffer layer and an intrinsic InGaAs active layer. The last three layers are the n doped InP cap layer, two silicon nitride layers one for diffusion masking the heavily p (Zn) doped junction and one to act as a anti-reflection/passivation layer with a Au ohmic contact centered over diffused region. The doping concentrations and layer thicknesses are in line with work published by AT&T Bell Laboratories engineers [26].

Figure 5. Structure of AT&T pin photodiode

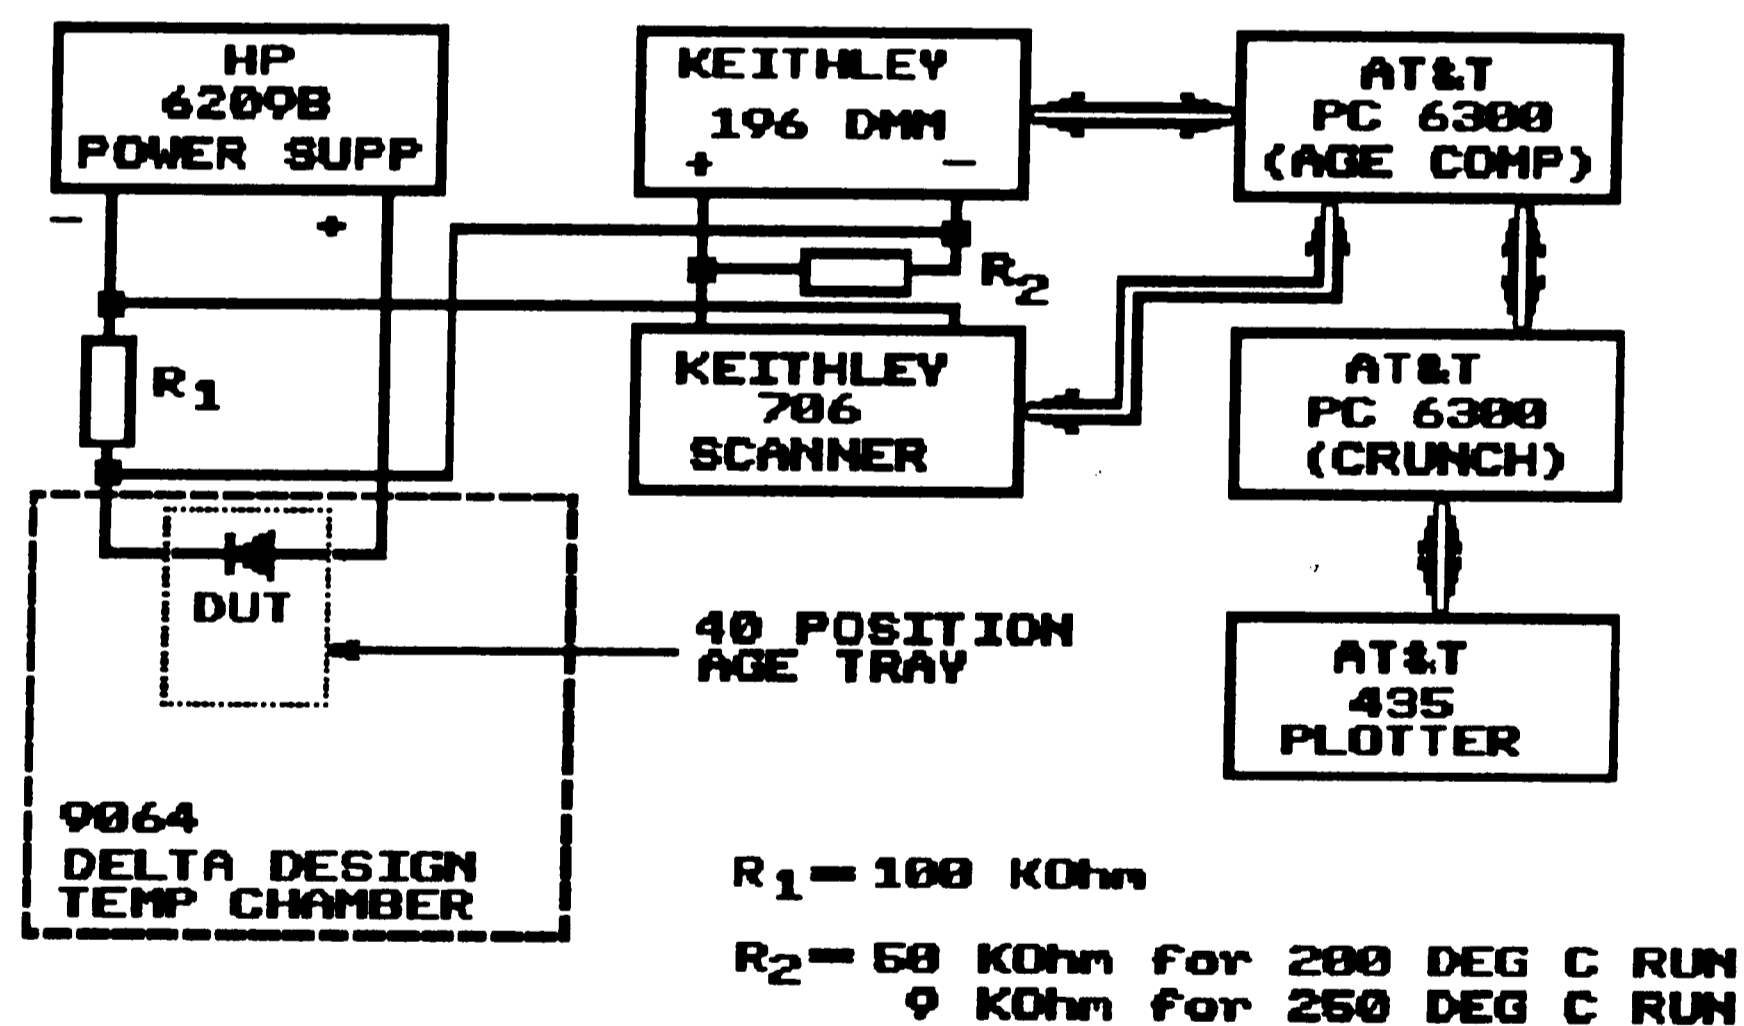
200 & 250 degree Celsius operation respectively to allow the leakage currents to increase as the devices age without affecting the measurements. Delta Design 9064 chambers were used to bring the devices to temperature and hold to a ± 0.5 °C accuracy. The chambers used liquid nitrogen to return the devices to room temperature for periodic dark current measurements.

An additional AT&T PC 6300, "crunch" computer, is networked with each age computer with an IEEE-488 card. It's sole responsibility is to gather data during and after each aging run and to plot the age data.

Diagram 1. Long Term Aging System Configuration

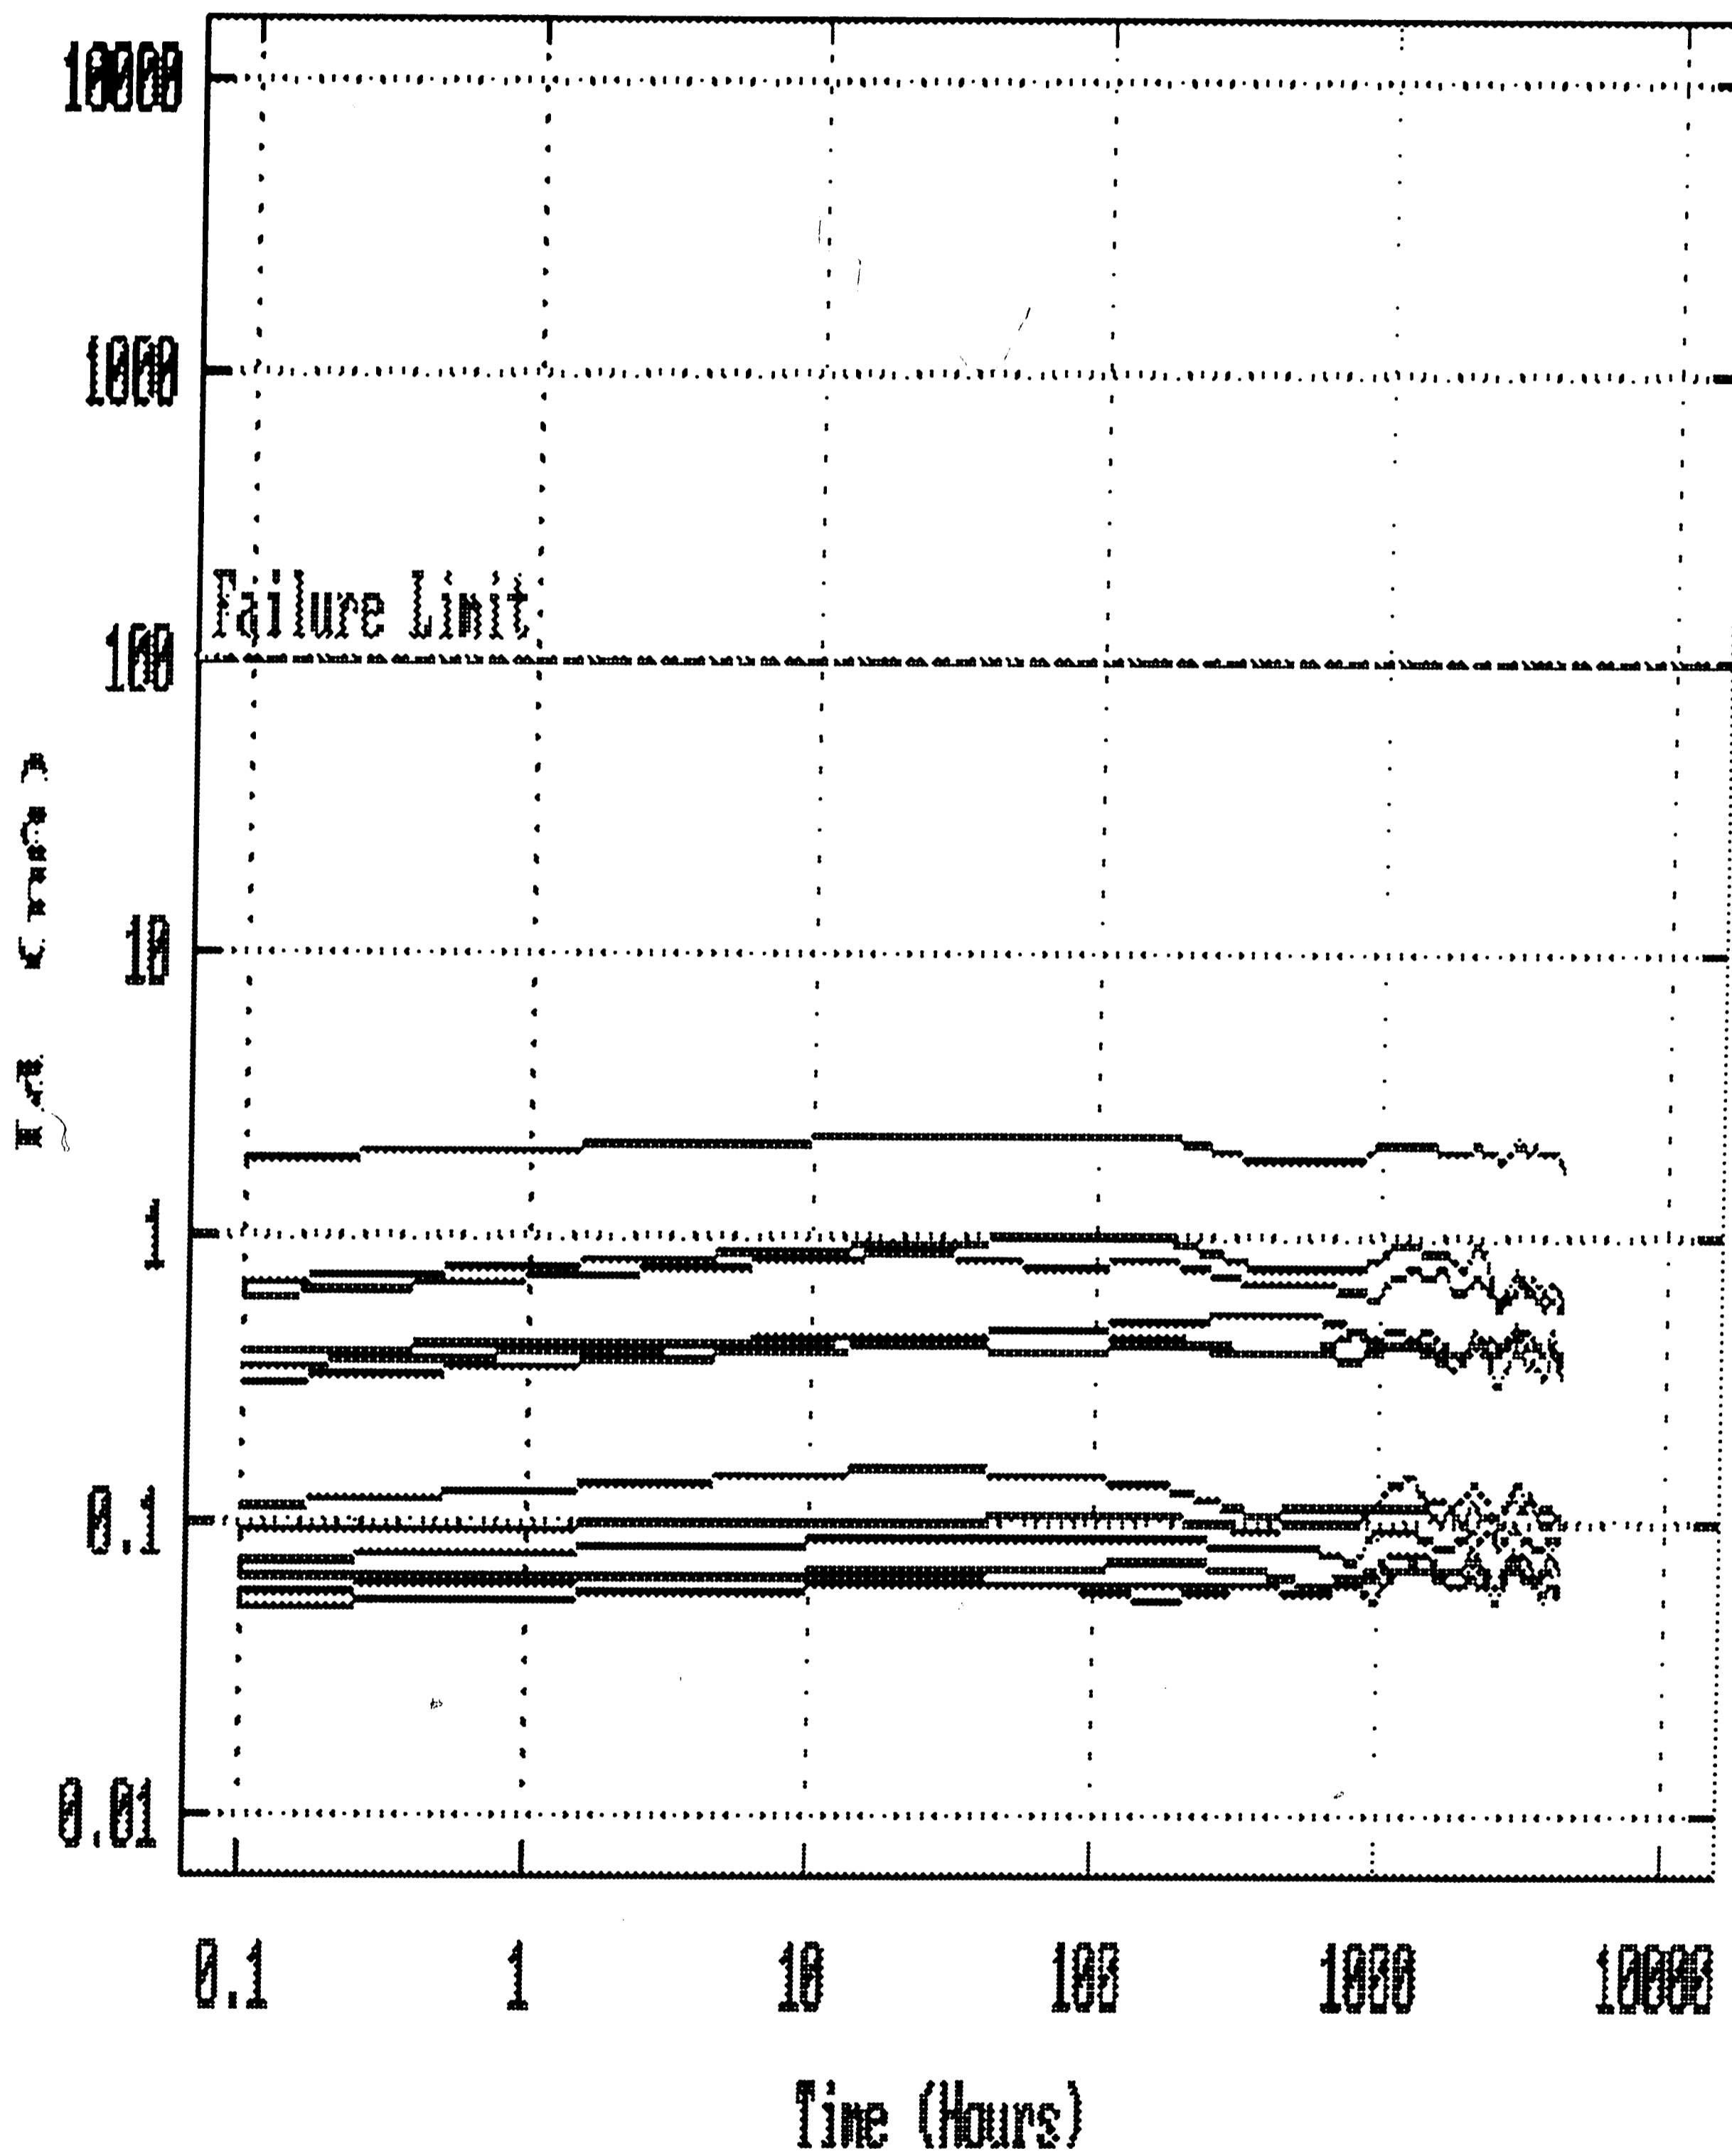
Figure 14(a) Dark Current for 76 μm Diameter Junction Device @ 200 Degree Celsius, High dI/dV Noise

Figure 14(b) Dark Current for 76 μm Diameter Junction Device @ 200 Degree Celsius, Mid dI/dV Noise

Figure 14(c) Dark Current for 76 μm Diameter Junction Device @ 200 Degree Celsius, Low dI/dV Noise

Figure 15(a) Dark Current for 254 μm Diameter Junction Device @ 200 Degree Celsius, High dI/dV Noise

Figure 15(b) Dark Current for 254 μm Diameter Junction Device @ 200 Degree Celsius, Mid dI/dV Noise

Figure 15(c) Dark Current for 254 μm Diameter Junction Device @ 200 Degree Celsius, Low dI/dV Noise

As mentioned earlier dI/dV measurements were taken at $t=2470$ hours for the 200 Degree Celsius group and $t=2307$ hours for the 250 Degree Celsius group. The 200 Degree Celsius group has not shown any failures after 4303 hours. Comparing the dI/dV traces for both $t=0$ and $t=2470$ there is no apparent change in the shape or amount of noise present in both the I-V or the dI/dV curve. Figures 14-16 displays the dark current readings for the 200 Degree Celsius group taken for each junction size and noise category used in the study. The dark current readings are extremely stable for all groups of devices regardless of junction size and cumulative dI/dV noise.
