MOISTURE DEGRADATION OF OPEN-FACED SINGLE LAP JOINTS

L. Goglio[#], M. Rezaei and M. Rossetto

Dipartimento di Meccanica, Politecnico di Torino

Abstract

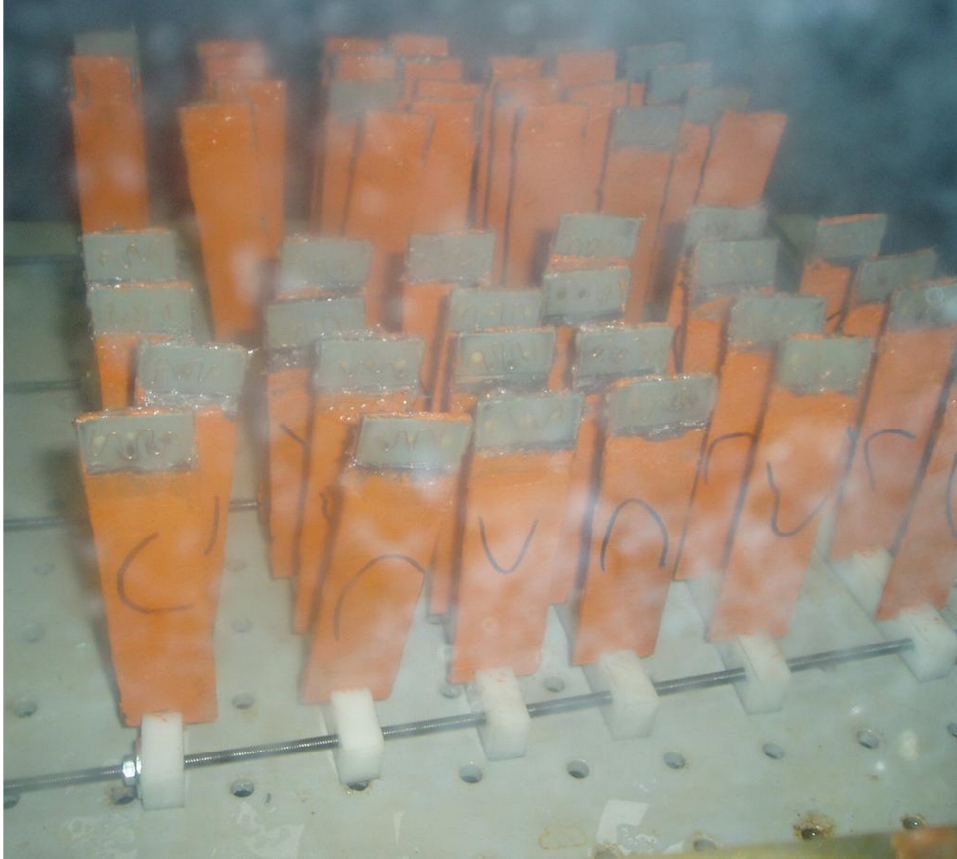
Fig. 4. Open-faced specimens during exposure to humid and warm environment.

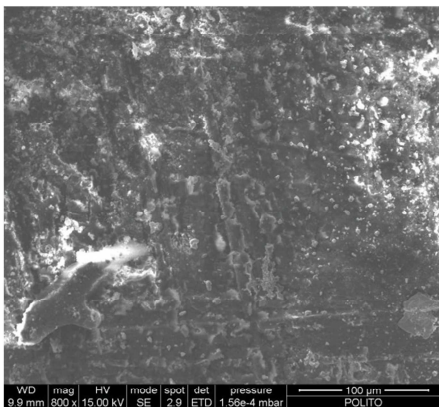
Fig. 8. SEM images (left) and EDX spectra (right) related to the fracture surfaces of unexposed specimens: a) uncontaminated case; b) contaminated case.

The SEM images of the fracture surfaces and the EDX spectra of the unexposed joint (as noticed previously, in this case fracture occurs in the combined adhesive layer) are shown in Fig. 8. The aspects of the surfaces are similar, as well as the element content related to the adhesive composition (note that Ag is added by the metallization process required for SEM observation).
