Stabilization of earthen plasters: Exchange of knowledge and experiences between Italy and Morocco

Stabilization of earthen plasters: Exchange of knowledge and experiences between Italy and Morocco / Mattone, M.; Ibnoussina, M.; Rescic, S.; Fratini, F.; Magrini, D.; Mecchi, A. M.; Nocairi, M.. - In: JOURNAL OF MATERIALS & ENVIRONMENTAL SCIENCE. - ISSN 2028-2508. - ELETTRONICO. - J. Mater. Environ. Sci.:7(10)(2016), pp. 3647-3655.

## Stabilization of earthen plasters: Exchange of knowledge and experiences between Italy and Morocco

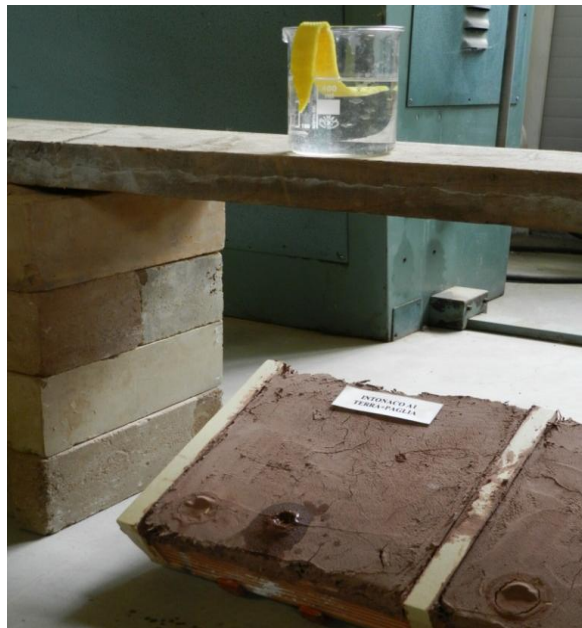
The Geelong test is based on the measurement of the samples' erosion caused by the repeated impact of a water drop (from an height of 400 mm and for a total of 100 ml) on the tested surface which is placed at an angle of nearly 30° to the horizontal (Figure 1). The evaluation is done by measuring the cavity depth due to the impact of the water drop on the surface.

**Figure 1:** The Geelong test (Manuela Mattone).

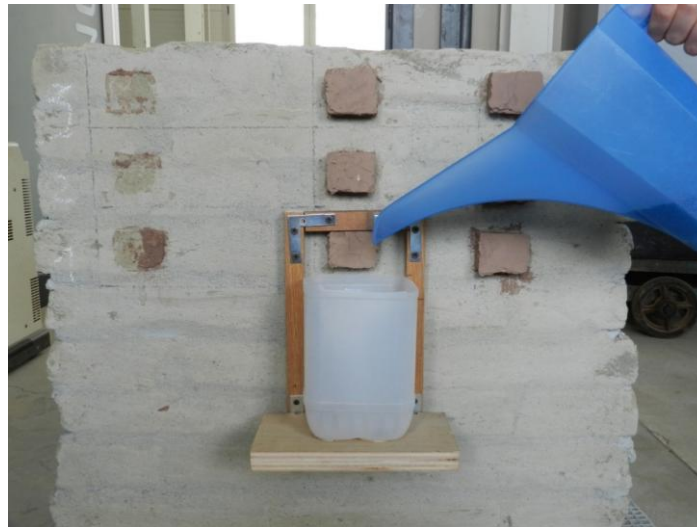
In order to evaluate the bond of the plasters to the wall, shear tests were conducted according to what suggested in recent researches (Hamard et al., 2013). Three specimens (size 40x50x20 mm) of each kind of plaster were prepared. The shear test measures the load necessary to make the specimen fail. Each specimen was loaded with little lead balls until fail, using a special device (Figure 2). The load at which the sample fails was recorded. It was possible to evaluate the average shear stress ( $\tau$ , N/mm<sup>2</sup>) of each plaster considering the failure load ( $m_f$ , Kg) and the surface ( $S$ , mm<sup>2</sup>) of the samples since  $\tau = m_f \times g / S$ , where  $g = 9.81 \text{ m/s}^2$ .

**Figure 2:** The shear test device (Manuela Mattone).

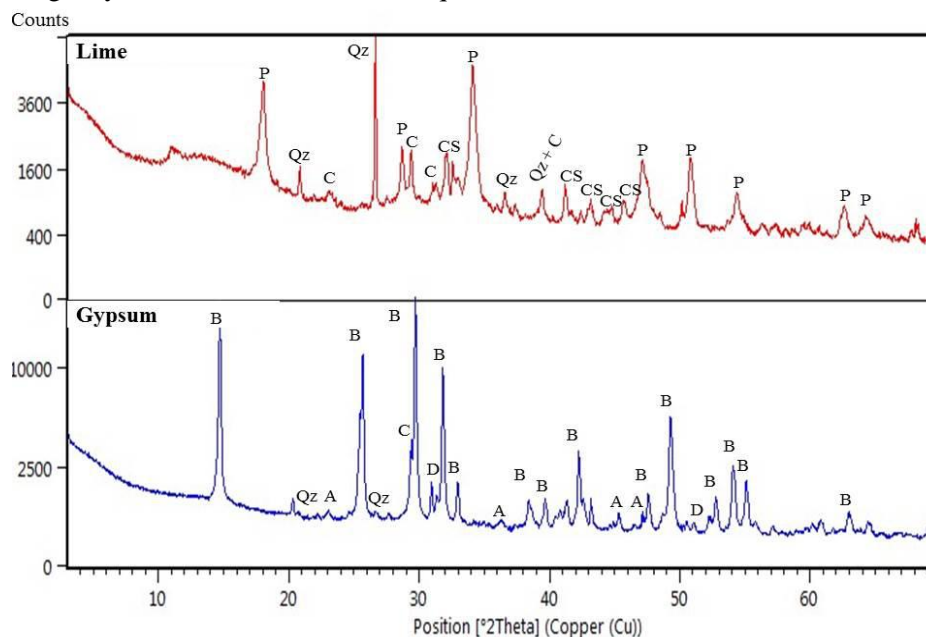
**Figure 3:** XRD spectra of Moroccan lime and gypsum. Calcium silicate (larnite) is a typical compound of hydraulic lime (P=portlandite; CS=calcium silicate; B= bassanite; A= anhydrite; Q=quartz, C=calcite, D=dolomite).

The mineralogical investigation made it possible to verify that the gypsum can be ascribed to a “soluble anidrite” while the lime is a natural hydraulic lime due to the presence of  $\beta$ -calcium silicate (larnite). After 28 days of curing, as new mineralogical phases, we have evidenced the presence of calcite in earthen plaster stabilized with lime and presence of calcite in earthen plaster stabilized with gypsum (Fig.4). Hydraulic phases due to hydration of larnite (CS) or pozzolanic reaction between calcium hydroxide (portlandite) with clay minerals have not been identified (may be due to amorphous state or low crystallinity).

The composition of the Moroccan starting materials carried out by XRD analysis is described in Table 3 and Figure 3.

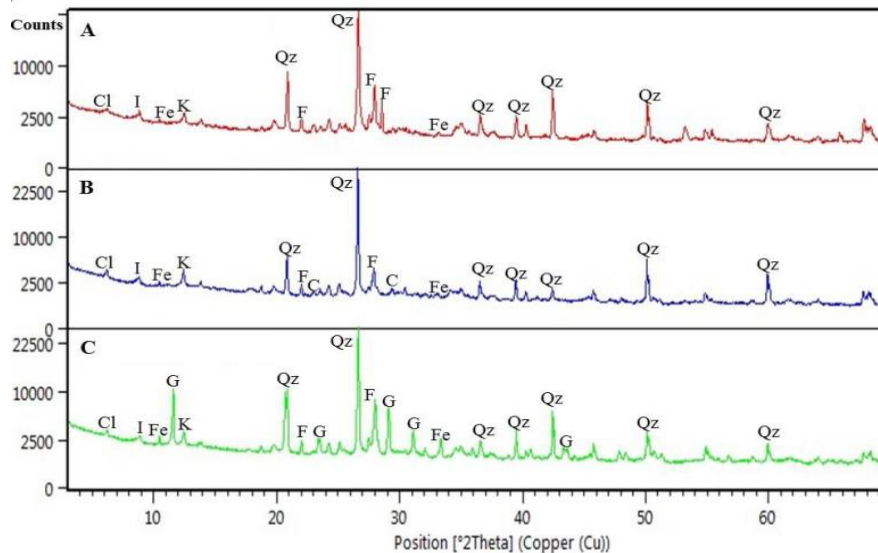
**Figure 4:** Comparison among XRD spectra of earthen plaster made with only earth (A) earth + lime (B) and earth + gypsum (C). Qz=quartz, F=feldspars, C=calcite, D=dolomite, P=portlandite, I=illite, K=kaolinite, Cl=chlorite; G= gypsum, Fe= iron oxides.

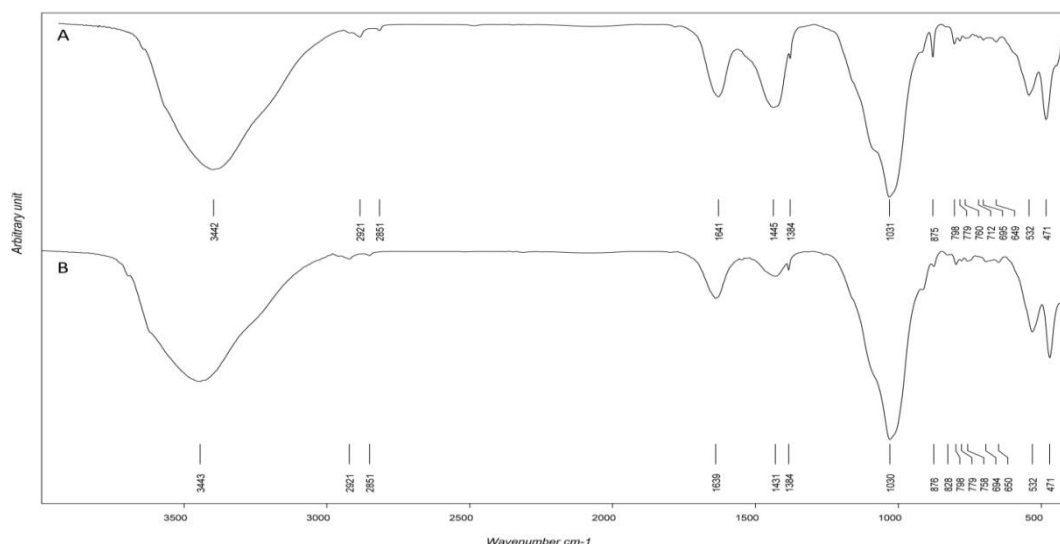
**Figure 5:** Mid -IR spectra: comparison between sample of earth with lime (graph A) and sample of only earth (graph B).

The spectra are very similar and IR bands are comparable. In particular, in both spectra, the following peaks are present: symmetric and asymmetric stretching of Si-O ( $800-1000\text{cm}^{-1}$ , silicates) and, specifically, a high peak at  $1030\text{cm}^{-1}$  attributable to stretching of Si-Al-O (aluminosilicates); deformation of  $\text{SiO}_4$  tetrahedron ( $400-500\text{cm}^{-1}$ , silicates) (Hanke, 1986); asymmetric stretching of  $\text{CO}_3^{2-}$  ( $1400-1500\text{cm}^{-1}$ , carbonates) and a shoulder

of bending out-of-plane of  $\text{CO}_3^{2-}$  ion ( $875\text{cm}^{-1}$ , carbonates) (Hunt 1971); bending H-O-H of molecular  $\text{H}_2\text{O}$  ( $1640\text{cm}^{-1}$ ) and -OH stretching vibration of  $\text{H}_2\text{O}$  ( $2800\text{--}3700\text{cm}^{-1}$ ) (Williams, 1966). It should be noted that, the main vibrations characteristics of C-S-H compounds (peak at  $\sim 970\text{cm}^{-1}$  and two shoulders at  $\sim 1060\text{cm}^{-1}$  and  $900\text{cm}^{-1}$ ), related to Si-O stretching vibrations of the Q2 tetrahedra (Trezza, 2007, Yu, 1999), are not visible (probably they are hidden by the broad band of silicates at  $800\text{--}1000\text{cm}^{-1}$ ).

In Figure 5 the results of mid -IR investigation carried out on earth - lime samples (graph A) compared to those obtained from the earth ones (graph B), are shown.

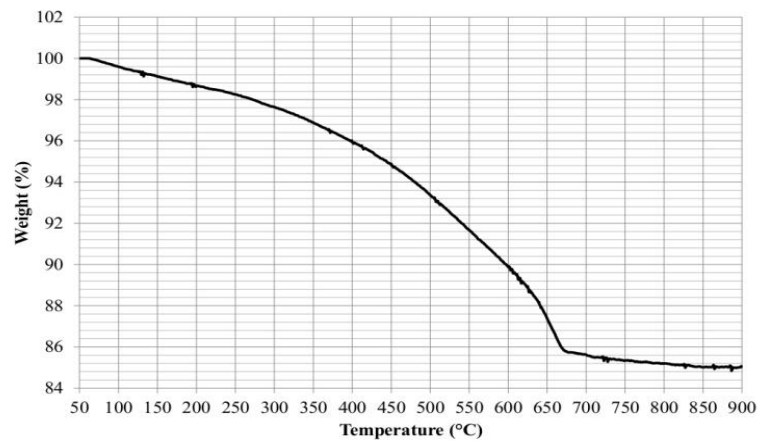
**Figure 6:** Thermogravimetric curve of sample of earth with lime (plaster B).

The thermogravimetric curve (Figure 6) indicates that the dehydration of the earth + lime sample occurs in more stages:  $60\text{--}110^\circ\text{C}$  loss of absorbed water;  $130\text{--}190^\circ\text{C}$  loss of water from calcium silicate hydrates (CSH) (Eskander et al, 2012);  $250\text{--}450^\circ\text{C}$  loss of water from different stages of dehydration of C-S-H and calcium aluminate hydrates, and loss of water from dehydration of interlayer water of clay minerals (Eskander et al, 2012; ěč et al, 2013; Plante et al., 2009);  $450\text{--}600^\circ\text{C}$  expulsion of OH-ion from the clay mineral lattice (dehydroxylation) (Plante et al., 2009);  $600\text{--}680^\circ\text{C}$  dehydroxylation of clay mineral and initial stage of decomposition of carbonates ion associated with calcite (Eskander et al, 2012);  $680\text{--}900^\circ\text{C}$  decomposition of carbonate ions of calcite (Eskander et al, 2012). It should be noted that this analysis is the only one that allows to evidence the presence, as expected, of products of larnite's hydration.

The result of the thermal analysis carried out on the sample of earth - lime plaster (B) is shown in Figure 6.

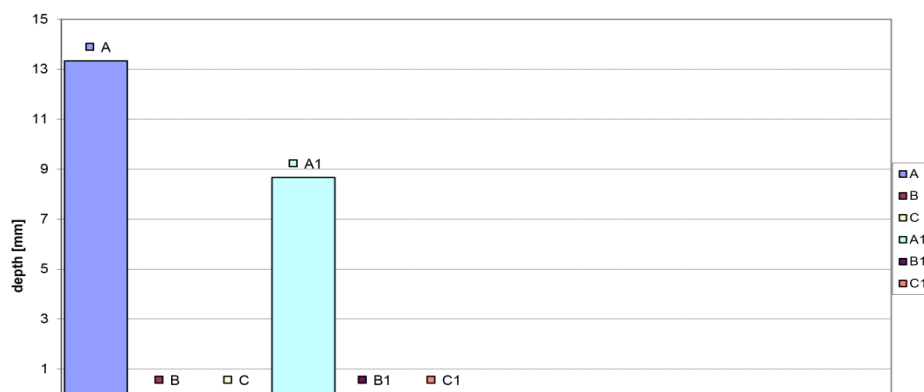
The Geelong test shows that, except for the earthen plasters (A and A1) which failed, all the other tested samples were not eroded at all (Figure 7). Concerning the Spray test as well (Figure 8) higher erosion resistance is evidenced for the stabilized earths. In particular, the erosion is none for the plasters stabilized with lime (B and B1).

**Figure 7:** Diagram showing Geelong test results (in ordinates is the depth of erosion)

The performance tests carried out in laboratory show that, with regard to water resistance (determined with the Geelong test and spray test), the addition of lime gives the best results. To be noted however that the plaster with no additives has not withstood the test.

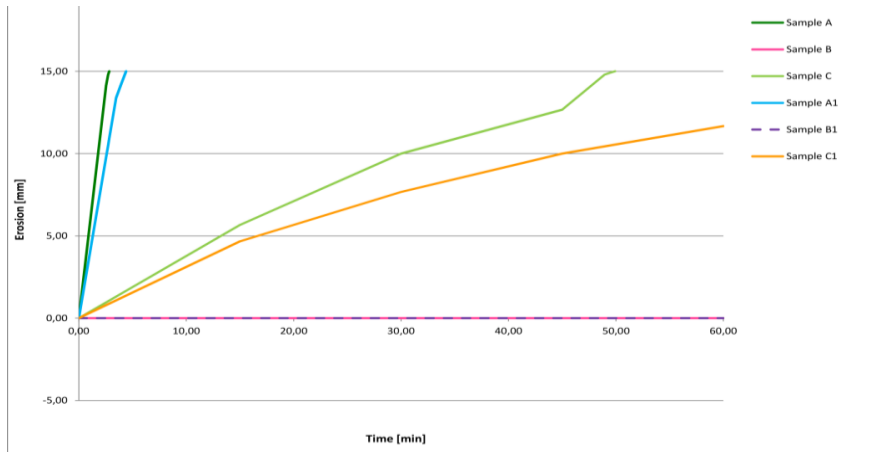
Figure 8: Diagram showing the erosion spray test results

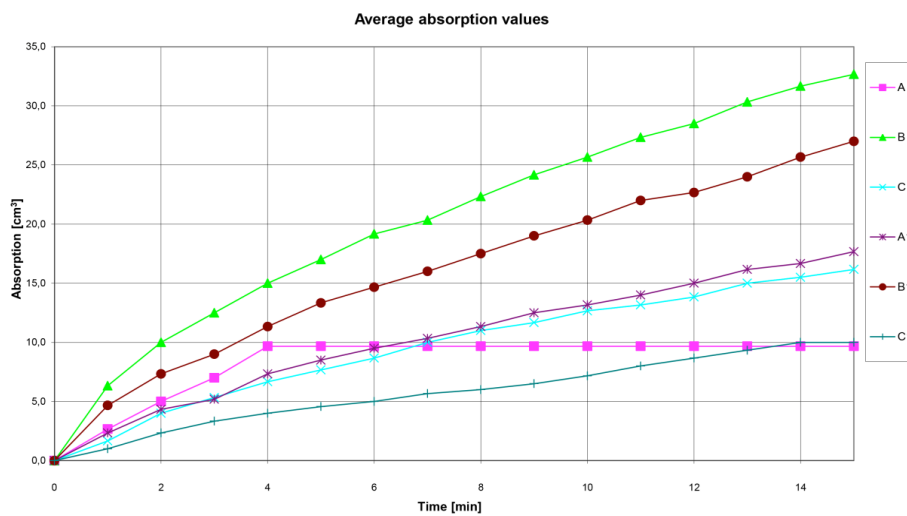
The water absorption test shows that, while gypsum (C and C1) reduces the rate of water absorption, the lime (B and B1) determines an increase of absorption with respect to the earth plaster (A) and the earth + straw (A1) (Figure 9).

Figure 9: Diagram showing the water absorption test results.

With regard to the capillary absorption capacity, the values obtained show that gypsum has reduced it while the addition of lime has made the plaster more absorbent. With regard to shear tests, the presence of straw generally worsens the behaviour, while for gypsum and lime, the best performance has been obtained by the first one. Regarding the permeability to water vapour, it keeps almost unchanged in all the plasters.

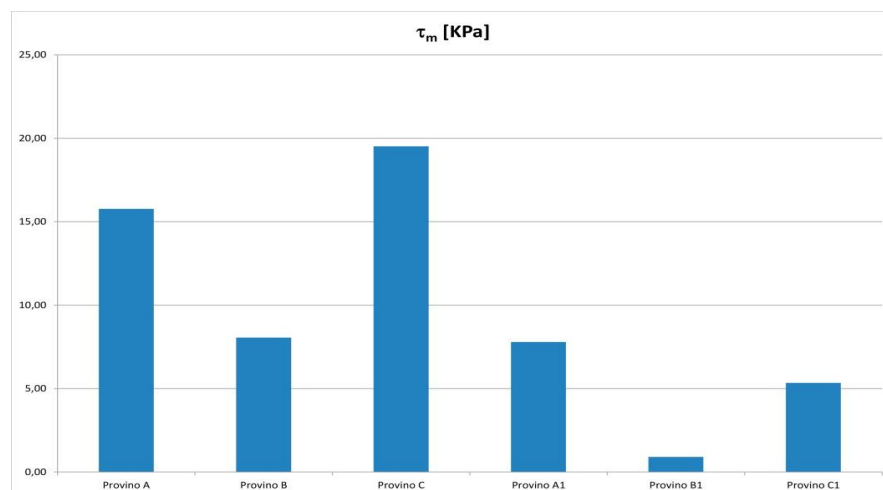
The shear test point out that all the plasters made with straw (A1, B1, C1) are characterized by a lower shear strength compared to the others (Figure 10). The higher shear strength was obtained for the plaster stabilized with gypsum (C). However the results are quite scattered, which could be due both to heterogeneities of the wall and to the dimensions of the samples that makes it difficult to guarantee a good application of the coating. Therefore, the shear strength should be evaluated preparing more samples and increasing their size.

Figure 10: Shear test to evaluate the bond of the plasters to the wall ( $\tau_m$ [KPa]).
