Multitemporal 3D modelling for cultural heritage emergency during seismic events: Damage assesment of S. Agostino church in Amatrice (RI)

## MULTITEMPORAL 3D MODELLING FOR CULTURAL HERITAGE EMERGENCY DURING SEISMIC EVENTS: DAMAGE ASSESMENT OF S. AGOSTINO CHURCH IN AMATRICE (RI)

**KEY WORDS:** UAV photogrammetry, multi-temporal model, structural assessment, seismic emergency, Cultural Heritage

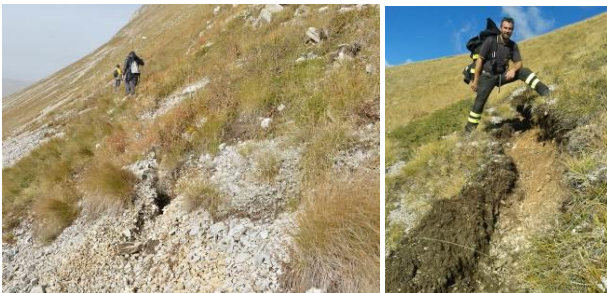
Figure 1. The Fault of Mt. Vettore before the earthquake of Norcia (Left) and after (right)

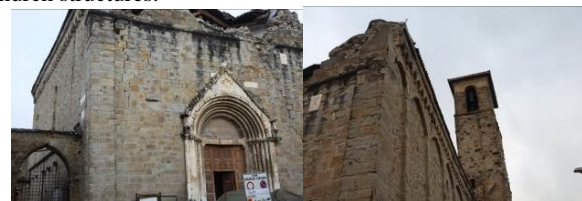
Figure 3. Two terrestrial images acquired in the first campaign

The first reconnaissance (5<sup>th</sup>- 9<sup>th</sup> of September) performed after the earthquake of Amatrice (24<sup>th</sup> of August) allowed to acquire a terrain dataset of the S. Agostino church with some topographic measurements as well. The images were acquired by a Nikon D800E reflex digital camera equipped with a 24x36mm frame. The camera has a 36 Mpx full-frame CMOS sensor with a pixel size of 4.89µm. The images (7360 x 4912 pixel) have been acquired from almost 8 m, then were post processed for balancing light and colours and masked for the next processing steps. The access to the area was, during this first campaign, very short since the area was in the red zone. Only images of the main façade (south), west and bell tower were recorded since in the other parts the entrance was forbidden according to the instability of the church structures.

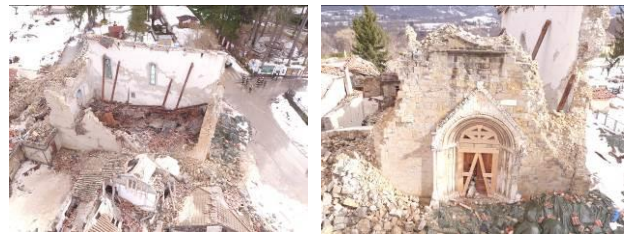
Figure 5. Oblique image of the Sant'Agostino Church; the top of the bell tower and the collapse after the Norcia earthquake; the structure after the January seismic events

As one can clearly deduce from the previous paragraph, the extremely poor balance situation was definitively exceeded after the sequence of three earthquakes occurred at 9:25 (M5.1), 10:14 (M5.5) and 10:25 (M5.4) on the 18<sup>th</sup> of January 2017. This new seismic swarm produced the collapse of the belt tower, the east and south façades and an important increasing of the damages on the main façade. The west part of the church is still preserve although very important damages are clearly recognizable on the structure.

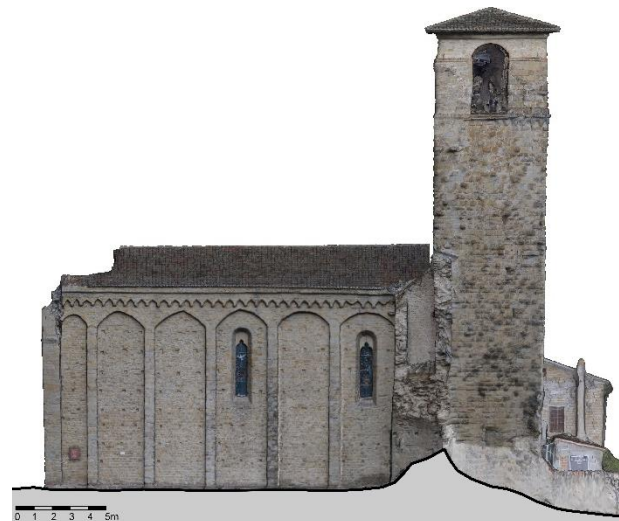
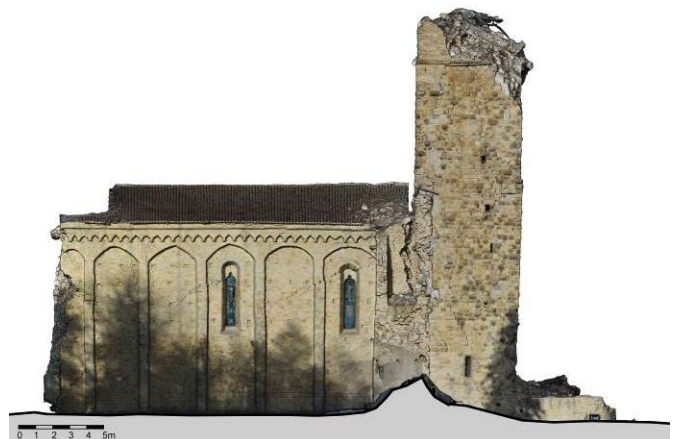
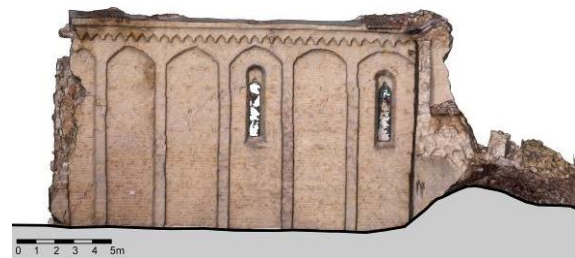
Figure 7. Orthophoto of East wall. Top: September (t1); centre: December (t2); down: January (t3)

As is possible to deduce from the orthophotos of the west façade realized according to the three employed dataset (t1, t2 and t3) showed in the next Figure 7, the influence of the sunlight seriously affect the radiometry of the final output. Despite an image pre-processing that as usual was performed for the acquired images, especially in the DJI sensor is very difficult to correct those effects. Some analysis are ongoing in the research group according to the national and international research on this topic (He et al., 2013; Milanfar, 2013; González-Aguilera et al., 2016) in order to define the better strategy for image pre-processing.

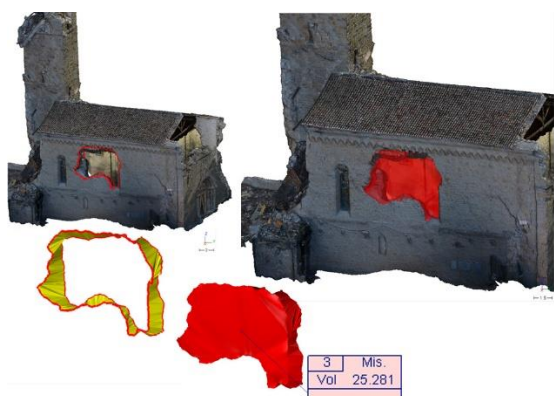
Figure 12. Analysis on West wall where the damage mechanisms caused the collapse of the central part of the masonry by shear failures.

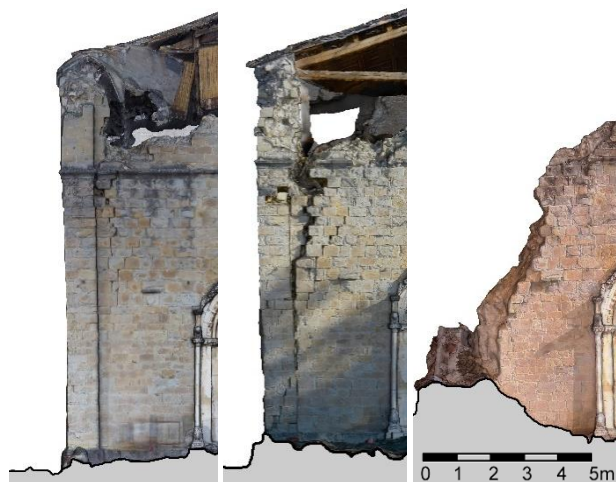
Figure 14. Orthoimages of the main façade in t1, t2, t3.

In this specific focus on the left connection with the West wall (Figure 14) the progressive evolution of collapse a series of break lines traces were detected in t1 in relation to the ones identified in t2 before the decisive collapse.

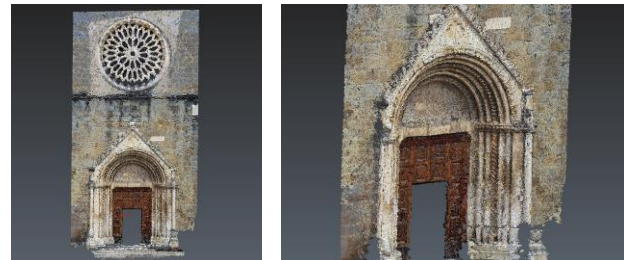
Figure 17. First test of point cloud generation of the portal before the earthquakes

In March 2017, we started a new project to evaluate if it would be possible to create a 3D model of the church of S. Agostino through an online campaign of crowdsourcing. In the first phase of the project we wanted to evaluate the type of images that were online available for the church and the quality of the results we can expect. We performed some researches on the major online platforms for the storage and sharing of images and we selected a set of around 20 images. The images were selected depending on size, quality and presence of metadata and were all focussed on the decorated portal of the church. The same solution for SfM (Agisoft Photoscan) was used in this first phase and some encouraging results have been reached (Figure 17).
