UAV strategies validation and remote sensing data for damage assessment in post-disaster scenarios

UAV STRATEGIES VALIDATION AND REMOTE SENSING DATA FOR DAMAGE ASSESSMENT IN POST-DISASTER SCENARIOS

KEY WORDS: UAV photogrammetry, Rapid Mapping, Remote Sensing, Seismic emergency, 3D models, Damage assessment

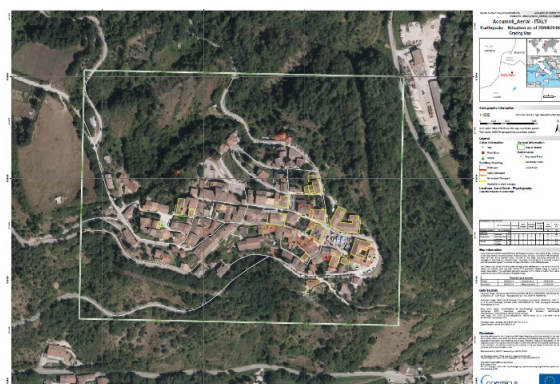
Figure 1. Post-event Grading Map for Accumoli (RI), Italy.

Aerial image from © European Commission (acquired on 25/08/2016, GSD 0.1m, 0% cloud coverage) provided under COPERNICUS by CGR, *Compagnia Generale Riprese aeree*.

Once the service is activated, three different products as is reported in (Boccardo, 2013) could be obtained: *reference maps*, *delineation maps* and *grading maps* (Figure 1 provide an assessment of the damage grade and of its evolution if requested. In this specific paper the focus will be oriented to the produced grading maps in the area of central Italy that are available, according to the EMS rapid mapping procedure, in a time range between 3 and 12h.

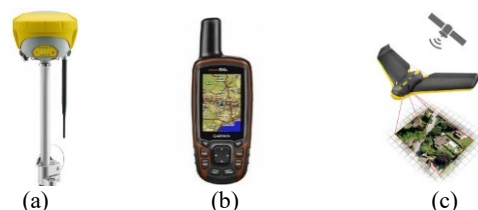
Figure 4. Tested strategies for georeferencing the UAV photogrammetric blocks. (a) GNSS RTK Geomax Zenith35 receiver, ~10.000€; (b) Garmin GPSMAP® 64s handheld receiver, ~300€; (c) exterior orientation associated to the UAV images by *GeoTag*.

The use of consumer grade GPS/GNSS handheld receiver, Figure 4(b), has proved to be faster than the traditional RTK procedure, involving undoubtedly cheaper and easy-to-use instruments; however, this won't firstly overcome the related safety issues, as the operator will have to traverse dangerous areas anyway. The comparison of residual errors on check points (CPs), in Table 4, has been performed on the cartographic product, separately computed by use of GCPs measured by the two GNSS receivers, the geodetic RTK and the handheld receiver. The results demonstrated the expected problem of accuracy, in meters magnitude, affecting those types of receivers.

The use of the positioning information embedded in the acquired UAV images as exterior orientation, Figure 4(c), can be another valuable solution in case of impossibility to directly measure GCPs on the ground. The UAV device used in this case is the eBee™ Basic version, equipped with consumer GPS on board receiver; neither the RTK version nor the recent PPK version have been tested. It can provide, by the so-called *geotag*, the exterior orientation, i.e. the direct georeferencing of image shooting position. The comparison of the parallel use of geodetic GNSS receiver and images *geotag* is performed and validated, as reported in Table 5, and show more limited errors results in comparison with those ones from Table 4.

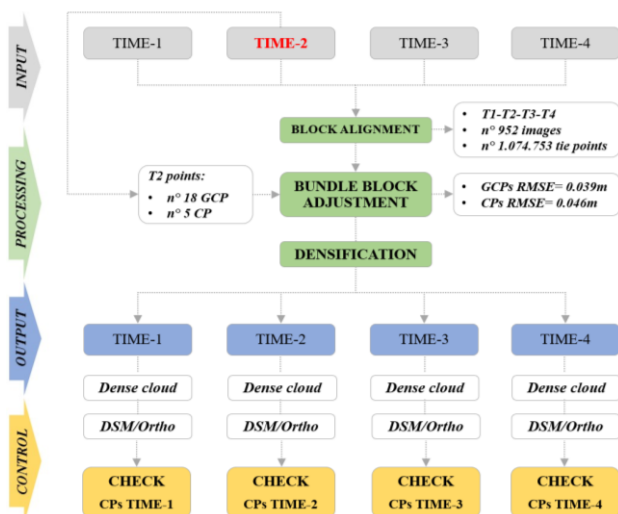
Figure 7. Ad-hoc workflow for multi-temporal co-registration

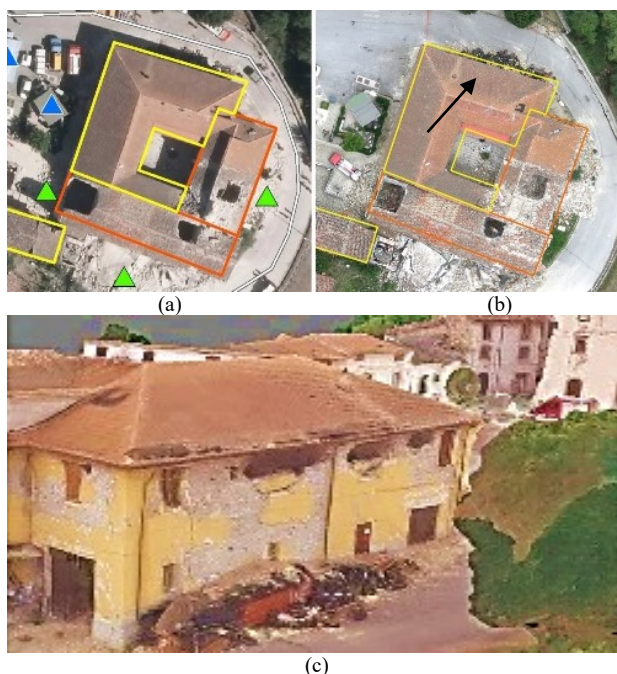
Figure 11. BDA on Accumoli site, in a sample building. The aerial image of Copernicus (a), the UAVs orthophoto (b) and a view of the considered damaged façade in the 3D model inspection (c).

A straightforward example of the significant contribute of UAVs for BDA is reported below. In this case one of the main buildings of Accumoli doesn't show almost any roof damages from a nadir point of view and was then classified by the Copernicus EMS as "Negligible to slight damage", Figure 11(a) but the UAVs 3D model contributed to a more accurate analysis in two ways.

Firstly, the orthophoto generated after the field survey, with a higher detail, Figure 11(b) allows to identify some debris that were not visible from the airborne image; secondly, the 3D model achieved with the integration of oblique images Figure 11(c) permits to perform an inspection of the façades, revealing some highly damaged portions of the buildings that were otherwise not identifiable. Moreover, a significant contribute of UAVs mapping in Central Italy was related with the Geotechnical reconnaissance. In the report created by the GEER team (GEER, 2016b) it's clearly visible a good example, specifically for the Accumoli site, where a system of cracks in the ground was identified between the UAV photogrammetric mapping of September and December.
