Seismic resilience of road bridges: lessons learned from the 14 November 2016 Kaikōura Earthquake

A.I. Sarkis & A. Palermo

ABSTRACT: The 14th of November 2016 Kaikōura Earthquake sequence has highly affected the transport infrastructure in New Zealand. From the perspective of life-safety, the overall bridge performance was satisfactory; however, based on the observed undesirable sub-system performance of the damaged bridges, further investigation into possible improvements of the current design philosophy was warranted.

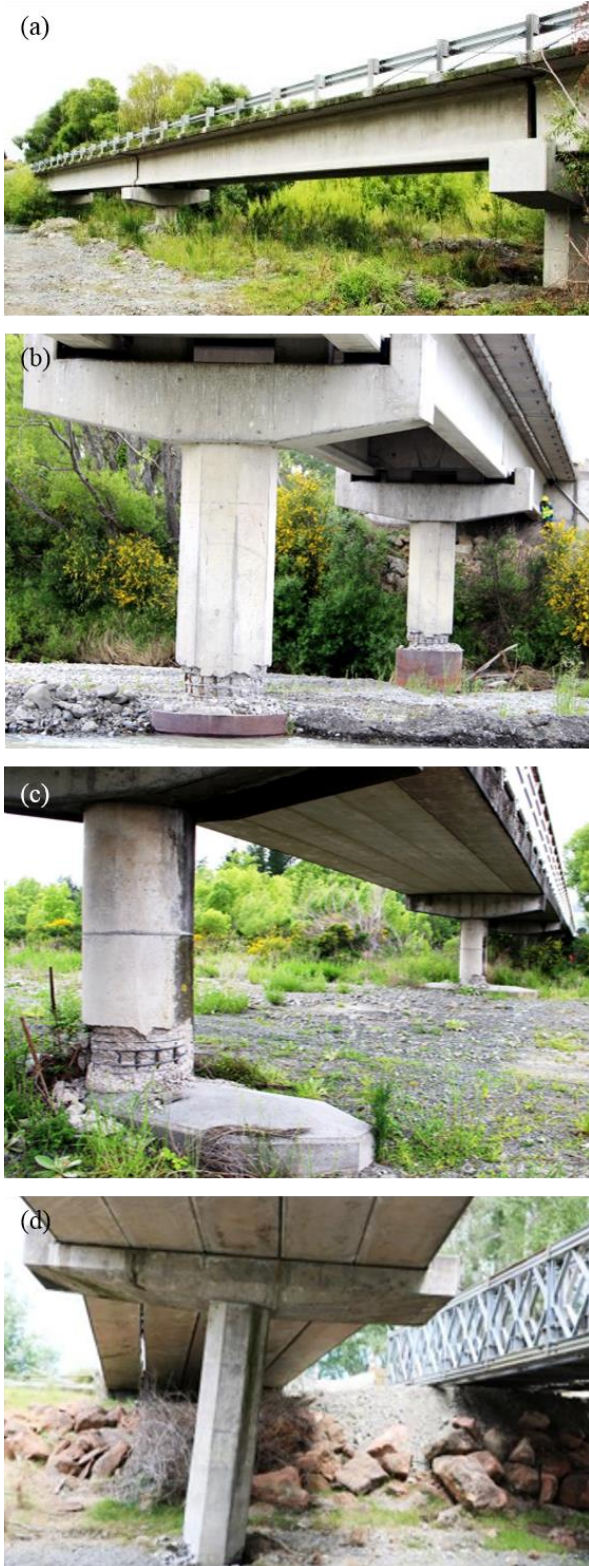
Figure 3. Bridges under study: (a) Lottery River Bridge; (b) Lower Mason River Bridge; (c) Mason River Bridge; (d) Wandle River Bridge (Palermo et al., 2017).

The Lottery River, Lower Mason River, Mason River, and Wandle River bridges (Figure 3) are structurally similar to one another. They are all multi-span precast concrete bridges supported on single column piers with hammer head pier caps. Further structural details are summarized in

In the way they resist lateral loading, the Lottery River (Figure 3a) and Lower Mason (Figure 3b) bridges are identical. The transverse interaction has

Similarly, the Mason River Bridge (Figure 3c) is split in two with a central movement joint. There are transverse shear keys at the abutments and internal longitudinal shear keys and linkage bars over all of the piers except the central pier. At the central pier, provision is made for longitudinal movement with loose linkage bars but steel plate lateral support stubs cast into the piers restrain the transverse movement. Therefore, the overall transverse response can be thought of as the deck having a curved displaced shape where the largest transverse displacement occurs at the central pier (Palermo et al., 2017).

The Wandle River Bridge (Figure 3d) is curved in plan and has a slope in the longitudinal direction. Linkages, shear keys and elastomeric bearings restrain the transverse and longitudinal movement over the piers, but only linkage bars resist both the transverse and longitudinal movement at the abutments. Longitudinal movement towards the backfill at the abutments is resisted by the abutment back-wall which is cast against the beams.
