Comparative fragility methods for seismic assessment of masonry buildings located in Muccia (Italy)

The current paper focuses on a sector of the historic centre of Muccia, in the district of Macerata (Italy), affected by the seismic sequence that involved Central Italy in 2016. The main goal is comparison, in terms of fragility curves, among two vulnerability assessment methodologies (empirical and mechanical). The study area has been structurally and typologically identified according to the Building Typology Matrix (BTM). Physical vulnerability analysis of the urban-sector was performed through application of an index-based method, specifically for masonry building aggregates. An isolated masonry building, damaged after the seismic sequences, has been selected as a case study. For the assessed building, empirical fragility curves are presented according to Guagenti & Petrini's correlation law. Furthermore, a numerical model has been set up by using the macro-element approach, which has allowed to perform non-linear static analyses. Mechanical properties of masonry were defined according to the New Technical Codes for Constructions (NTC18), assuming a limited knowledge level (LC1

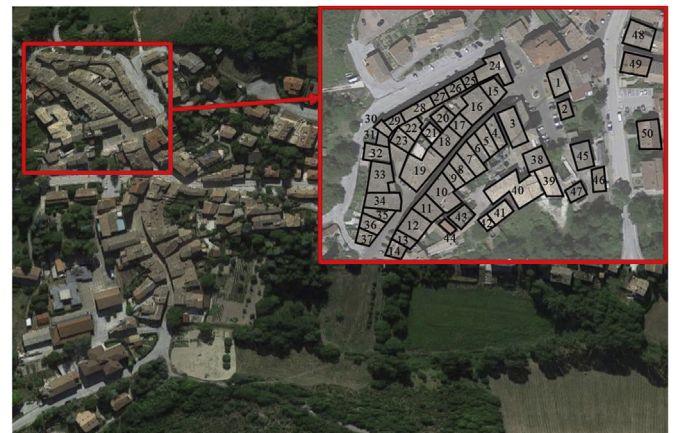
Fig. 6. The sub-urban sector identification.

The sub-urban sector analysed (Fig. 6) is to be considered homogeneous from a typological and structural point of view. It consists of 50
