VERIFICATION OF SHORE PROTECTION EFFECT OF BEACH NOURISHMENT ON CHIGASAKI COAST

ABSTRACT: On a stretch of the Chigasaki coast of 1.4 km length extending between Chigasaki fishing port and Chigasaki artificial headland, beach nourishment using coarse materials has been carried out since 2006. Since the start of beach nourishment, various monitoring surveys have been carried out to investigate beach changes and verify the effect of beach nourishment. In this study, various monitoring data such as the narrow-multibeam survey and photographs of the shoreline taken from a fixed position were analyzed. It was found that the beach width of the coast was significantly increased by beach nourishment, and it was effective.

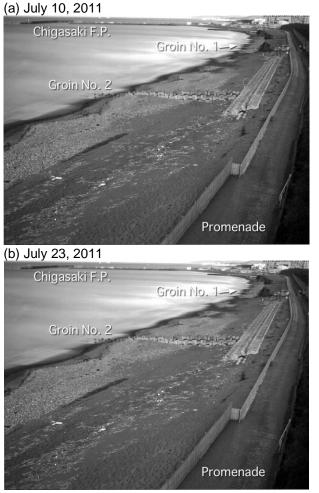
Fig. 12 Time-averaged images of shoreline before and after Typhoon No. 6

A monitoring survey has been carried out using the photographs from a fixed position since May 2007. For this purpose, the time-averaged images using oblique photographs taken at 50 s intervals every hour were compared to investigate the shoreline and beach changes (Lippmann and Holman, 1989). Figure 12 shows the time-averaged images taken on July 10 and 23, 2011, before and after the storm waves, respectively, with a significant wave height of $H_{1/3} = 4.5$ m (T = 12.4 s) associated with Typhoon 1106, which hit the coast on

July 19, 2011. Because storm waves with a period longer than 10 s were incident for 76 h, as shown in Fig. 4, a large amount of gravel was deposited on the foreshore, forming the berms and cusps by July 23, 2011 and debris was scattered on the backshore.

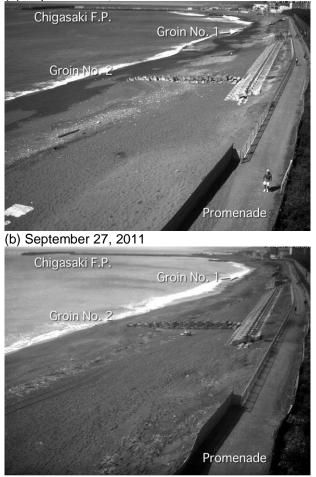
Fig. 13 Time-averaged images of shoreline before and after Typhoon No. 15

Figure 13 shows the photographs taken on September 12 and 27 in 2011 before and after Typhoon 1115 hit the coast on September 21, 2011, respectively. Although sand was deposited on the backshore on September 12 before the storm, debris was transported by the run-up waves and left on the backshore in front of the fence preventing windblown sand on September 23. However, no beach changes occurred except for a slight shoreline recession. The same situation was observed in the case of the storm waves associated with Typhoons 0709 and 0918. Taking these facts into account, it is concluded that the sandy beach recovered by beach nourishment using coarse materials has a high stability against storm waves. Also, in this case, a large amount of gravel was not deposited on the foreshore as in the case after the storm associated with Typhoon 1106. This is because the duration of storm waves with a period longer than 10 s (a) May 12, 2007

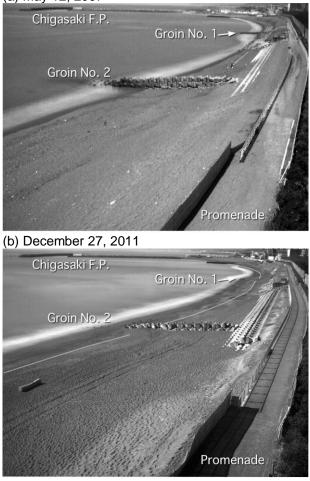
Fig. 14 Time-averaged images in May 2007 and December 2011

Figure 14 shows the time-averaged images taken on May 12, 2007 in the beginning of the observation and on December 27, 2011. The shoreline on May 12, 2007 is also shown in Fig. 14(b). It is clearly understood that the shoreline advanced in parallel each other and a continuous shoreline was formed with no obstruction at Groin No. 2 owing to the beach nourishment. In addition, the shoreline positions were determined from the vertical images transformed from the oblique photographs using the geometrical transformation method, and the shoreline change after the beach nourishment with reference to that on March 16, 2007 was obtained, as shown in Fig. 15. The maximum and mean shoreline advances until July 10, 2011 were 19 and 8 m, respectively. In addition, it was found that the short-period shoreline variation owing to the storm waves was less than 5 m, as shown in the shoreline changes immediately after Typhoon 1115.
