## BEACH EROSION TRIGGERED BY RIVER MOUTH DREDGING AS A MEASURE AGAINST RIVER MOUTH CLOSURE

**ABSTRACT:** On a pocket beach, the impact of the formation of the wave-shelter zone and the maintenance dredging of a river mouth reaches the entire pocket beach, and overall beach changes are triggered, devastating the natural environment. These topographic changes owing to anthropogenic factors took place at many coasts in Japan with the development of the coastal zone. We investigated this issue, taking the Haraoka and Tataro coasts in Chiba Prefecture as examples. Although several measures have been taken such as the sand back pass to mitigate the erosion, problems have not yet been solved. We discuss the reality and propose several measures to solve these problems.

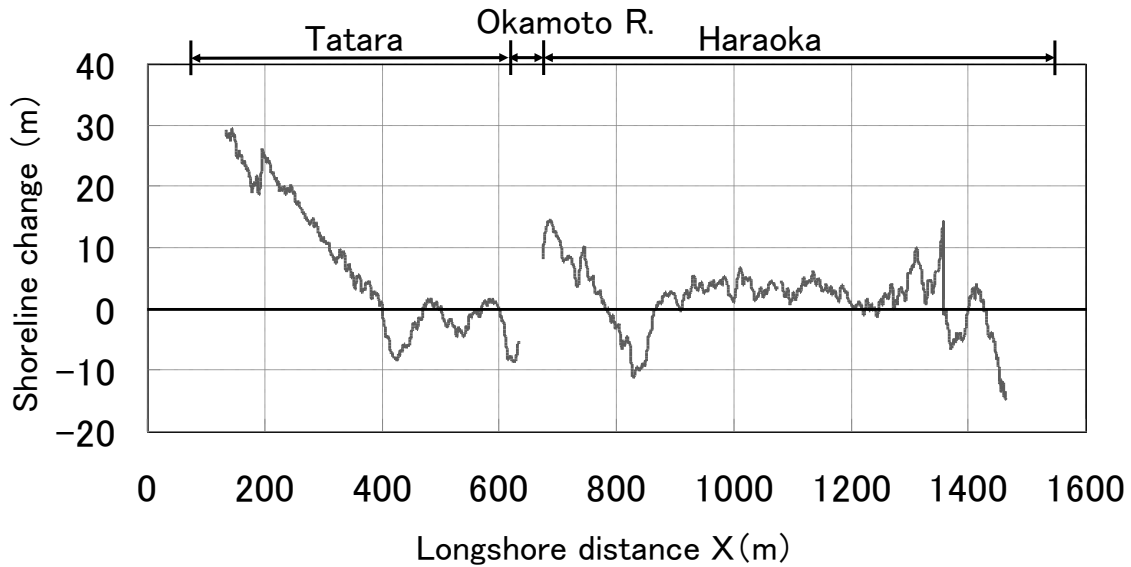
Fig. 3 Shoreline changes on Haraoka and Tatara coasts between 1970 and 2011.

Figure 3 shows the shoreline changes in the study area between 1970 and 1990 determined from the aerial photographs. The construction of the Tomiura fishing port breakwater started in 1974 and was completed by 1986. After the extension of the breakwater, the shoreline advanced at a maximum of 30 m at the corner between the breakwater and the sandy beach owing to the effect of the formation of the wave-shelter zone. In addition, the shoreline advanced on the immediate right side of the Okamoto River.

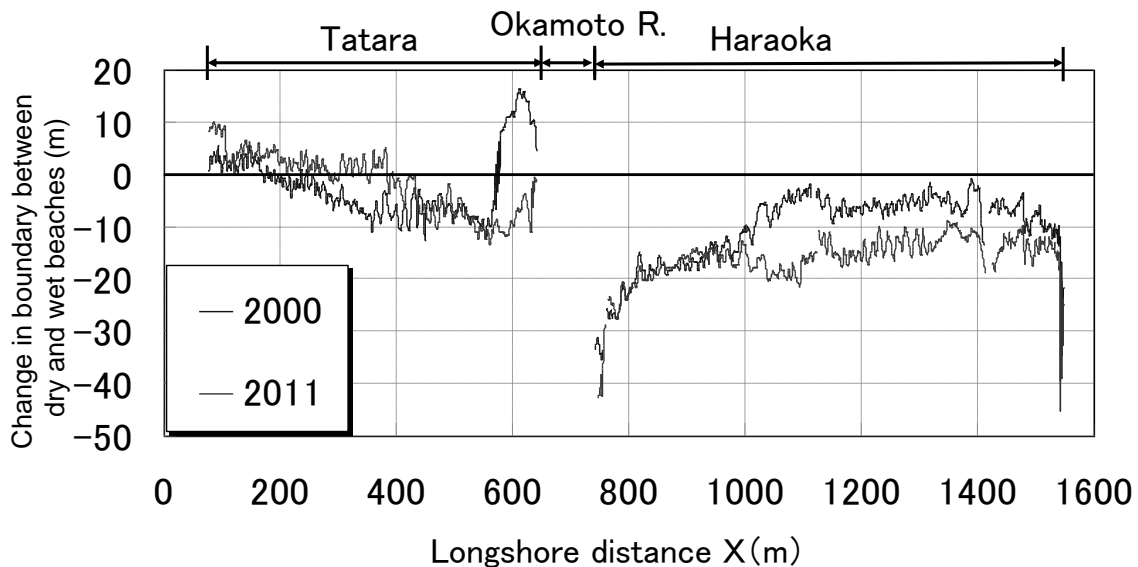
Fig. 4 Change in boundary line between dry and wet beaches.

read from the aerial photographs, and the change in the boundary line until 2000 and 2011 with reference to that in 1990 was calculated, as shown in Fig. 4.

On the south side of the Okamoto River, a river mouth bar protruded near the river mouth in 2000, and except for this sand bar, the beach near the river mouth was erosive, whereas the beach was slightly accretive at a location very close to the Tomiura fishing port. Until 2011, a protruding sand bar on the south side of the river mouth was eroded. In contrast, on the right side of the river mouth, maximum shoreline recession occurred on the right bank, which gradually decreased eastward in 2000, but the severely eroded area expanded up to the north end of the Haraoka coast until 2011. It is clearly realized that although the Tatar coast south of the river has become almost stable since 1990, the Haraoka coast north of the river mouth has been eroded.

Immediately north of the river mouth, a number of sand bags were continuously placed along the shoreline, as shown in Fig. 11, with scarp formation behind these sand bags. Because the shoreline has retreated by 20 m since 1990 in this area, as shown in Fig. 4, it is reasonable for sand bags to be installed in this area as a measure against beach erosion. On the other hand, a large amount of sand was deposited inside the river mouth next to this area, as shown in Fig. 9. Thus, two opposite features of erosion and sand deposition suggest that both are closely related to each other and erosion immediately north of the river mouth was caused by sand movement from the nearby coast to inside the river mouth.

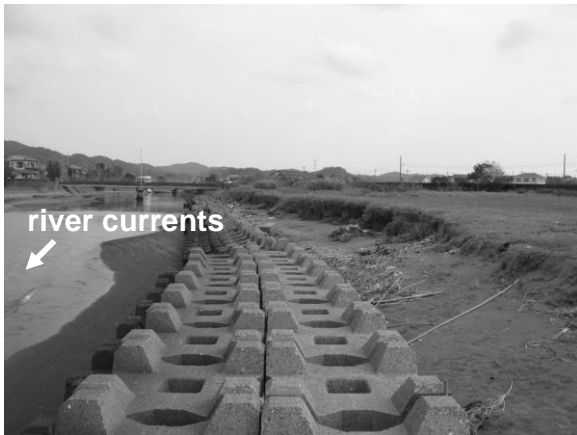
Fig. 6 Subsided concrete blocks and erosion along left bank of Okamoto River (October 13, 2011).

Site observation was carried out on June 11 and October 13, 2011 to investigate the beach erosion of the study area. On September 21, 2011 before the second site observation, storm waves associated with Typhoon 15 hit the study area, and the impact of the storm waves was observed on the beach. Figure 6 shows a photograph of the channel of the Okamoto River taken from the top of the revetment along the left bank, looking upstream. The revetment was permeable and its crown height was so low that the land behind the revetment had been eroded. Figure 7 shows the enlarged photograph of the same site where scarp was formed on the left bank. The concrete blocks significantly subsided and inclined toward the river bed, implying that river bed excavation might have been carried out.

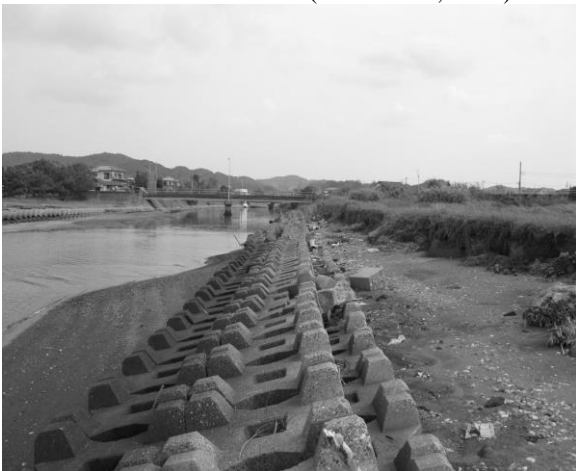
Fig. 7 Concrete blocks inclined toward the channel (October 13, 2011).

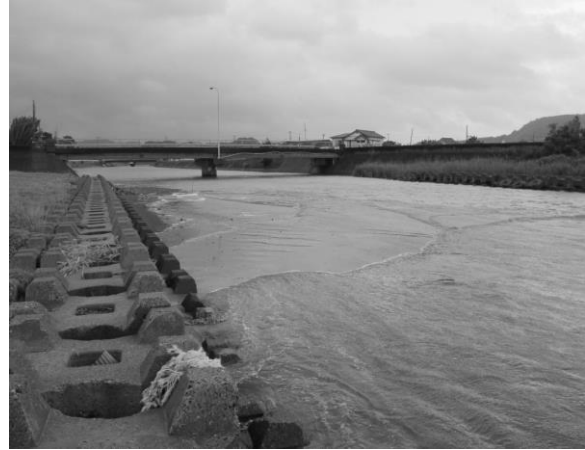
Fig. 8 Concrete blocks on right bank of Okamoto River and sand deposition in front of the concrete blocks (June 11, 2011).

On the right bank of the river, only a small amount of sand was deposited while forming a sand bar along the inner side of the meandered channel on June 11, 2011, as

shown in Fig. 8, but on October 13, the sand bar markedly developed in scale, as shown in Fig. 9. The concrete blocks buried under the ground surface were exposed and the vegetation next to the revetment was eroded, implying that the wave overtopping over the revetment with a low crown height occurred and a large amount of sand was transported from the right bank to the channel. The remains of debris on top of the revetment were further evidence of the wave overtopping over the revetment, and this means that sand could be transported directly into the river mouth while crossing the right revetment.

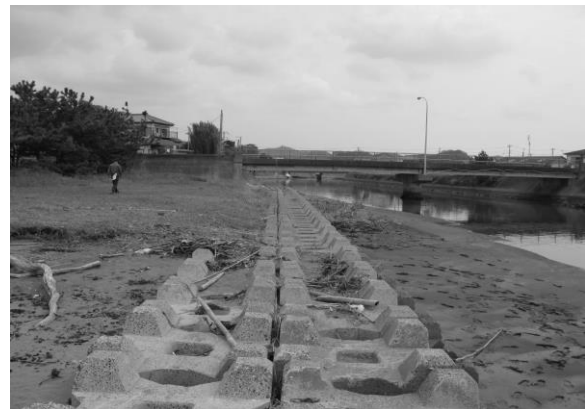
Fig. 9 Enlarged river mouth bar (October 13, 2011).

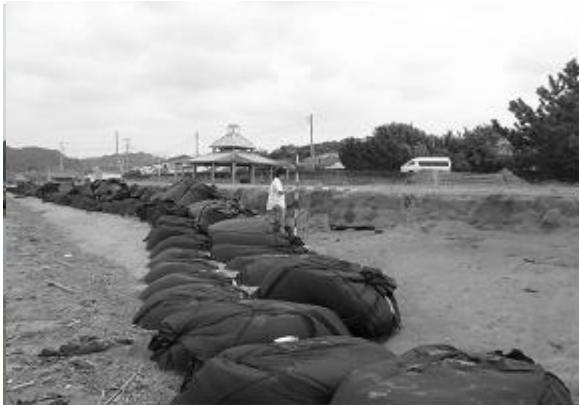
Fig. 11 Severe erosion with formation of scarp immediately north of the river mouth.

deposition at the river mouth and the simultaneous erosion immediately north of the river mouth are considered to be inadequate. The crown height should be raised to prevent the wave overtopping over the crown of the jetty, in particular, near the shoreline, and the structure of the jetty should be impermeable so as not to permit the sand transport across the jetty. In addition, the sand bags placed along the shoreline were ineffective even as a temporal measure against beach erosion and excess accumulation at the river mouth. More reasonable measures such as sand back pass to the shoreline of the northern Haraoka coast along with raising the crown height of the right bank jetty should be taken. As a result of our study, an impermeable jetty had actually been

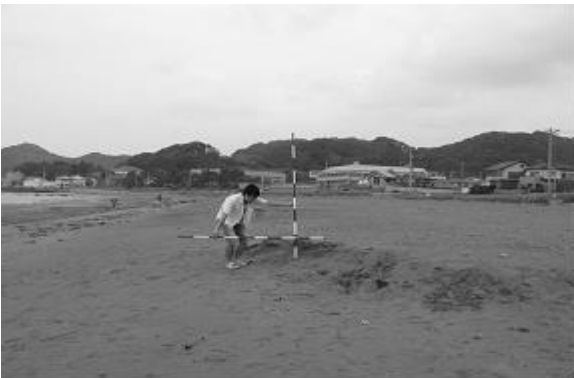
Fig. 12 A mound produced by beach nourishment at northern end of Haraoka coast.

Figure 12 shows the beach condition on the northern Haraoka coast taken on October 13, 2011. The backshore is plane, and the lamination, which is usually formed by the sand deposition by waves or wind, was not observed in the cross section of the area, as shown in Fig. 13,

The local authority responsible for the river management has recently carried out river mouth dredging in the Okamoto River and the dredged material had been transported to the northern Haraoka coast. Thus, the mound shown in Figs. 12 and 13 is assumed to be produced by the dredged materials. The location of the mound on the backshore was far from the shoreline, as shown in Fig. 12, where not only normal waves but also storm waves were difficult to reach the seaward toe of the mound. Every time when the dredging was carried out, a significant volume of beach sand could decrease from the sandy beach, causing beach erosion.

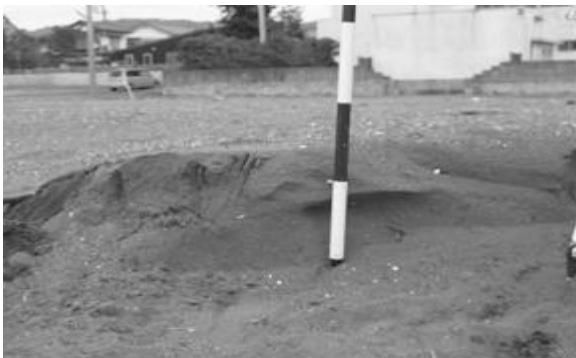
Fig. 13 Cross section of mound.

implying that this sand mound was artificially produced. The volume of sand of the mound was estimated to be approximately 1500 m<sup>3</sup>. Moreover, on the surface of this mound, shell debris was found, as shown in Fig. 14. This strongly suggests that the sand composed of this mound is the beach material once deposited in the nearshore zone.

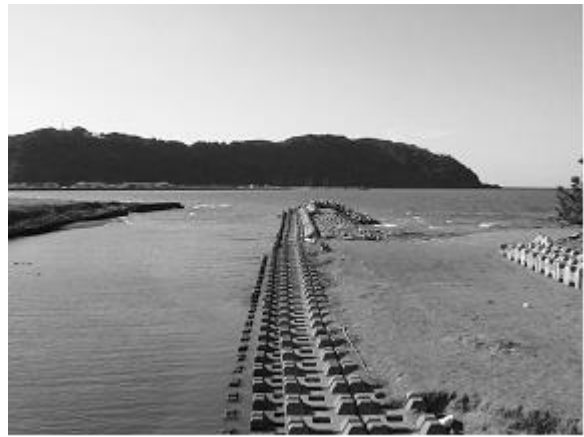
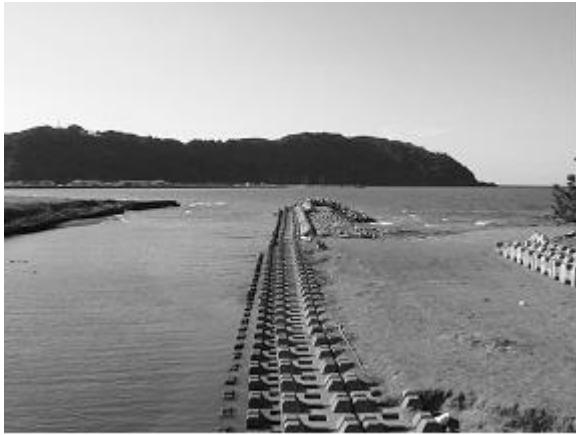
Fig. 15 Impermeable jetty constructed.

extended by November 2012, as shown in Fig. 15. Soon after the extension, a sandy beach rapidly extended, as shown in Fig. 16, and beach erosion was mitigated without the river mouth closure of the Okamoto River.

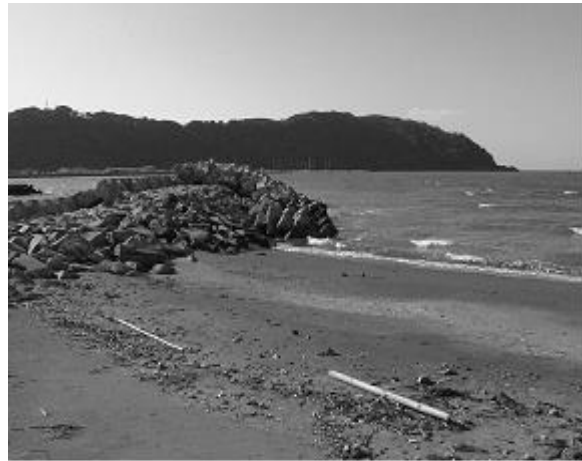
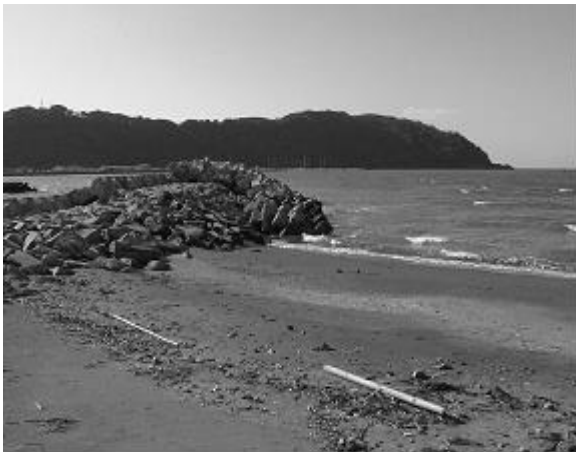
Fig. 16 Recovery of sandy beach north of the jetty.
