SURVIVAL OF SHRINES FROM THE 2011 GREAT TSUNAMI

ABSTRACT: A massive earthquake with a magnitude of 9.0 occurred on March 11, 2011, and a powerful tsunami devastated a large area along Japan's eastern coastline. We investigated the tsunami damage using satellite images and aerial photographs, and visited damaged sites including 27 shrines near the coast in 2011 and 2012. It was found that all but two of these shrines survived the tsunami, even though the tsunami height differed from place to place. As a memorial to people who lost their lives in previous tsunamis, shrines were built on safe places where people can evacuate. Many of these shrines were undamaged because their elevation was higher than the tsunami height, and the lives of people who evacuated to the shrines were saved.

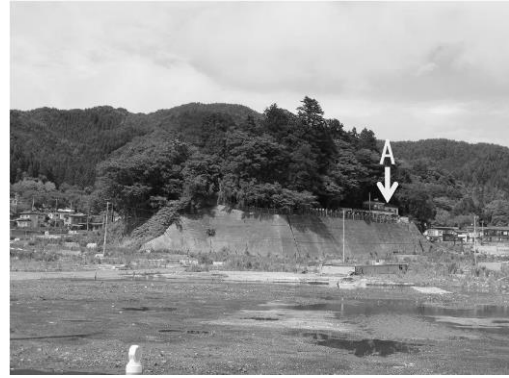
Fig. 3 Isolated hill with Ootsuchi-inari Shrine.

Figure 3 shows an overall view of the hill with Ootsuchi-inari Shrine located on top. The south side is protected by a high concrete wall, and the shrine is located on top of the hill and surrounded by dense forest. The chief priest living at the house, as shown by arrow A in Fig. 3, witnessed the tsunami on March 11, 2011 in front of his house. He testified that the Showa Great Tsunami in 1933 inundated land up to the first torii (an archway in front of the shrine), as shown in Fig. 4. When we carefully observed the surface of the concrete wall protecting the shrine (Fig. 4), many scars could be seen on the wall, which were made by driftwood scratching the wall, as shown by an arrow. The torii was carried away by the tsunami, but it was found undamaged in the next town. After the tsunami, it was rebuilt at the same location. The tsunami reached the second step below the top of the stairway, as shown by arrow B in Figs. 4 and 5, which was 12 m above the elevation of the intersection of the roads in the city, as shown by arrow C in Fig. 5.

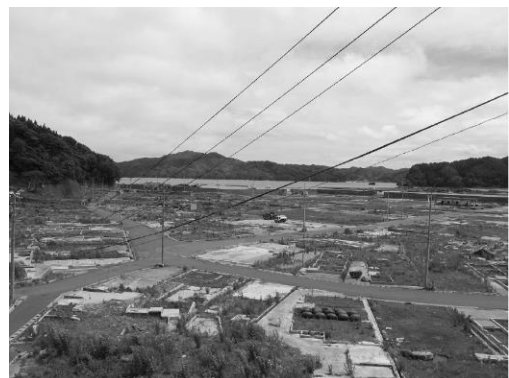
Fig. 6 Seawall along Ootsuchi Bay and damaged area.

Figure 6 shows an overview of Ootsuchi Fishing Port from the top of the stairway shown in Fig. 4. All the houses behind the seawall were completely destroyed. Approximately 1300 people were killed in Ootsuchi City and almost 500 people were still missing on July 20, 2012. Figure 7 shows a photograph of the east side of the shrine, which was taken from the same position as in Fig. 6, facing east. The houses built above the straight line shown in Fig. 7 belong to people who were moved to higher land after the Showa-Sanriku Tsunami in 1933, and they were left intact by the 2011 tsunami. In contrast, the houses built below the line were all destroyed by the tsunami.

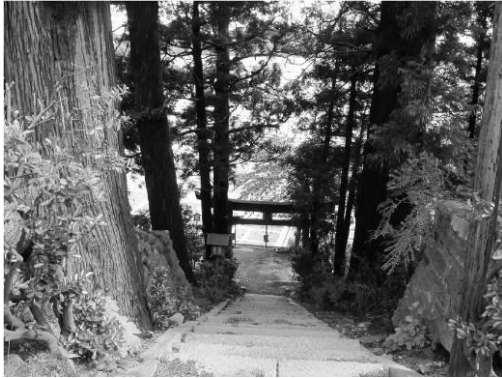
Fig. 8 Overview of lowland inundated to the second torii and steep stairway.

Figure 8 shows an overview of the lowland that was inundated and the steep stairway from the precinct of the shrine. Both sides of the stairway were surrounded by Japanese cedars over 100 years old. Figure 9 shows the

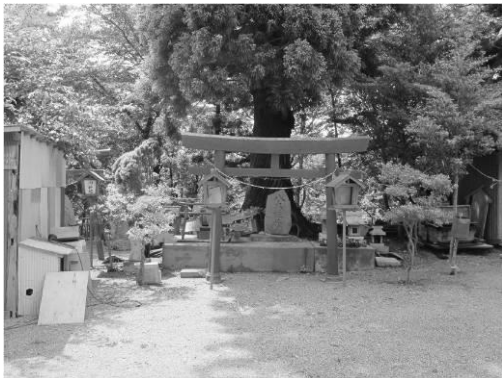
Fig. 9 Precinct of Ootsuchi-inari Shrine.

precinct of the shrine. According to the chief priest of the shrine, this precinct of the shrine was used as a refuge for 160 people after the tsunami, who stayed there for six months. Thus, Ootsuchi-inari Shrine not only survived the tsunami but also the precinct of the shrine was used as a refuge for many people of the town because of its location on top of a hill. The shrine worshiped at by the residents of the town for a long time saved the lives of many people.

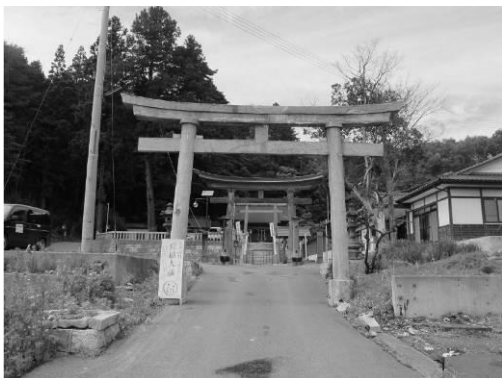
Fig. 10 Main shrine along with first, second and third torii of Kozuchi Shrine.

Kozuchi shrine was founded in 1629. Figure 10 shows a photograph of the main shrine along with the first, second and third torii taken from the approach to the shrine. The first wave of the tsunami inundated land up to the first torii. Then, the second wave reached an elevation of 0.56 m below the level of the precinct of the shrine and 5.8 m above the elevation of the road, as shown in Fig. 11. Figure 12 shows the village in front of the shrine; the tsunami propagated along the narrow valley bounded by mountains from east to west. Figure 13 shows the main shrine. After the tsunami, approximately 200 people evacuated to the area in front of the main shrine.

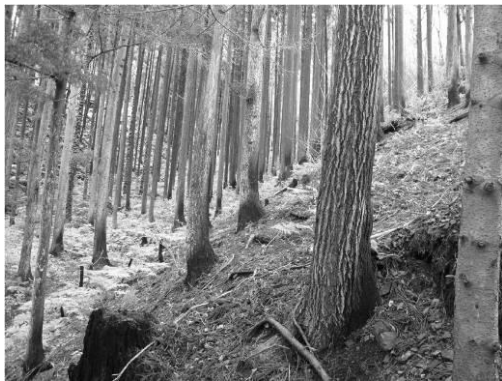
Fig. 14 Charred remains of many trees on mountain behind the shrine.

The chief priest of the shrine testified that a large-scale fire occurred, which was ignited by the large amount of floating debris including cars immediately after the tsunami, and this fire reached the forest behind

the main shrine covered with Japanese cedars. Although people moved to the back of the shrine to escape from this fire, the fire started to approach them. Therefore, most of the people climbed the steep slope of the mountain behind the shrine and escaped to the east from the fire. However, the evacuation of elderly people was difficult because of the very steep slope of the mountain densely covered by trees. Finally, five elderly people gave up their attempt to evacuate by climbing the mountain and stayed at the back of the shrine. As the fire approached the east of the mountain, the five elderly people removed the flammable dry leaves of the Japanese cedars to arrest the spread of the fire and they extinguished the fire using spring water from the back of the shrine. Figure 14 shows the charred remains of many trees on the mountain behind the shrine. The spread of the fire to the main shrine was prevented by the fire-fighting efforts. The chief priest of the shrine, who saved the lives of many evacuees, returned to the shrine on March 14, three days after the tsunami. First, he thought that the shrine would have been burned down by the fire. However, he found that the shrine was left intact owing to the effort of the five elderly people, who remained there and fought the fire.

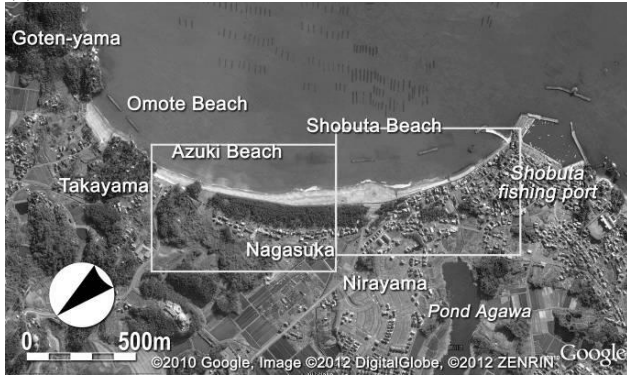
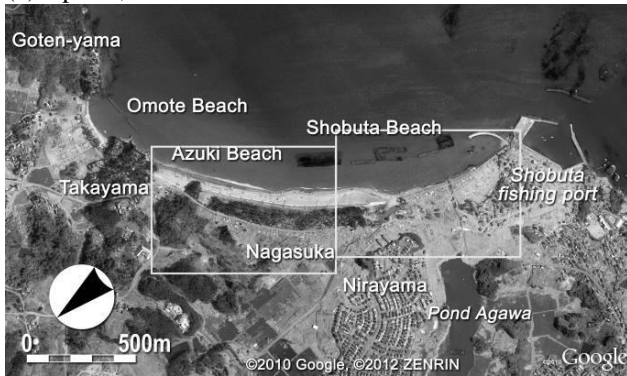
Fig. 15 Satellite images of Shobuta coast taken on November 29, 2002 and March 14, 2011.

The Shobuta coast is located immediately north of Sendai-Shiogama Port in Sendai Bay, as shown in Fig. 1. Although this beach was a well-known beach for bathing near Sendai City, the coast was severely damaged by the tsunami (Uda et al., 2012). Figure 15 shows enlarged satellite images of the Shobuta coast. The study area is a pocket beach of 1.7 km length bounded by Shobuta fishing port and Point Takayama. In Fig. 15(a), the locations of Omote and Azuki Beaches are also shown along with the location of the Shobuta coast. In the northern half of the Shobuta coast, a dense coastal forest of 100 m width consisting of pine trees extended over a distance of 700 m as a protective measure against tsunamis, and two detached breakwaters of 100 m length and an artificial reef of 200 m length had been constructed offshore of the coast, resulting in the formation of cusped forelands owing to the wave-sheltering effect of these coastal structures.

A massive tsunami hit the coast, resulting in major damage to the coastal area and destroying many houses built along the coastline. The largest change was the destruction of the coastal dike in front of Nirayama Town owing to the currents of the returning tsunami, leaving a deep wedge-shaped scouring hole in the hinterland. The destruction of the coastal dike occurred at the opening of the detached breakwaters, implying the concentration of tsunami currents. Although the shoreline changes at Azuki Beach, north of the Shobuta coast, were small, the shoreline markedly retreated at Omote Beach, resulting in the disappearance of the beach of 50 m width. In the southern part of this coast, Agawa pond, which was surrounded by reclaimed coastal lowland, was markedly enlarged owing to tsunami inundation. The location of the destruction of the coastal dike corresponded not only to the mouth of a small river but also to the landward location of the artificial reef constructed in the opening of the detached breakwaters, implying that such a location with these characteristics is difficult to protect from a tsunami, in accordance with the results of Tanaka et al. (2011).

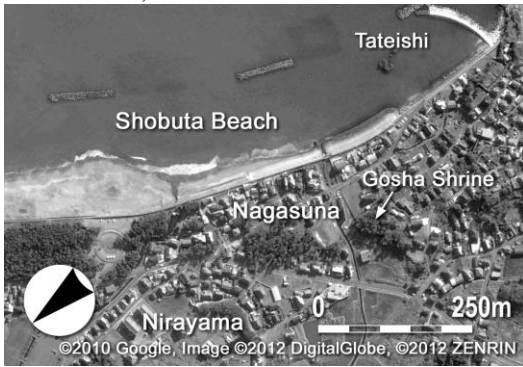
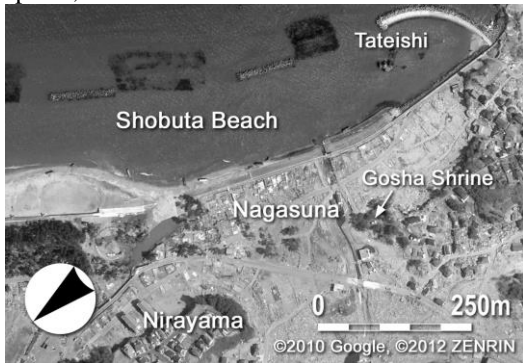
Fig. 16 Enlarged satellite images of southern Shobuta coast.

On April 20, 2011, site observation was carried out on the Shobuta coast to investigate the tsunami damage. Figure 16 shows enlarged images of the rectangular area shown in Fig. 15.

Figure 19 shows the scouring hole formed by the overflow of the tsunami over the top of the coastal dike, where houses had been built before the tsunami, as shown in Fig. 16(a). All the houses were destroyed by the tsunami currents. Figures 20 and 21 show the site of the complete destruction of the coastal dike; a large hole

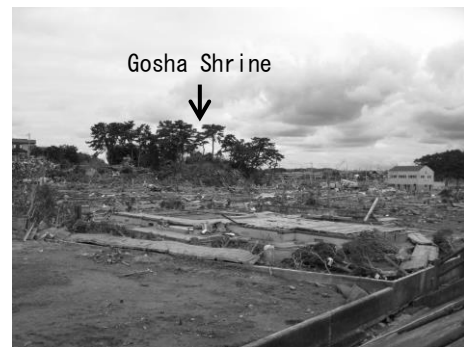
Fig. 17 Devastated houses with only their foundations left and Gosha Shrine located on top of isolated hill.

Figure 17, taken on top of the coastal dike facing north, shows the coastal condition. The tsunami flooded over the crown of the coastal dike, strong currents flowed down the back slope of the dike, and all the houses built along the coastal dike were completely destroyed, leaving only their foundations. An isolated hill surrounded by pine trees could be seen 150 m inland of the coastal dike, which seemed to be unaffected by the tsunami. On top of the hill is Gosha Shrine, which survived the tsunami, as did many shrines in other areas subjected to the large tsunami. Figure 18 shows the front of the shrine. Tsunami debris was scattered around the shrine, implying that the ground level was approximately equal to the tsunami inundation height. From this, the tsunami inundation height was measured to be +9.7 m above MSL at this location, taking the debris scattered around the shrine into account. The tsunami inundation height measured on the sand dune immediately south of Sendai-Shiogama Port, 5 km southwest of this shrine, was 15.6 m above MSL (Public Works Research Center, 2011). Even though such a high tsunami struck the shrine, the shrine survived.

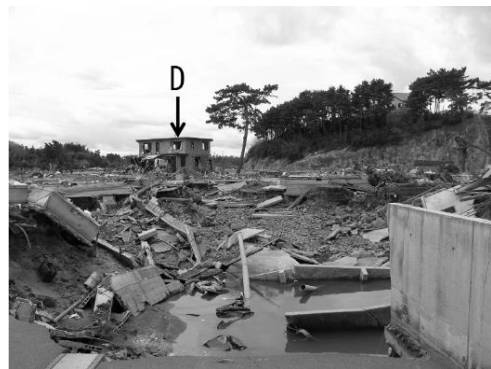
Fig. 21 Destroyed coastal dike.

was formed by the tsunami currents that severely damaged the concrete coastal dike. Figure 22 shows a two-story house (indicated by arrow D in Fig. 21) severely damaged by the tsunami. A car and debris from other houses were carried into the rooms of this house.

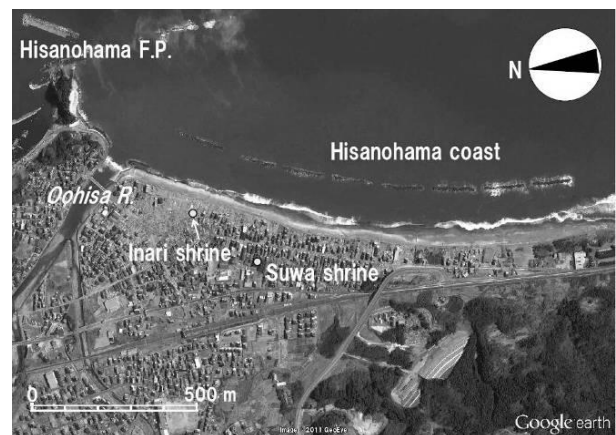
Fig. 23 Satellite images of Hisanohama coast in Fukushima Prefecture.

Figure 23 shows satellite images of the Hisanohama coast taken on March 18, 2011 after the tsunami. This coast is a pocket beach of 3 km length located in the south part of Fukushima Prefecture and bounded by Hisanohama Port and Yotsukura fishing port at the north and south ends, respectively. The Hisanohama coast is the northern half of this beach. Fluvial lowland extends along the Oohisa River, and the residential area is concentrated in the south part of this lowland. Severe tsunami damage occurred in this lowland.

Suwa Shrine is located 170 m inland from the coastline, as shown in Fig. 23. Figure 24 shows the approach to the shrine facing the road, which extends from the first torii to the main shrine. The house built on the left of the approach was completely destroyed by the tsunami, but the main shrine survived. Figure 25 shows

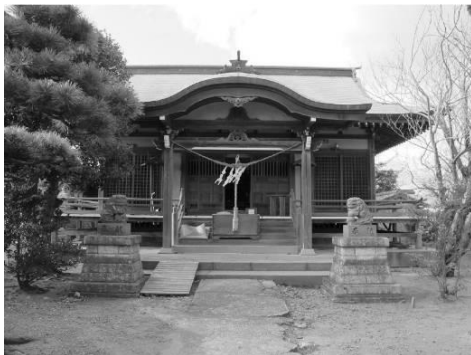
Fig. 25 Main building of Suwa Shrine.

the front of Suwa Shrine. The ground elevation of the shrine was 7.8 m above MSL. In general, shrines have a raised floor, and Suwa Shrine was built with a clearance of 0.8 m above the basement, as shown in Fig. 26. The chief priest of the shrine revealed that the tsunami flooded the clearance below the floor. Two reasons were considered as to why this shrine escaped tsunami damage: the basement of the shrine was slightly raised, and it had a raised floor with a clearance below the floor, as shown in Fig. 26. Finally, Fig. 27 shows the approach from the shrine to the sea. Even though this shrine was built at a location only 170 m from the coastline and was not built on top of a hill, it escaped tsunami damage.
