FIELD EXCURSION TO ENHANCE COASTAL AND ENVIRONMENTAL ENGINEERING CAPACITIES OF ENGINEERS IN ADMINISTRATIVE POSITIONS

ABSTRACT: The capacity building of coastal administrators is essential for sustainable coastal zone management. In order to enhance the ability of trainees in coastal and environmental engineering, the College of Land, Infrastructure, Transport and Tourism of the Japanese Government has carried out annual field excursions to Kujukuri Beach, a typical sandy beach in central Japan for comprehensively learning about real phenomena occurring on the beach and in the hinterland. This paper describes the excursion in 2011, in which 20 trainees participated. The importance of learning through the field excursions to coasts is discussed.

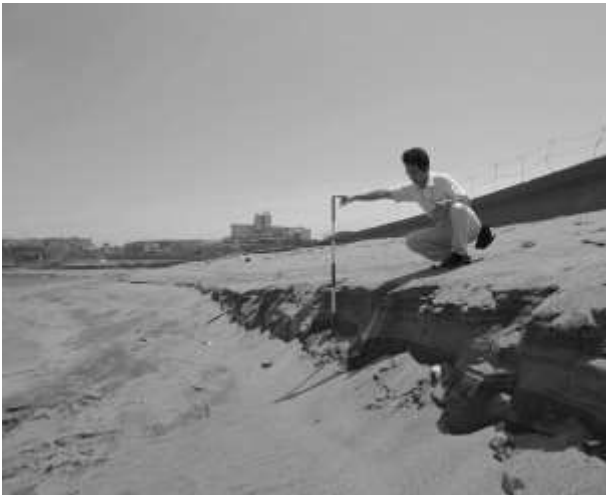
of using a measuring stick (Uda and Ishikawa, 2007) to take field pictures that can be effectively used in analysis, while also considering the formation pattern of the scarp and the angle of the sunlight. As seen in Fig. 2, the relative height of this scarp was 0.6 m as seen next to a trainee, and it decreased alongshore, implying that the scarp was formed due to the wave-sheltering effect of the artificial reef.

Fig. 2 Measuring of scarp height.

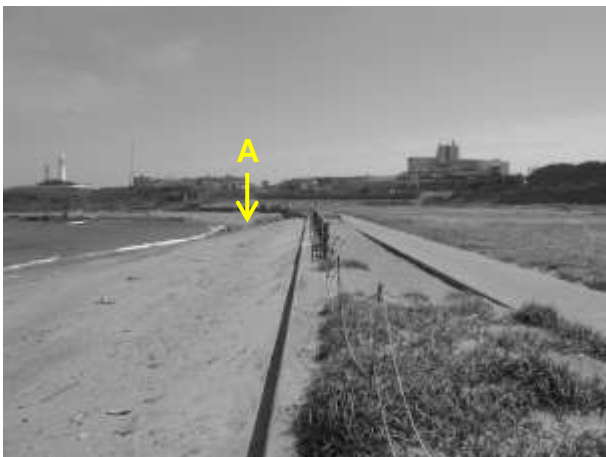
Figure 3 shows the beach and its wide foreshore as seen from top of the seawall landward of the artificial reef. A large amount of sand has been deposited close to the top of the seawall forming a gentle slope, and fine windblown sand has been deposited on the walkway landward of the seawall. From this, the trainees realized that windblown sand was severe at this site because of the wide foreshore.

Fig. 3 Wide sandy beach with a gentle slope formed by the deposition of windblown sand.

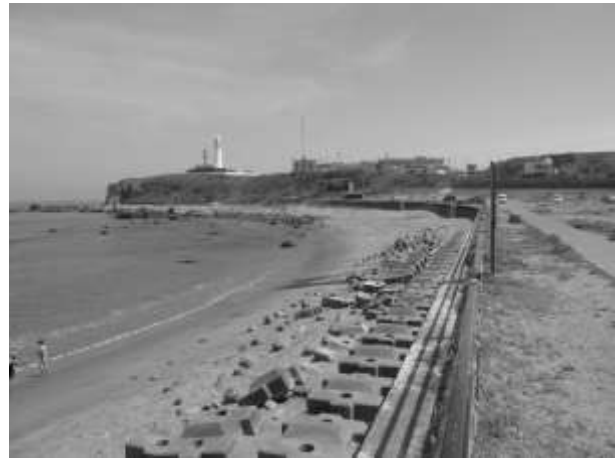
Figure 4 shows the narrow beach near point A as indicated in Fig. 3, where a large number of concrete blocks have been installed along the foot of the seawall

to prevent wave overtopping, in contrast to the excess accumulation of sand on the nearby beach shown in Fig. 3. Figure 5 shows the entire length of Kimigahama Beach taken from the top of Inubo Point. The wave breaking at point B was caused by the existence of an artificial reef. In addition, Fig. 6 gives a close look at the cusped foreland formed behind the artificial reef. The trainees realized from the scene shown in Fig. 6 that the cusped foreland had formed behind the artificial reef because of its wave-sheltering effect. This example clearly illustrated that the sand required for the formation of a cusped foreland is transported in from both sides, resulting in erosion on both sides of the cusped foreland. For trainees who are accustomed to considering the effects of shore protection structures two-dimensionally, this example was useful for understanding three-dimensional beach changes in the vicinity of the offshore

Fig. 4 Concrete blocks placed along the coastline to prevent wave overtopping.

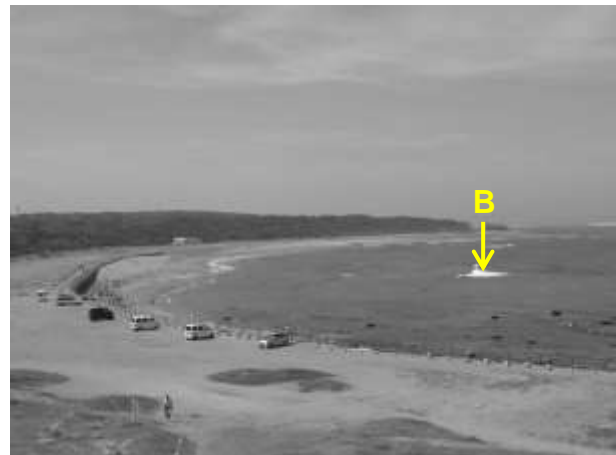
Fig. 5 Overview of Kimigahama Beach.

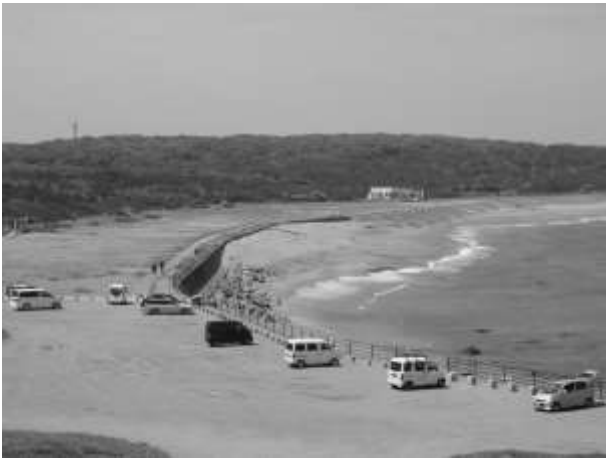
Fig. 6 A large cusped foreland formed behind an artificial reef.

breakwaters. They further understood that when an artificial reef is constructed in the middle of a pocket beach as in the case of Kimigahama Beach, sand accumulates in the lee of the structures while the beaches on both sides of them are eroded.

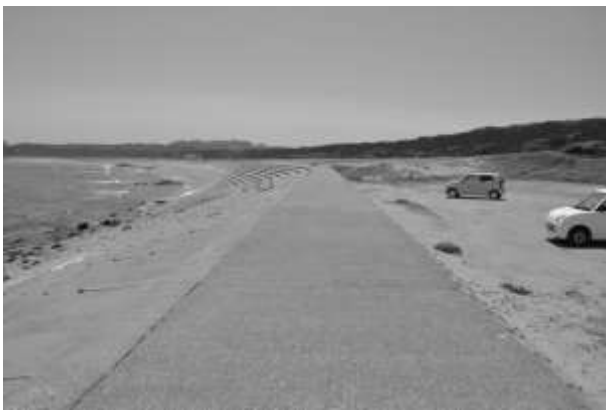
Fig. 7 A wide concrete walkway.

Furthermore, in many cases a wide concrete walkway is built on the backshore, as shown in Fig. 7. However, the backshore, which is considered useless land by some, forms an important buffer zone against wave action and windblown sand, and the impact of its loss extends to the entire sandy beach as well as to the coastal vegetation. Thus, trainees realized through this example that excess construction of artificial structures on the beach should be avoided in a coastal tourist resort.

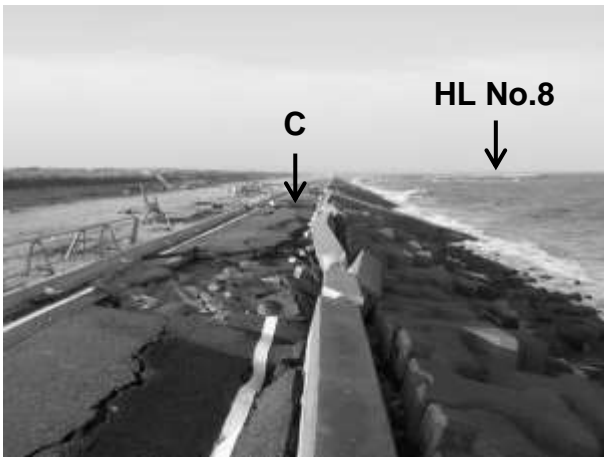
Along the Node coast located in northern Kujukuri Beach, as shown in Fig. 1, the beach has been severely eroded leaving no foreshore in front of the gently sloping revetment, and the seawall is directly exposed to waves. Although the seaward slope of the revetment had already been damaged before 2010, this damage was exacerbated by the effect of the 2011 Great Tsunami. Figure 9 shows the damaged revetment on this coast. Concrete blocks on the seaward slope were scattered and the foot of the revetment was exposed to waves. Furthermore, Fig. 10 shows the damaged revetment located near arrow C. The 0.5 m thick concrete revetment was completely breached as a result of the discharge of foundation gravel carried by the return currents.

Fig. 9 Damaged seawall on the Node coast.

Since the early 1990s, gently sloping revetments have been constructed along many coasts in Japan to create easy access to the shoreline. However, many of these revetments have been destroyed by the discharge of the foundation gravel (Uda, 2010). The trainees

observed a clear example on this coast, and understood the mechanism of how a gently sloping revetment is damaged and the weakness of this structure.

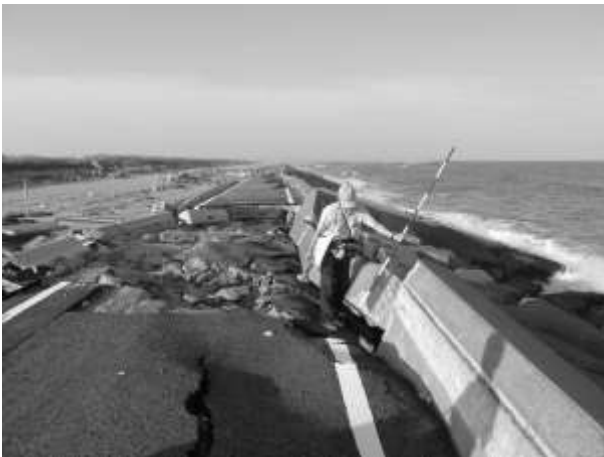
Fig. 10 Enlarged photograph of the damaged seawall.

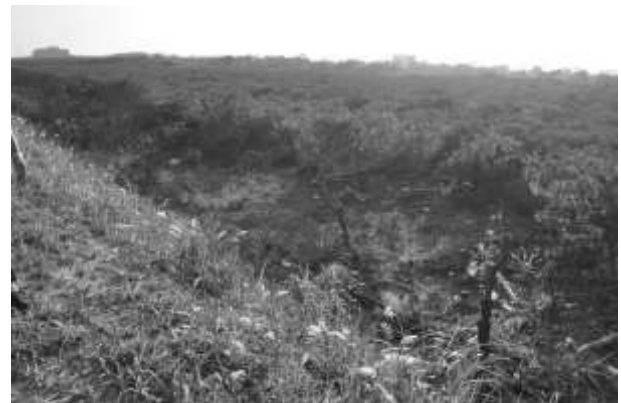
The 2011 Great Tsunami also hit this coast on March 11, 2011, and evidence of the tsunami inundation was observed. Figure 11 shows the damage to the coastal forest which occurred when the tsunami flowed over the low-elevation sand dunes on this coast. Pine trees toppled and died owing to the tsunami inundation and the plastic debris such as PET bottles were scattered behind the dunes. This observation was of interest to the trainees because they could observe real tsunami damage first-hand.

Fig. 11 Dead trees behind sand dunes killed by tsunami inundation and tsunami-transported debris.

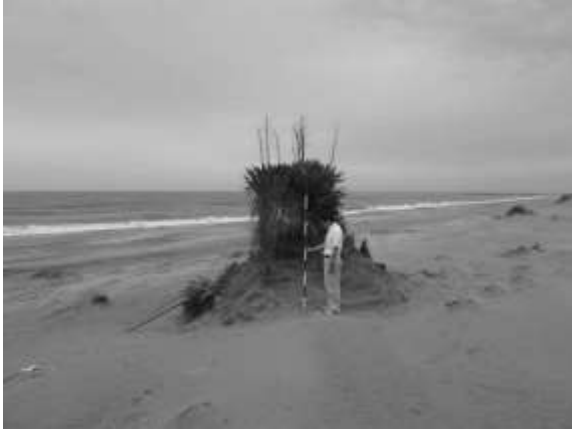
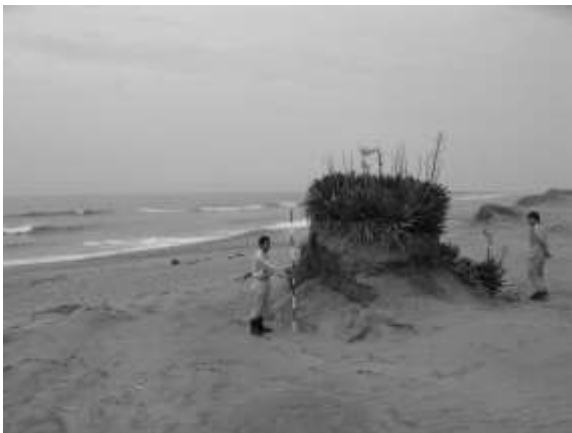
various features. In this area, there is still a sandy beach left, although it has been gradually eroded. The trainees gained an understanding of the severity of beach erosion from observing the isolation of an agave tree (*Agavaceae sp.*) which originally grew on the sand dune but had been scoured out both by run-up waves and windblown sand, and in addition, also damaged by the tsunami. This tree is located at arrow D in Fig. 12 halfway between HL Nos. 9 and 10. Figures 13 and 14 are photographs of this tree taken on June 23, 2011, and June 18, 2010, respectively, both from the northwest side of the tree, showing that the tree's width was reduced by half in a single year due to erosion, from 2.2 m to 1.1 m.

Fig. 13 Tree (*Agavaceae*) photographed on June 23, 2011.

Fig. 14 Tree (*Agavaceae*) photographed on June 18, 2010.

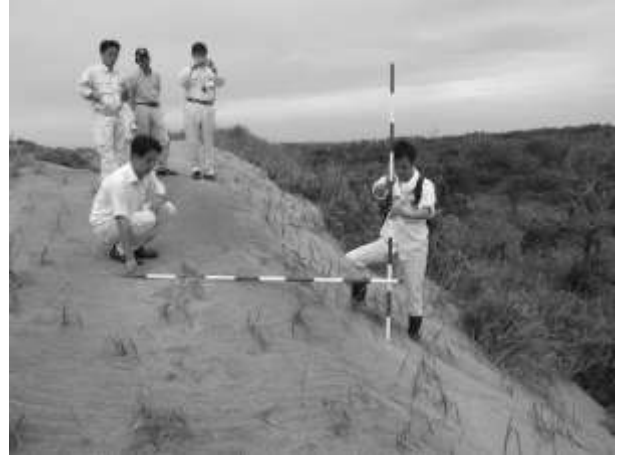
When we went up the sand dune behind this tree, we found that a blowout had been formed on top of the dune, as shown in Fig. 15, and near this site a steep slope with a 1/2 angle of repose of fine sand was found along the sand dune/coastal forest boundary, and pine trees had been buried by sand, as shown in Fig. 16. From these observations, the trainees learned about the effects of windblown sand and the value of coastal forests in preventing them.

Fig. 16 Landward slope of a sand dune with a 1/2 slope of angle of repose.

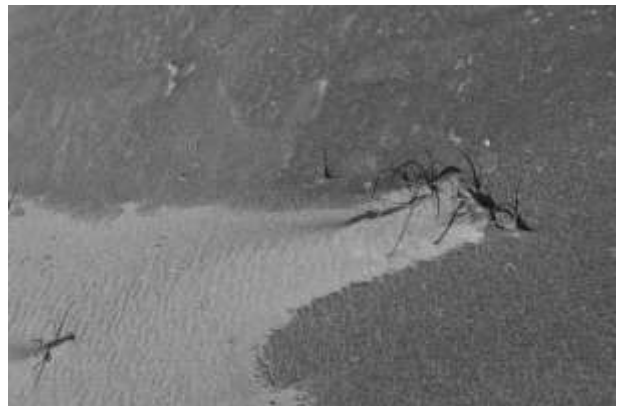
growth of vegetation. Figure 17 shows an example of sand being trapped by vegetation on the sand surface. While sand mounds can develop when windblown sand is trapped by vegetation, their habitat can also develop when the scale of the mound increases to a point which is appropriate for their growth, resulting in an increased number of plants. This picture shows a good contrast: the color of windblown sand deposited around the

vegetation is white because it is dry, whereas the ground behind it is black because it is wet. Furthermore wind blowing over the sand surface was disturbed by the leaves of *Carex kobomugi*, as shown in Fig. 18, resulting in the reduction of wind velocity and deposition of sand. Observing this, the trainees understood that the effects of windblown sand are also significant on Kujyukuri Beach.

Fig. 17 An example of sand trapped by vegetation on the sand surface.

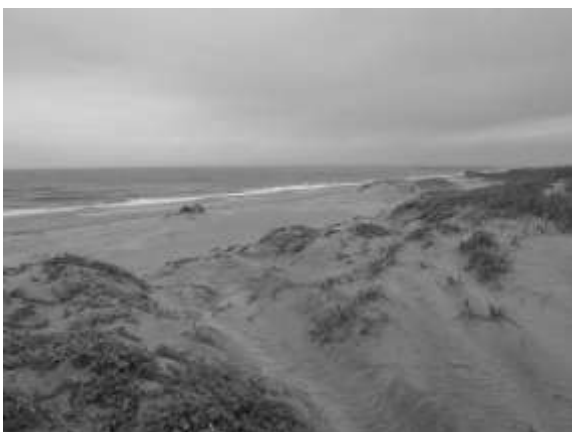
Fig. 15 Blowout formed on top of a sand dune.

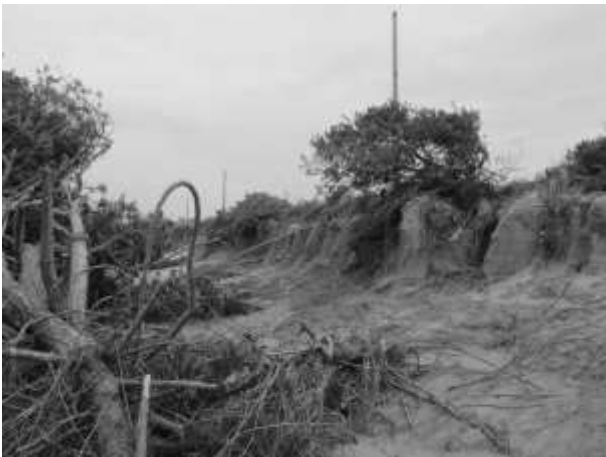
On the Hasunuma coast located in the central part of Kujukuri Beach, as shown in Fig. 1, a wide coastal forest extends landward of the sand dunes. This coastal forest has long been used for recreation, and an access way extended straight from the inland area to the coastline through the forest. The tsunami was concentrated in this straight access way keeping its intensity. Figure 19 shows the damage to the landward slope of the sand dune by the tsunami overflow at the seaward entrance of this access way. The pine trees on the sand dunes were felled by the strong tsunami flow, and the coastal forest behind the sand dune was inundated.

Fig. 19 Damage to the landward slope of a sand dune by the tsunami overflow.

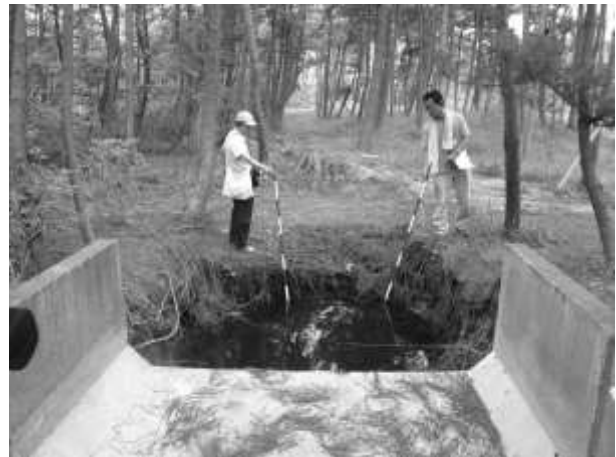
The rail shown in Fig. 20 is a small locomotive built for children, which runs across the coastal forest park. The concrete facility shown in Fig. 20 is a side wall built to stabilize the side slope of a low sand dune. The tsunami currents flowed over this structure and at its landward end a one meter deep scour hole was formed, as shown in Fig. 21. The trainees understood that one

of the tsunami impacts was serious scouring such as that which took place at the end of this impermeable structure. In addition, it can also be noted from this picture that the ground water level is very high just 0.6 m below the ground surface, which restricts the growth of trees in this coastal forest. The trainees realized the difficulty in planting trees in lowland area such as the Hasunuma coast.

Fig. 21 One meter deep scour hole at the end of a concrete structure.

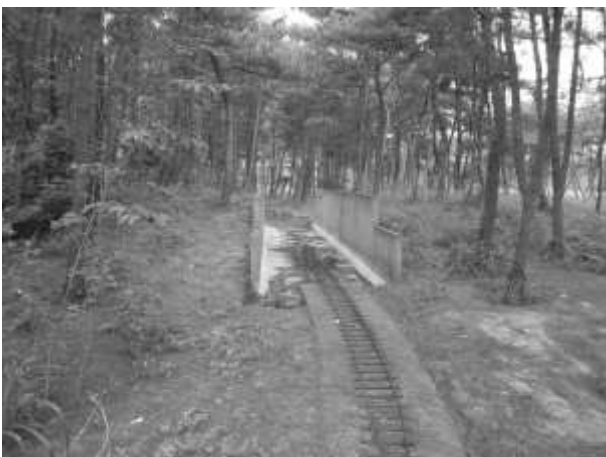
Fig. 20 Track for a small locomotive for children in the coastal park.

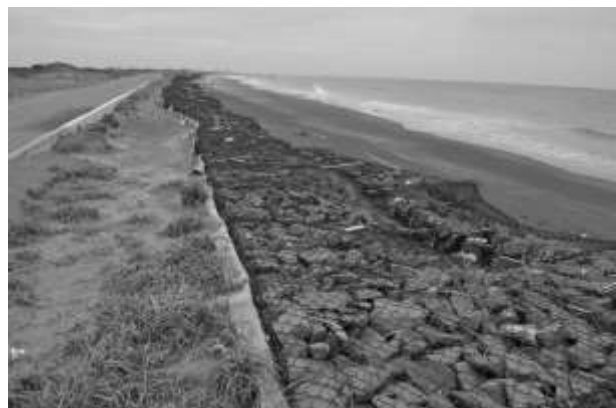
The Hitotsu-matsu coast is located near the end of Kujukuri Beach, as shown in Fig. 1, and the beach has recently been eroded. As a countermeasure, gabions have been placed along the coast, as shown in Fig. 22. In the past, the sandy beach extended along the shore with no structures, but now the coastline is protected by these gabions. However, even with this protection, subsidence and damage to the gabions are occurring every year, requiring further measures. Although these gabions were deployed as an urgent measure against beach erosion

Fig. 22 Gabions placed along the coastline.

because of their inexpensive initial cost, they are easily destroyed by scouring and are not resistant to wave force and thus suffer from inferior durability. Despite these weak points, this method was adopted, and the trainees understood how it really functions *in situ*.
