A Experimental Research On The Anti-erosion Material For Hydraulic Machinery

Lu Jinling, Zhang Xin, Zhang Jie, Feng Jianjun, Xingqi Luo

Lu Jinling, Zhang Xin, Zhang Jie, Feng Jianjun, Xingqi Luo. A Experimental Research On The Anti-erosion Material For Hydraulic Machinery. International Symposium on Transport Phenomena and Dynamics of Rotating Machinery, Dec 2017, Maui, United States. hal-02369358

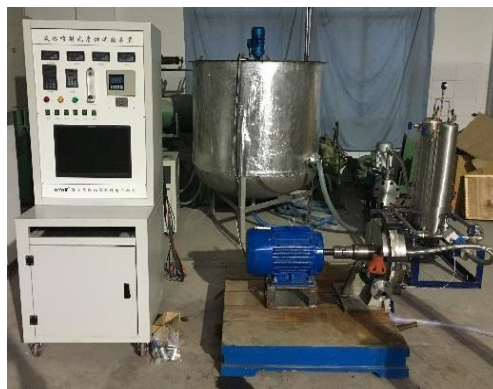
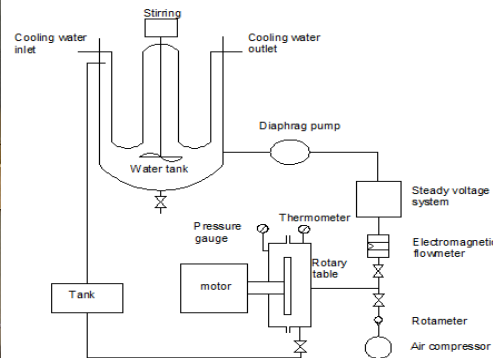
Figure 1. Rotary spray erosion testbed

As the Fig. 1(a) and (b) show, the testbed consists of adjustable speed motor, diaphragm pump, mixed water tank, steady voltage system, air compressor, refrigeration system and rotary table room. In the testbed, with the help of diaphragm pump, the flow with sands went through steady voltage system into rotary table room, and impact rotary table surface by using nozzles where the velocity could be set. Furthermore, rotary table was driven by motor and in high speed, it made the rotating centre pressure decrease and formed pressure gradient, and created opportunity for cavitation. Flow pattern at the back of the hole was damaged owing to cavitation hole. The area in low pressure produced gas nucleus and the gas nucleus were broken in the high pressure area, which lead the phenomenon of cavitation damage. Moreover, the flow with sands in high speed impacted material surface through nozzles and lead wear damage. Cavitation and wear could affect each other and formed erosion. Eventually, the flow with sands returned to mixed water tank.

To keep the temperature of the water in the mixed water tank below 50 degree centigrade, so the cooling system used to absorb energy from rotary table was been set. Besides, the impacting velocity and impacting angle were regulated by changing flow and rotational speed of the rotary table. Other functions could be achieved on the control cabinet. Fig. 2(a) and (b) show the diagram of rotary table. Eight test materials were installed in the rotary table. In present paper, same materials were installed at the opposite angle, so four kinds of materials could be tested at the same time.

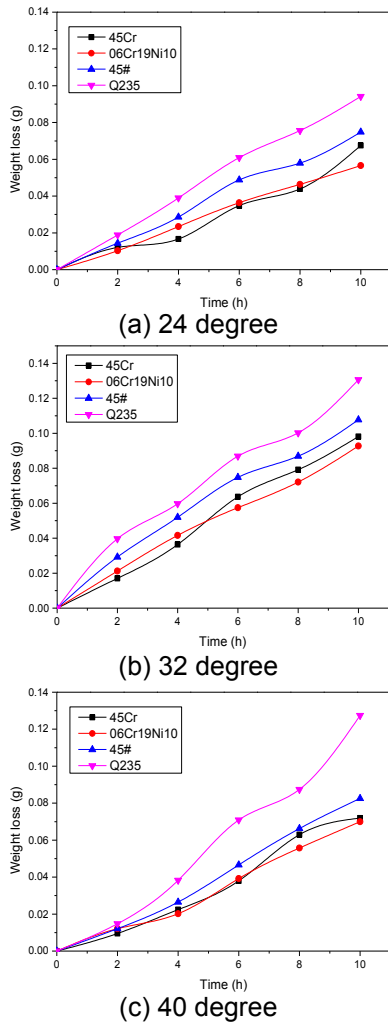
Figure 3. Variation curves of weight loss of specimen under different erosion angle

After the test, four kinds of materials weight loss curves were shown in the fig. 3. The impacting velocity was set at 35 m/s, and impacting angle was set to 24 degree, 32 degree and 40 degree, respectively.

As Fig. 3 shows, the four kinds of materials show the same rules of erosion weight loss under three kinds of impacting angle. The accumulated weight loss of Q235 was the maximum and the one of 06Cr19Ni10 was the minimum. According to the material weight loss curves under three different impacting angles, the anti-erosion performance of the four kinds of materials could be obtained. The accumulative weight loss of 06Cr19Ni10 was the smallest, so the anti-erosion performance was best. The accumulative weight loss of Q235 was the largest and the anti-erosion performance was poor. The curves in Fig3 also show that weight loss of the erosion material included the incubation period, the rising period and the stabilization period [10,11]. During the incubation period (from 0 to 2 hours), the surface of the material was damaged mainly by impacting wear. During the rising period (from 2 to 6 hours), due to wear and cavitation interaction, the material damage increased quickly. During stable period (6 hours later), wear and cavitation damage entered the relatively stable. Within the allowable range of test error, the trend of weight loss curve of four kinds of materials was almost the

same. Comparing the erosion weight loss curves under three kinds of angles, it could be seen that the gradient of the weight loss curves of four materials was larger than that of the other two angles when the angle of impacting was 32 degree. Therefore, it could be concluded that the wear damage of the material was the most serious when the impacting angle was about 32 degree.

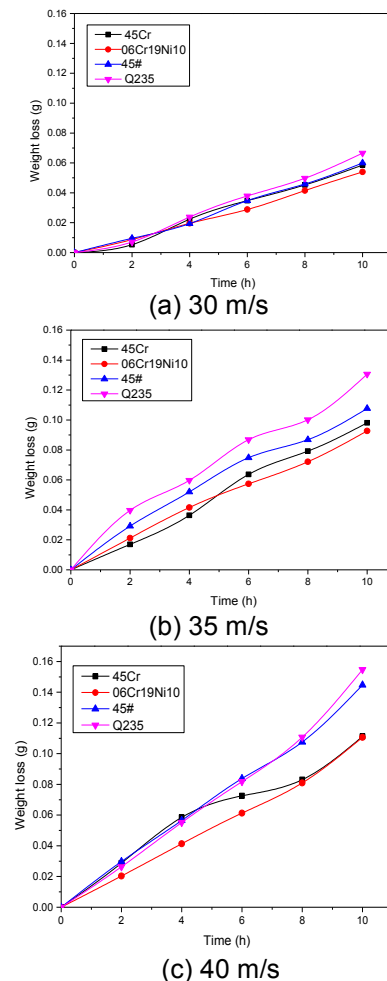
Figure 4. The variation curves of the weight loss of specimen under different erosion velocity

Fig. 4 shows that the accumulative weight loss of four kinds of materials changed with test time when impacting angle was 32 degree and the impacting velocity were 30m/s, 35 m/s and 40 m/s, respectively. It had a positive proportion relation between the weight loss and the test time under the erosion damage. At the same impacting velocity, the weight loss of Q235 was the largest; the damage of 45Cr was close to the one of 06Cr19Ni10.

When the impacting velocity of Q235 was set at 30 m/s, 35 m/s, and 40 m/s, the accumulative weight loss was 65.45 mg, 117.3 mg, 143.95 mg respectively after test. The weight loss of the largest is 2.19 times bigger than the smallest. Other materials had the same rules. According to these curves and experimental data, it could be concluded that the increasing of impacting velocity caused the sand particle momentum increase continuously. Which leded material damage serious, and the weight loss of erosion increased quickly.

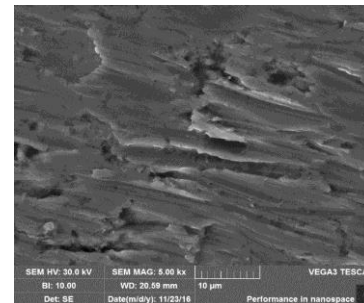
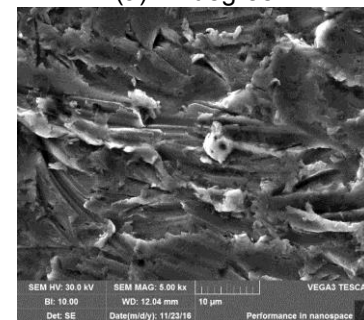
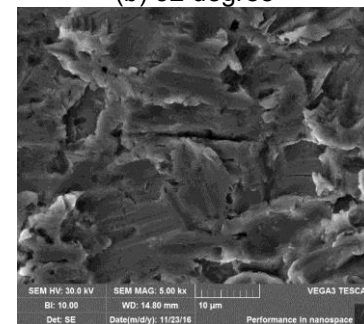
Figure 7. SEM images with erosion angle 24degree, 32 degree, 40 degree .(5000x)

The Q235 was chosen as the study object, Fig. 7 shows the surface topography after 10 hours of erosion under 24 degree, 32 degree and 40 degree, respectively. The surface damage of the material mainly concentrated in the back of the cavitation hole, and the surface appeared furrow, fish scales lip, small cracks and small pit.

When the impacting angle was small, the interaction between cavitation and wear was mainly micro cutting and the second was the effect of cavitation damage. The velocity of the sands in the process of movement was constituted by horizontal component and vertical component. The vertical component determined the sand into the material surface depth. The horizontal component completed the micro-cutting on the material surface [12,13]. It formed a lamellar deformation layer after many times of impacting on the material surface. Subsequently, the layer at the edge cracked and formed some concaves and convex lips. Eventually it leded the surface micro volume shedding. When impacting angle was large, the wear loss was mainly decided by sand kinetic energy, the influences

vertical impact and cavitation effect of the flow with sands on the material destroyed structure of the surface layer, causing fatigue spalling and leaving the pitting on the surface of the material. When the impacting angle was 24 degree, the surface of material were mainly large lips and also appeared small amount of cavitation pits and furrows. Direction of the furrow was neat, and depth was shallow. When the impacting angle was 32 degree, the cutting of sands made the surface plastic deformation seriously. At same time, the direction of lips and furrow are more chaos, and lip flanging was more serious. When the impacting angle was 40 degree, material surface damage was mainly based on vertical impact and cavitation damage, furrow trip was short and the lips appeared as small patches.

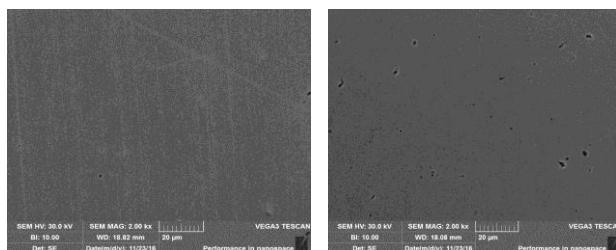
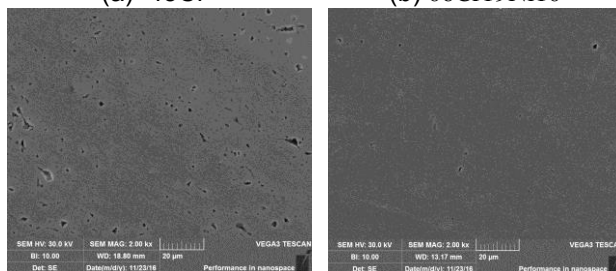
Figure 6. Original specimen appearance

To analyze easily, the original surface topographies of four materials which were not been tested after polishing were shown in Fig. 6. After polishing, the surfaces of the materials were relatively smooth without obvious scratches. Due to the defects of Q235, there were many pores in the surface of the material, but the influence of these pores was relatively small on test results, so it could be ignored.

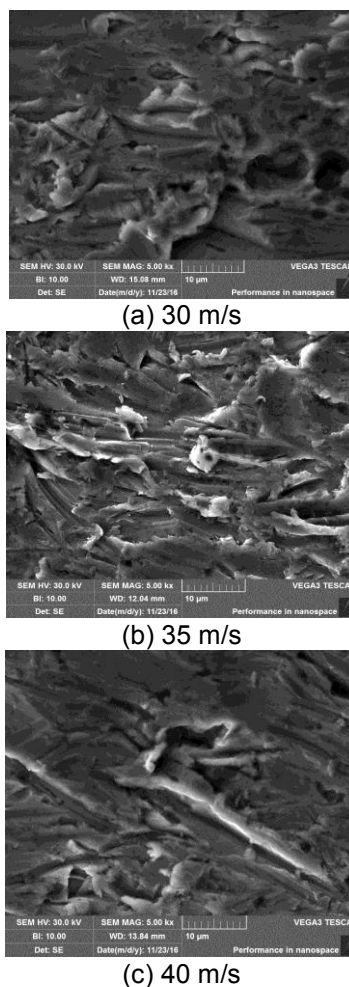
Figure 8. SEM images of erosion velocity 30 m/s 35 m/s, 40 m/s .(5000x)

Also, Q235 was chose as the study object. Fig. 8 shows the surface morphology after 10 hours of erosion under 30 m/s, 35 m/s and 40 m/s.

In the erosion test, , the wear scar of the material surface was shallow and deep with the increasing of the impacting velocity, and the wear degree was also gradually increased . When the impacting velocity was 30 m/s, wear scar on the surface caused by sand were short and disorderly, the damage concentrated mainly in the surface layer. When the impacting velocity was

35 m/s, the surface cutting degree of the sand particles increased continually, and the furrow wear marks became longer and the wear direction was gradually neat. When the impacting velocity was 40 m/s, the cutting marks on the surface of the material were further increased and the furrow wear was deepened, and the damage of cavitation was further promoted.

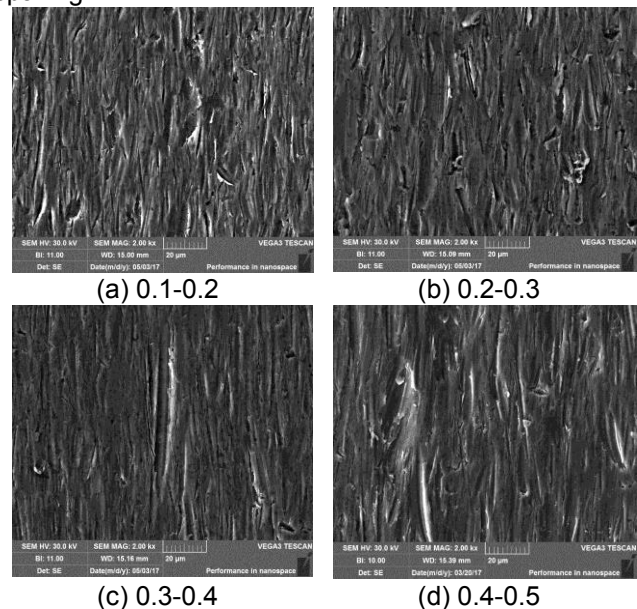
Figure 9. SEM images of different particle sizes. (5000x)

The Fig. 9 shows the aluminum bronze surface morphology caused by erosion under four different particle sizes. The damage of the material surface became seriously with the increasing particle sizes of sand. The surface morphology of the material mainly included furrow, scaly lips and pits which came from lips spalling^[14,15] .

As the hit of the sands again and again, the furrow overlap became serious, and lips fatigue loss increased quickly. The shedding lips from outside to inside and furrow led the material loss. As the Fig. 9(a) and (b) show, aluminum bronze surface was worn seriously. The cutting effect of the sands made the material surface produce plastic deformation and led to accumulation of materials, as well as appeared lips and short furrows whose width was a small, however it distributed uniform. As Fig. 9(c) and (d) show, with the increase of the particle sizes, the furrow width increased and the furrow length also increased correspondingly. The damage of the furrow between (d) and others had a clear difference, it kept consistent with the test date when the size of from 0.4 mm to 0.5 mm, whose weight loss increased suddenly.
