## Rail squats

Kaewunruen, S & Ishida, M 2015, 'Rail squats: understand its causes, severity, and non-destructive evaluation techniques', Paper presented at 2015 National Convention in Civil Engineering, Pattaya, Thailand, 8/07/15 - 10/07/15.

## Rail squats: understand its causes, severity, and non-destructive evaluation techniques

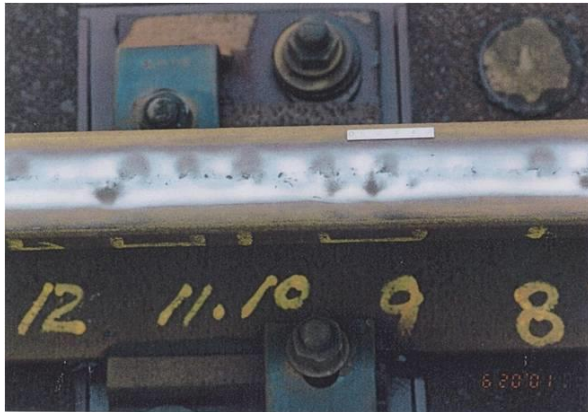
a) WEL-related stud (multiple squats)

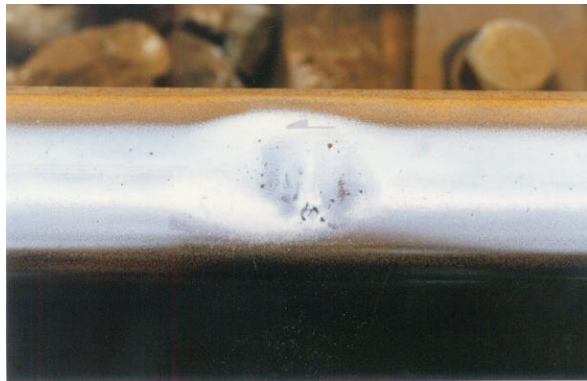
b) RCF-related squat (single squat)

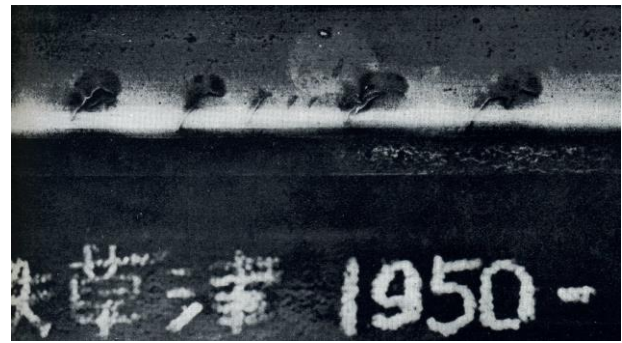
a) dark spots in gentle curve

The rail squat/stud problem has largely been noticed when the ride quality of the passenger trains exceeds acceptable limits [7]. Excessive noise and vibration have later increased complaints against rail operators. Most importantly, the impact forces due to the wheel/rail interaction have undermined the structural integrity and stability of track components [8-12]. In Japan and Europe, frequently the rail squats have transversely grown and turned into the broken rails, which could derail the trains and potentially result in a catastrophe [2]. An infamous example of the tragedy was the Hatfield accident in the UK. Fig. 2 shows some examples original rail squats found over 60 years ago in Japanese ballasted tracks. The dark spots, so-called 'rail surface shelling'

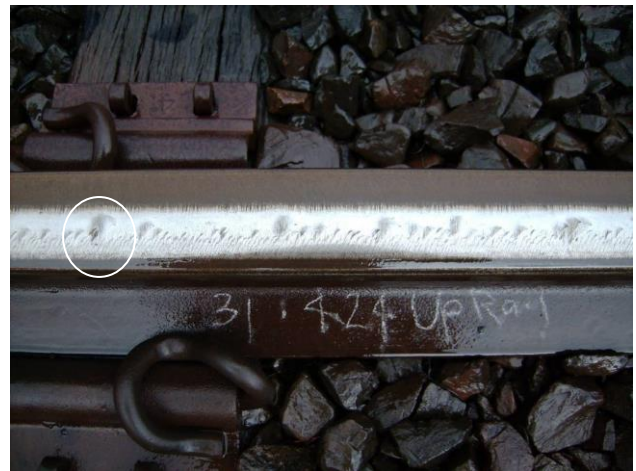
a) High rail typical of squat features in a squat zone

The rails at various locations have been assessed visually and recorded. Fig. 5 shows examples of rail squat found in the area.

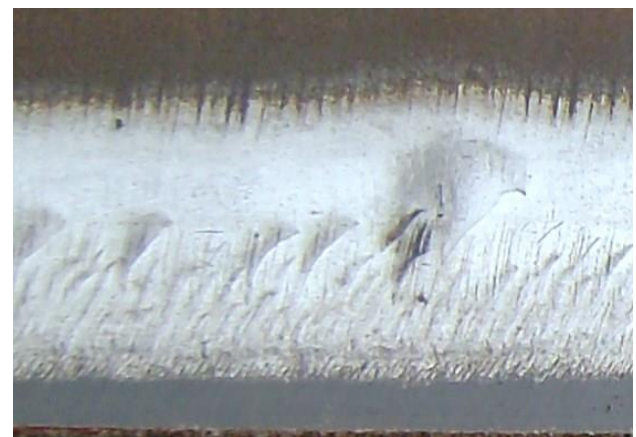
b) Close up for visible Cracks  
Fig. 5 Rail squats in the field

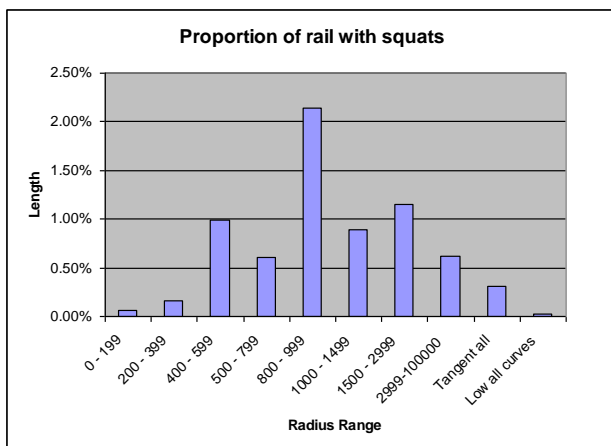
Fig. 6 Distribution of ultrasonically reported squats by curve radius.

Based on the data, Fig. 6 shows lengths of squat affected rail as a proportion of total length of rail in each curvature band of railway track geometry [5, 14-15]. Critical features are:

- Most squats recorded in separate curvature bands are high rail only.
- A peak of squat frequency in the track curvature band from 800m to 1000m radius.
- A secondary peak in the curvature band 400m-600m, possibly associated with squats in the transitions of sharper curves.
- A secondary peak of squat frequency for the curvature band 1500m-3000m.
- A relatively small proportion of squats in tangent track.
- A very small proportion of squats in curves <200m.
- Almost all the squats in curves are in the high rail. Only an extremely small proportion of squats are in the low rail of any curves.
- A lesser incidence of squats can be observed in curves sharper than about 900m radius in standard carbon (SC) rail compared to head hardened (HH) rail.

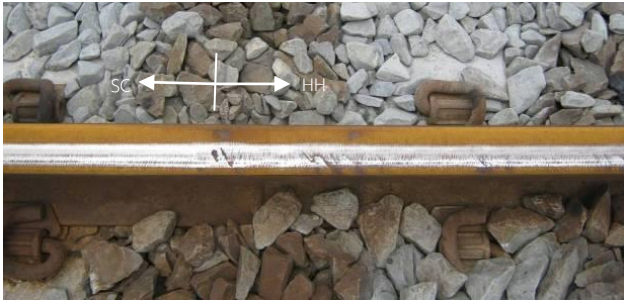
Fig. 7. Interface between SC rail and HH rail. The SC rail is squat free. Squats are visible at the weld and in the HH rail. High rail in transition to 932m radius curve [5].

- Squats occurred in both types of rail, but were significantly more extensive and severe in the HH rails.
- Several cases occurred where there was a significant contrast at the interface between the 2 rail types, with much more severe squat damage in the HH rail. These were in curves with radii in the range 800m–1,000m. The SC rail was generally older (around 1995) than the HH rail (around 2002), as shown in Fig. 7.

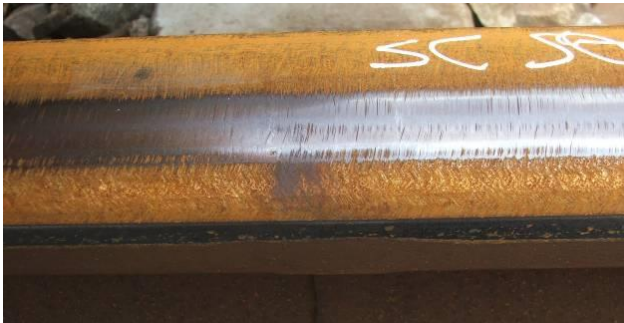
Fig. 8. Squat at flashbutt weld in SC rail which is otherwise squat free. Measured hardness 305-312HB in parent rail and 372HB in weld. High rail in arc of 872m radius curve [5].

- Squats occurred at flashbutt welds in otherwise squat free SC rail. The weld material was found to be harder than the parent metal, as illustrated in Fig. 8.

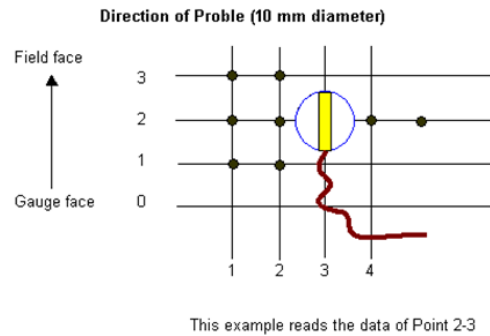
Fig. 9 Illustrative testing method

For practicality and suitability in the field measurement, the hand-held ultrasonic testing device (with the accuracy range of  $\pm 0.1$  mm) is chosen for this test. The square grids of 10mm x 10mm size were developed over the cracks, in order to map the cracks with a benchmarking reference. At each grid point,

the digital ultrasonic testing device with a 10mm-diameter probe was applied to detect the existence of crack. If the crack exists, the depth of crack will be recorded. In some cases, a smaller probe (e.g. 5mm diameter) will be used to accurately evaluate shallow cracks and the thickness of crack tip ( $<3$  mm deep). It is important to note that the orientation of the probe should be set consistently as illustrated in Fig. 9 to obtain consistent measurements. Using this technique, the squat defects can be monitored. A standard reference grid on transparent plastic slides and the reference punch mark system was developed for field work.

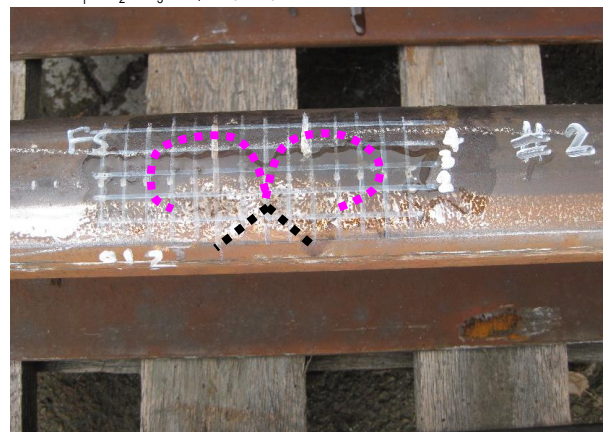
Fig. 10 Ultrasonic testing (Top: crack depths at each grid; Bottom: top view rail surface)

The crack depth data has been recorded accordingly in order to develop a crack contour. As a case study, two data sets of the 3D mapping of rail squats are demonstrated in this paper [17-20]. Note that an attempt to change the probe orientation has been made. It was found that when the crack is about flat, the orientation has little effect on the crack depth reading. Using the ultrasonic testing, subsurface crack depths have been measured at each grid point.

In Fig. 10, the testing grid is first marked at about 210 mm away from the left end of Sample No. 2. Squat depths at each grid intersection (10mm x 10mm) are shown in the top chart. It is found that crack does not exist in row three (about 30 mm from the gauge face). It is clear that the squat cracks were developed from the depression of rail surface around the V-shape, which can be regularly observed in the field visual inspections.

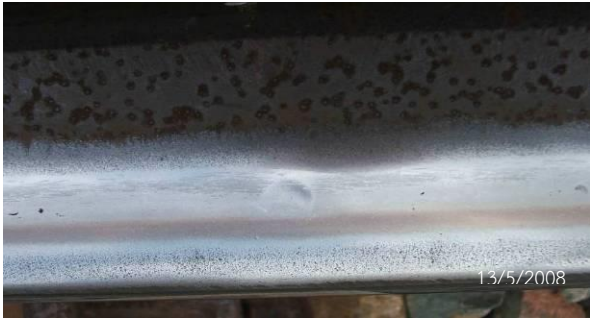
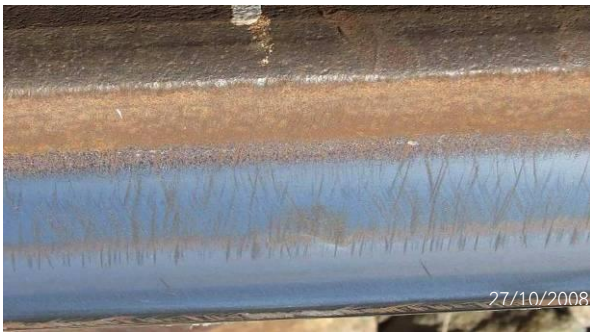
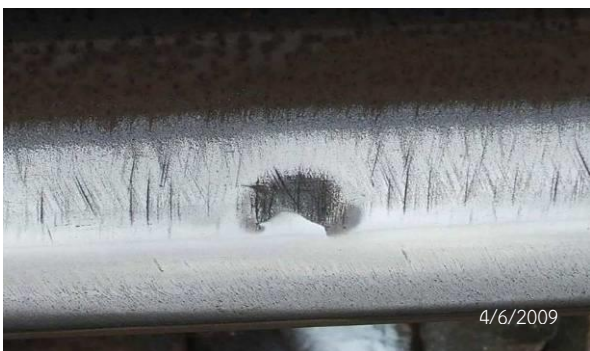
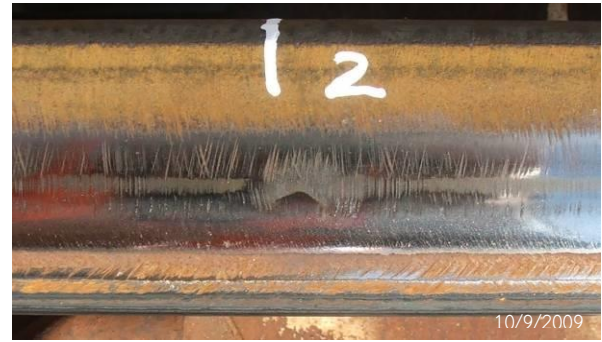
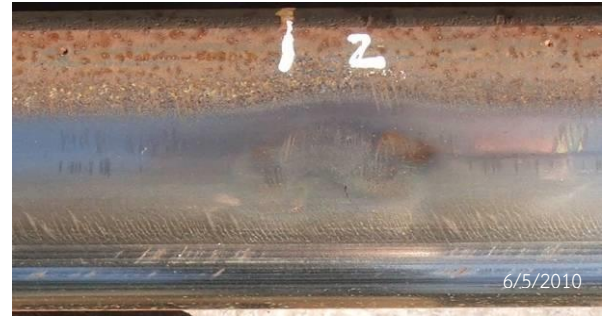
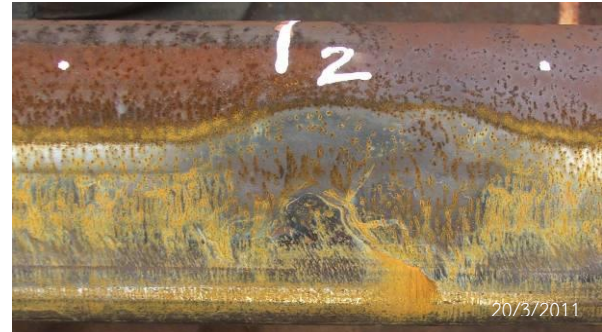
**Fig. 13** Progressive squat development.

Fig. 13 shows evolution of a rail squat defect every half a year, dating from late 2007 through to early 2011. It can be seen that the area growth is higher for the larger squats, as would be expected. The increase in equivalent radius appears quite constant for all sizes of squat. The exception to this is the period in 2009. It was believed that such the nonlinear growth pattern corresponded to a period of low rainfall in Sydney, and it can be seen that the growth rate was lower here than for other periods.

It is evident from the squat under monitoring that the very small squat (which is barely visible in 2007) could grow to a very much larger size of squat. It is important to note that the squat crack was too shallow to be detected by the ultrasonic equipment used in 2007. The squat was firstly quantified in 2008 and it had a measurable depth of 3.5mm, and by 2011 maximum measured depth was 4.1mm. It had been reported that there was an intervention grinding during the period. The grinding removed approximately 1mm of rail metal and the rail squat could not be removed and eventually returned as shown in Fig. 13(g). In 2013, the rail section was replaced due to the severity of squat defects and excessive maintenance in the area [29].
