**Análise de estabilidade tridimensional de um talude urbano localizado em João
Monlevade, Brasil**

Three-dimensional stability analysis of an urban slope located in João Monlevade, Brazil

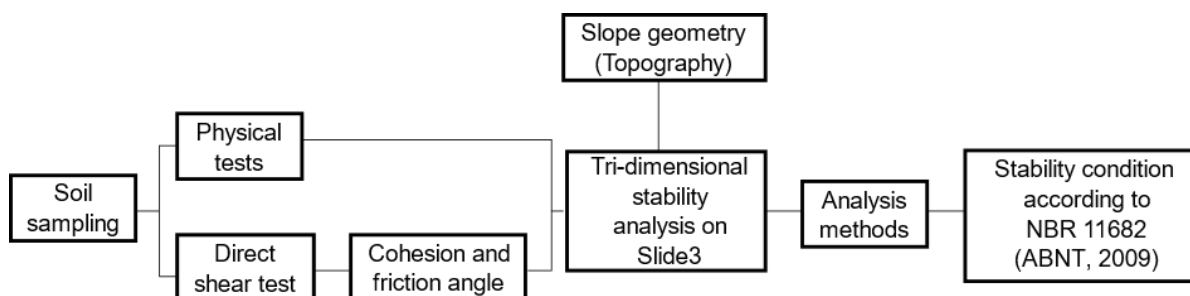
Figure 1: Research methodology.

Figure 1 presents a flowchart of required methodology to perform the tri-dimensional stability analysis of the slope.

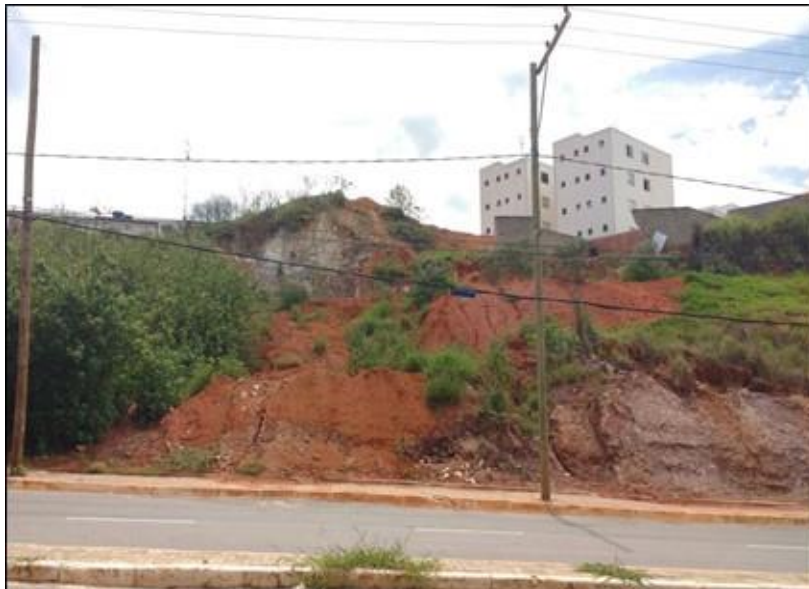
Figure 2. Studied slope.

The studied slope (Figure 2) is located at Alberto Lima Street, in city of João Monlevade. The city is located in the central part of Minas Gerais State in Médio Piracicaba region. It has a territorial extension of 99.65 km², 73610 inhabitants and 21665 residences (Instituto Brasileiro de Geografia e Estatística, 2010).

Slope is upstream of a busy city street and above of it, two buildings and some residences were built. The mature residual soil is exposed and there is vegetation cover only in some parts of the slope.

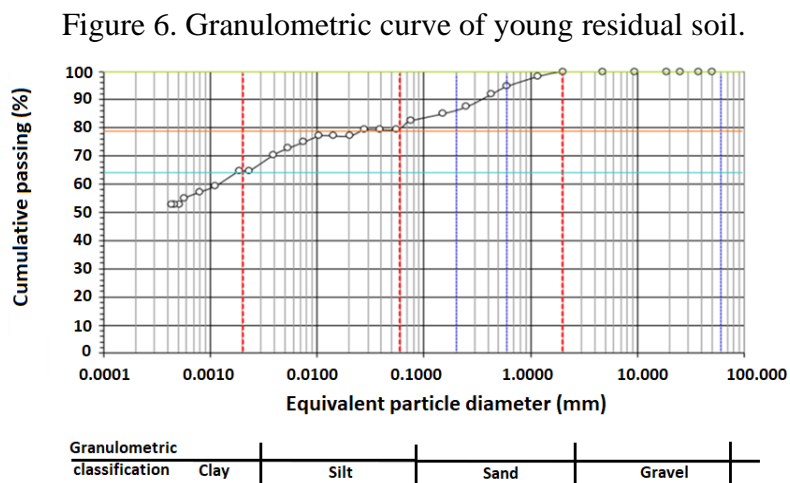
The granulometric curves of young and mature residual soils are presented in Figure 6 and 7, respectively. The granulometric curves of young and mature residual soils consist of a cumulative soil percentage according to the particle diameter in millimeters. The percentage of each particle size fraction of soils was determined.

The young residual soil presented 64% of particles with size until 0.002 mm (clay), 15% of particle with size until 0.06 mm (silt), 21% of particles with size until 2 mm (sand) and 0% of particles above 2 mm (gravel). Then, the young residual soil was classified as clay without gravels. The mature residual soil presented 39% of particles with size until 0.002 mm (clay), 45% of particle with size until 0.06 mm (silt), 16% of particles with size until 2 mm (sand) and 0% of particles above 2 mm (gravel). Then, the mature residual soil was classified as clayey silt without gravels.
