## EXPERIMENTAL STUDY OF BAMBOO AS A HOUSE RETROFITTING MATERIAL FOR DEVELOPING COUNTRIES

Keywords: earthquake, retrofitting, bamboo, tensile test, shaking table test

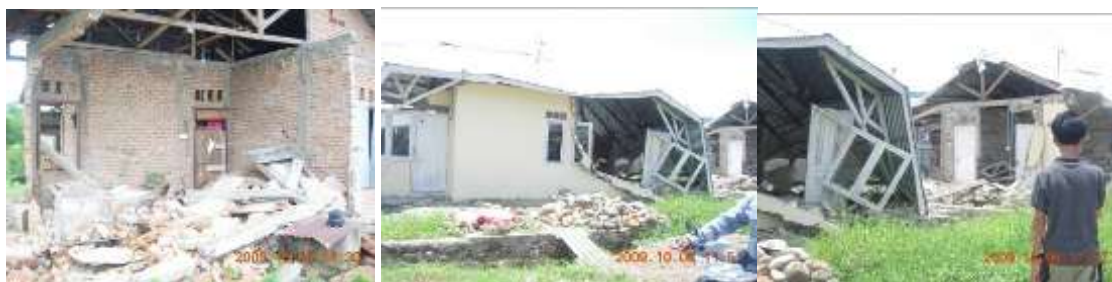
Figure 1. Condition of Masonry Houses after earthquake

Survey were conducted a few days after the earthquake 30 September 2009 shows variety of conditions the collapse of several masonry

houses located in Padang city, as shown below

Generally, the damage condition occurs in non engineered buildings, but no less severe failure occur in engineered buildings, caused by an incorrect construction practices or building code (Steffie, 2010). An earthquake occurs in West Sumatra in September 2007 has provided an early warning that the possibility of a larger earthquake could occur and would cause severe damage if

construction authorities do not pay attention to the correct building code in construction practices. In fact, many people do not learn from the experiences and only a moment's attention to get more profits. Based on a field survey to several buildings and masonry houses in Padang, various damages were obtained (Figure 1 and Figure 2).

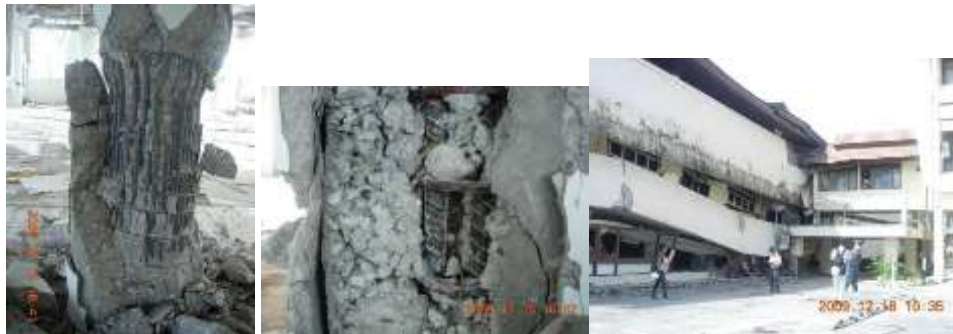
**Figure 2. Mitsubishi Motors Building**

Types of collapse that occurred in these buildings due to earthquake 30 September 2009 include; beam-column joint failure, soft story effect, short column effect, joint failure, and overturning
