Applying and validating the PTVA-3 Model at the Aeolian Islands, Italy: assessment of the vulnerability of buildings to tsunamis

F. Dall’Osso^{1,2,4}, A. Maramai³, L. Graziani³, B. Brizuela³, A. Cavalletti^{2,4}, M. Gonella^{2,4}, and S. Tinti⁵

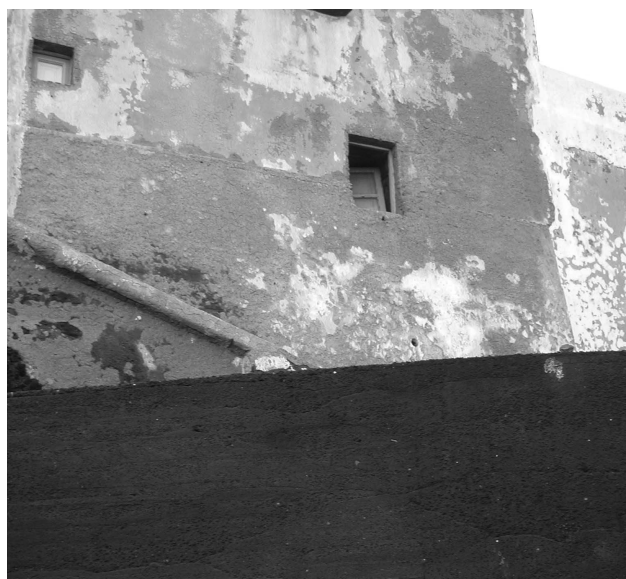
Fig. 8. View from north-west of building #1, at Piscità (Stromboli – Fig. 4). The picture was taken few days after the 2002 tsunami. The only visible damage is an unhinged window on first floor. The PTVA-3 Model classified building #1 as having a “very low” RVI score which correlates well with the actual damage sustained by this building.

Figure 8 shows the façade of building #1 after the 2002 tsunami. The footprint of the same building is highlighted in the vulnerability map of Piscità (Fig. 4). Although the picture provides only a partial view, no relevant damage can be seen, except from an unhinged window on the first floor. Building #1 is located on the coastal cliff and intersects the line of maximum horizontal water inundation. Accordingly, the water depth impacting the building was minimal and did not even flood the whole ground-floor. Damage to the interior and to parts vulnerable to water contact was negligible. The RVI score calculated by the PTVA-3 Model for that building is “very low” and result are thus consistent with the observed damage.

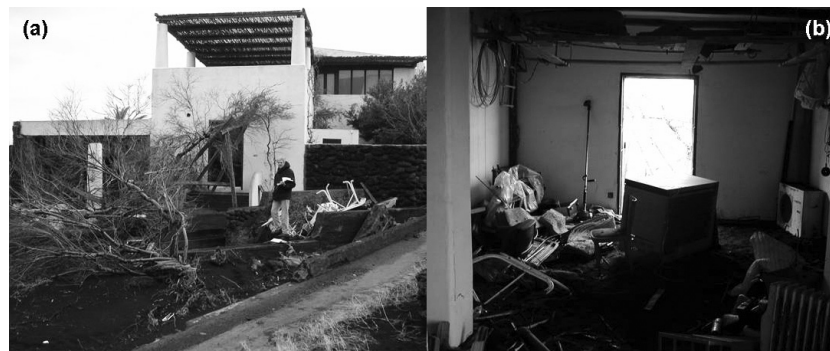
Fig. 9. Pictures of building #2, at the eastern end of Ficogrande (Stromboli – Fig. 5), taken after the 2002 tsunami. **(a)** A view of the building from north-west. **(b)** Damage to the interior. The PTVA-3 Model classified building #2 as having an “average” RVI score.

Damage to building #2, at Ficogrande (Fig. 5), is shown in Fig. 9. The flow broke through a door in the front wall, penetrated indoors, destroyed the interior and one partition wall and travelled through the backdoor of the house (Tinti et al., 2006a). The overall damage level is clearly heavier than the one observed in building #1 at Piscità. The PTVA-3 Model classified building #2 as having an “average” RVI. Although such an RVI score may appear to be an underestimate, Fig. 9 shows that no damage occurred to the weight-bearing walls of the building. Apart from an internal partition wall, which is not designed to withstand any kind of pressure, damage involved only doors, windows, furniture (which is not considered by the PTVA-3 Model) and the interior, especially parts vulnerable to water (electric appliances, fixtures, paving tiles, etc.).

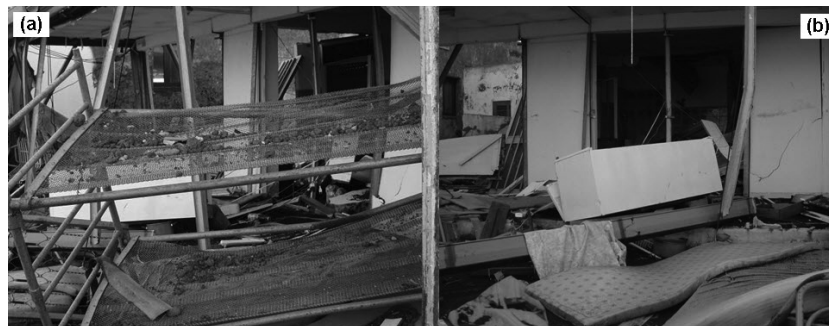
Fig. 12. Two pictures of building #5 (Punta Lena, Stromboli – Fig. 6) taken after the 2002 tsunami. The flow broke doors and windows, penetrated indoors and dragged the building contents outside (a). A large crack can be observed in the front side wall (b). However, that wall does not appear to be part of the load-bearing structure of the building, as does the undamaged column at its right. The PTVA-3 Model classified building #5 as having an “average” RVI score.

Figure 12 shows damage to building #5 (RVI = “average”). Like building #2 and 3, window and door frames have been ripped off the wall. The building interior has been completely destroyed and the contents widely dispersed. The im-

pact caused a crack in the front-wall, but left load-bearing column to its right undamaged (Fig. 12b). The front-porch has been almost completely destroyed. However, the load-bearing structure of the building is largely untouched.

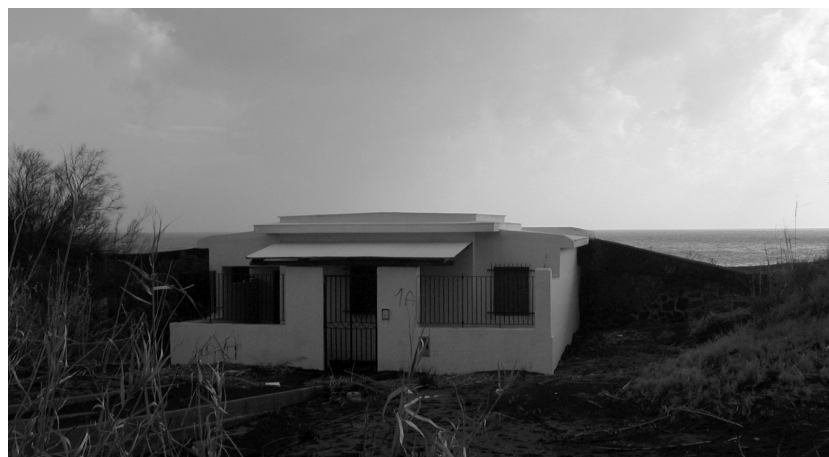
Fig. 13. View of the western side of building #6. The picture was taken a few days after the 2002 tsunami. Building #6 is a Coastguard station on the beach of Scari (Stromboli – Fig. 6). As clearly shown by the picture, the seaward side of the building is totally “covered” by a coastal dune. The PTVA-3 Model attributed to building #6 an “average” RVI score.

Building #6, the Coastguard station, is situated on Scari beach (Fig. 6). It has one storey, a brick-made structure and a ground-floor almost completely closed, with no openings on the seaward wall. There is no protection from the sea apart from a coastal dune that rests against the seaward side of the building. The RVI score of building #6 is “average”. Figure 13 shows a picture of the building taken few days after the 2002 tsunami. Whilst the picture does not provide a detailed view of the structure, it appears that the general damage level is lighter than that observed in buildings #2, #3 and #5, although they have the same RVI score. This is due to the relative position of the building and the coastal dune. The shielding effect provided by the dune was higher than predicted by the model, which is designed to consider the protection from natural defences but does not include such particular cases. However, whilst building #6 was well protected against the first impact of the tsunami, it has been inundated by more than 1 m of water. As a consequence, some damage to the interior must have occurred, although this was not recorded and cannot be seen in the photograph (Fig. 13).
