Reparatory and Manufacturing Hard-Facing of Working Parts Made of Stainless Steels in Confectionary Industry

S. Rakić^a, V. Lazić^b, S. Aleksandrović^b, S. Mitrović^b, R. Nikolić^{b,c}, D. Milosavljević^b, R. Čukić^b

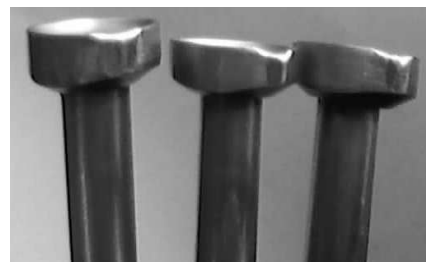
Fig. 2. Worn shape punches.

parts of the tools come into contact under the effect of pressure needed to deform the product. The pressure increases when the sugar mass is sub-cooled. Fatigue wear occurs as a result of frequent changes in the loading direction when movable and fixed parts come into contact during forward and backward movement of the tool. Worn shape punches are shown in Fig. 2.

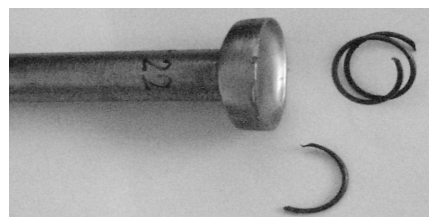
Fig. 3. Damage caused by broken pieces of the spring.

Since the main cause of fracture is the low quality of springs, there have been many investigations and activities aimed towards solution of this problem. However, brittle fracture remains a cause of damage. Figure 3 shows damage caused by broken pieces of the spring.

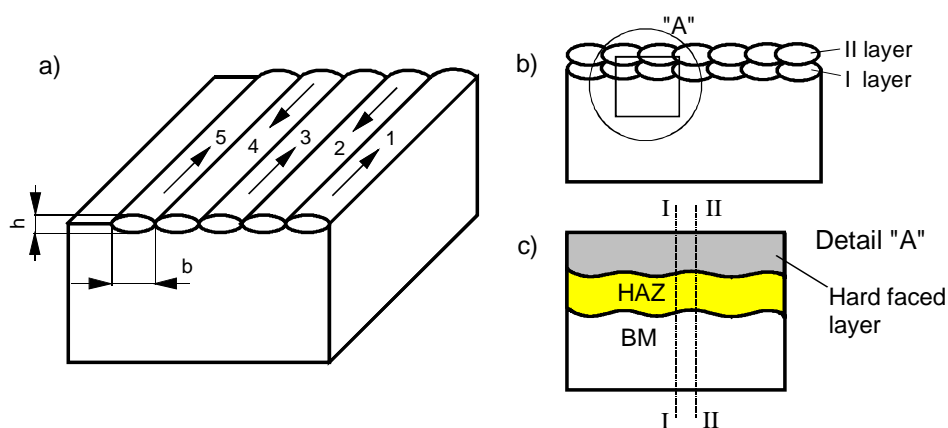
Fig. 5. The order of hardfaced layer deposition: a- 1 layer, b- 2 layers, c- metallographic sample (block).

The third shape punch was hardfaced and cut out into a block used for tribological investigations (Fig. 5c). Hardfacing was carried out in two layers as show in Fig. 5b. The height of one layer was 1.2-1.5 mm and the width was 3-4 mm (Fig. 5a). The TIG-hard facing parameters for tribological investigations are given in Table 5.

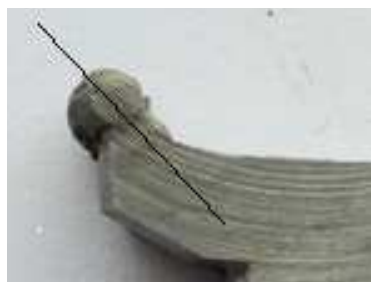
**Fig. 6.** Direction of microhardness measurements on a hardfaced edge of a shape punch.

Metallographic investigations and hardness measurements were performed on models obtained by hardfacing and cutting real parts (shape punches) normally to the hardfaced cutting edge (Fig. 6).

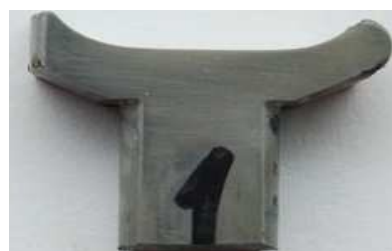
**Fig. 7.** Hardfaced shape punch – Sample I (BM-Č4172, FM-Č4172)

Macro appearance of the TIG- hardfaced shape punch is shown in Fig. 7. The depth of penetration was about 0.8 mm, while the height of the hardfaced layer was approximately 2.5 mm. There were neither cracks nor flaws on the cross-section, which means that the bonding between the hard faced layer and the base material was firm.

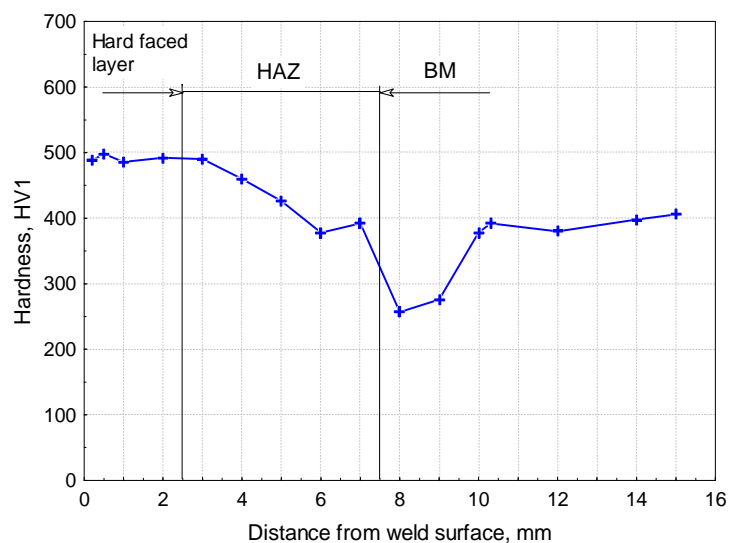
Fig. 8-1. Distribution in the cross-section of the hardfaced layer - Sample I (BM-Č4172, FM-Č4172).

The base material microstructure was estimated as small-grained interphase quenched and tempered structure. The hardfaced layer has martensitic structure with needle-shaped carbides at metal grain boundaries. The transient zone is hardly visible and is dominated by interphase structure with little residual martensite. The HAZ is about 5 mm wide, not especially prominent, and it has interphase quenched and tempered structure. The hardness distribution diagram shows that hardness decreases in the HAZ, which means that tempering and not hardening occurred. This is highly favourable because it reduces the possibility of cracking. Hardening in the HAZ would affect the desired mechanical properties of the repaired shape punch. Hardness distribution and microstructures of the hardfaced layer zones are given in Figs. 8-1 and 8-2 [15-18].

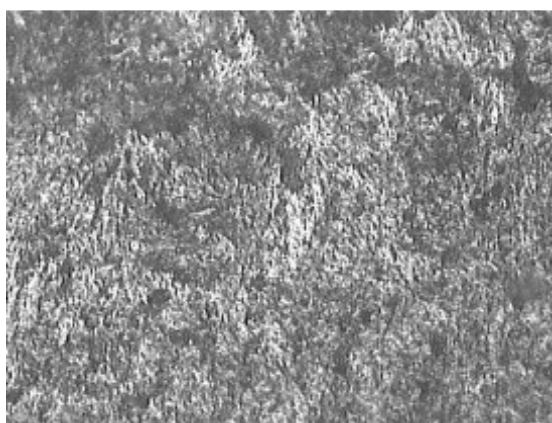
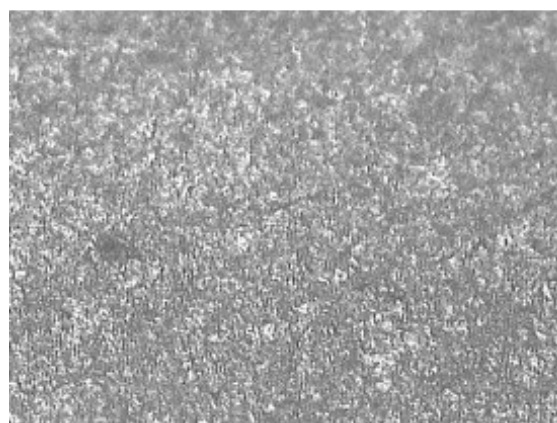
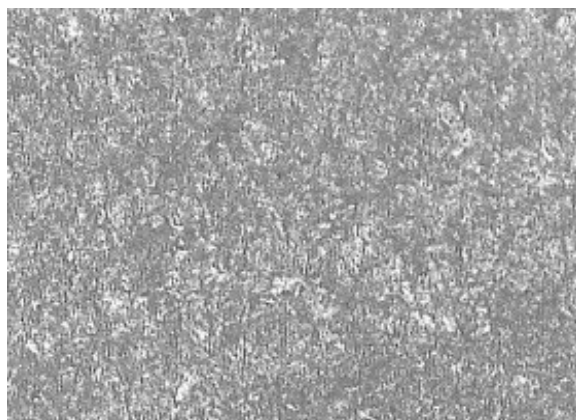
Fig. 8-2. Microstructures of typical hardfaced layer zones – Sample I.

The hardfaced layer – martensitic structure with needle-like carbides at metal grain boundaries (200×)

HAZ – interphase quenched and tempered structure (200×)

BM – homogenous small-grained interphase quenched and tempered structure (200×)

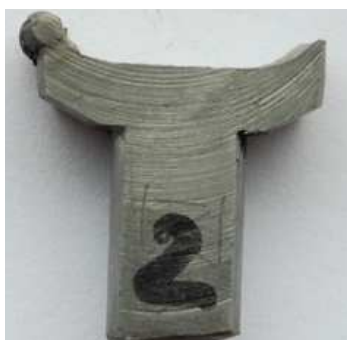
Fig. 9. Hardfaced shape punch - Sample II (BM-Č4172, FM-Č4850).

Macro appearance of the shape punch hardfaced using TIG procedure is shown in Fig. 9. The depth of penetration was about 0.8 mm while the height of the hardfaced layer was approximately 2.2 mm.

There were neither cracks nor flaws on the cross-section, which means that the bonding between the hard faced layer and the base material was firm.

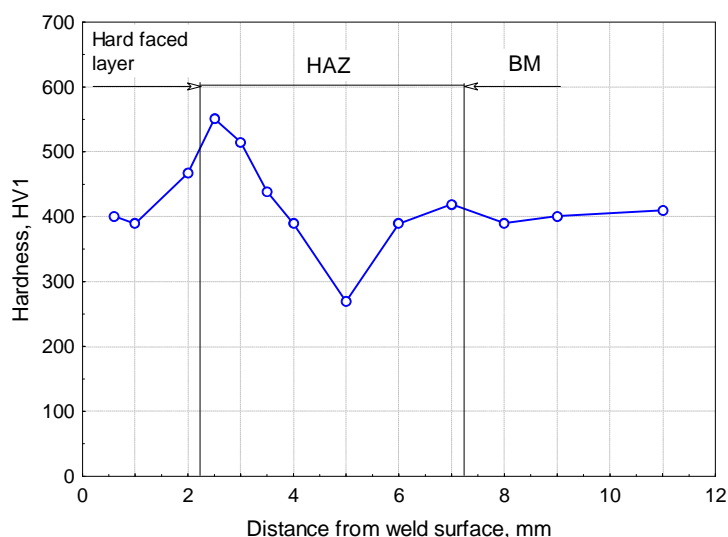
Fig. 10-1. Distribution of microhardness in the hardfaced layer - Sample II (BM-Č4172, FM-Č4850)

The base material microstructure was estimated as small-grained interphase quenched and tempered structure. The hardfaced layer has martensitic structure with needle-shaped carbides at metal grain boundaries with a lot of residual austenite. The transient zone is easily visible and dominated by interphase structure with little martensite. The HAZ is about 5 mm wide, it is not especially prominent and it has interphase quenched and tempered structure. The hardness distribution diagram shows that hardness increases in the HAZ, which is explained by hardening of the base material particularly in the transient zone. Hardness distribution and microstructures of the hardfaced layer zones are given in Figs. 10-1 and 10-2.

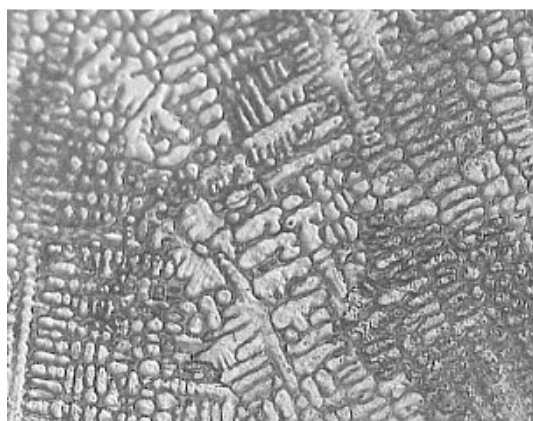
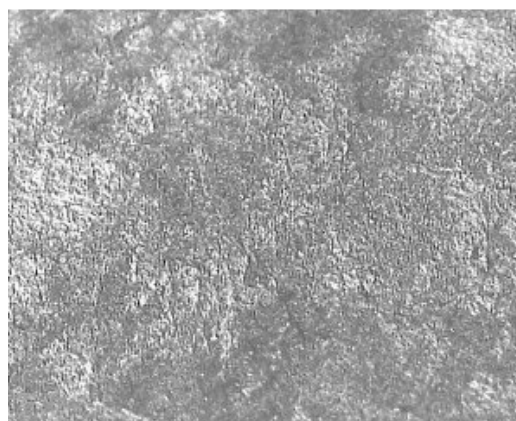
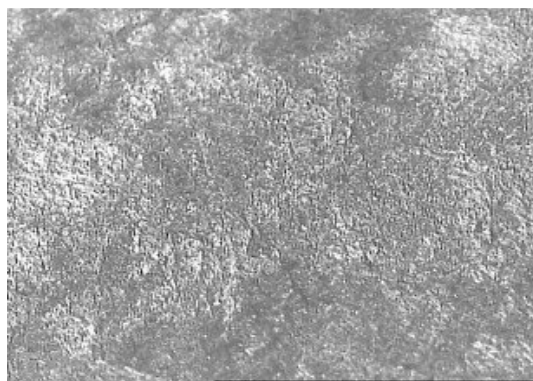
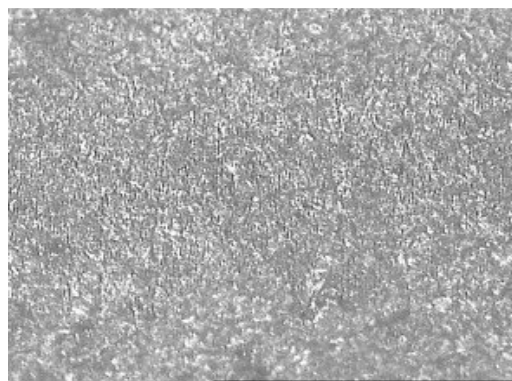
Fig. 10-2. Microstructures of typical hardfaced layer zones.

Hardfaced layer - martensitic structure with needle-shaped carbides at grain boundaries with residual austenite (200×)

Hardfaced layer/HAZ - interphase quenched and tempered structure with residual martensite (200×)

HAZ - interphase quenched and tempered structure (200×)

BM - homogenous small grained interphase quenched and tempered structure (200×)

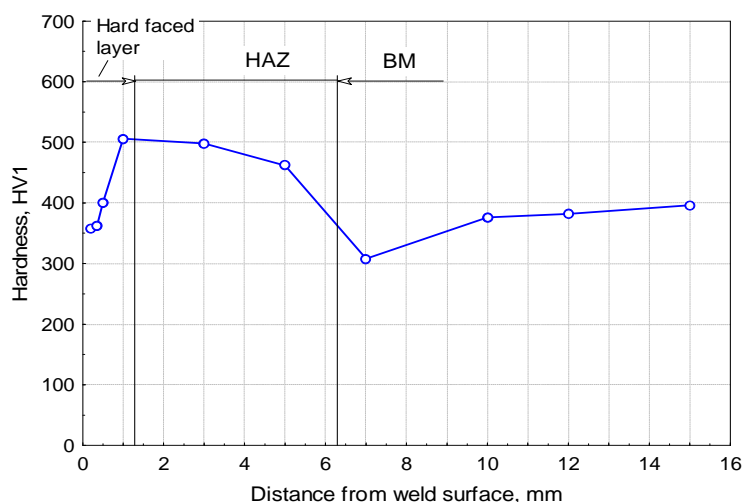
Fig. 12-1. Distribution of microhardness in the cross-section of the hardfaced layer - Sample III (BM-Č4172, FM-powder Castolin EUTALLOY BRONZOCROM 10185).

The base material microstructure was estimated as small-grained homogenous interphase quenched and tempered structure. The hardfaced layer has austenitic structure with small-grained needle-shaped martensitic structure at austenite grain boundaries. The transient zone is visible because the base and filler materials have not mixed. The HAZ is not particularly wide, but the metal grains of interphase quenched and tempered structures have clearly increased in size. The hardness distribution diagram shows that hardness increases in the HAZ, which is explained by hardening of the base material. The increase in hardness is not significant, therefore it will not have a considerable effect on the output properties of the hardfaced layer. Hardness distribution and microstructures of the hardfaced layer zones are given in Figs. 12-1 and 12-2.

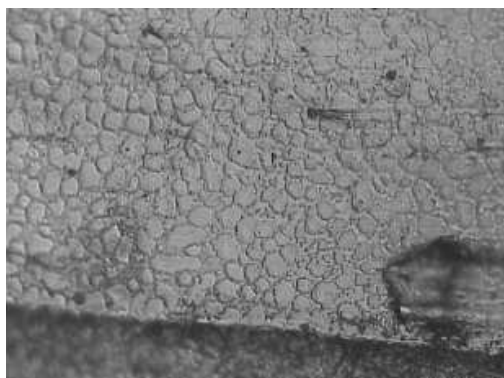
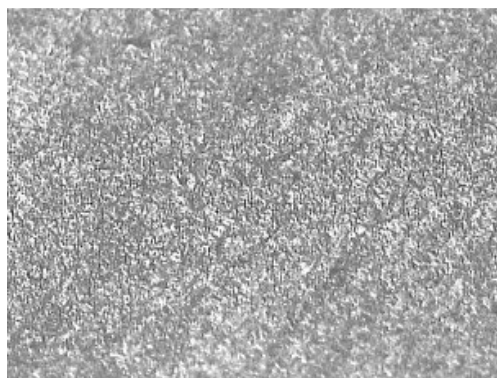
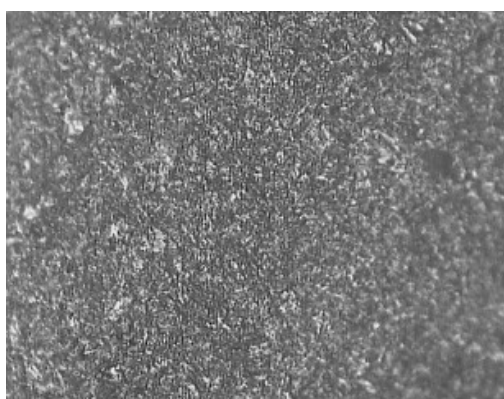
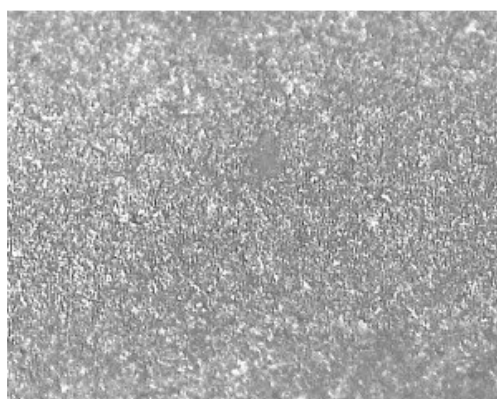
Fig. 12-2. Microstructures of typical hardfaced layer zones.

Hardfaced layer – austenitic structure with small-grained needle-like martensitic structure at grain boundaries (200×)

Hardfaced layer/HAZ –coarse-grained interphase quenched and tempered structure with residual martensite (200×)

HAZ – interphase quenched and tempered structure (200×)

BM – homogenous small-grained interphase quenched and tempered structure (200×)

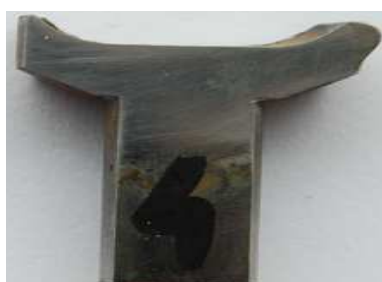
Fig. 13. Macrostructure of the hardfaced layer obtained using gas hardfacing procedure (BM-Č4172, FM-powder Castolin EUTELLOY 10494).

Macro appearance of the shape punch hardfaced using gas-powder hardfacing is shown in Figure 13. The height of the hardfaced layer was approximately 2.25 mm.

There were neither cracks nor flaws on the cross-section, which means that the bonding between the hard faced layer and the base material was firm enough to ensure good

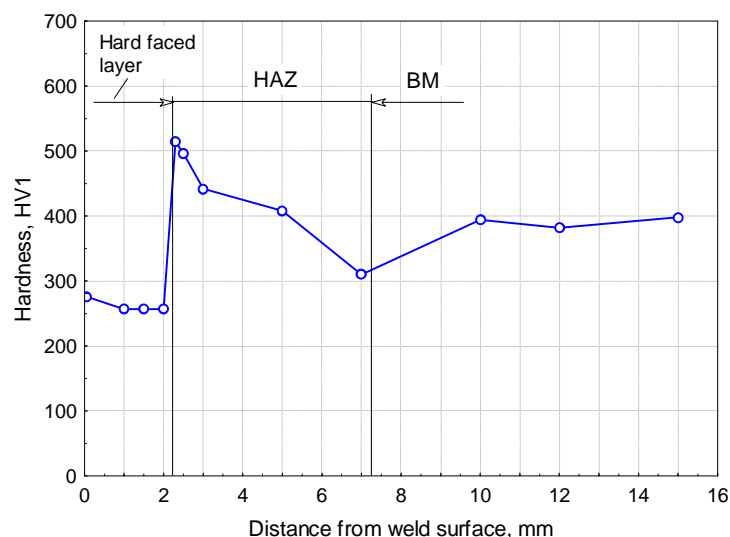
Fig. 14-1. Distribution of microhardness in the cross-section of the hardfaced layer - Sample IV (BM-Č4172, FM-powder Castolin EUTELLOY 10494).

The base material microstructure was estimated as small-grained homogenous interphase quenched and tempered structure. The hardfaced layer has austenitic structure with small-grained needle-shaped martensitic structure distributed at austenite grain boundaries in a net-like pattern. The transient zone is easily visible because the base and filler materials have not mixed. The HAZ is about 5 mm wide, but it is not very prominent although it has been treated with aqua regia [16]. The hardness distribution diagram shows that hardness increases in the HAZ, which is explained by hardening and change in the structure of the base material due to the input heat. The increase in hardness is not significant so it will not have a considerable effect on the properties of the hardfaced part. Distributions of hardness and microstructure of hardfaced layer zones are given in Figs. 14-1 and 14-2.

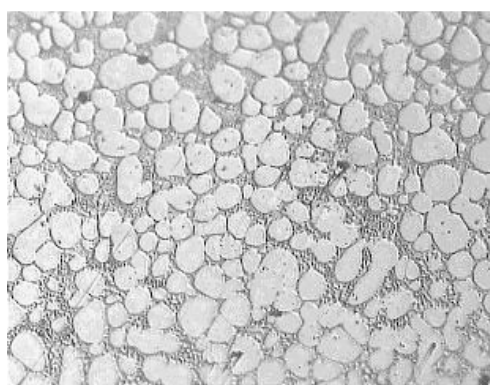
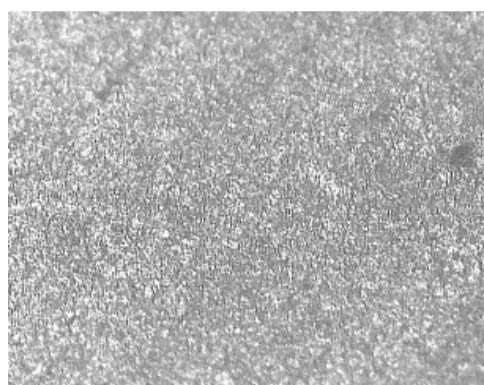
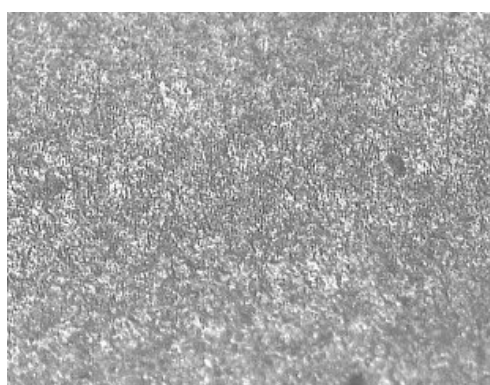
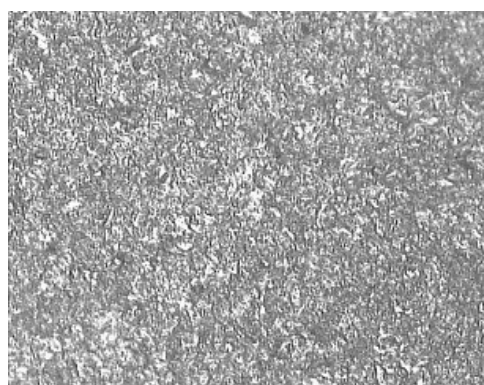
Fig. 14-2. Microstructure of typical hardfaced layer zones.

Hardfaced layer – austenitic structure with small-grained needle-like martensitic structure at grain boundaries (200×)

Hardfaced layer/HAZ –coarse-grained interphase quenched and tempered structure with residual martensite (200×)

HAZ – interphase quenched and tempered structure (200×)

BM – homogenous small-grained interphase quenched and tempered structure (200×)

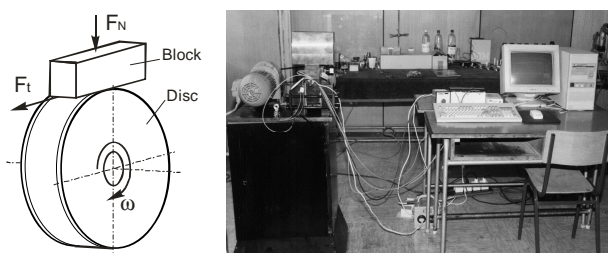
Fig. 15. Tribometer TPD - 93 and other measuring equipment for tribological testing.

Tribological investigations were carried out for a block-on-disk contact, on a tribometer TPD-93 (Fig. 15) installed at the Faculty of Mechanical Engineering in Kragujevac. The aim of these

investigations was to evaluate the resistance to wear of the base materials and deposited layers [4-5,15-18]. Prismatic samples (four from the hardfaced layer and one from the base material) were prepared for tribological tests ($6.5 \times 15 \times 10$ mm). During the tests, the line block-on-disk

contact was realized. The outer variables of the tested samples were contact forces, sliding speed and the lubricant. Motor oil Nisotec SE15-40 was used for the tests.

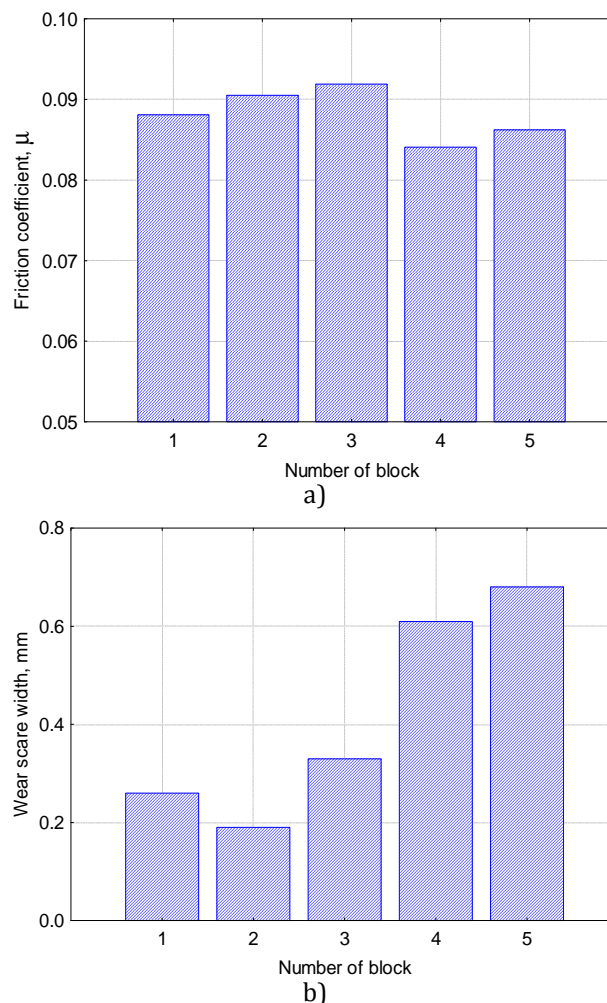
Fig. 16. Histogram of distributions of the mean values of the friction coefficient and (a) and wear scar width (b).

Figure 16a gives a summary graph (histogram) of the mean values of the friction coefficient and

Fig. 16b displays a histogram of the mean values of wear scar width for tribological couples.

Figure 16a shows that all the materials have approximately the same mean value of the friction coefficients ranging from $\mu = 0.08409$ (block 4) to $\mu = 0.09192$ (block 3). As seen in Fig. 16b, the block 2 (FM-Č4850) has the smallest mean wear scar width $b_{sr} = 0.1865$ mm, while the block 4, whose friction coefficient is the lowest, has the largest wear scar width $b_{sr} = 0.614$ mm. It is noticed that the base material has the lowest friction coefficient but the largest wear scar width $b_{sr} = 0.68$ mm, which indicates the possibility of production hardfacing of new parts. Figure 17 shows wear scar images for the blocks 2 and 5.

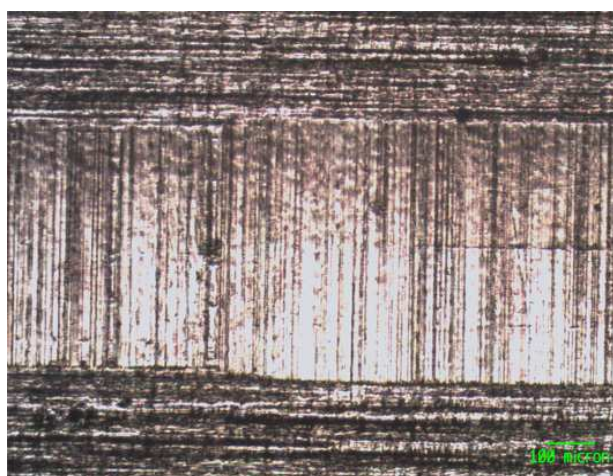
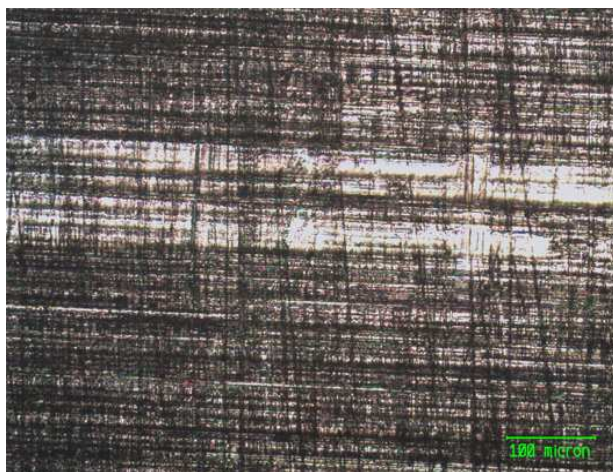
Fig. 17. Microscopic view of the wear scar on the blocks tested using the lubricant Nisotec SE 15-40 during the contact of 60 min (50 \times).

a) Block 2

b) Block 5

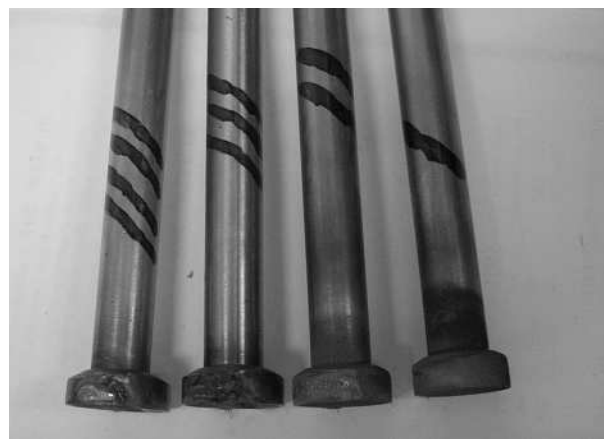
Fig. 18. Hardfaced shape punches.

Technological parameters for hardfacing of real parts are given in Table 4. Damaged cutting edges of the shape punch are hardfaced in two passes and then manually ground to fit the needed geometry (Fig. 18). After that, they were mounted on the candy manufacturing tool (Fig. 19) and the interrupted production process was continued.

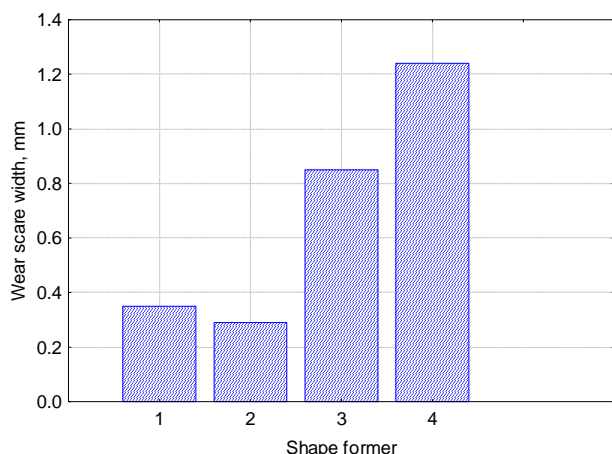
Fig. 20. Distribution of the mean value of the wear scar width for real parts.

In order to insure a genuine comparison of the service life, there was no new shape punches mounted together with the repaired ones. Whilst in service, geometry and wear scar width of the shape punches were periodically checked. After the repaired shape punches had been used for nine months, wear scar width was measured again. The results of these measurements are shown in Fig. 20.

In all four cases, the hardfaced shape punches not only proved to be more resistant but some of them also had a few times longer service life compared to the new ones. This increase in resistance is the result of a more favourable microstructure of the hard faced zones and a better bonding between the hardfaced layer and the base material.
