Pollution Maintenance Techniques in Coastal High Voltage Installations

The power system in the Greek island of Crete suffers from intense pollution problems due to sea influence [9]. Several techniques have been employed from the Greek Public Power Corporation (PPC) to cope with the problem [10]. In this paper a brief description of substation pollution maintenance techniques that have been employed in the power system of Crete is presented. Further, the use of RTV SIR coatings is thoroughly investigated since a large scale application of such coatings has been issued by PPC in the Cretan Power Systems. In addition, data from a field leakage current monitoring system that has been installed in a 150 kV Substation are presented and the performance of coated insulators is further investigated.

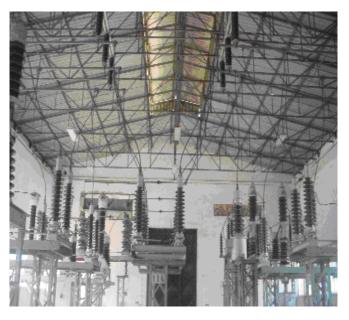
Figure 1. View of the 66kV enclosed air substation at Linoperamata

If severe pollution problems are due to appear, then the construction of enclosed substations can also be considered. In the case of Crete, the majority of the 150kV/20kV substations are partially enclosed, with only the 150kV side exposed to the environment. In addition there is one 66kV air insulated substation that is fully enclosed, a view of which is illustrated in Figure 1. In both cases, the environment oriented problems are suppressed, however a control of the inner atmosphere is necessary considering that phenomena such as condensation may appear. The substation scheme that totally encounters pollution problems is a GIS installation, a substation enclosed in SF6. In this case the possibility of a pollution related problem is totally eliminated and the save of space achieved is an added considerable advantage. However there are issues to consider, concerning the maintenance means and procedures and the installation cost. In Crete at the moment there are two GIS 150kV substations. A picture of the 150kV GIS substation located in Heraklion is shown in Figure 2.

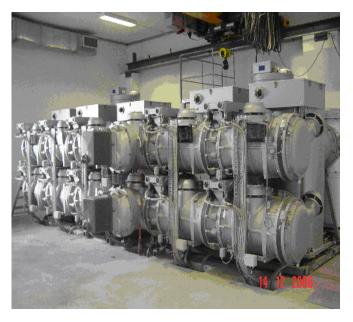
Figure 2. View of the 150kV GIS at Heraklion Crete
