## Investigation of the potential sources of water pollution affecting the Companhia Hidromineral Caldas da Imperatriz through physical, chemical, and biological analyses

Leopoldo Duarte Pereira, Marcielly Melo Freitas, Aline Ferreira Ali de Ávila, José Gabriel da Silva e Rachel Faverzani Magnago

Universidade do Sul de Santa Catarina, Palhoça, Brasil

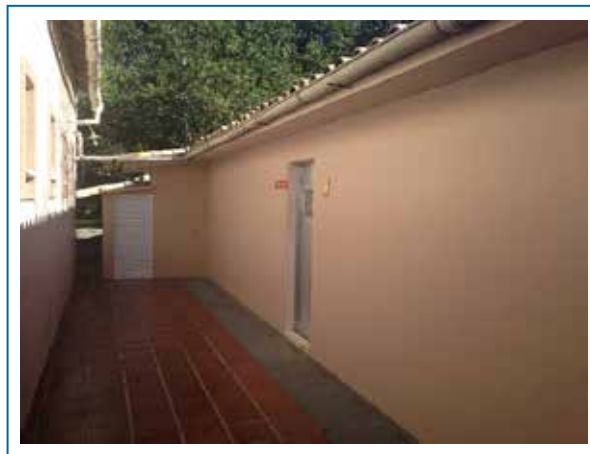
Figure 3 - Image of the outside of the water fountain  
Source: The author (2016)

Figure 3 shows the access to the fountain (right door) and the pump (bottom door) that distributes water for the hotel use and baths.

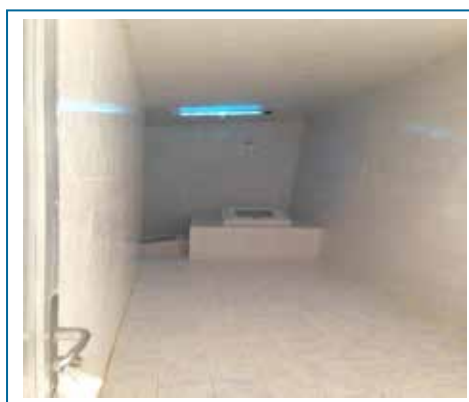
Figure 4 - Image shows the inner part of the water fountain  
Source: The author (2016)

Figure 4 shows the room where the fountain is located.

The room where the water fountain is located has ultraviolet lights that are kept on to ensure an environment without risks of biological water contamination.

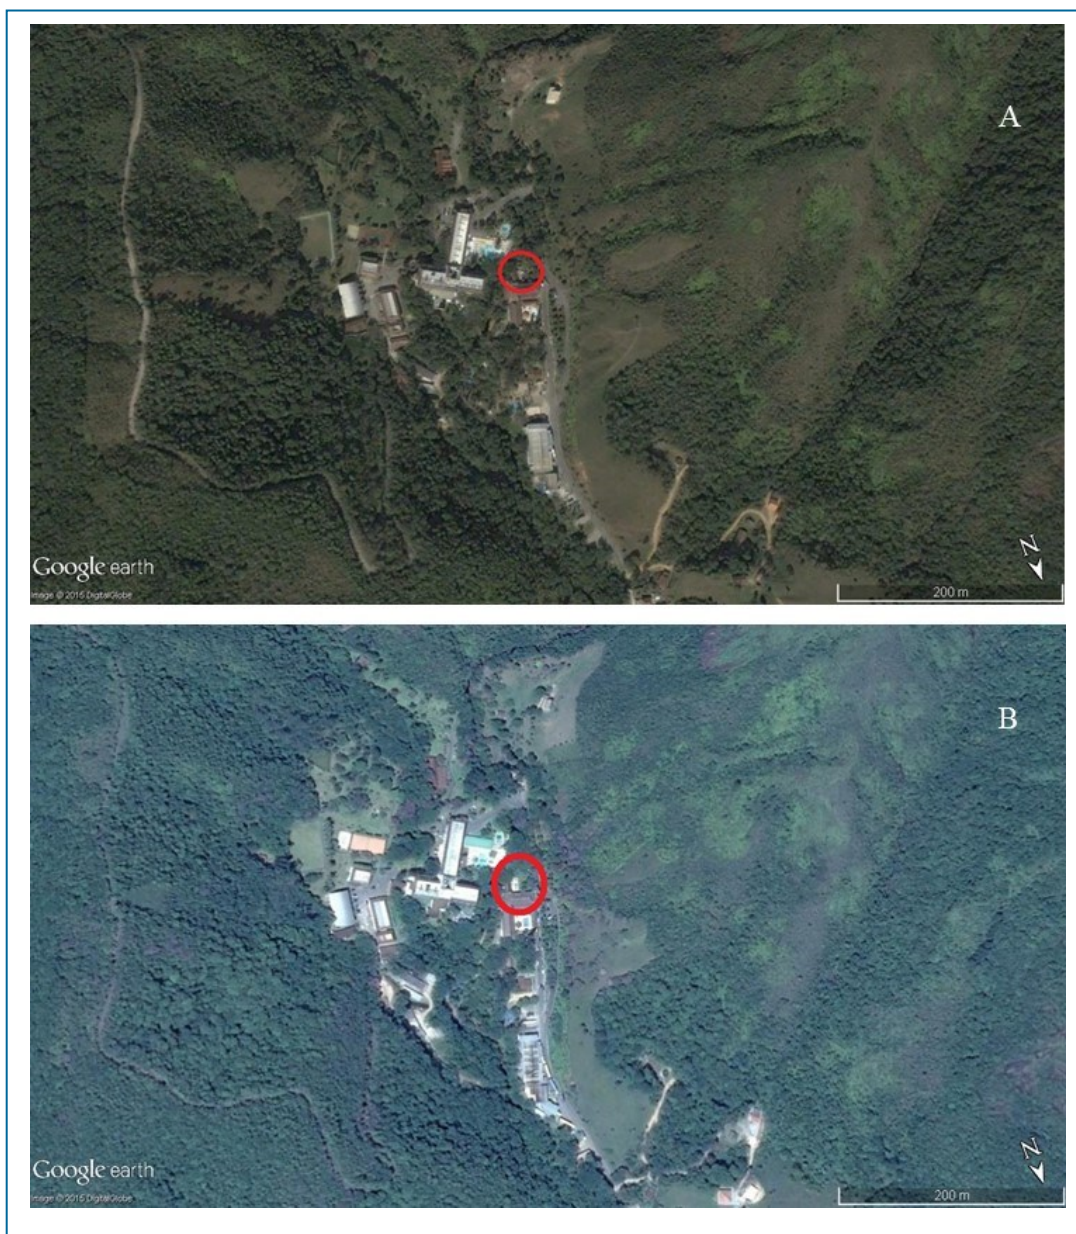
Figure 5 - (A) Satellite image of the fountain site in 2003 and (B) satellite image of the fountain site in 2014 in the municipality of Santo Amaro da Imperatriz

The water fountain was located in the satellite image and is shown in Figures 5A and 5B highlighted by a red circle. The surroundings can be observed for the years 2003 and 2014, respectively.

A comparison of the two images reveals the similarity of the vegetation cover between 2003 and 2014. After eleven years of the satellite image in Figure 5A (2003) and in Figure 5B (2014), there was no vegetation cover removal that could be perceived by using the spectral radiation band of the visible region.

Figure 5B also shows there are no residences in the surroundings of the fountain, except for the hotels, which have adequate sewage treatment, posing no risks to water contamination.

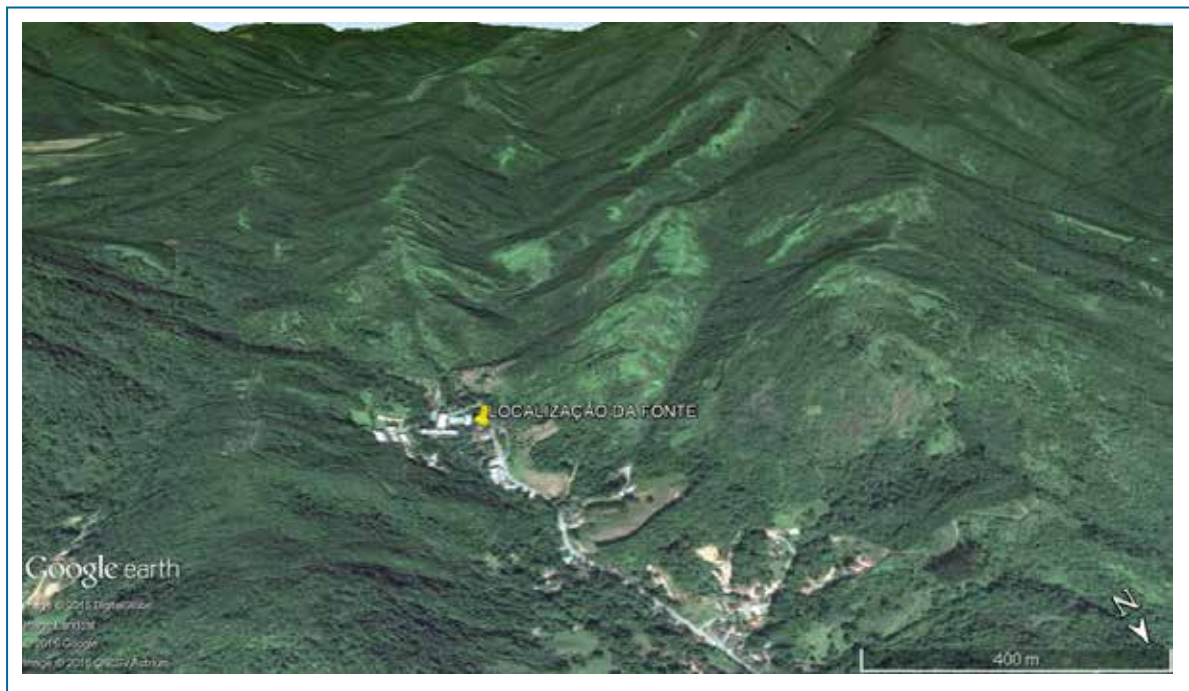
Figure 6 - Topography of the region surrounding the fountain in the municipality of Santo Amaro da Imperatriz

Topography is of great importance in terms of water quality, due to the direction and volume of water flow in the studied region. In the satellite image (Figure 6), the fountain is highlighted in yellow, and the topography of the environment refers to the year 2015.

As it can be seen in Figure 6, the fountain is located at the base of a mountain range. In this way, surface water runoff from rainfall will flow towards the fountain. When the amount of rainfall is higher than normal, attention should be paid, given that a large volume of water coming from the surface and subsurface runoff of the mountains may affect water quality. To collect water samples, we took two days into account for the water runoff to reach the fountain.

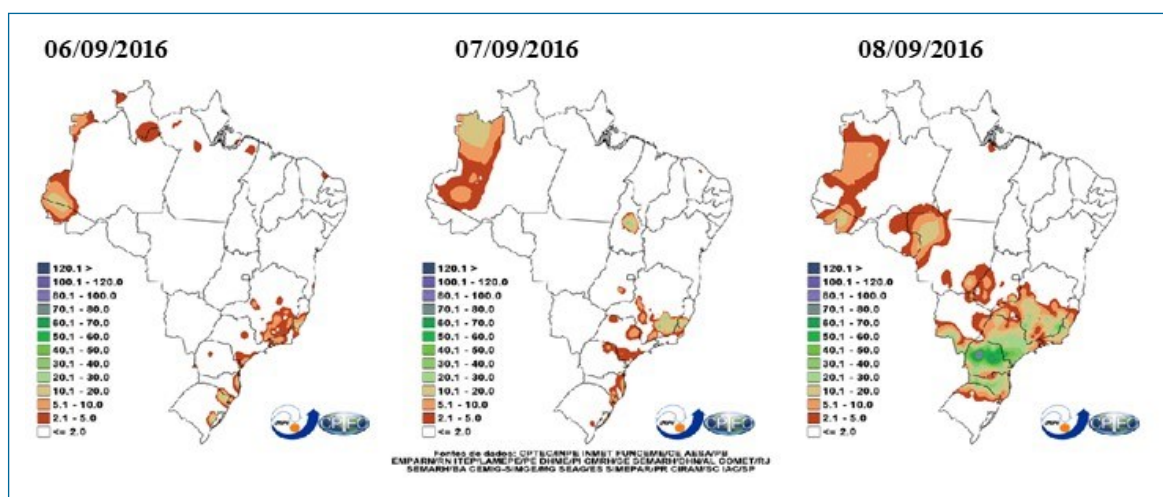
Figure 11 - Rainfall data for September 6, 7, and 8, 2015  
Source: Adaptated from (CPTEC/INPE, 2015)

Figure 11 shows the rainfall map for August 4, 7, and 8, 2015. According to INPE (2015), a rainfall volume between 5.1 and 20 mm occurred August 4, but the water sample was collected at 2 p.m., before the expected rainfall precipitation around 2 p.m.
