EFFECTS OF MEDU AND COASTAL TOPOGRAPHY ON THE DAMAGE PATTERN DURING THE RECENT INDIAN OCEAN TSUNAMI ALONG THE COAST OF TAMILNADU

J.P. Narayan, M.L. Sharma and B.K. Maheshwari

Department of Earthquake Engineering, Indian Institute of Technology Roorkee,
Roorkee-247667, Uttaranchal, INDIA,
email: jaypnfeq@iitr.ernet.in, mukutfeg@iitr.ernet.in.

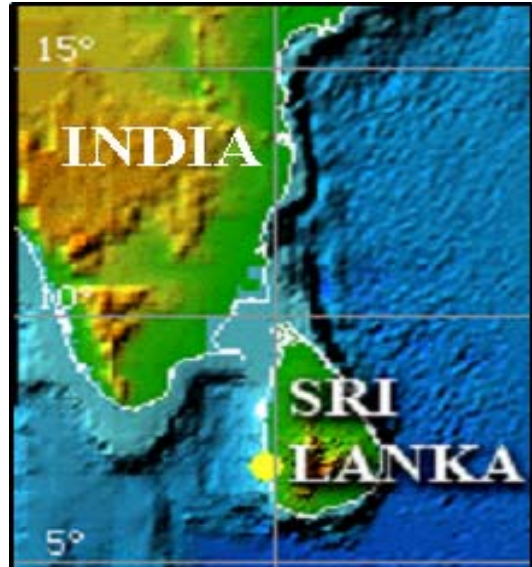
Figure: 2 Coastal and ocean basement topography around Tamilnadu and Sri Lanka.

The southern part of Tamilnadu from Kanyakumari to Pudukkottai district, situated in the shadow of Sri Lanka, suffered the least damage (Fig. 1 & 2). But, the damage survey revealed large variations in the tsunami run-up and damage. Further, tsunami damage was highly variable from Nagapattinam to Chennai. Maximum tsunami damage (run-up 10-12 m) was observed along the coast of Nagapattinam. There was decrease in damage from Cuddalore to Kanchipuram district. Increase of damage was again observed to the north of Adyar River from Srinivaspuri to Anna Samadhi Park in Chennai district. Along the coast of Nagapattinam district run-up and inundation were 10-12 m and 2-3 km, respectively. General panic was reported every where and people were unable to understand what was happening. Many people were washed away and lost their life.

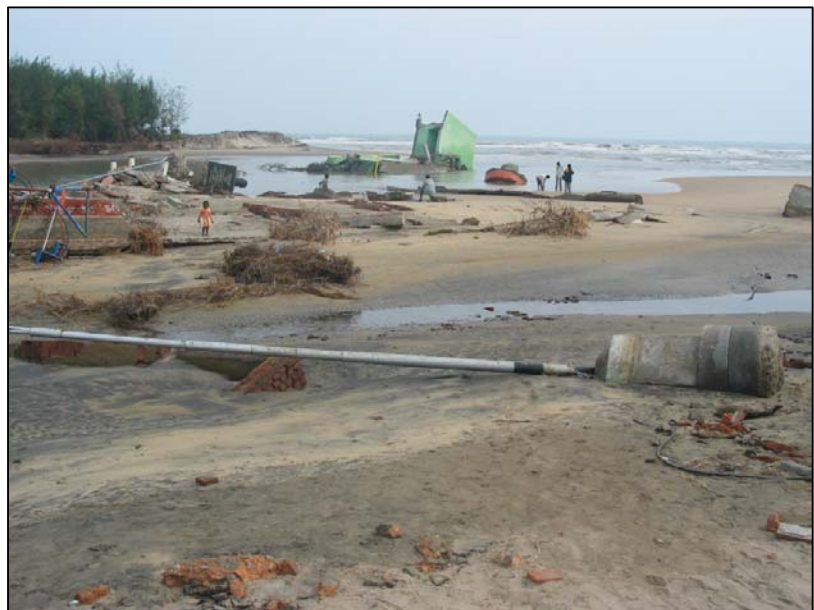
Figure 3: Depicts the damaged children's park, uprooted electric pole, damaged SINGNADH and the collapsed auditorium on Nagapattinam Beach.

Nagapattinam beach, a newly constructed tourist spot was completely destroyed (Fig. 3). Extensive ground erosion and uprooting of trees was observed every where (Fig. 4 & 5). Many structures suffered damage of grade G4 and some destroyed. Severe damage to lifelines (road, bridges, telephone and electric poles and railway line), port and harbors took place (Fig. 5). Many big boats/vessels were thrown violently towards the coast (Fig. 6). It seems that lesser width of continental shelf near the coast of Nagapattinam district and the interference of the direct waves and the reflected waves from Sri Lanka developed largest tsunami run-up (10-12 m) in Nagapattinam district (Fig. 2). On the other hand, much lesser damage occurred along the coast of Kanchipuram district due to some what wider continental shelf (Besana et al, 2004).

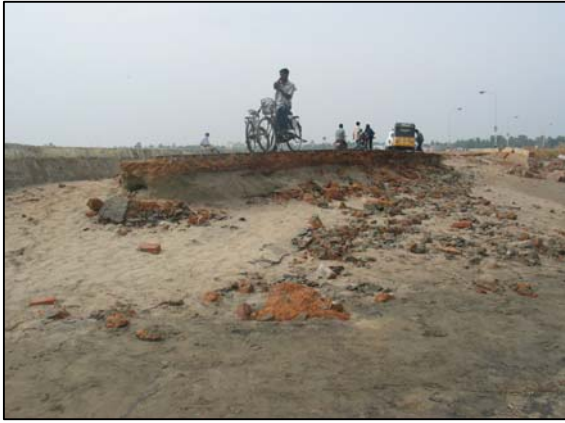
Figure 4: Intense erosion of front portion of beach road, facing to the sea coast at Nagapattinam beach.

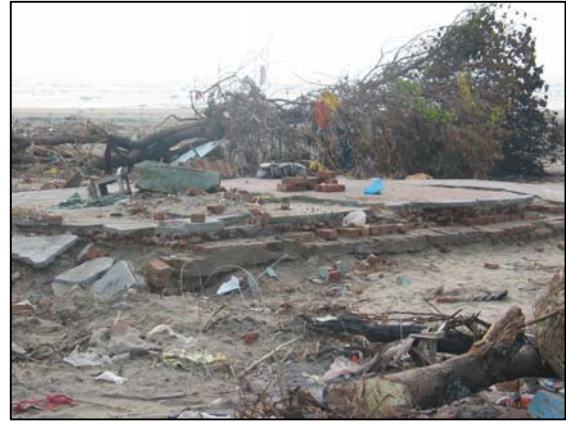
Figure 5: Uprooting of the trees and washing away of destroyed building materials in Vellaipallyam village

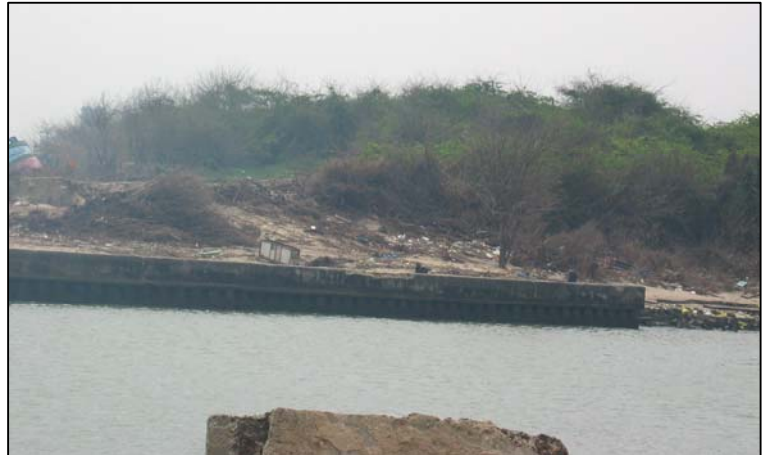
Figure 12 depicts the Nagapattinam Medu, existing just in front of the southern part of the Nagapattinam Port. The height of Medu is around 7 m with respect to the port level. Tsunami crossed the Medu. There is Kaduvaiyar River between port and the Nagapattinam Medu (Fig. 13).

Figure 12: Medu in front of the Nagapattinam port.
