GEOMORPHOLOGICAL HAZARDS AND RISKS IN JIU DEFILE

I. SANDULACHE, CATALINA SANDULACHE

ABSTRACT: Jiu Defile has a length of 33 km and is located in the Southern Carpathians, between Parâng Mountains (east) and Vâlcan Mountains (west). This paper starts from the analysis of field mapping and measurements (based on topographic maps, scale of 1:25 000), and data from local institutions and other sources (web, press). In Jiu Defile, geomorphological hazards results from the combined action of meteorological conditions and other factors such as geology, geomorphology and socio-economic development. They may affect transport infrastructure, which is at risk especially in spring and summer.

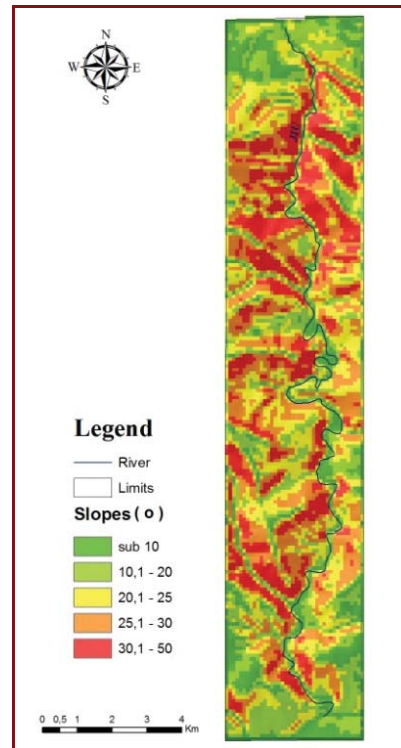
Figura 3 Jiu defile – slopes map

- **Geomorphological factors.** Jiu River forms a defile – narrow pass, with steep slopes and confined meanders. It is considered the wildest valley of our country (Orghidan, 1969). Local relief reaches 300-400 m/km² and even exceeds 400 m/km² in some sectors. Hillsides' slope (fig. 3) averages 20-30°, outreaching locally 30°. Road's embankment has a slope of 80-90°. Active geomorphological

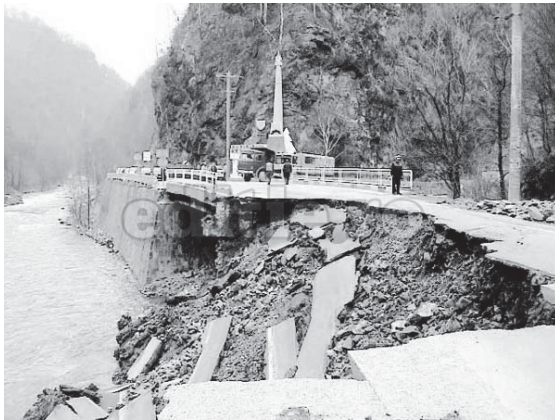
Figure 6. Bank's collapse and asphalt's damage (www.editie.ro), near the confluence Polatiștea-Jiu, at km 121+ 272

Fluvial erosion (sidewise and incision) is continuous and increases with water level and discharge. The sidewise erosion creates overhangs on the banks,

breaking down portions of road's asphalt. For example, one event took place on April 11th 2005 at km 121 + 272 (Polatiștea) (Fig. 6). At present, such events could happen in meanders' concavities (Murga Mare, Cotor, Cărligul Închis, Cărligul Mare, Dragu, Leurzoaia and upstream from the confluence Polatiștei – Jiu).

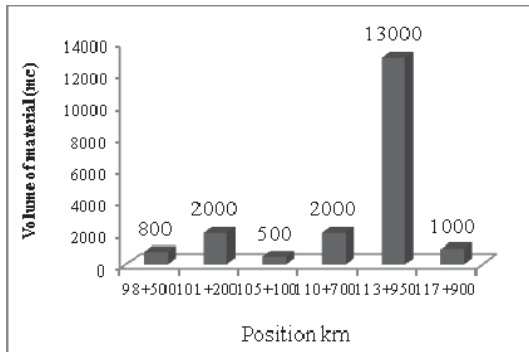
Figure 7 The largest landslides in Jiu Defile (according to A.N.D. – of Gorj)

Landslides occur in thicker altered deposits, especially on crystalline schists. They may affect them partially or totally, creating scarps of 1-3 m of height; these landslides have 30-60 m of elevation and 50-150 m of length. The largest landslides, based on the amount of material transported and deposited, are presented in Fig. 7, 8.

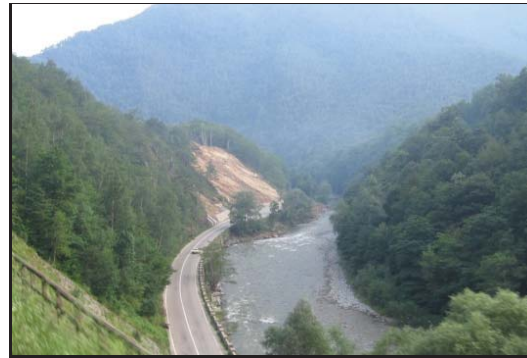
Figure 8 Landslide at km 113+900 (on 07/13/2005)

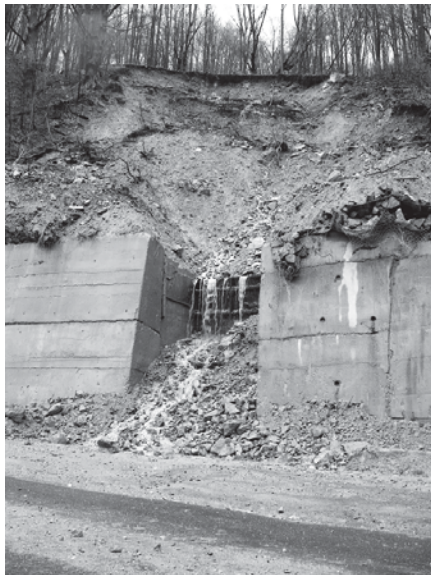
Figure 9 The landslide from km 110+700 (Cârligul Întors)

Some of the analysed landslides are stabilised by engineering measures and are inactive (km 113+950), while others, despite human interventions, still raise problems (km 110+700) (Fig. 9). Besides the rainfall, this processes’ activity is due also to a spring that continuously moisture the deposit. In order to solve this problem, this spring will be capture and redirect towards Jiu River (according to A.N.D. - of Gorj).

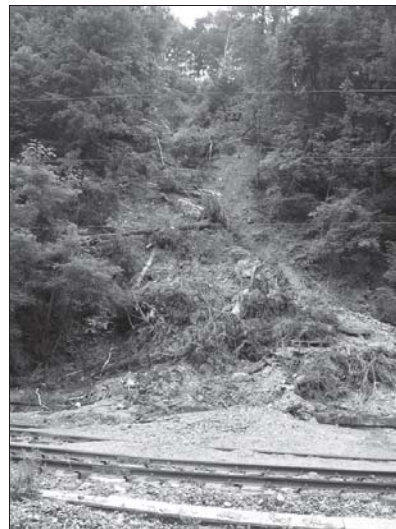
Figure 12. Earthflow from July 2005 Upstream from Lainici Station, which caused the interruption of railway's traffic

It creates ravines, which are generally small, and torrents. Most torrents, especially the big ones, are stabilised due to engineering works. The torrential erosion manifests itself also by earthflows (fig. 12).
