## LANDSLIDES INCIDENCE IN THE PIEDMONT OF BAIAMARE URBAN AREA (CASE STUDIES)

**ABSTRACT.** the landslides incidence in the piedmont of baia mare urbana area cae studies). The General Urban Plan (GUP) of Baia Mare municipality requires the study of expected susceptibility for landslides in order to build infrastructure within sustainable development conditions. The complexity and diversity of local geographic area factors, strongly affected by the human pressure, favours the triggering and extension of slope processes in the municipality's piedmont area. To prevent some major imbalances it is imperative to implement some adequate measures based on in-depth studies.

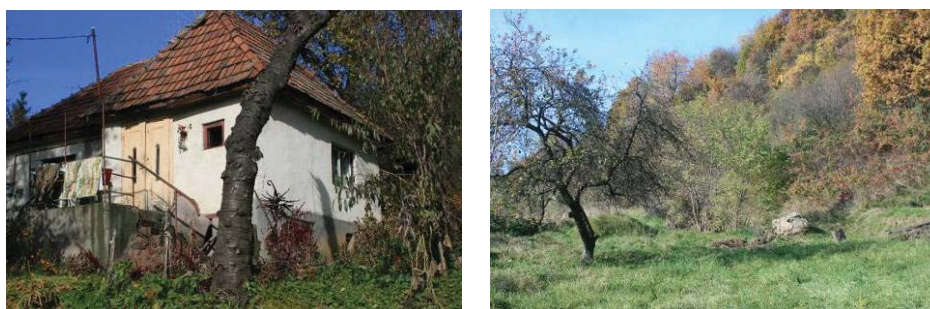
Figure 5. Landslide from Plaiului street

**Landslide 26 – from Plaiului street.** It is situated upstream of the stable area with a volcanic pyroclast in substratum. It is an active landslide, in a constructed area, determining chinks in the grating and the walls of a house, as well as land unevennesses determined by the landslide (figure 5).

At the superior side of the landslide, there is lowland, where the water is accumulated under the shape of bonds with bulrush. This suggests the presence of a deep landslide, a separation of a significant mass of ground, not just a superficial landslide.

The surface of the landslide is of 0,19 ha, maximum length of 63 m, medium width of 30 m. There are no data in respect to the rocks from the substratum of the quaternary rocks, but probably this is formed from clays and pannonien marls. The cover quaternary deposits, while digging, have a thickness larger than 1,5 m, being made from flysch deposits, formed from a brownish matrix, where fragments of grey, porphyria andesites are clamped. The permanent stagnation area of the infiltration water from the upstream, permanently moistens the rupture level, determining the active character of the landslide. In upstream of the landslide area, in the yard of the Greek-catholic monastery "Saint Mary", in a fountain of 5 m depth, the level of the water is at - 4 m. The landslide is **active**, deep, but of small dimensions with a risk coefficient  $K_m=0,38$  and occurrence potential from **medium to high**.
