RESTORATION AND PRESERVATION OF ENGRAVED LIMESTONE BLOCKS DISCOVERED IN ABU MOUSA EXCAVATION, SUEZ- EGYPT

Abstract

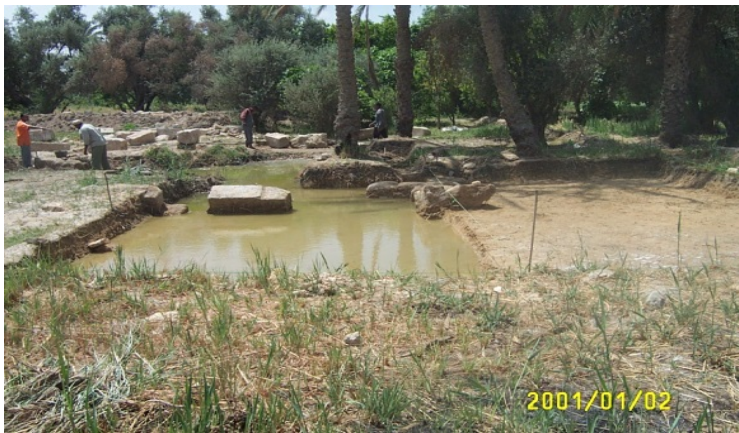
Fig. 1. The Abu Musa Excavation during 2001 season.

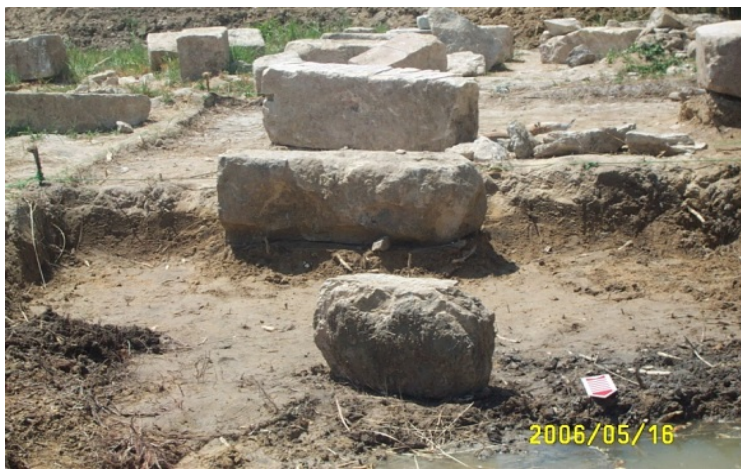
Fig. 2. The Abu Musa Excavation during 2006 season.

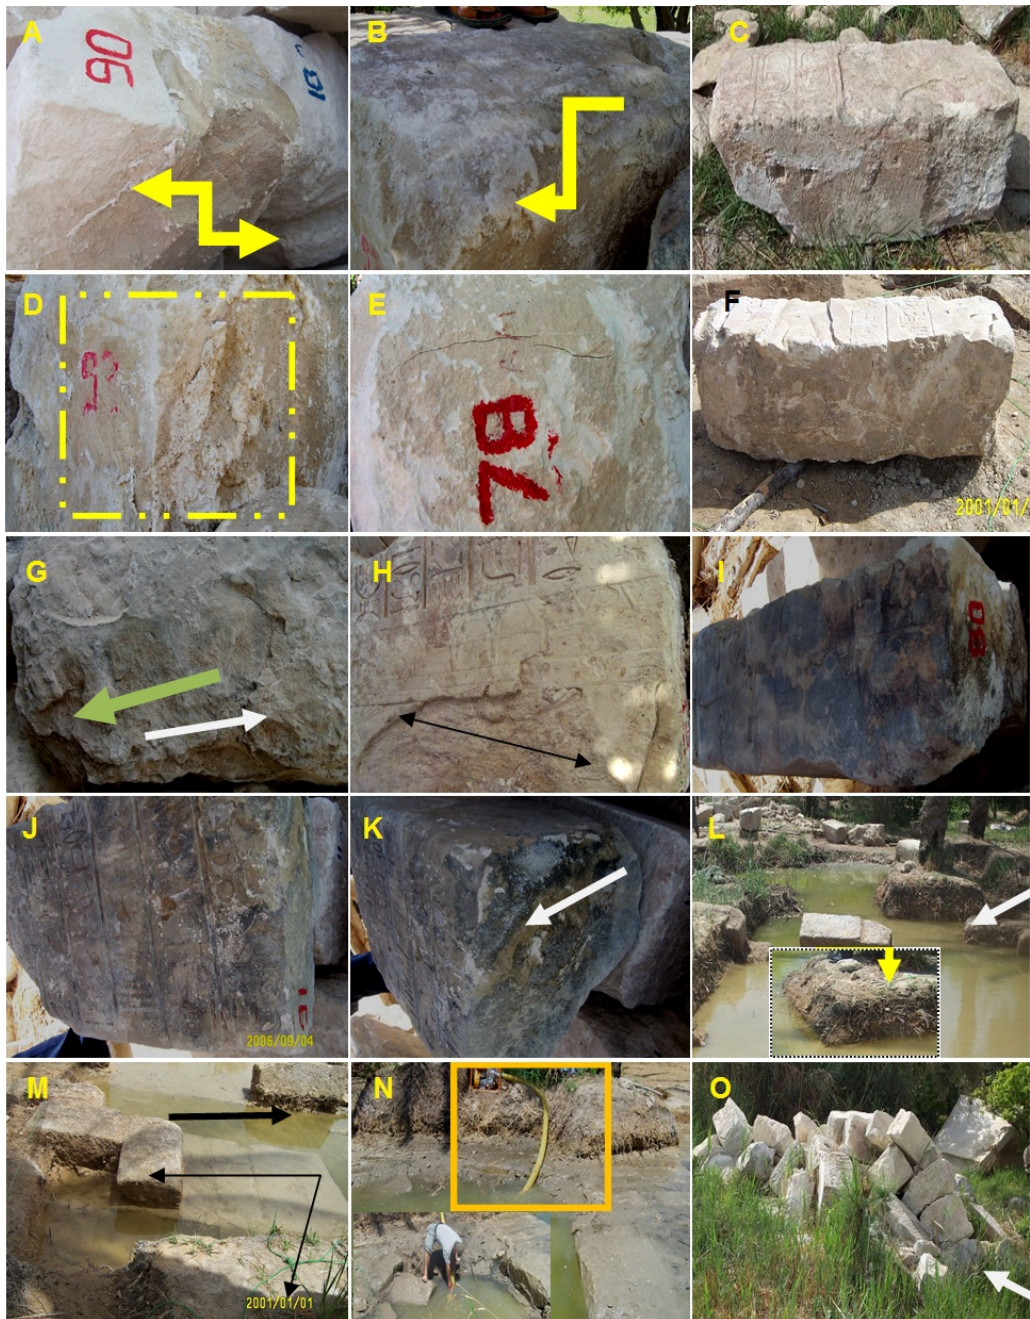
Water is the most aggressive agent in Abu Muasa excavation, which acts as a vehicle for weathering processes. Water dissolves and transports soluble salts within the stone causing efflorescence on the surface and/or "sub- efflorescence" (Fig. 3A and B). The salt crystallization and hydration processes lead too loss of cohesion between grains and causes the spalling, current detachment of individual grains (Fig. 3C), pushing surface layer of stone (Fig. 3D), different type of cracks (Fig. 3E), powdering/crumbling with possible appearance of white efflorescence of salts (Fig. 3F), high failure, fragile and flaking, Some reliefs were eroded because of exfoliation, detachment of the superficial layers (Fig. 3G) and granular disintegration into powder (Fig. 3H). Discoloration and removal of reliefs were observed in as a result of the high humidity and the presence of soluble (Fig. 3I). Very dense layers of biological colonization accumulated on the surface of stone blocks observed the accumulation of black to dark-colored crust tracing the surface and brown, green and white stains of microorganisms caused the discoloration of stone surface (Fig. 3J). Black rust was found in the surface of some limestone blocks (Fig. 3K). All stone blocks were covered with thick clay layer with soil particles and vascular plants. Roots are growing which disfigured them and hid their reliefs (Fig. 3L). The deterioration caused by plants is both mechanical and chemical. In this case the chemical action is influenced. The chemical action is due to the acidity of the root tips and the acidity and chelating properties of the exudates. Certain plants, for instance ivy, can also cause a change in stone color as a result of the release of organic compounds [5]. Also the main weathering forms characterizing deposits on the stone blocks were the growth algae (Fig. 3M). These are in fact extremely simple plants which live in very damp places or in water. They appear as greenish or brownish slimes or suspensions in water; a sudden increase in their numbers gives a dense bright coloration known as a bloom.

Fig. 3. Abu Muasa excavation site: A and B - crystallization of different salts to light-colored crust tracing the surface and between layers of engraved limestone; C - loss of cohesion between grains caused the current detachment of individual grains; D - Crystals of soluble salts pushing off a surface layer of stone; E - cracks and microcracks; F - powdering/crumbling of the engraving stone due to salts efflorescence; G - Exfoliation of the engraving limestone; H - disintegration of the engraving limestone; I - discoloration of the engraving limestone; J - Microbiological colonization to dark-colored crust tracing the surface of reliefs; K - Black rust found in the surface of some limestone blocks; L - Stone blocks were covered with thick clay & soil particles and vascular plants; M - Growth of algae as greenish, brownish slimes at stone blocks; N - The process of water suction; O - Wrong storage between grass and areas of high humidity.

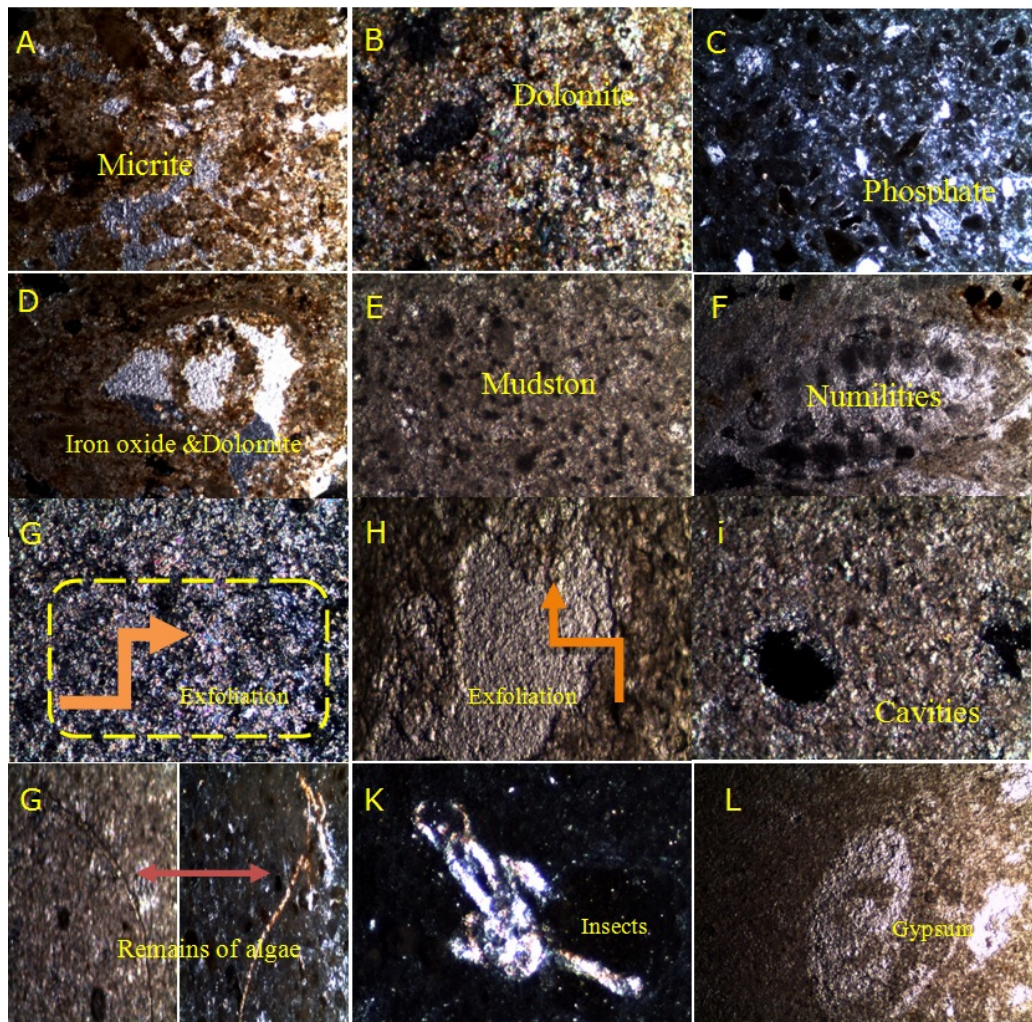
The examination of thin sections of the limestone samples under plan polarized light microscope (PLM) revealed that, the limestone consists of fine grained calcite (micrite), iron oxides, dolomite, fossil fragments, phosphate, clay minerals and some fine grained quartz. Also micrographs revealed deterioration aspects such as micro-exfoliation of calcite grains, cavities and cracking in calcite grains, remains of alga, insects, and Gypsum crystals. The micro cracks, halite and gypsum crystals related to weathering processes, all of these features are shown in figure 4.

Fig. 4. The examination of the limestone samples under polarized microscope shows A - fine grained calcite (micrite), B - Dolomite and iron oxides, C - phosphate, D - iron oxide and dolomite, E – mudstone, F - Numulities, G and H - micro-exfoliation of calcite grains, I - cavities and variety of cracking in calcite grains, J - remains of alga, K - remains of insects, L - Gypsum crystals.

Plan polarized light microscope (PLM) displayed that; the micrite is the main component of limestone cemented by sparry calcite. The amount of the fossil fragments numulites and insects embedded in a micrite matrix. Remains of remainder of micritized red alga are also observed. Opaque minerals and shapeless aggregates that coated by ferruginous martial are also observed. Impregnating ferrous substances are probably responsible for the reddish color of some limestone blocks. Dolomite crystals are also noticed in the sample (M3). Numerous grains of Quartz are found, occurring as sub-rounded to angular grains. Slide showed the intrusions of Gypsum. Phosphate crystals are noticed in the sample (M5). The photographs show an increase in porosity, more micro-cracks and micro-exfoliation within the thin section, increasing the rate of stone decay.

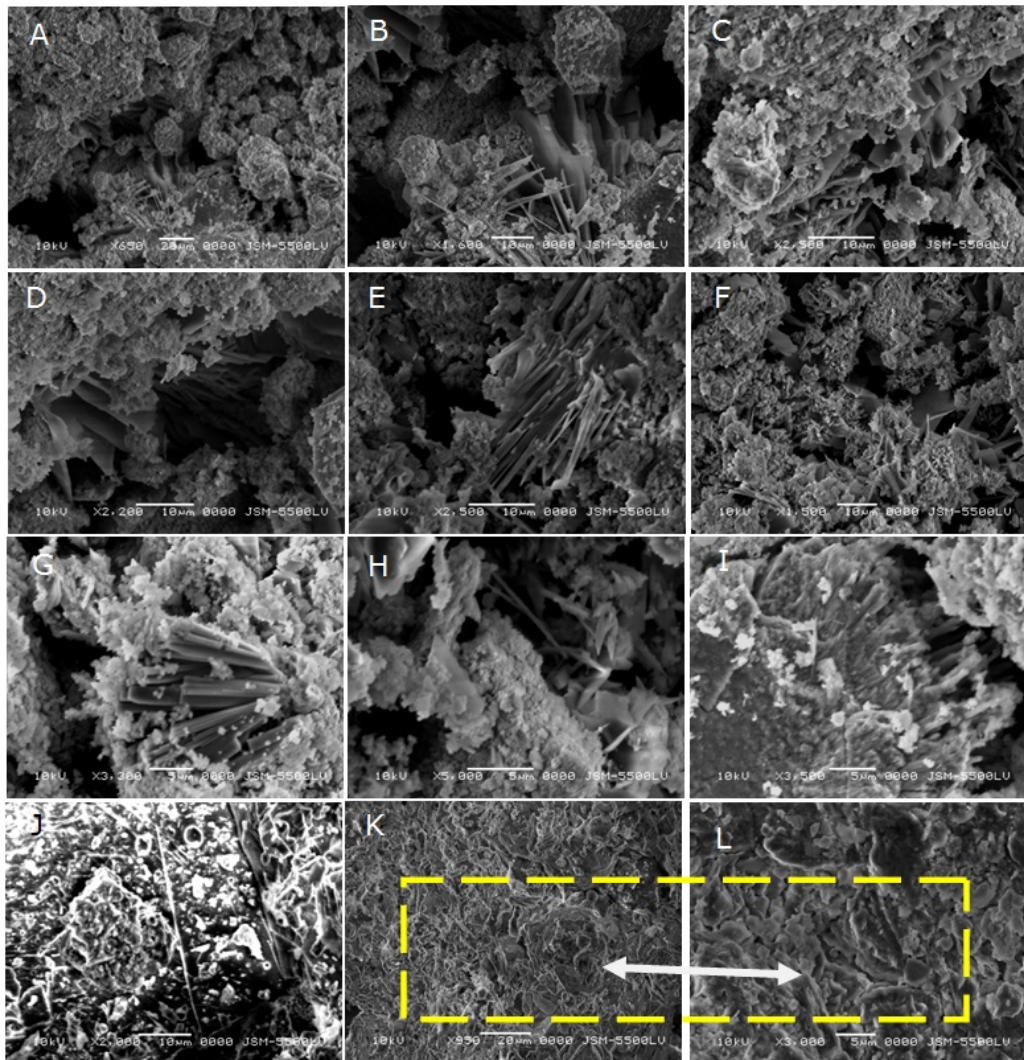
The scanning electron microscope results confirm that a major deterioration is the abundance of soluble salts in the rock. SEM photomicrographs show that there is wide range of deterioration features as shown in (Fig. 5) such as disintegration between calcite crystals. Dissolution of calcite crystals and loss in the binding materials between grains by the effect of salts crystallization dusting, small fissures and cracks, localized cavities, the clay minerals is also existing among the calcite grains; also, it showed the content of gypsum in the samples is due to the transformation of calcite into gypsum. Scanning study also indicated growth of hyphae of fungi and remains of alga.

Fig. 5. SEM micrographs of deteriorated stone reliefs in Abu Musa excavation: A - Cracks, pitting and losses of cohesion between grains, B - Different salt crystals such as halite and Gypsum; C - Destroyed and dissolution of calcite crystals, D - gypsum crystals, E - Halite crystals occur as blocky shaped and rectangular crystals, F - A variety of cracking patterns in calcite grains, G - Gypsum and halite salts grow on calcite cleavage plane and dissected it into several flakes, H and I - Many cracks and separation of scales from the rock as a result of gypsum and sodium sulphate salts, J - growth of hyphae of fungi, K and L - collapsed of grains and micro exfoliation of the calcite grains.

SEM photomicrographs showed disintegration between calcite crystals; lose in the binding materials between grains by the effect of salts crystallization. Decayed samples show etching features in some calcite grains indicating micro-dissolution processes (chemical weathering). Carbonate cement dissolution and subsequent calcite recrystallization are also observed. Halite crystals are found in glassy shape. Observation by SEM also showed destroyed calcite grains, droplets of halite mixed with clay minerals crystals. Gypsum in white crusts accumulates below the surface of the crust was detected. This suggests that reprecipitation takes place on moisture exposed surfaces where white crusts are forming after gypsum dissolution. SEM observation indicated the hyphae of micro-organisms.

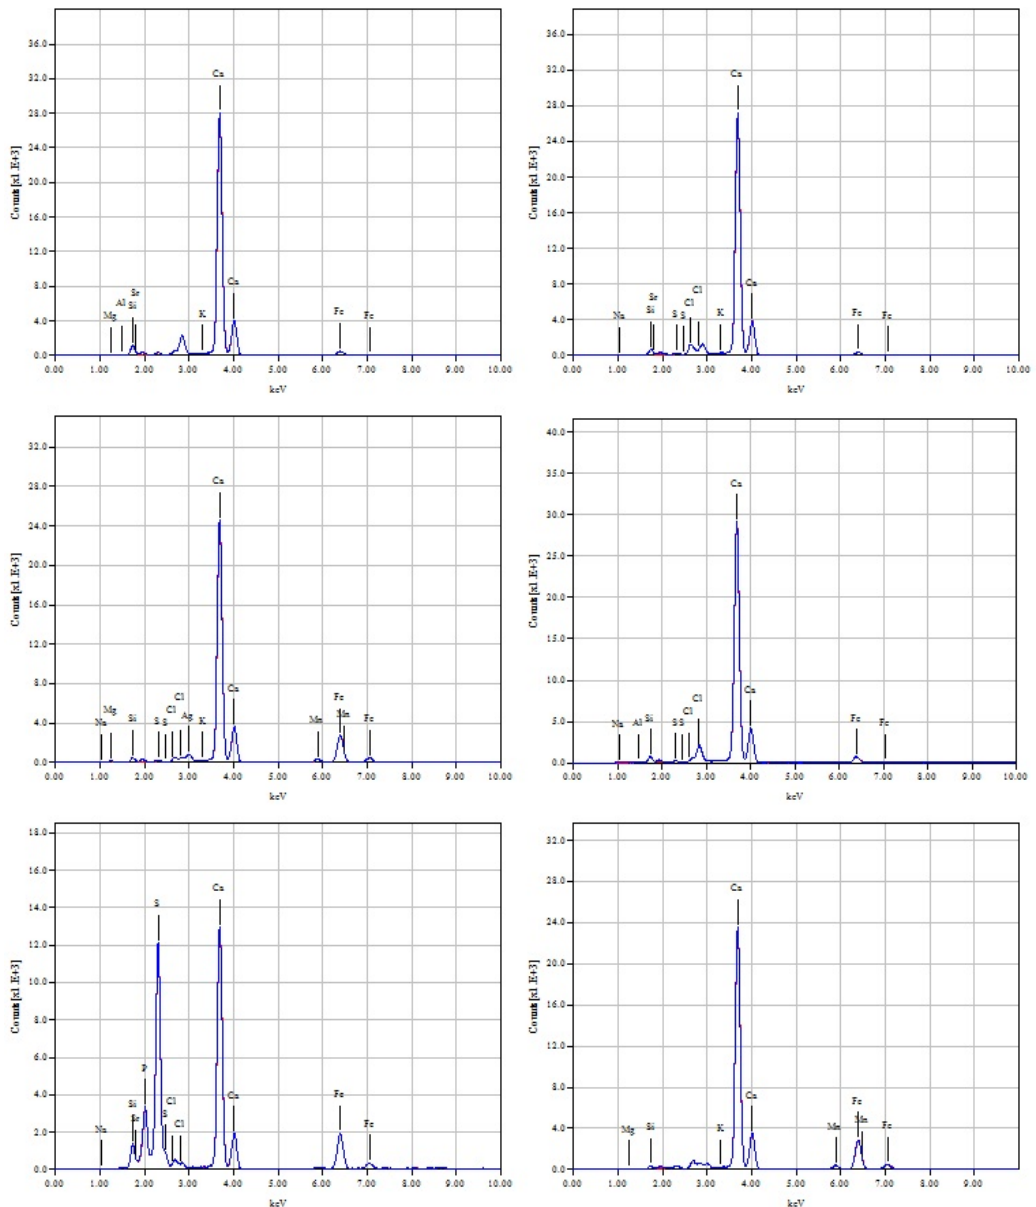
EDX microanalysis of various samples listed in figure 6 and table 1 showed that, the samples essentially consist of calcium (Ca), silicon (Si), sulfur (S), chlorine (Cl), sodium (Na), magnesium (Mg), aluminum (Al), potassium (K), iron (Fe), strontium (Sr), phosphates (P), manganese (Mn) and silver (Ag) potassium (K) and phosphorus (P). Ca as a main source of limestone samples is decreasing in all weathered samples compared (92.60, 90.90, 83.77, and 53.78). These variations may have been due to the ions exchange between the main components of stone samples and different salty ions present in groundwater. High concentration of phosphate (P_2O_5 5.84%), it attributed to phosphates salts, which was produced from fertilizers (ammonium phosphates) used in agriculture land of Abu Musa.

Fig. 6. EDX patterns of the engraved limestone samples from Abu Musa excavation.

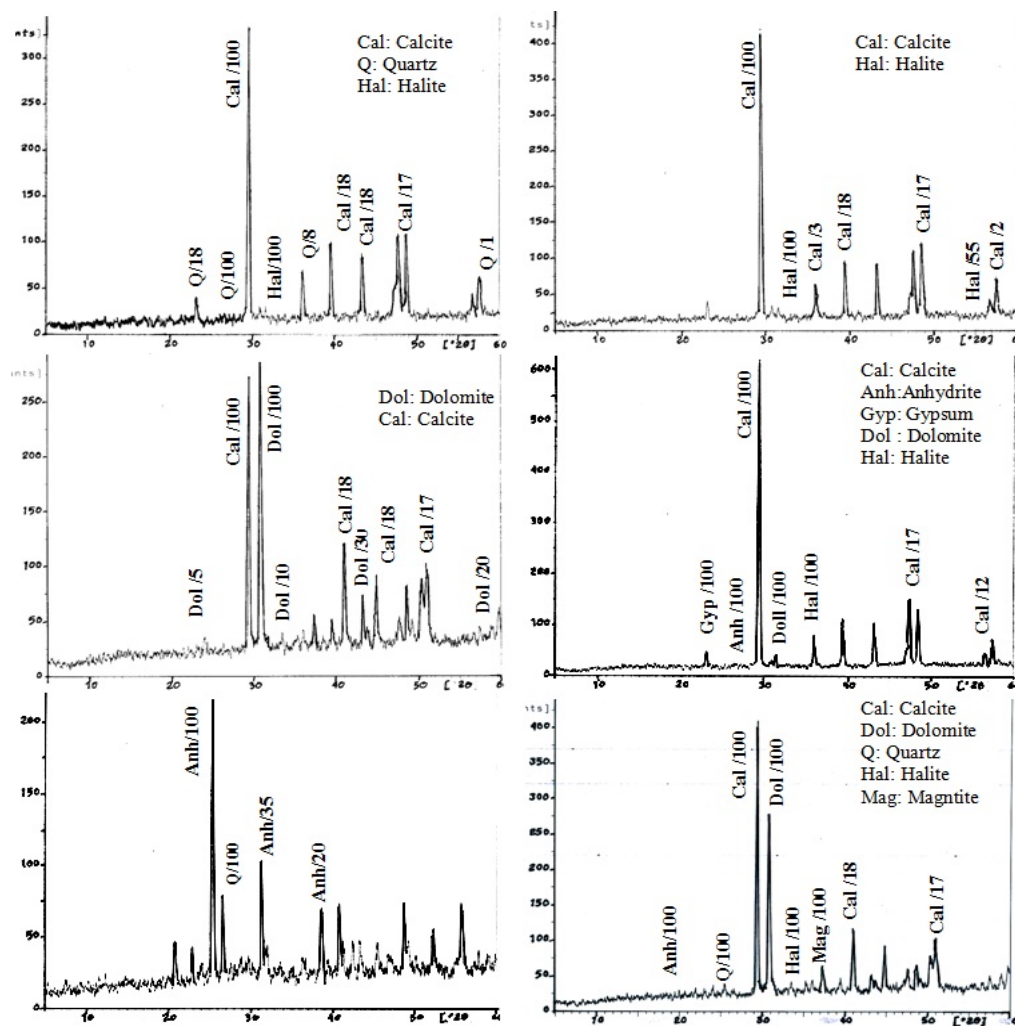
The XRD analysis of studied samples (Table 2, Fig. 7) have shown that the, the sample consisted essentially of calcite CaCO₃ and Dolomite (Ca,Mg)CO₃, and small amount of halite NaCl, Quartz SiO₂, Gypsum CaSO₄·2H₂O, Anhydrite CaSO₄ and traces of iron oxide and Orthoclase KAlSi₃O₈.

Fig. 7. The XRD patterns of investigated limestone samples of Abu Musa.

The mineralogical analysis using XRD of the limestone samples have shown that, the salt layers consists mainly of halite and phases of sulphates (gypsum and anhydrate). The halite salts related to groundwater salinity from Sues Canal and cultivated land. Gypsum was produced by the reaction between the SO_4^{2-} ions present in the acid deposition and the calcium carbonate (CaCO_3) present in limestone or perhaps it is a natural mineral in the stone, it is generally found in Abu Musa limestone in the form of dehydrated sulphate ($\text{CaSO}_4 \cdot 2\text{H}_2\text{O}$) Gypsum and Anhydrate (CaSO_4). The most important source of sulphate is the atmospheric

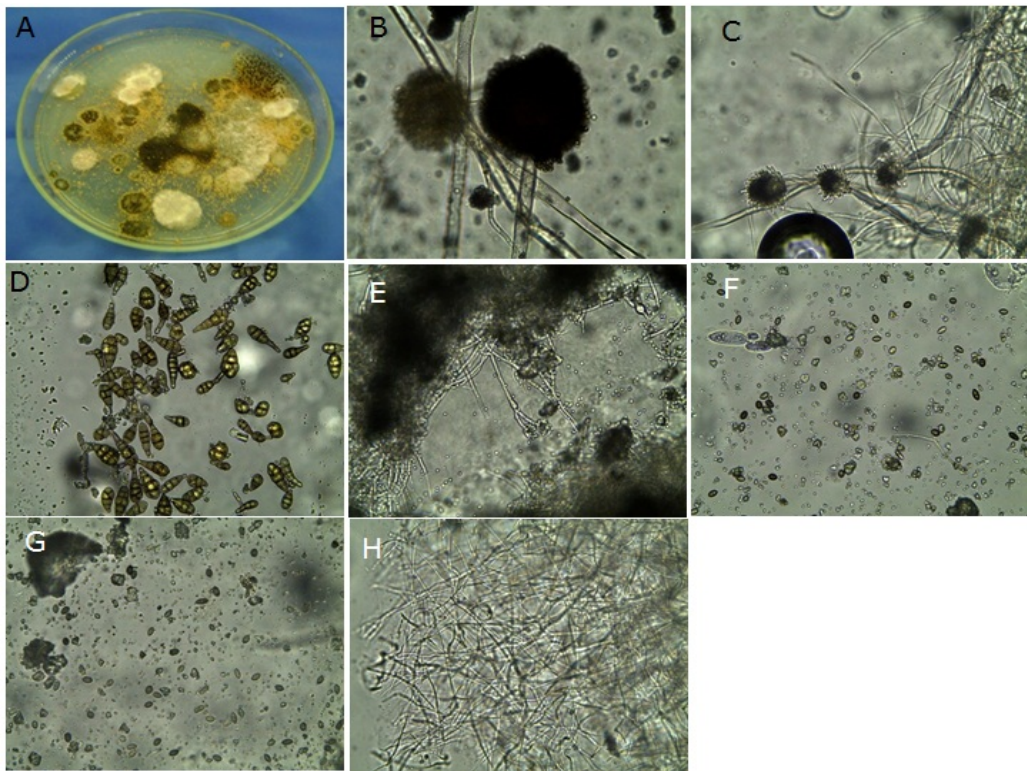
Depending on the conditions at the excavation, various kinds of fungi were identified as shown in (Table 3, Fig. 8), and the study revealed the growth of Bacillus Bacteria (negative gram - Fig. 9).

Fig. 8. Light microscope photos of isolated fungi from engraved stone: A - different colonies of isolated fungi, B - *Aspergillus niger*, C - *candidus*, D - *Alternaria alternate*, E – *Penicillium*, F - *Stach state*, G - *Stachbotrys state*, H - *Sterile mycelia*.

Biodeterioration study revealed seven fungi isolated from weathered samples (*A.niger*, *candidus*, *Alternaria alternate*, *Penicillium*, *Stach state*, *Stachbotrys*). These micro-organisms play an important and substantial role in all alteration processes that occur in the stone. It was estimated that, biological weathering is 100-1000 times greater than inorganic weathering [18]. Biodeterioration of stone blocks in the Abu Musa excavation classified broadly into three categories: biophysical, biochemical, and aesthetic deterioration [19, 20]. The aesthetic or visual effects of biodeterioration resulting in the engraved stone in Abu Musa from the growth of microbiological colonization to dark-colored crust tracing the stone surfaces alter their appearance due to chromatic alterations and development of biological patinas [21]. Biophysical deterioration of stone may occur due to pressure exerted on the surrounding surface material during the growth or movement of an organism or its parts. The biochemical action of fungi on stone appears to be a more important process than mechanical degradation. The deterioration of limestone by filamentous fungi through the action of excreted oxalic and citric acids, the acids produced by various species of fungi function as chelating agents that can leach metallic cations, such as calcium, iron, or magnesium, from the stone surface [22]. Oxalic acid can cause extensive corrosion of primary minerals. Fungal species such as *Aspergillus niger* were able to solubilize powdered stone and chelate various minerals in a rich glucose medium because they produce organic acids such as gluconic, citric and oxalic acids [23]. Many detromycetes belonging to the families of hyphomycetes and coelomycetes (such as *Alternaria*, *Penicillium*), there are common in the soil and in the air and that can be producers of melanin, can also develop in stone, but only in more favorable condition, they tend to be

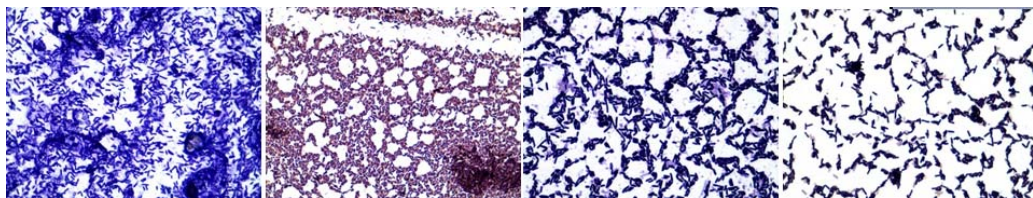
Fig. 9. Light microscope photos of isolated Bacteria from engraved stone infection Bacillus Sp.

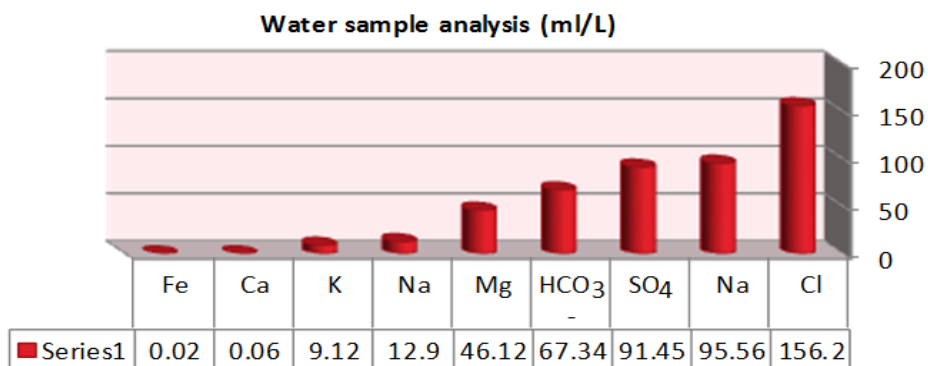
The chemical analysis of the water samples showed that the water sample is rich in sodium (Na⁺), chloride (Cl⁻), potassium (K⁺), magnesium (Mg²⁺), nitrate (NO₃⁻) and calcium (Ca²⁺) ions. The water also has a high content of bicarbonates (HCO₃⁻) and (Cl⁻), sulphates (SO₄²⁻), pH was 8.2 and the temperature was 26°C, (Fig. 10).

Fig. 10. Show the chemical analysis and ASS results of groundwater analysis from Abu Musa.

Chemical analysis showed that the water sample is very rich in Sodium (Na^+), chloride (Cl^-), potassium (K^+), magnesium (Mg^{2+}) and calcium (Ca^{2+}) ions. The water also has a high content of bicarbonates (HCO_3^-) and sulphates (SO_4^{2-}). Sample from groundwater was analyzed for comparison with the samples from the stone blocks to see how much the water had affected them, The analysis of several stone blocks and salt samples showed similar results and the presence of the same salts in addition to percentage of sodium and chloride, which are contained in halite, sulphate, potassium, magnesium and calcium related to the presence of gypsum and anhydrate. The results in the present study proved that the engraved stone is affected by the water of the nearby canals (Ismailia and the Suez Canal represent the main source of water in the Abu Musa area).

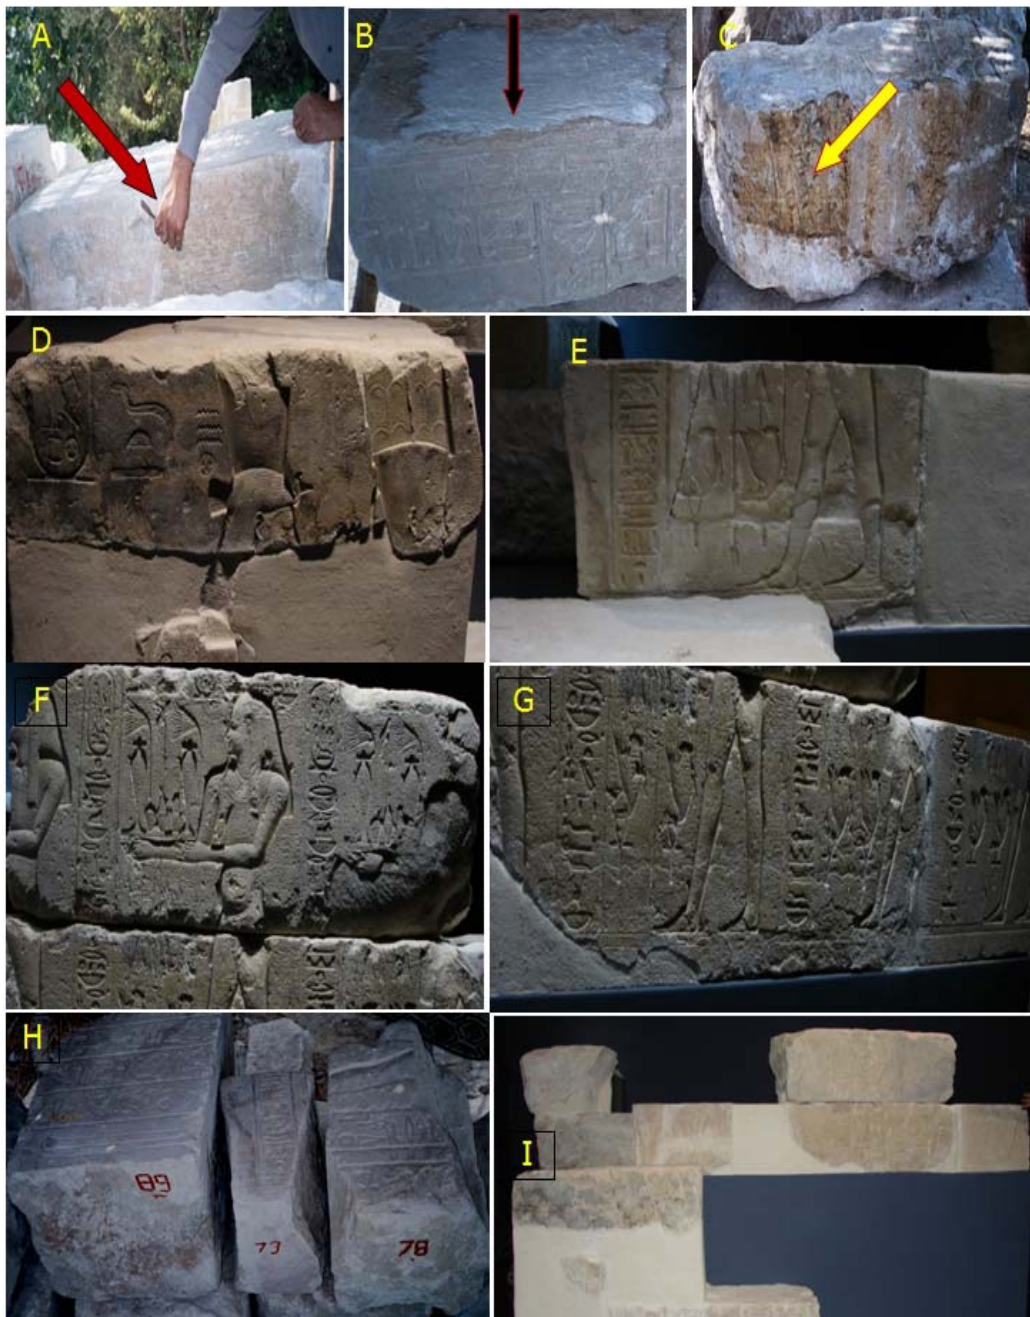
Fig. 11. Restorations steps of stone blocks (A) mechanical cleaning (B) absorbent poultices (C) the stone block after poultice. (D, E) Completion of missing parts (F, G) Re-jointing the stone blocks, (H) the blocks after restoration in Excavation field (I) the exhibition of stone blocks at Suez Museum.

When dry, the stone is cleaned wherever possible mechanically, the friable dirties were firstly cleaned mechanically from the surface by using soft brushes with different size advanced to metallic spatulas and scalpels carefully without any damage occurred. Where dirt is particularly ingrained, distilled water with ethyl alcohol was employed by absorbent packs. During mechanical cleaning it was found that some deteriorated scene surfaces were so weak that application of any cleaning process would result in the loss of large amount of scene. Primary it was performed the consolidation of separated weak surface by using 2% Paraloid B.72 "by spray methods" to consolidate weak parts and then cleaned.

Chemical cleaning (wet cleaning) was done to remove what mechanical cleaning failed to remove. Ingrained dirt, unsightly patchiness and blackened crusts of calcium sulphate were cleaned using two poultices, the first one was absorbent poultices loaded with mixture of 10% sodium thiosulphate ($\text{Na}_2\text{S}_2\text{O}_3 \cdot 5\text{H}_2\text{O}$) + 5% ammonium carbonate with distilled water. After that, used distilled water with ethyl Alcohol to rinse treatment places to remove ammonium sulphate with severe susceptibility to water solubility. The second one employs the sodium salt of the ethylenediaminetetra-acetic acid, abbreviated as (EDTA) as active ingredient. They are particularly appropriate for gypsum crusts because EDTA forms a stable complex with Ca^{2+} ions. Thus gypsum is transformed into soluble sodium sulfate (Na_2SO_4) that is mobilized into the poultice as well as into the stone. The pigments produced by the fungi and alga which were brown and black pigments, were cleaned by using poultice of Methyl Cellulose + triethanolamine + ethylenediaminetetra-acetic acid (EDTA) with Preventol R.80 as biocide.

After the fundamental restoration works (cleaning, salt extraction and consolidation), ten stone blocks have sunken reliefs representing the King Nkhtenbo II caring Lotus flower plant and behind him rows of hieroglyphic writing, were chosen. These blocks were collected and grouped to obtain an accurate profile of a relief or design, so as to be displayed and to keep contiguous blocks together to avoid further abrasion during storage. Re-jointing and linking of these blocks were done by using lime mortar only, consisting of 1 lime + 2 fine sand mixed with 20% primal Ac33 and then complete the missing gaps and spaces with the same lime mortar components. The mortar was applied by a spatula to flatten the putty and smooth it out until it comes well to the edges of the stone surface. The last mortar had very fine-grains and its level was less than the level of the existed archaeological surface according to the known restoration rules. Wood stand was designed for the exposition after completing restoration processes in Suez Canal Museum (Fig. 11).
