## Cultural Resources Survey of the Leander Rehabilitation Center, Williamson County, Texas

**CULTURAL RESOURCES SURVEY  
OF THE LEANDER REHABILITATION CENTER,  
WILLIAMSON COUNTY, TEXAS**

November 1996

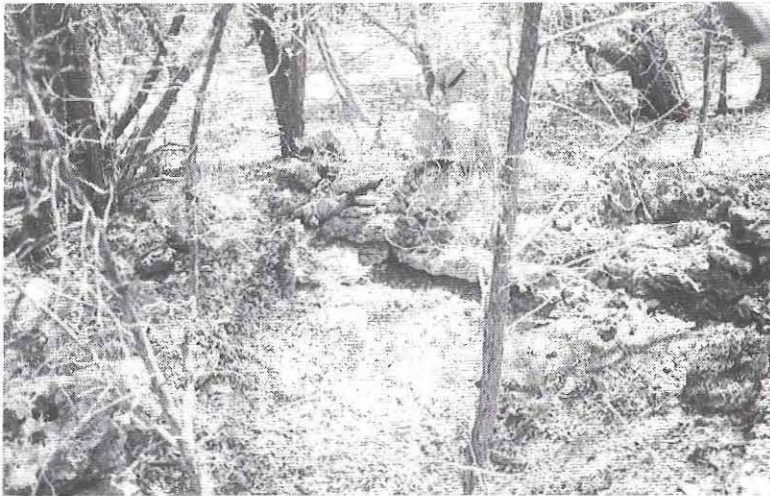
Figure 13. View north of stone enclosure in Area 1 of 41WM892.

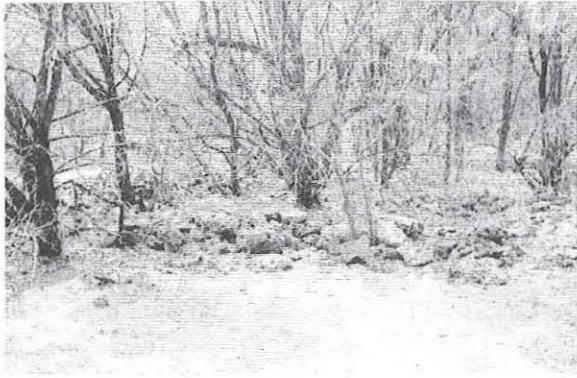
Figure 15. View south of stone enclosure in Area 2 of 41WM892.

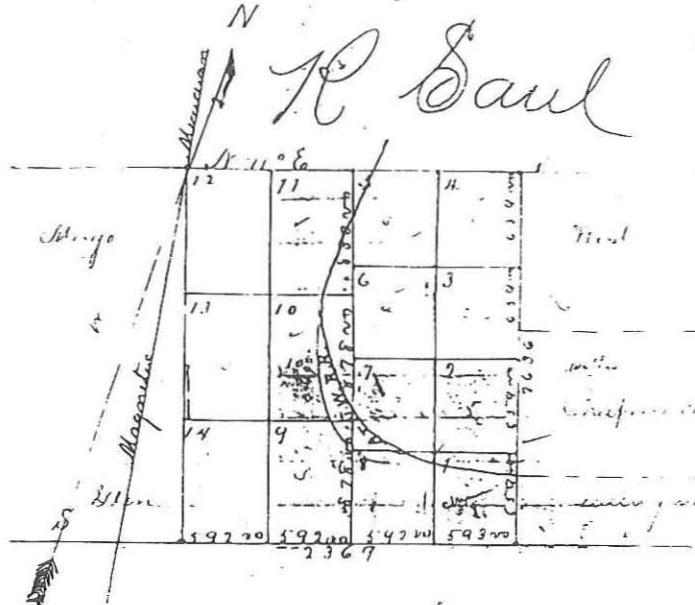
Plat and field notes of the Hamilton survey

Lot No. 1<sup>st</sup> Beginning at the S. E. corner of the Hamilton survey on the S. League line, being the same as the S. W. corner of Milligans tract a stake in a stone mound, thence S 71° 9' along the League line 543 varas a stake in a stone mound; Thence N 19° 9' 659 varas a stone mound; thence N. 71° E 543 varas a stone mound on the line between Hamilton and Chapman; Thence along said line S. 19° 9' 659 varas to the beginning containing about 69 1/2 acres -

Lot No. 2<sup>nd</sup> Beginning at the N. W. corner of Lot 1<sup>st</sup> Thence N 19° 9' 659 varas a stake in a stone mound Thence N 71° E 573 varas a stone mound; thence S 19° E 669 varas along Hamilton and Chapman's line a stone mound thence S 71° W 573 varas along the dividing line between Nos 1<sup>st</sup> and 2<sup>nd</sup> to the place of beginning containing about 69 1/2 acres -

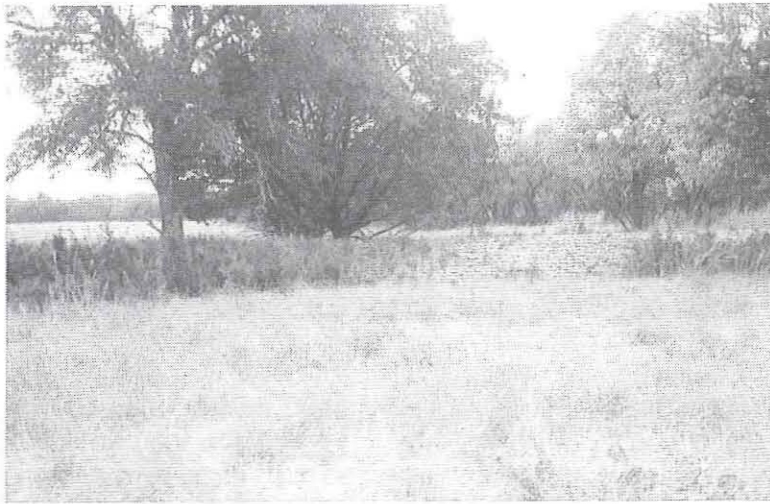
Figure 18. View south of railroad bed with exposed gravels, site 41WM893.

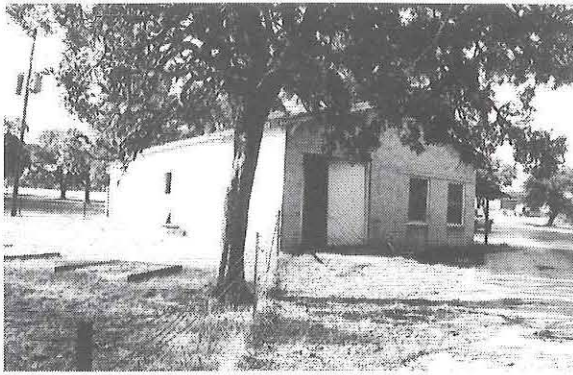
Description: This one-story, rectangular-plan, yellow brick building (Figure 21) includes space for an office and a warehouse. Resting on a concrete slab foundation, the building has a side-gabled standing-seam metal roof and overhanging eaves with exposed rafter tails and knee braces. Although a compact building, the general effect of the massing is reminiscent of the horizontality typically associated with Ranch-style architecture. The building utilizes interior and exterior brick walls separated by a narrow air space for insulation. This building method is known as cavity-wall construction. The yellow bricks used in this building are nearly identical to those seen on the other brick buildings at the facility, but slight variations of color and texture suggest that the bricks used here came from a different source or from a different batch, or may be slightly older. The primary elevation faces west and is sheltered by an attached, full-width, shed-roof porch supported on square wood posts. Entry to the office is through a five-panel wood door at the northwest corner of the building. Warehouse entry is through hinged double wood doors on the north elevation. Most of the regularly spaced windows, which were originally wood-frame casement with horizontal lights, have been replaced with hinged plywood within the original openings. The original casement windows are similar in form and materials to those seen in buildings designed by the National

**Figure 21.** View to the southeast of Historic Resource No. 1, storekeeper/accountant's office and warehouse.

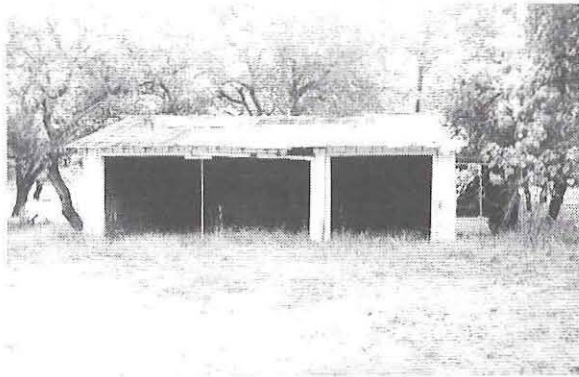
Description: This one-story, rectangular-plan, wood-frame, wood-sided, three-bay garage (Figure 23) has a side-gabled standing-seam metal roof, exposed rafter tails, board-and-batten siding, and an earthen floor. None of the three bays have doors. The detached garage faces west and is located directly behind the house with which it is associated (Historic Resource No. 2a). Alterations include the addition of a small metal-sided storage room on the south elevation and the replacement of one of the original wood posts in the bay area with a metal Lally column. The roof is thought to be a replacement for original composition shingle roofing. The garage retains a moderate degree of integrity.

Figure 23. View to the east of Historic Resource No. 2b, Superintendent's garage.

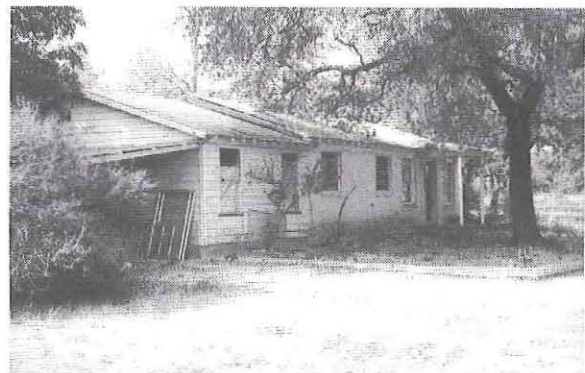
Description: This one-story, rectangular-plan, yellow brick dwelling (Figure 25) rests on what appears to be a pier-and-beam foundation enclosed by a concrete sill. Decorative brick vents provide crawlspace ventilation. The house faces north and has an asymmetrical facade with a partial-width, shed-roof, attached porch supported on square posts. The house is sheltered by a side-gabled standing-seam metal roof. Board-and-batten siding in the gable ends, exposed rafter tails, and knee braces enhance the building. Although a compact one-bedroom house, the general effect of the massing is reminiscent of the horizontality typically associated with Ranch-style architecture. The building utilizes interior and exterior brick walls separated by a narrow air space for insulation. Entry to the house is through the wood panel door with four fixed lights. The original double-hung wood-sash 2/2 windows with brick sills remain in place. All interior walls were originally exposed brick. Most are now covered with drywall. Alterations include a side-gabled wood-frame room addition and a shed-roof carport on the east end of the house. While these alterations are sensitive to the overall massing of the house, their prominent placement on the main elevation has altered the original scale of the building. The use of shiplap siding on the addition is incompatible with the original brick construction.

Figure 25. View to the southwest of Historic Resource No. 4, dairyman's residence.

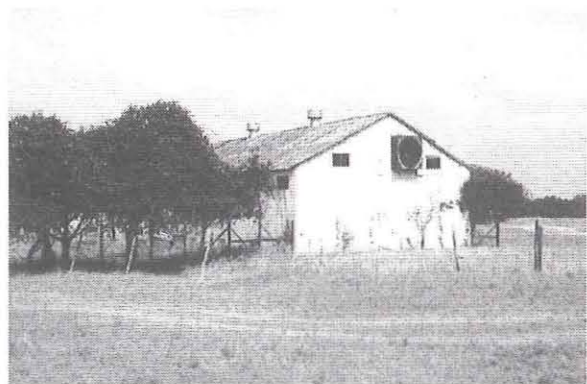
**Description:** This one-story, wood-frame, rectangular-plan barn (Figure 26) faces west and is covered by a front-gabled corrugated metal roof pierced by three projecting metal vents. The exterior walls are clad in corrugated metal. A large nonoriginal exhaust fan is mounted on the east endwall, which also contains two four-light fixed-pane transoms in the gable end. Along the south elevation are five equidistant above-grade openings with corrugated metal doors. Just below the shallow eaves is a row of four-light fixed-pane transom windows. A sliding barn door is located in the west wall. Inside, the barn has a concrete slab floor and a wood truss roof structure. Assembled from a salvaged barn originally located at the National Youth Administration Camp at Inks Lake, alterations to this building include the installation of the exterior exhaust fan and the construction of the concrete slab floor. Although changes to the barn are minimal, it is somewhat deteriorated and in only fair condition. It retains a moderate amount of architectural integrity.

**Figure 26.** View to the southwest of Historic Resource No. 5, maintenance barn.

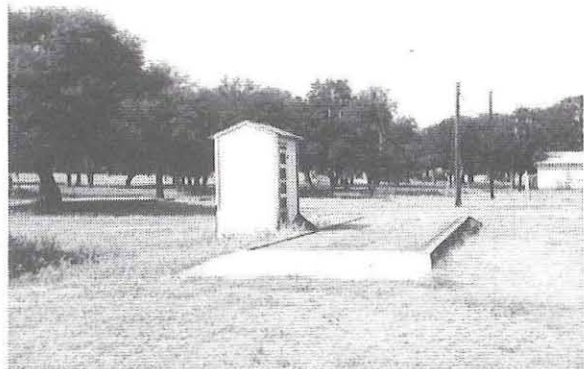
Description: This truck scale is comprised of a one-story side-gabled shed and an in-ground scale (Figure 28). The shed has corrugated metal siding and roofing and a five-panel wood door, in ruinous condition. No alterations are apparent, and the scale retains a moderate degree of integrity.

Figure 28. View to the southwest of Historic Resource No. 6b, truck scale.

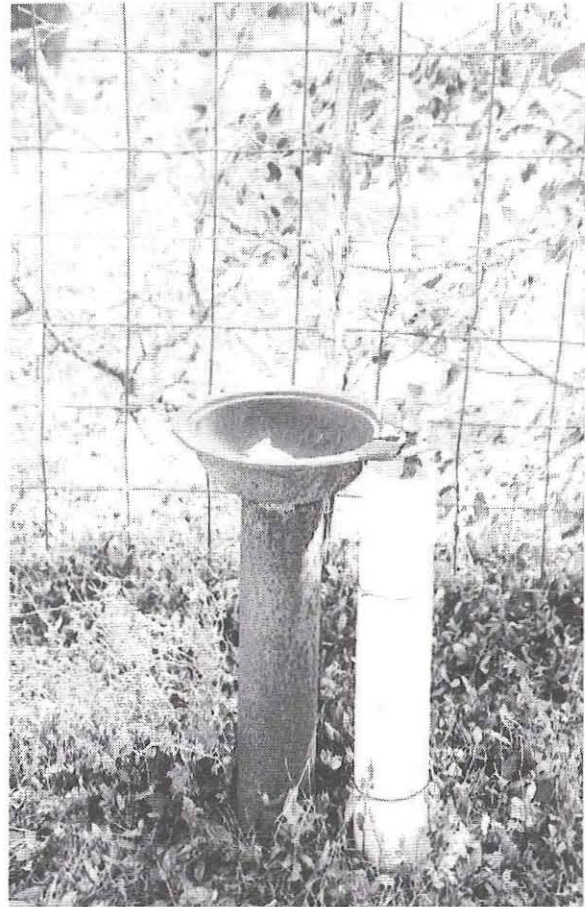
**Description:** This drinking fountain is constructed of a metal pipe to serve as a stand and a metal bowl (Figure 30). Adjacent to the fountain is a water valve sheathed in a section of PVC pipe. The valve delivers water to the fountain. The fountain has a moderate degree of integrity.

**Figure 30.** View to the northeast of Historic Resource No. 8, water fountain.

**Assessment:** Because this water fountain is not yet 50 years of age, is not associated with the historic farming context of the property, and is not exceptional or rare, it is recommended that it be considered not eligible for listing in the National Register of Historic Places or for designation as a State Archeological Landmark.

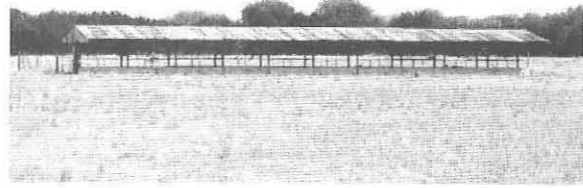
**Description:** This cattle feed trough is constructed of poured concrete that bears the pattern of its wood form and is sheltered by a side-gabled corrugated metal roof supported on metal poles (Figure 34). A horizontal pole attached to vertical members runs the length of the concrete trough. In fair condition, it appears unaltered and retains a moderate degree of integrity.

**Figure 34.** View to the northeast of Historic Resource No. 15, feed trough.

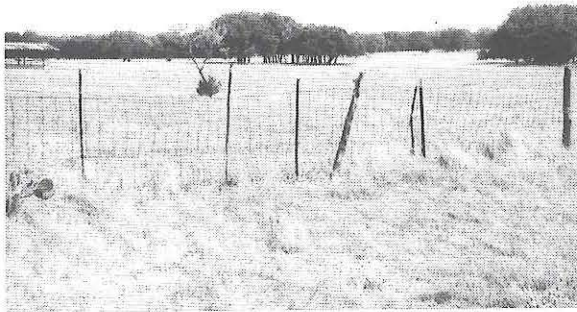
Description: Constructed from rectangular mesh wire strung on wood and metal poles (Figure 35), this fence is a remnant of similar original fencing scattered throughout the project area. The introduction of metal poles as replacements for original wood posts has diminished the fence's integrity somewhat. However, the fencing is recognizable to its date of construction and retains a moderate degree of integrity.

**Figure 35.** View to the northeast of Historic Resource No. 17, fence.

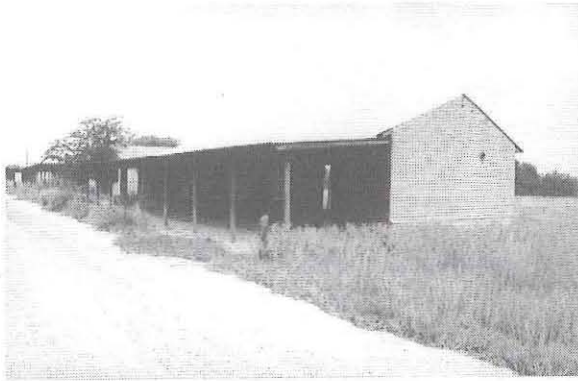
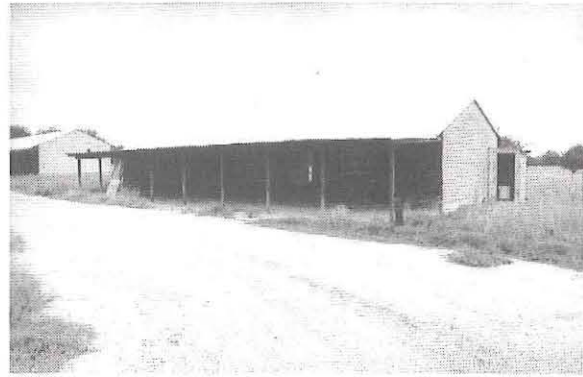
Description: These six buildings are one-story, wood-frame, rectangular-plan pole barns that have been converted into dormitories (Figure 36). They rest on concrete slab foundations and have side-gabled corrugated metal roofs. The buildings face south and have full-width attached porches with flat roofs supported on square wood posts. The porch floors are at-grade concrete slabs. The front and rear walls of the buildings are plywood; the end walls are corrugated metal. Three of the buildings have corrugated metal-sided water heater sheds attached to their east end walls. Fenestration is comprised of aluminum-frame double-hung sash windows arranged roughly equidistant in the front and rear walls. Entry is through plywood doors in the front and rear walls. Originally six of seven pole barns designed to serve as group sheds for hogs, these buildings were modified about 1975 into "rough-out," or camping, dormitories for Department of Mental Health and Mental Retardation clients. The alterations have significantly modified the buildings' original appearance by enclosing the formerly open fronts and installing windows and doors and changing the use from agricultural to domestic. Because of the changes, the buildings no longer retain sufficient integrity to be recognizable to their date of construction. They have a low

Figure 36. View to the northwest of Historic Resources Nos. 22 (left) and 23 (right), group sheds/dormitories.

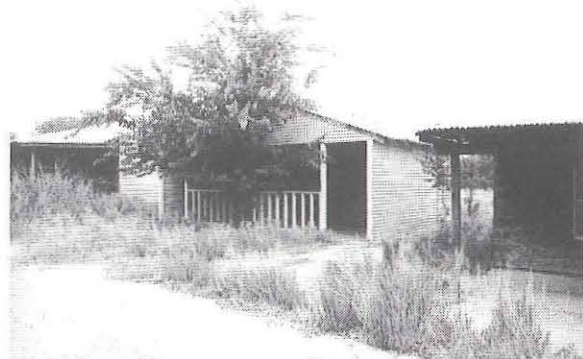
**Description:** This one-story, wood-frame, front-gabled kitchen-laundry-restroom (Figure 37) has a corrugated metal roof and walls and rests on a

concrete slab foundation. Wood posts and a wood "porch" railing at the front impart a residential look to the building. Behind the railing is an open area divided by a double sink. At the rear of the building are the remains of laundry and what appear to be toilet facilities. Appliances and most plumbing have been removed from the building, which is in poor condition. It has a low degree of architectural integrity.

Figure 37. View to the northwest of Historic Resource No. 21, kitchen-laundry-restroom.

Assessment: This building was constructed after the historic period and is unrelated to the historic context of the State Dairy and Hog farm's agricultural operations. It is not rare or exceptional in design or use and has no known significant historical associations. It is recommended that it be considered not eligible for listing in the National Register of Historic Places or for designation as a State Archeological Landmark.

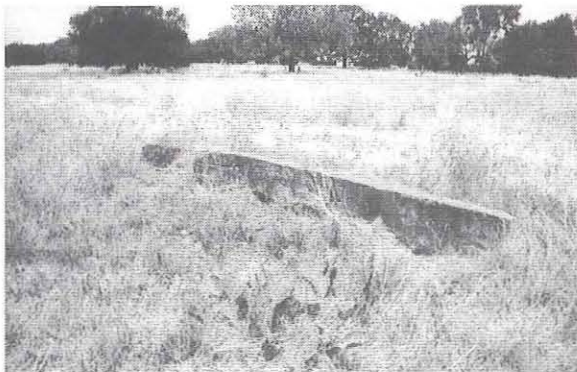
Description: This culvert (Figure 38) was designed to channel wastewater from the adjacent hog sheds under the road to the spreading grounds on the opposite side. The culvert consists of a metal drain pipe connected to a poured-in-place concrete head wall at each end of the pipe. Associated with the culvert is a concrete drain pipe that extends from the barn/dormitory buildings to the north. The culvert appears unaltered and retains a high degree of integrity.

**Figure 38.** View to the northwest of Historic Resource No. 25a, culvert.

Historic Background: This culvert is one of three similar infrastructural elements at the farm (Historic Resources Nos. 25a, 25b, and 25c). On the north side of the road, the culvert attaches to a concrete drain pipe that brought the feed and manure runoff from the ca. 1955 barn/dormitory buildings during the time they were used to shelter swine. It provides a record of the way agricultural waste was handled at the facility in the 1950s and 1960s.

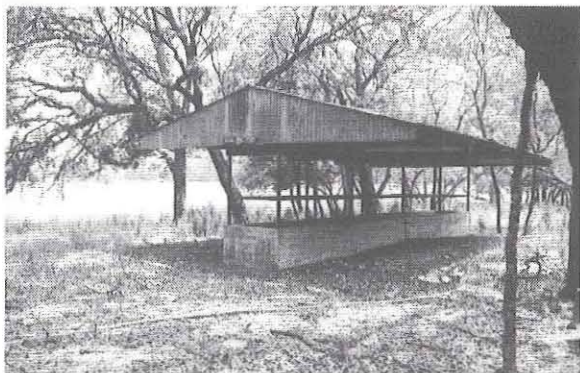
Description: This cattle feed trough is constructed of poured concrete bearing the pattern of its wood form and sheltered by a side-gabled corrugated metal roof supported on metal poles (Figure 46). A horizontal pole attached to vertical members runs the length of the concrete trough. In fair condition, it appears unaltered and retains a moderate degree of integrity. Other features located in the vicinity are a dip tank, the swineherd's house, three water troughs, and a feed trough (Historic Resources Nos. 32a-32c, 32e, and 32f).

Figure 46. View to the northwest of Historic Resource No. 32d, feed trough.

Hog Farm. According to informant data, the gestating cows were segregated from the milk-producing cows in this area of the facility, and this trough was used as a hay feeder. Identical in form with, but somewhat smaller than the feed trough at Historic Resource No. 15 in the dairying area, this trough is one of two that survive on the property. Its design is attributed to programs at Texas A&M University. Other agricultural features at the Rhodes farm that were likely used in the care of the gestating cows by the State include the log barn, now demolished, as well as the two water troughs at this location.

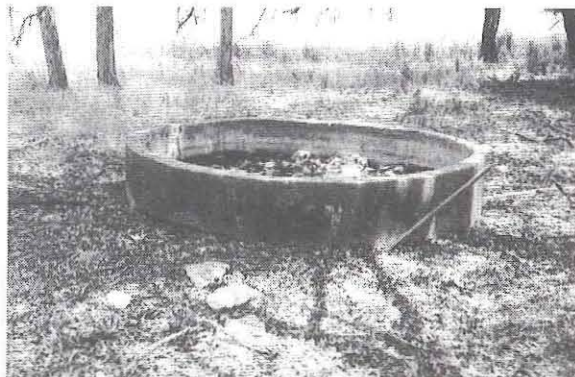
Description: This round water trough is constructed of smooth poured concrete (Figure 47). In fair condition, it appears unaltered and retains a moderate degree of integrity. Other features located in the vicinity are a dip tank, the swineherd's house, two water troughs, and a feed trough (Historic Resources Nos. 32a-32d and 32f).

Figure 47. View to the northwest of Historic Resource No. 32e, water trough.

Rhodes farm operations and was used in the operations of the State Dairy and Hog Farm. According to informant data, this trough was moved to its present location in 1951 from where it was originally placed when the swineherd's house was built. It was originally located near the Rhodes farm house.

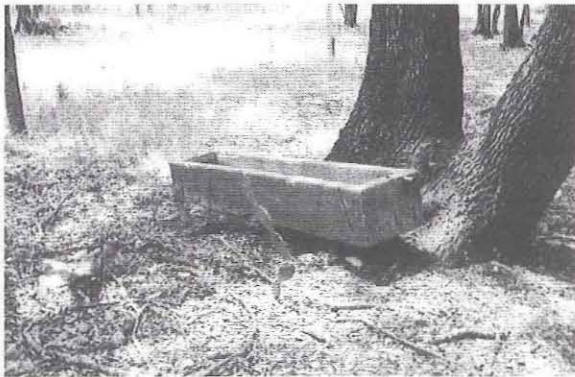
**Description:** This water trough is constructed of smooth poured concrete with pebble aggregate (Figure 48). In fair condition, it appears unaltered and retains a moderate degree of integrity. Other features located in the vicinity are a dip tank, the swineherd's house, two water troughs, and a feed trough (Historic Resources Nos. 32a-32e).

**Figure 48.** View to the southeast of Historic Resource No. 32f, water trough.

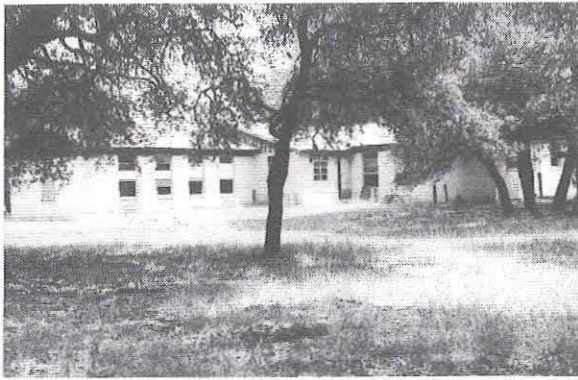
**Description:** This one-story, T-plan, yellow brick building (Figure 49) includes space for a kitchen, a dining room, and two dormitory rooms. The overall effect of the building is horizontal and somewhat sprawling. The kitchen area projects from the front of the dormitory, which faces west, forming the trunk of the T plan. Immediately behind the kitchen is the dining room. Originally, it was divided into two small rectangular areas, one for African American patients and one for white patients. Behind the dining room is the dorm area, which is composed of two separate wings that flank the kitchen-dining area and form the arms of the T plan. Resting on a concrete slab foundation, the dorm utilizes cavity-wall construction with the inner and outer brick walls separated by a narrow air space. The building has nonoriginal double-hung aluminum-sash windows in the dorm and kitchen areas installed inside the original window openings. The dining room and one window on the north end wall of the dorm retain their original steel-frame, fixed-pane, multilight windows. All interior walls, except those in the kitchen, are exposed brick, and the dorm and dining rooms have openings for wood stove pipes, the original heat source. Entry was originally through the kitchen at the front of the building or through the dormitory entrances that flanked the dining room and led to the segregated dorm areas. Original wood panel doors as well as replacement plywood hollow-core doors are found throughout the building. A cross-gable roof is covered with composition shingles. In addition to the window alterations, the entry into the north dorm wing, which housed African American patients, has been enclosed with plywood. The kitchen has been altered with the installation of plywood panels. In the dining room, the interior wall that originally divided the space into two segregated dining areas

Figure 49. View to the southeast of Historic Resource No. 33, kitchen-dining room-dormitory.

has been removed. Decorative features include horizontal wood siding in the gable ends and wood knee braces. Because of the alterations to the windows and the modification on the north side of the building, it retains a moderate degree of architectural integrity.

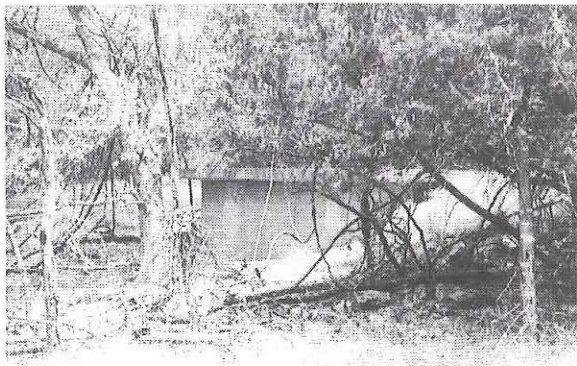
Figure 50. View to the northeast of Historic Resource No. 34, sewage treatment facility.

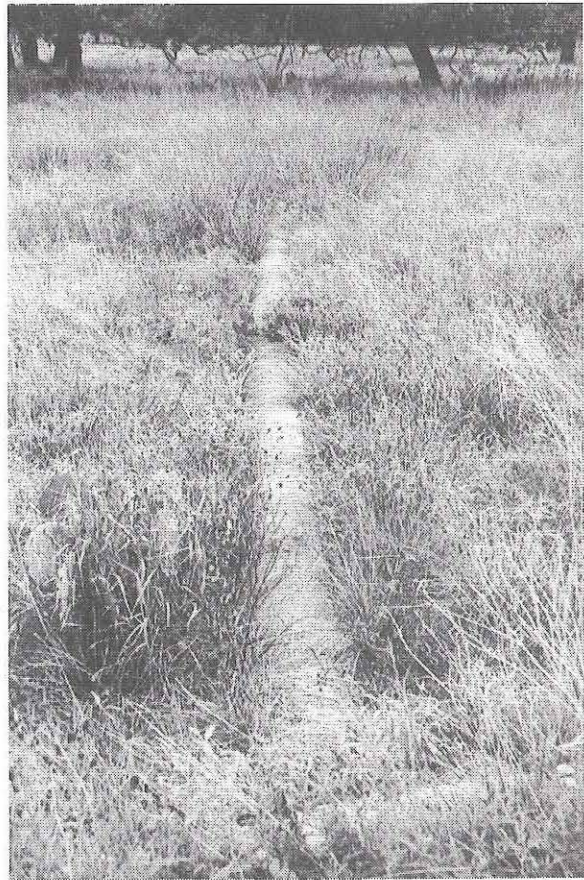
Description: This concrete pipe (Figure 51) measures about 6 inches in diameter and connects square concrete clean-out traps evenly spaced about 6 ft apart along the length of the pipe, which terminates at a culvert with a concrete head wall. A fragmentary part of a once-larger system, this portion of the pipe appears unaltered and retains a high degree of integrity.

Figure 51. View to the southeast of Historic Resource No. 35, sewer pipe.

Rhodes farmstead, this infrastructural resource was connected to the open feed troughs at the ca. 1955 group sheds. It is associated with the third phase of operations of the farm that focused solely on hog operations. The designer of the pipe is unknown.
