# Completion of the Long Duration Wear Test of the NASA HERMeS Hall Thruster

Prepared for the  
Propulsion and Energy Forum and Exposition  
sponsored by the American Institute of Aeronautics and Astronautics  
Indianapolis, Indiana, August 19–22, 2019

The NASA Hall Effect Rocket with Magnetic Shielding (HERMeS) 12.5-kW Hall thruster has been the subject of extensive technology maturation by NASA Glenn Research Center (GRC) and Jet Propulsion Laboratory (JPL) in preparation for development into a flight propulsion system. As part of this effort, a series of wear tests have been conducted to identify erosion phenomena and the accompanying failure modes as well as to validate service-life models for magnetically-shielded thrusters. This work presents a summary of the results obtained during the Long Duration Wear Test (LDWT), which was the third in this wear test series. The LDWT accumulated approximately 3,570 hours of operation and had the overall goal to identify and correct design or facility issues prior to the flight qualification campaign. Thruster performance, stability, and plume properties were invariant throughout the duration of the LDWT and consistent with measurements

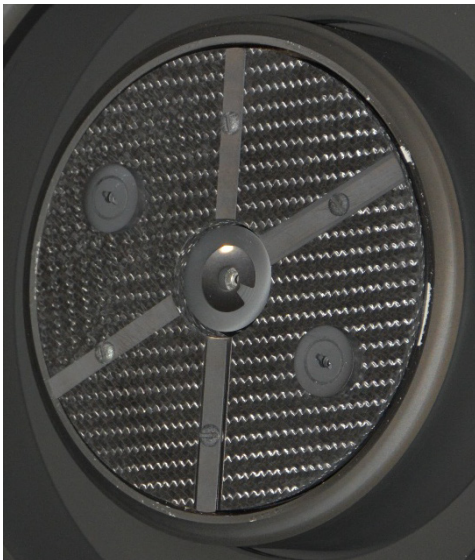
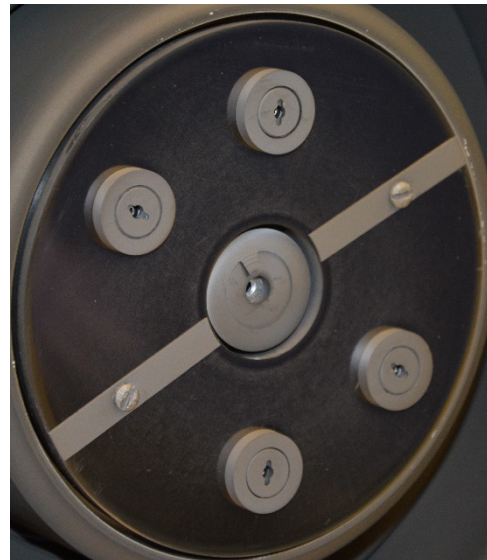
Figure 5.—IFPC configurations used during Segments (a) V and (b) VI of the TDU-3 LDWT.

The keeper configuration used during the TDU-3 LDWT is shown in Figure 5(b). The keeper was made of graphite and had the downstream surface polished prior to installation. A graphite ring was affixed to the outer edge of the downstream keeper face. This ring increased the diameter of the keeper to match the AEPS design and provided a masked reference surface for keeper erosion measurements. A small tab was also included as part of the mask, which protruded radially inwards towards the cathode orifice. This tab enabled an assessment of the radial variation in erosion rates across the keeper face. A new keeper was installed prior to the start of Segment V. It was re-used for Segment VI, but the mask was rotated prior to the start of that segment to expose a new region of polished graphite. This enabled direct measurements of the keeper wear for both segments.

Another possibility is that the apparent azimuthal variation is an artifact introduced by the orientation of the mask. As shown in Figure 5(a), the radial tab was placed at approximately the 4 o'clock location during Segments V and VI of the LDWT. The side of the tab on which net deposition was observed was therefore approximately horizontal during these segments and faced the ceiling of the facility. Since the top of the facility contains numerous backsputter sources (e.g., pumps, carbon paneling, etc.), the observed net deposition could also be due to a flux of carbon from these sources with a preferential downward angle. However, the keeper mask was oriented with the tab at the 12 o'clock location during Segment I. Thus, although it is a plausible explanation for the net deposition observed during Segments V-VI, this preferential downward flux of carbon cannot explain the azimuthal variation shown in Figure 13. Taken together, this suggests that the azimuthal velocity component of eroding ions is important for understanding HERMeS cathode keeper wear.

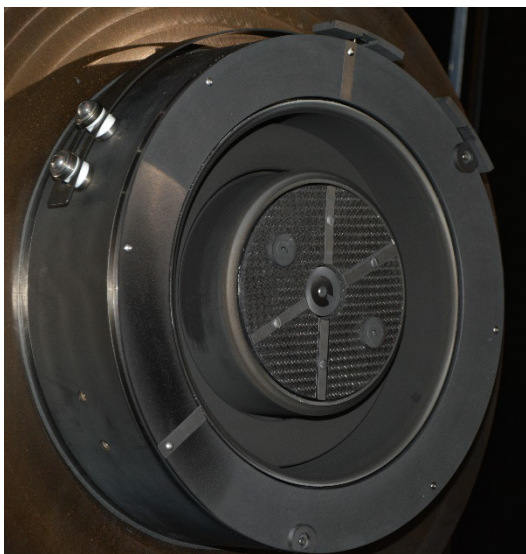
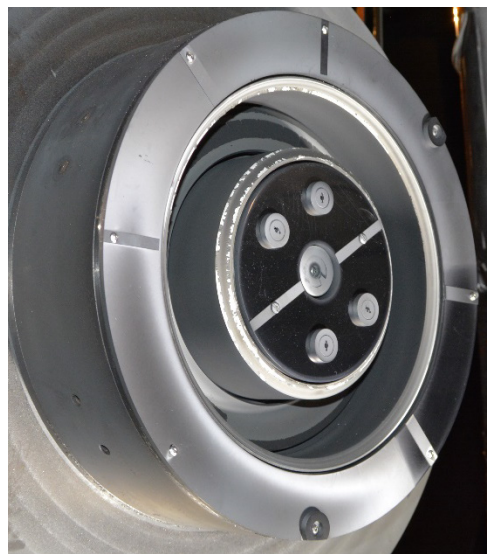
Figure 6.—OFPC configurations used during Segments (a) V and (b) VI of the TDU-3 LDWT.

As discussed in Section 3.5.2, masks were placed over both polished and unpolished sections of the OFPC during Segments V and VI of the LDWT in order to assess this hypothesized link between surface finish and erosion rates. For both segments, resolvable net erosion was measured in the regions of the OFPC that were polished pre-test, but no measurable erosion was detected on the unpolished sections of the OFPC. This provides additional evidence supporting the claim that the observed erosion rate time dependence is actually a surface roughness dependence introduced by the pre-test polishing of the pole covers.

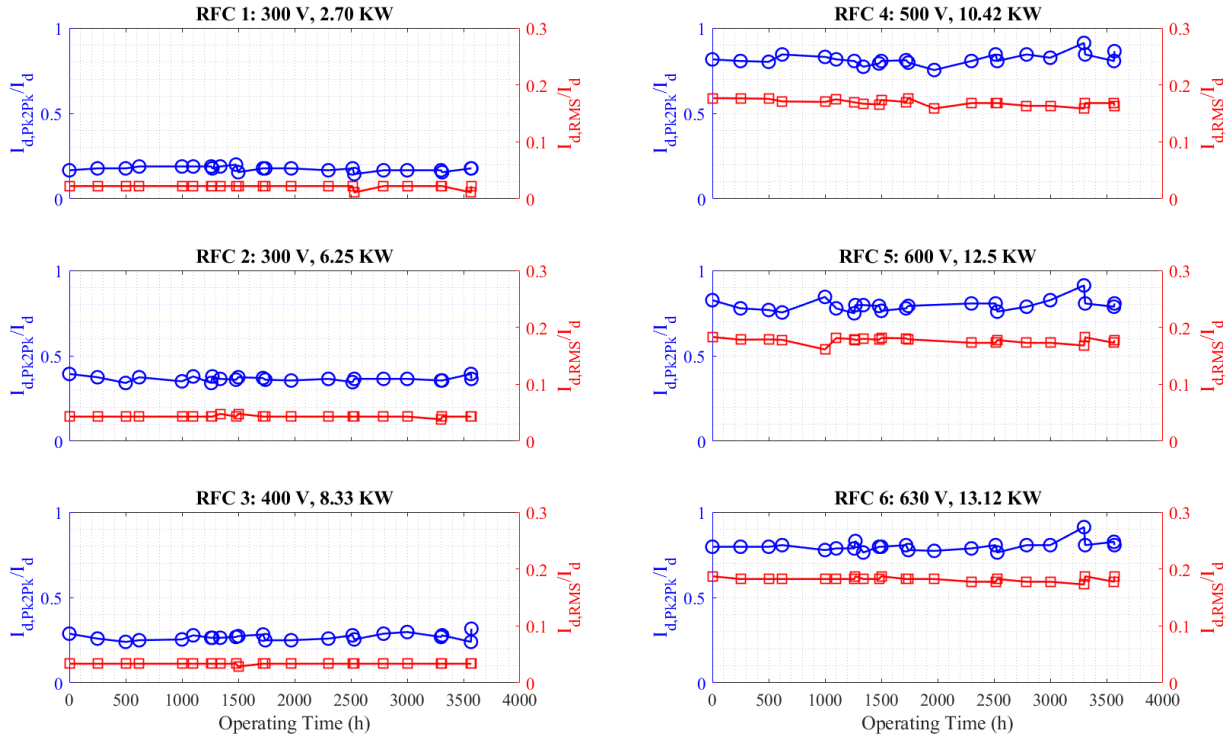
Figure 8.—TDU-3 discharge current oscillation characteristics as a function of operating time during the LDWT.

The discharge current oscillations of TDU-3 were characterized using the peak-to-peak ( $I_{dPk2Pk}$ ) and root-mean-square ( $I_{dRMS}$ ) of the recorded current waveform. The results were normalized by the average discharge current ( $I_d$ ) and are plotted as a function of operating time for each of the RFCs in Figure 8. Similar to the performance results discussed in Section 4.2, the discharge current oscillations varied by less than 4 percent for all RFCs over the LDWT. This consistency was also observed in the measured power spectral densities, which showed standard deviations of less than 2.5 kHz and 2 dB for peak frequencies and powers. The stability and spectral characteristics measured during the LDWT are consistent with those obtained during previous TDU wear and performance characterizations (Refs. 3, 4, 9, 15 to 17).

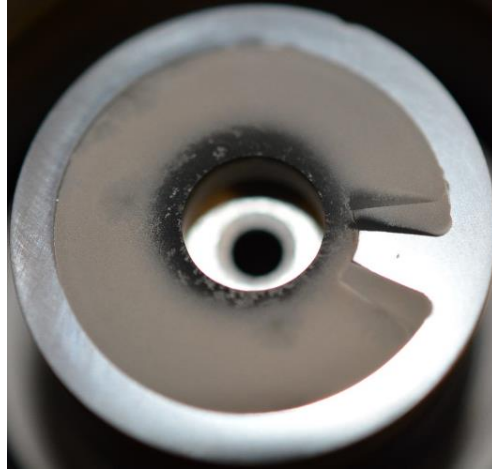
Figure 12.—A (a) photograph, (b) 3D surface scan, and (c) profile of deposition observed on the keeper after Segment VI of the LDWT.

Two features of note were observed during the keeper wear assessment performed after Segment VI. First, net deposition with a thickness of approximately 1  $\mu\text{m}$  was observed around the keeper orifice. This deposition is shown by the dark ring surrounding the orifice in Figure 12(a) and the rough peaks in the 3D surface scan of the near-orifice region in Figure 12(b). This is quite different from the net erosion observed at all other radii, but it does match observations made during the TDU-1 wear test.

A region of net deposition was also observed on one side of the radial tab that protruded inwards from the keeper mask. This deposition is shown by the dark triangular region near the unexposed keeper region at the 3 o'clock position in Figure 12(a). Evidence of deposition is also visible in the azimuthal profile extracted from this region and shown in Figure 12(c). Specifically, the hill adjacent to the leftmost masked region represents the net deposition observed during Segment V of the LDWT. The two heights visible in the masked region of the profile in Figure 12(c) were caused by the rotation of the keeper mask between Segments V and VI. Specifically, the lower region corresponds to the keeper region masked for Segment V and exposed for Segment VI, whereas the higher region was masked for both segments. This height change obfuscates the measurement of the deposition that occurred during Segment VI, even though a second dark region is visible adjacent to the masked region in Figure 12(a).

It is important to note that deposition was only visible on one side of the keeper mask. One possibility is that this was due to azimuthal variation in the process driving keeper erosion. Further evidence of this is shown in Figure 13, which depicts a sample keeper profile obtained at the end of Segment I of the LDWT. Although a clearly defined step between the masked and unmasked keeper regions is visible to the right of the masked region, almost no step is detectible on the left side of the masked region. This is different from profiles acquired on the IFPC, which have nearly identical steps on both sides of the mask. However, it does match the trends observed during the SDWT (Ref. 4).
