# The application of resistivity and IP-measurements as investigation tools at contaminated sites

A case study from Kv. Renen 13,  
Varberg, SW Sweden

Dissertations in Geology at Lund University,  
Master's thesis, no 442  
(45 hp/ECTS credits)

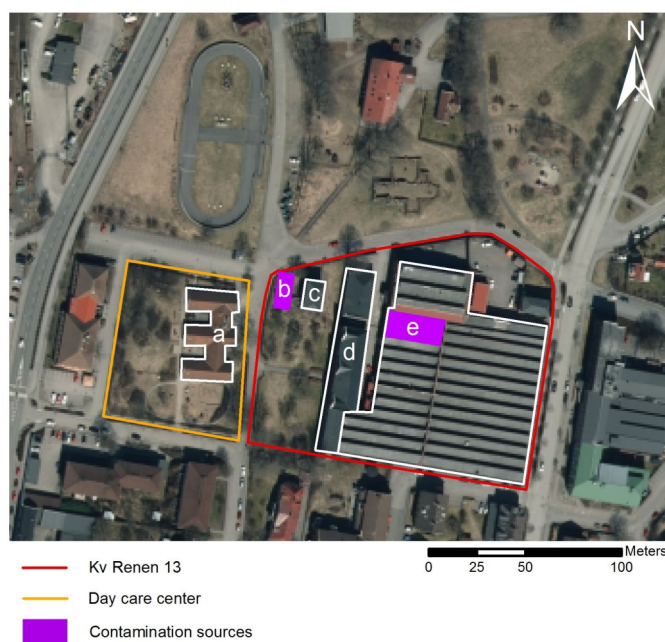
Fig. 2. Overview of Kv Renen 13, with the source areas for the described pollutants and the day care center marked in yellow. a) Day care center, b) sedimentation basin, c) director residence, d) administration building, e) industry building with the cellar marked as contamination sources (© Lantmäteriet I2014/00579).

tion of the foundation, the risks are low enough to be able to continue with the children presence within the building (Sällsten & Barregård 2004). A closer view of the area with the contaminant sources presented is shown in Fig. 2. In Fig. 3 a-e some overhead photographs are shown from fieldwork at the estate.

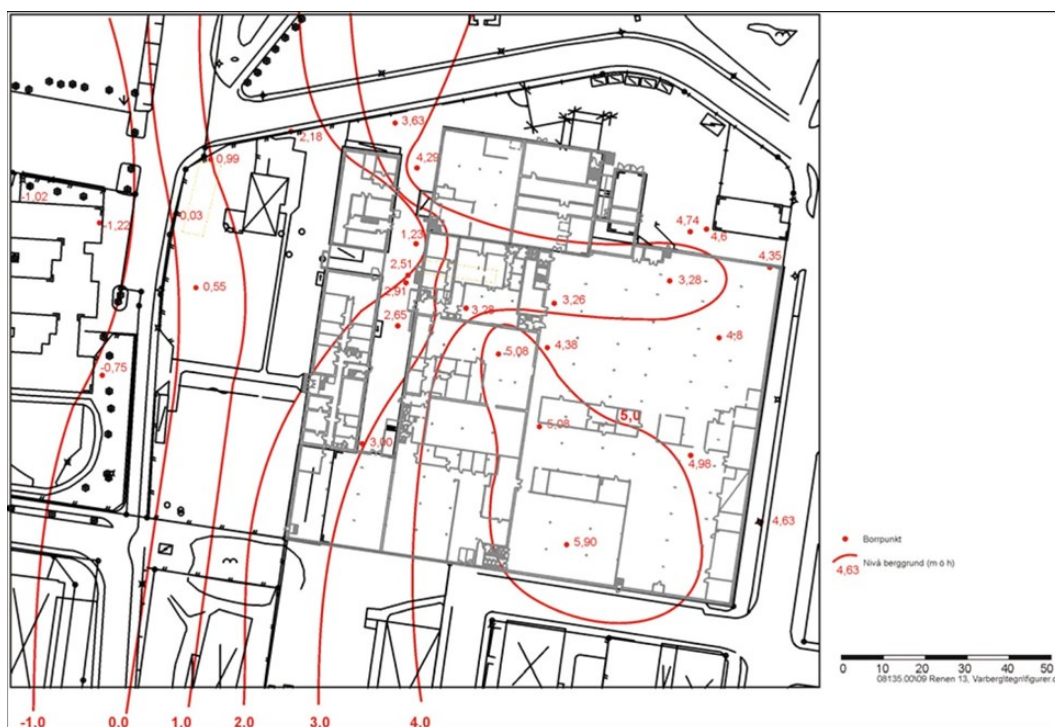
Fig. 5. Investigation of the bedrock location by drilling, and interpolation between the points. The points are given in meters above sea level. The map indicates a dip of the bedrock surface in a westward direction and a lower location in the middle of the estate. Used with permission from Tornberg *et al.* (2008).

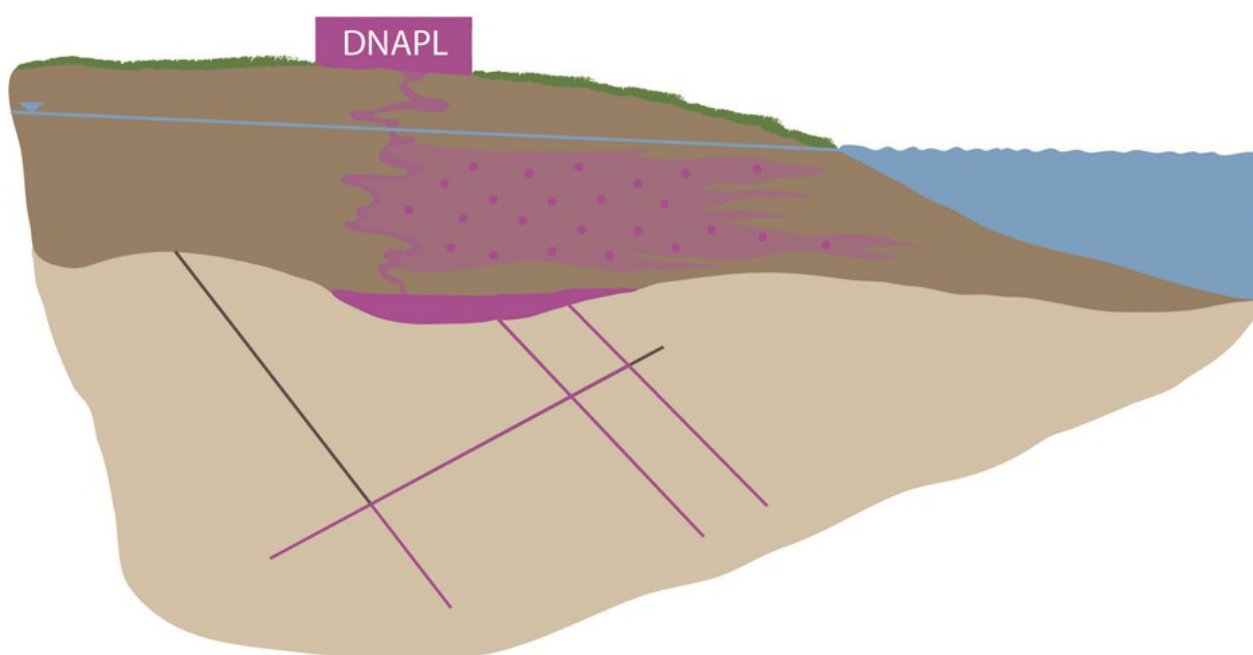
Fig. 9. Conceptual model of DNAPL subsurface dispersal.

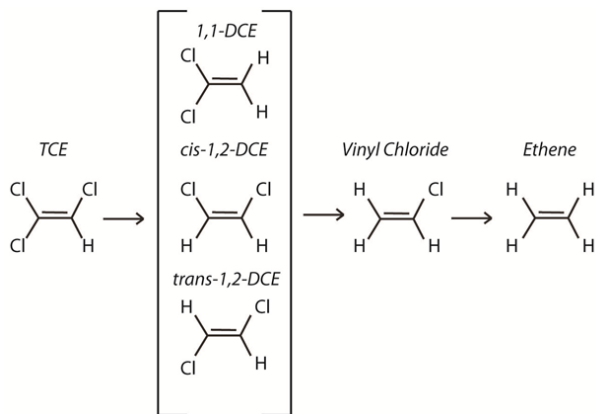
Fig. 10. Stepwise degradation of TCE

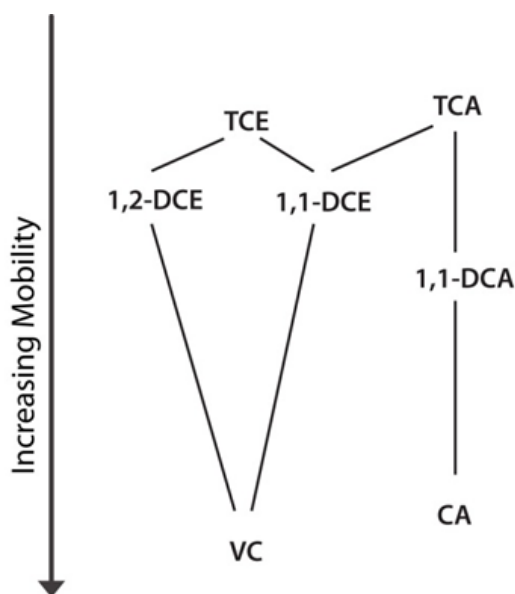
Fig. 11. Degradation of chlorinated solvents dissolved in groundwater and their relative mobility (based on Pankow & Cherry 1996).

TCE decomposition products are 1,1-dichloroethene (1,1-DCE) and 1,2-dichloroethene (cis- and trans-1,2-DCE). They decompose further on to vinyl chloride (VC), with the end products being ethene and chloride ions. 1,1,1-trichloroethane (TCA) is degraded to 1,1-DCE and 1,2-dichloroethane (1,1-DCA), and further to chloroethane (CA). The mobility in water increases when the numbers of chloride atoms reduce from the CAHs (Fig. 11) (Pankow & Cherry 1996).

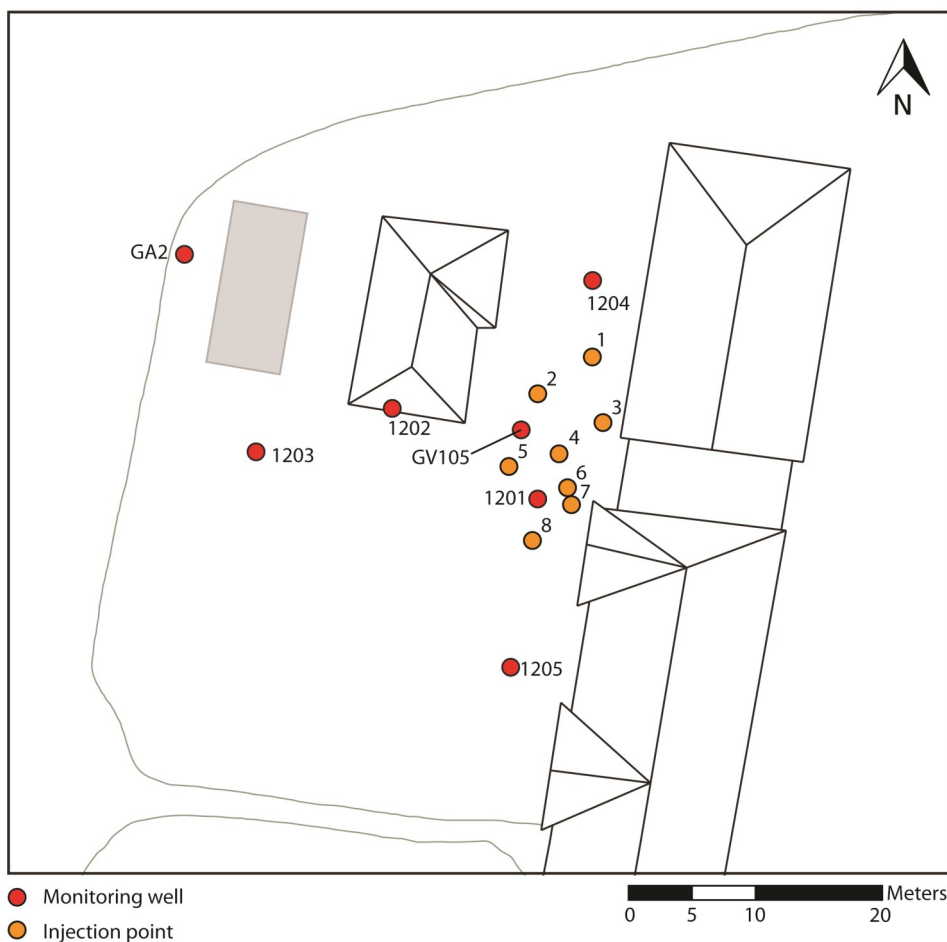
Fig. 13. Location of the direct-push injection points of 3D Microemulsion and HRC Primer, and the used monitoring wells in the area.

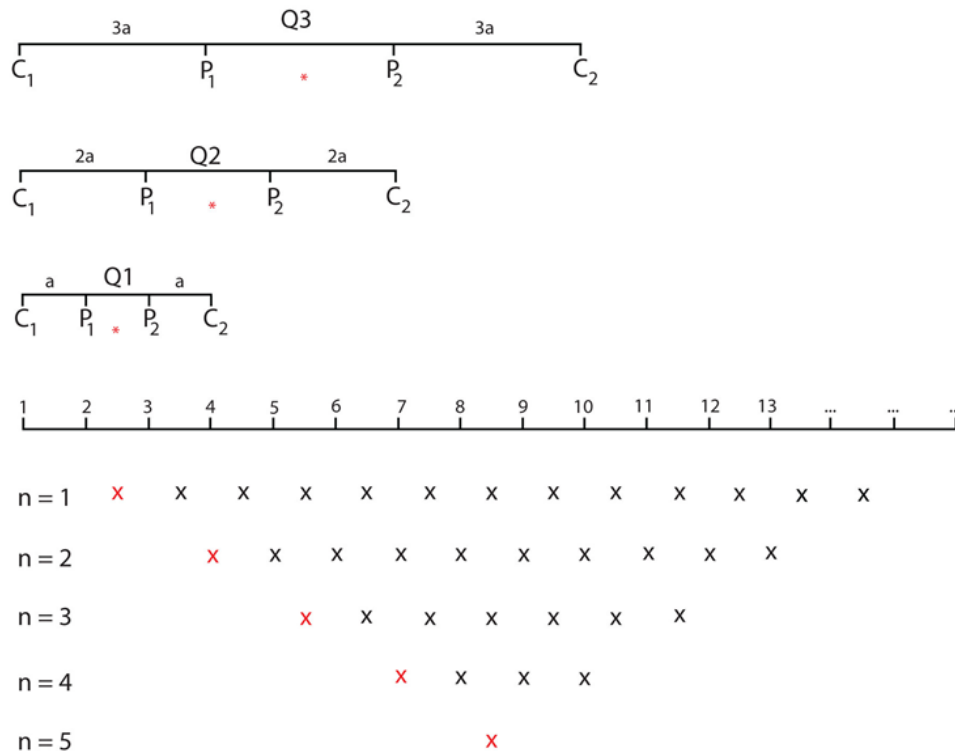
Fig. 18. An example of how the measurement sequence for building a pseudosection can be set up, showing three electrode quadrupole combinations. The greater the internal spacing in the quadrupole, the greater the depth (n) will be for which the data point can be plotted, i.e. the greater electrode distance, the deeper the measurement data point.

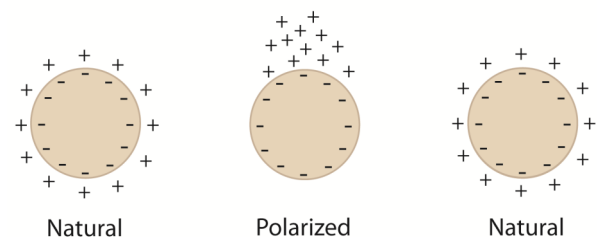
Fig. 19. A natural case with the grain negatively charged, most often, surrounded by positive charge. By turning on a current the surrounding charge will be polarized, when the current turns off the charging will stabilize to the natural conditions. The time it will take is measured during time-domain IP.

IP-effects are complex and the phenomena are not fully investigated. However, polarization of the ground can occur in two ways; electrode polarization or membrane polarization. Electrode polarization takes place if the material consists of free charges, e.g. metal sulphide and metal oxides. Grains are often negatively charged, surrounded by positive sharing particles and thereby possible to investigate with IP, where an applied voltage disturbs the ion balance and causes a current flow, as visualized in Fig. 19 (Reynolds 1997).

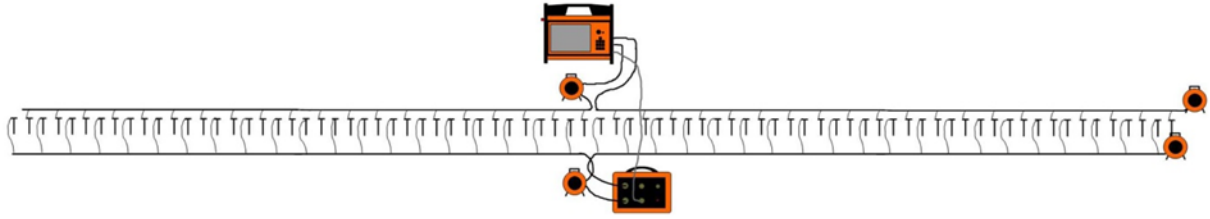
Fig. 24. Sketch of the set-up with separated cable spreads surveyed using 2x2 cables with 21 electrode take-outs each (personal communication Torleif Dahlin).

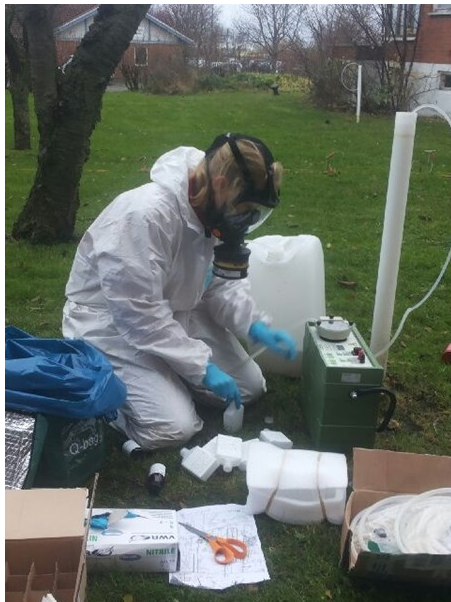
Fig. 25. Water sampling in progress; the expected high levels of hazardous substances in the water required the use of protective equipment.

Samples were investigated both in field with an Aquareader flowcell AP-800 Aquaprobe® and in the AlControl AB laboratory. Parameters measured in the field were: temperature, oxidation-reduction potential, pH, electrical conductivity, total dissolved solids, salinity and turbidity. Collected samples were sent to the laboratory in Helsingborg on the 27<sup>th</sup> of November, and were kept cold in a cooler until delivered. The samples were analysed for metals, dissolved organic carbons (DOC), total organics carbons (TOC), chlorinated solvents (*1,1-dichloroethane, 1,2-dichloroethane, dichloro-methane, trans-1,2-dichloroethene, cis-1,2-dichloro-ethene, 1,1,1-trichloroethane, 1,1,2-trichloroethane, tetrachloroethene, tetrachloro-methane, trichloroethene trichloromethane, monochlorobenzene, dichlorobenzenes, 1,2-dichloropropane, 1,1-dichloroethene and vinyl chloride*), cyanide and chloride. Protection equipment was required during sampling due to expected high levels of hazardous substances. The protective suit used was the Cat. III type 5/6, gasmask with filter A and gloves as shown in Fig. 25.

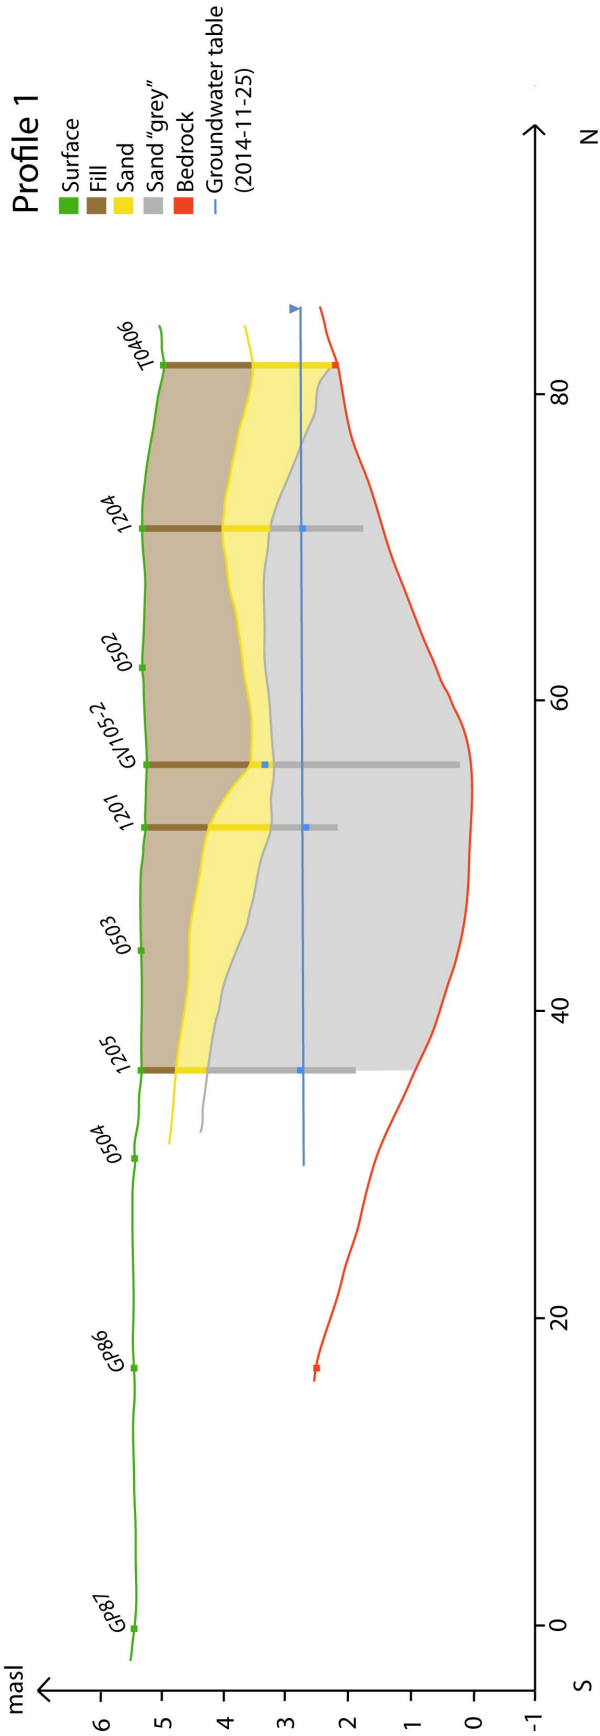
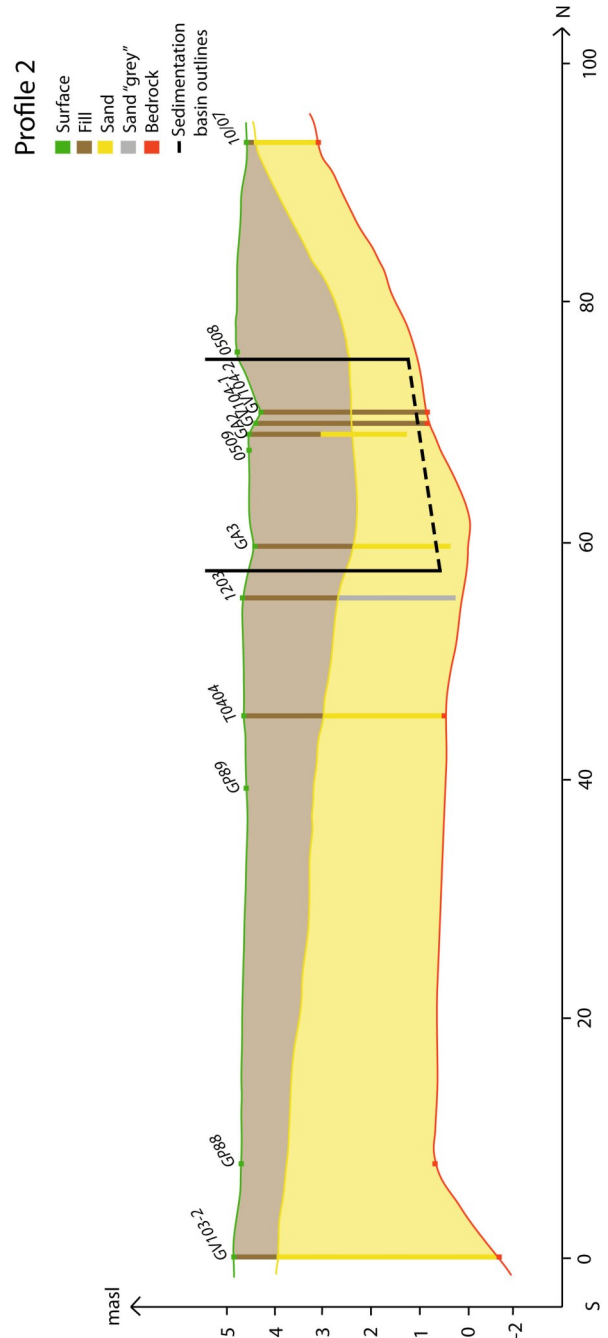
Fig. 27. Profile 2 crosses the sedimentation basin (outline marked as black lines (Larsson & Hübinette 2003)). The sedimentation basin depth is uncertain. The profile correlates to DCIP-survey line 2-4. The bedrock surface is elevated towards the north. The groundwater table is excluded in the figure due to the lack of reliable measurements.

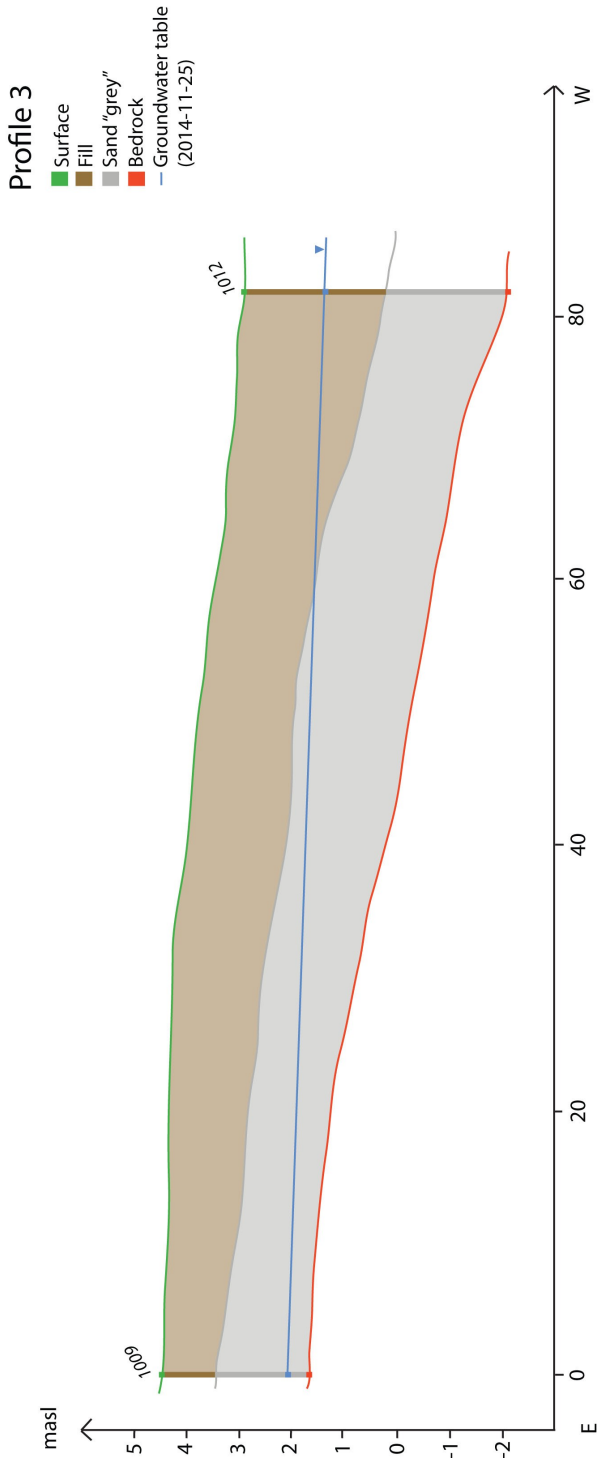
Fig. 28. Profile 3 correlates with the DCIP survey line MC by the miniature-golf course. The bedrock is dipping westward and the overlying sediments increase in thickness in the same direction. Notice the profile's direction, premeditated to correlate with the DCIP-survey line direction.

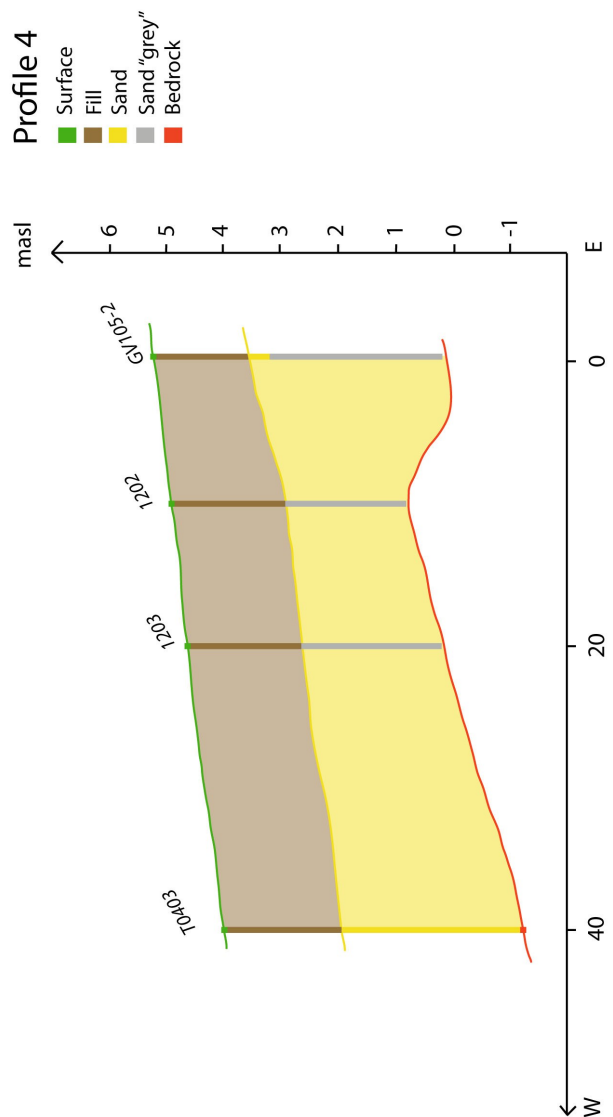
Fig. 29. Profile 4 crosses the estate south of the director's residence. The bedrock slopes westward with roughly the same thickness of sediment above. Groundwater levels were excluded due to the lack of reliable measurements. Notice the direction with east on the right hand and west to the left.

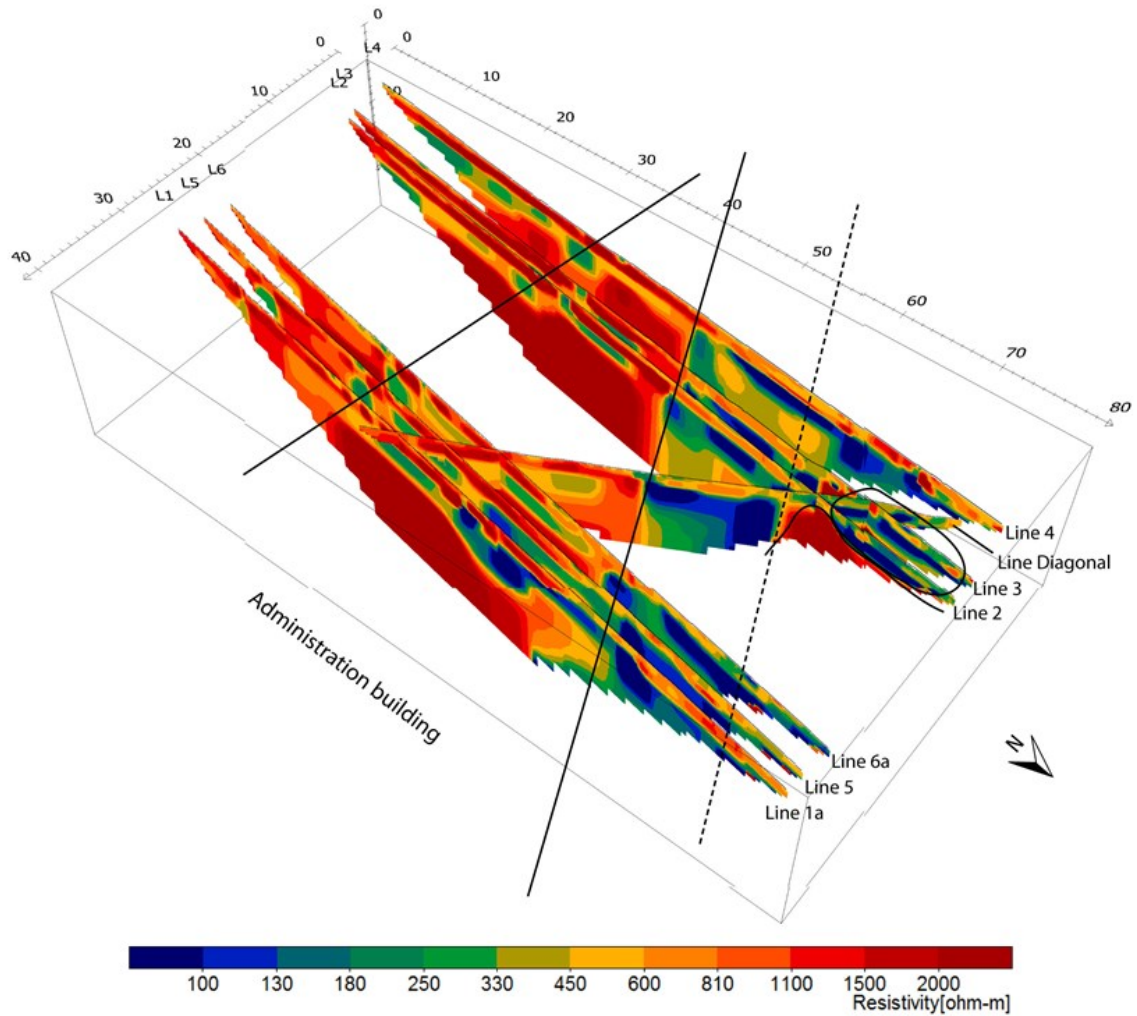
Fig. 30. Resistivity profiles from inside the estate, measured in May and November, are joined in a fence diagram. Noted units and anomalies are marked with black lines, dashed lines and circled. Note that north is towards the right hand side and downwards in the picture. It is presented this way to optimize the visualization of the most interesting features in the results.

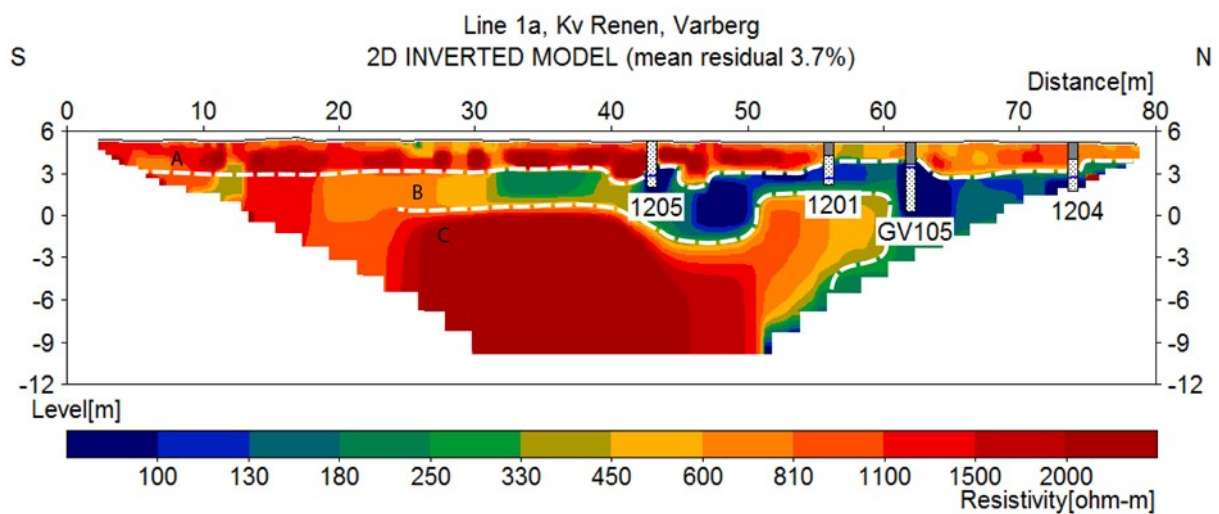
Fig. 31. Three fairly horizontal layers A, B and C are marked with white dashed lines. At 40 m into the DC-profile, the B unit gets thicker, and its resistivity decreases, while the unit C gets thinner. At 50 m, the C unit increases as the B unit thins out. At 60 m unit C disappears and B increases in depth.

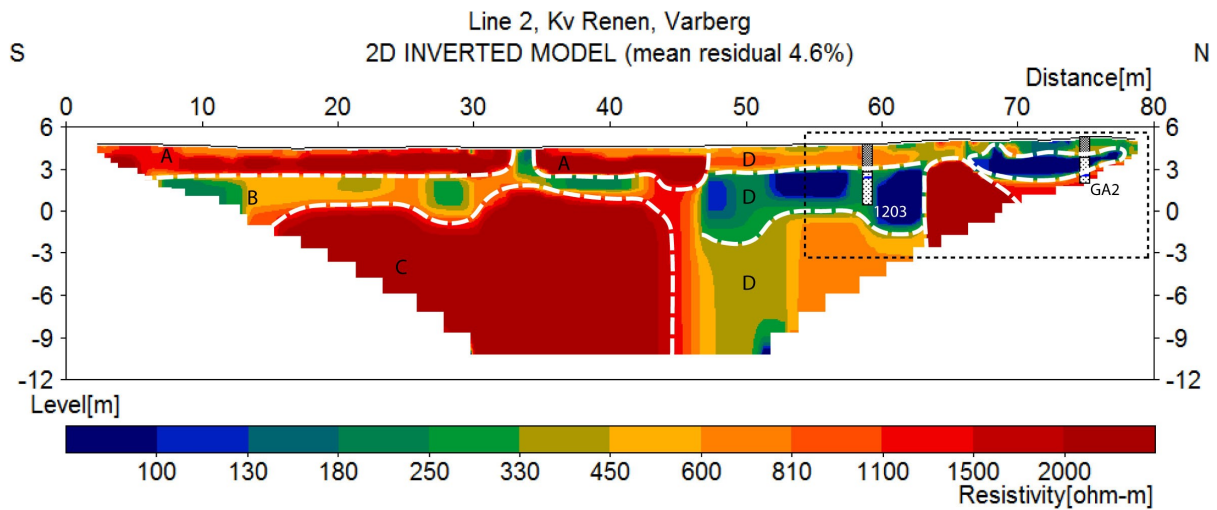
Fig. 32. Three main horizontal layers A, B and C are marked in the southern part of the profile. At approximately 45 m into the profile, unit C disappears. The area marked D is also divided into three layers with a less certain border between the lower two. The black dashed square marks the area where a closer zoom is shown in figure 33

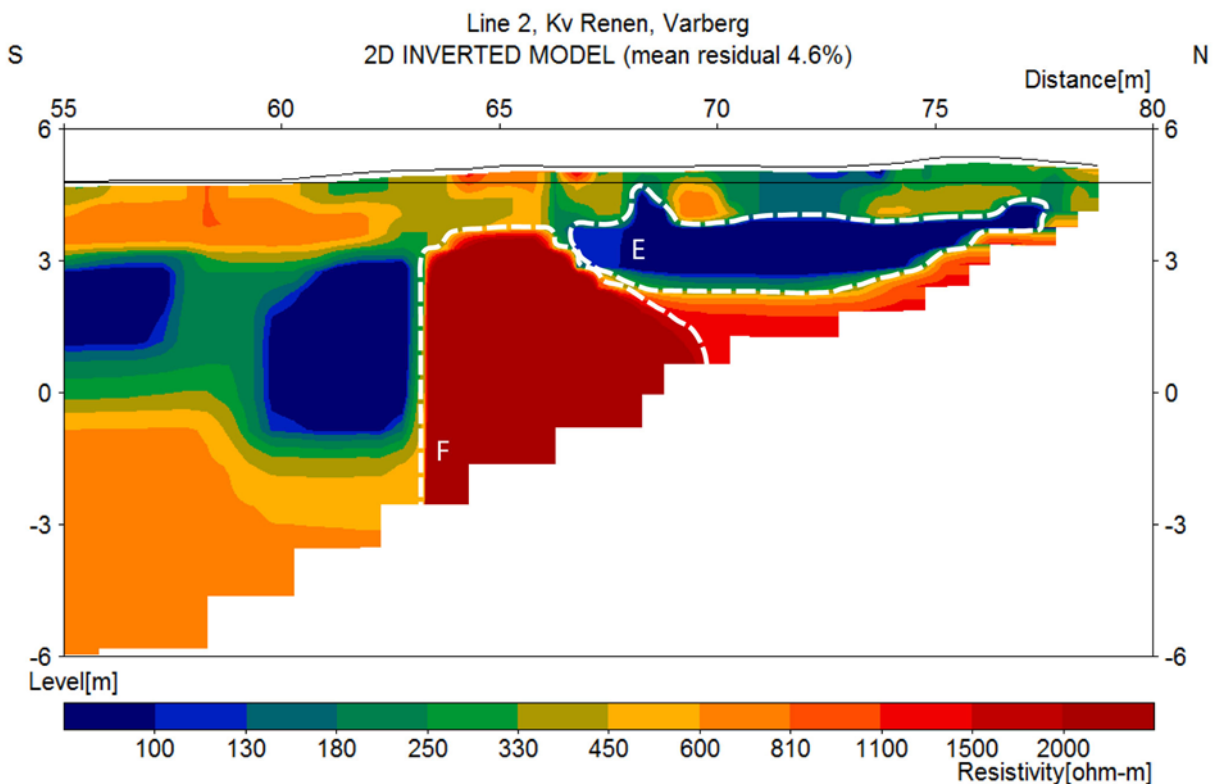
Fig. 33. A closer view of line 2, correlates to the dashed square in Fig. 32. Anomaly E is a strongly delimited structure with a low resistivity value. F has high resistivity values and is in the north not so well defined.

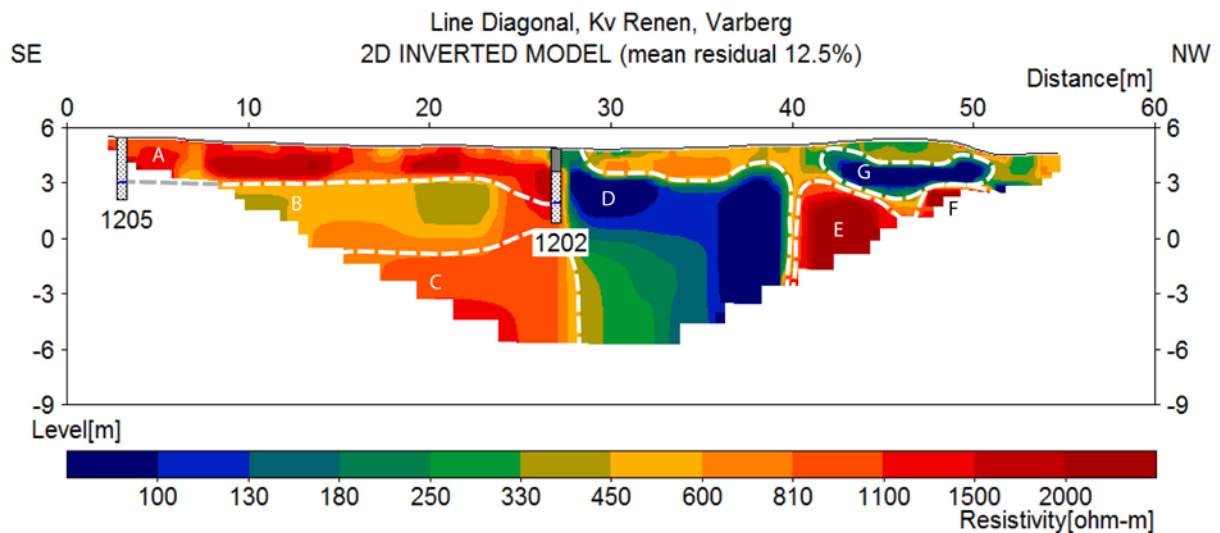
Fig. 34. The Diagonal DC-profile is shown in the figure. The patterns are similar to those in line 1a and line 2. However, there is an extra unit (F) identified. Note the orientation of the profile, from the left part of the figure showing the south-east and to the right, the north-west.

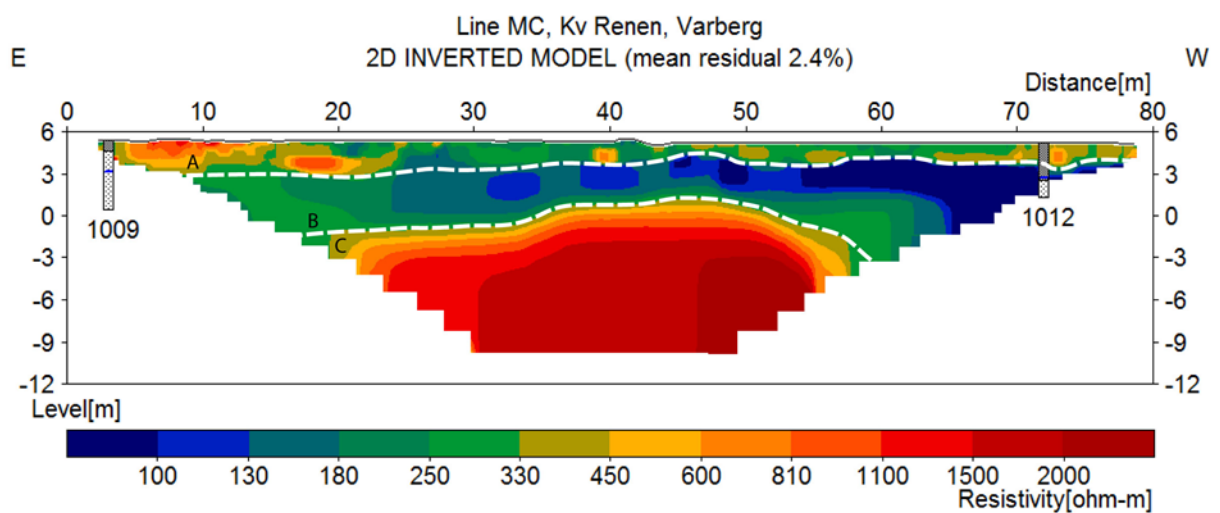
Fig. 35. This DC-profile for line MC located outside the estate, northwest of, Kv. Renen 13. The three main horizontal layers are distinct here, and unit B increases in thickness westwards. Note the orientation of the profile, from east to the left of the figure and towards the west in the right hand side.

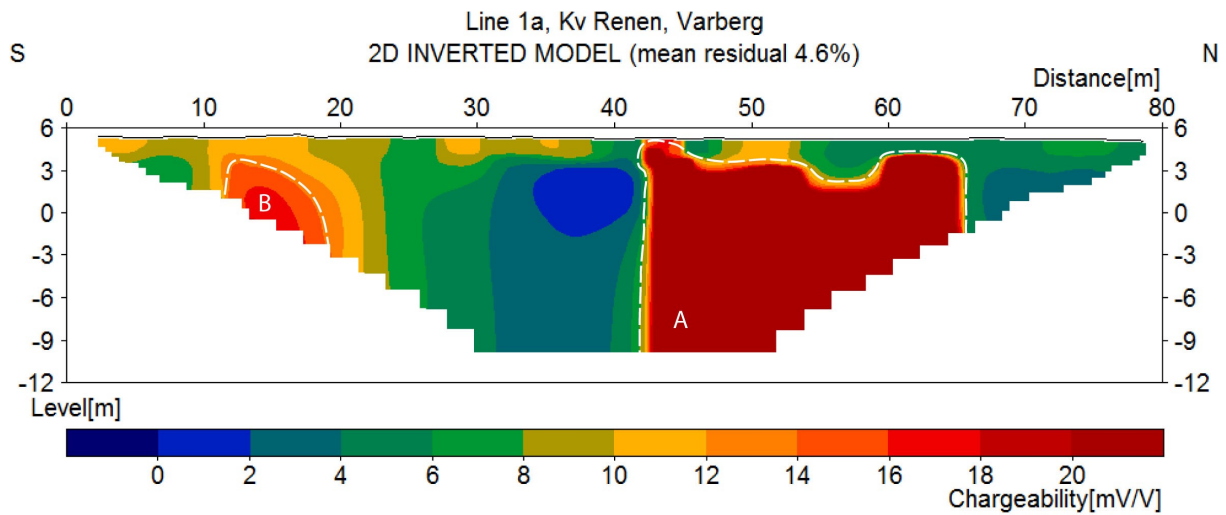
Fig. 37. IP-Profile for line 1a shows one large anomaly (A) between 45-65 m with extremely high chargeability. The smaller anomaly, B, is identified in the southern part of the profile, between 10-20 m.

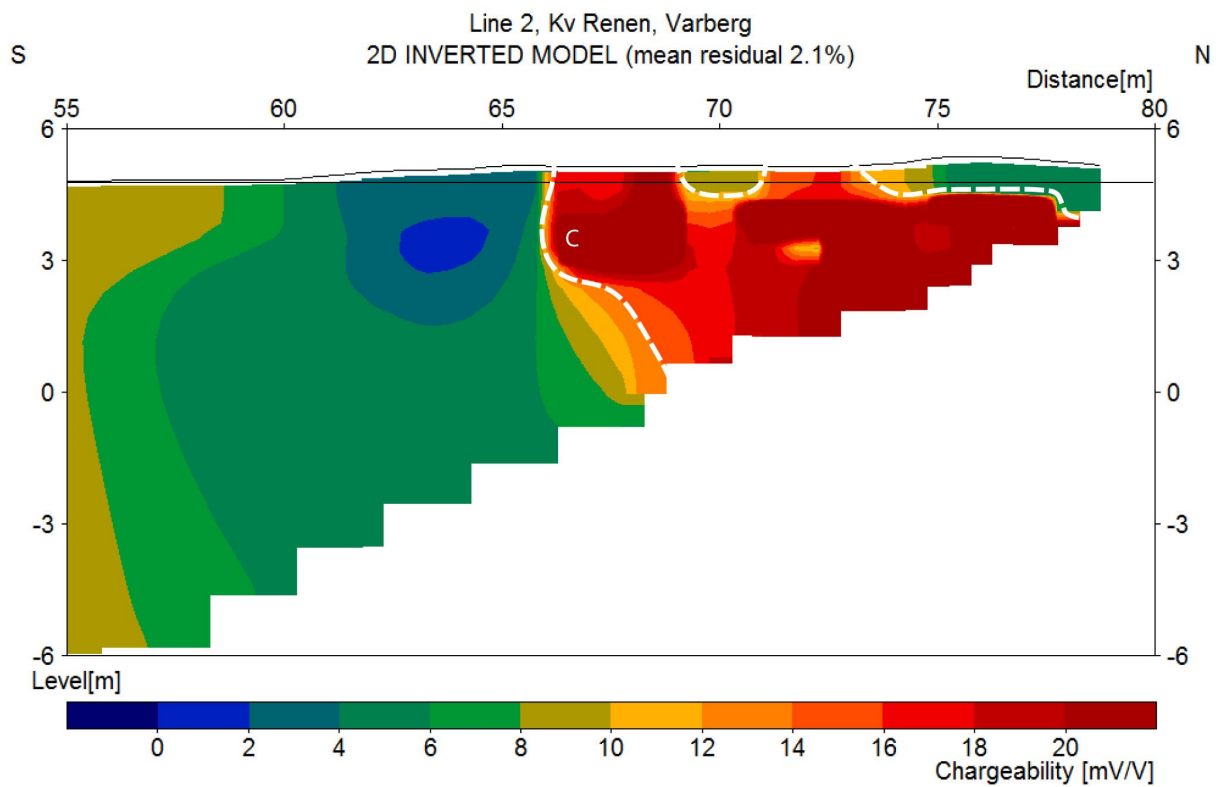
Fig. 38. A close-up of the interesting part in IP-profile of line 2; an anomaly (C) with high chargeability is identified, and appears at 65 m and covers the measured space towards the northern end of the profile.

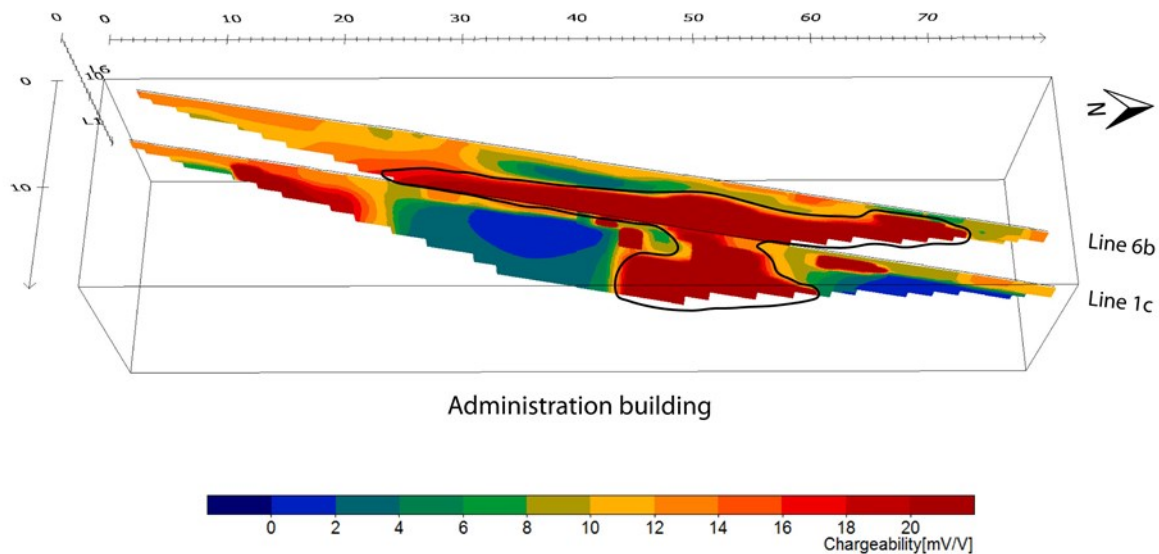
Fig. 39. The IP profiles measured in February, called line 1c and line 6b. Both profiles have an anomaly with high chargeability. Note that north is towards the right hand side in the picture. It is presented this way to optimize the visualization of the most interesting features in the results.

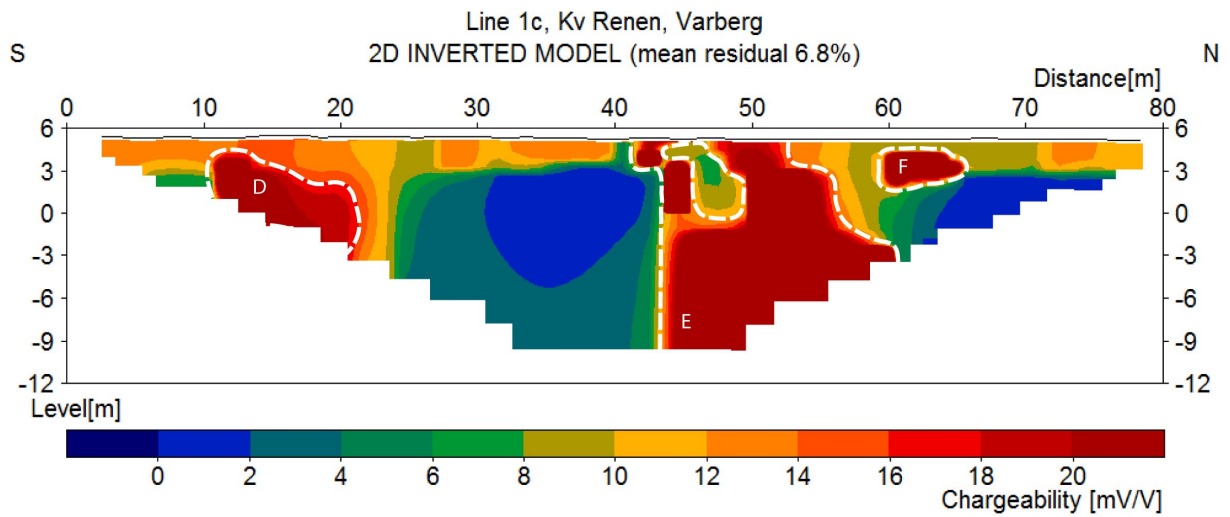
Fig. 40. The IP-profile from line 1c has three anomalies where high chargeability is identified, one in the southernmost of the profile (D), a large area (E) in the middle and one smaller isolated (F).

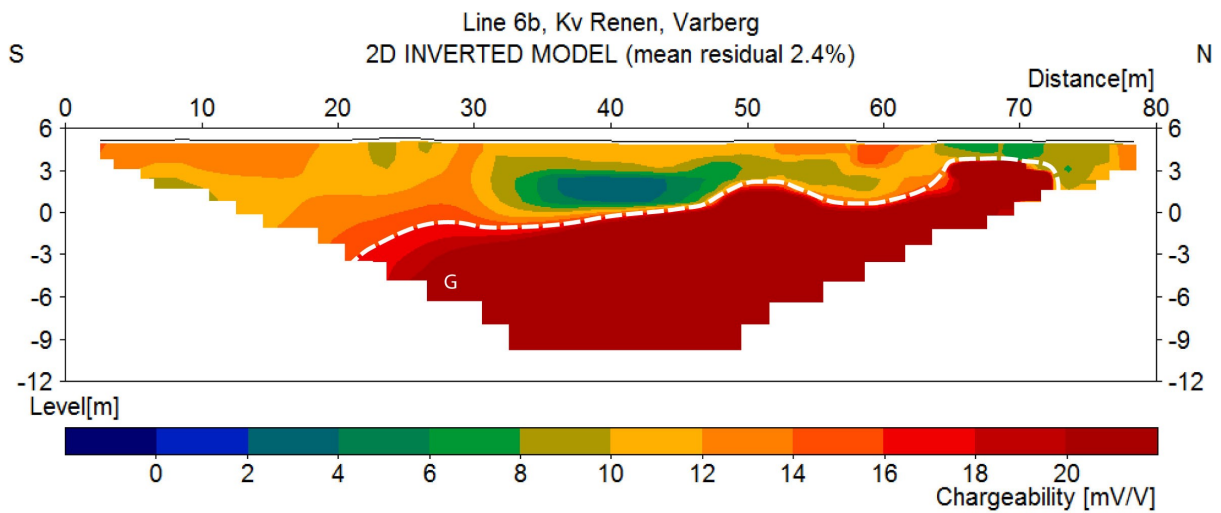
Fig. 41. IP-profile line 6b has one large anomaly identified at depths varying between +3 to -3 m a. s. l. smoothly sloping from the north towards the south.

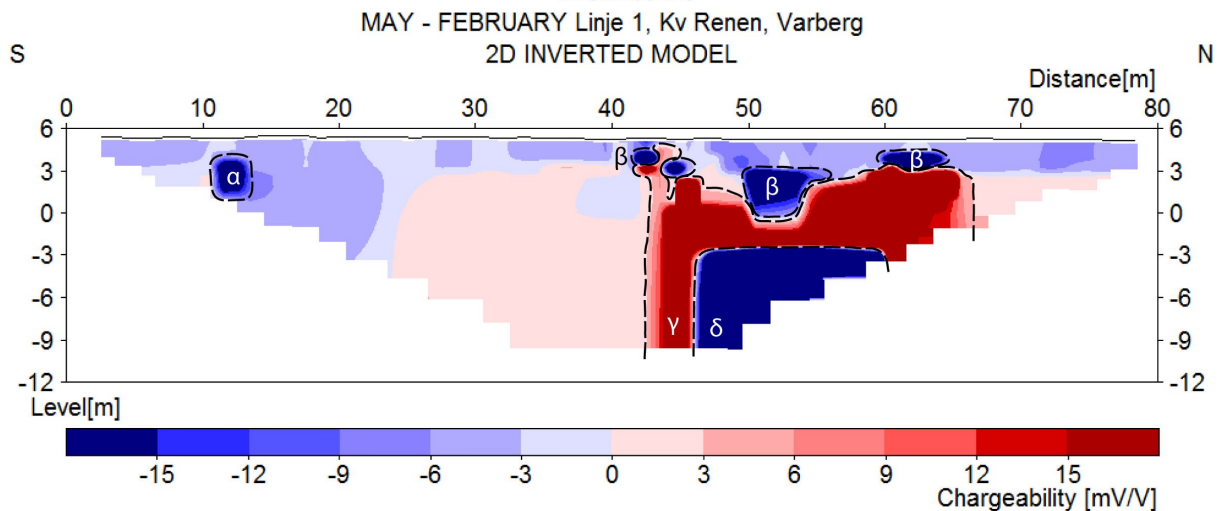
Fig. 43. Time-lapse data for the IP profiles measured along line 1 (see map in Fig. 23), where the IP-result acquired in May 2014 have been subtracted from the IP-result (inverted values) from February 2015. From the results, we can see that the anomaly has been reduced in extent from May (2014) to February (2015).

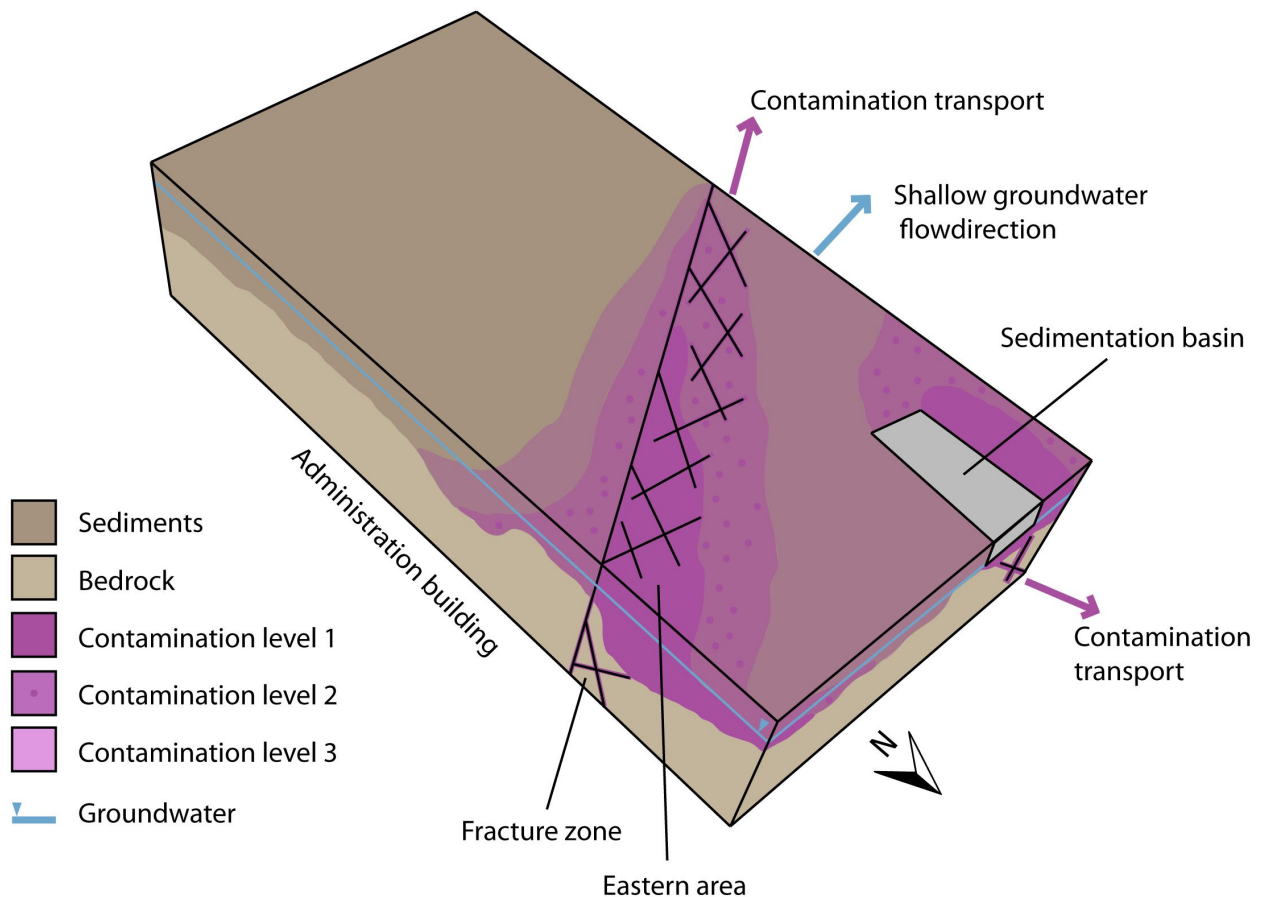
Fig. 45. A conceptual model of Kv. Renen 13, based on previous knowledge and new data collected within this work. Two primary zones with high contamination levels are detected, in the eastern source area and by the sedimentation basin, with lower levels in between and around the plumes. The interpreted fracture zone is in a southwest-northeast direction, and is marked and interpreted as a pathway of dispersal. Note the fracture zone beneath the sedimentation transporting pollutants in a NNW direction.

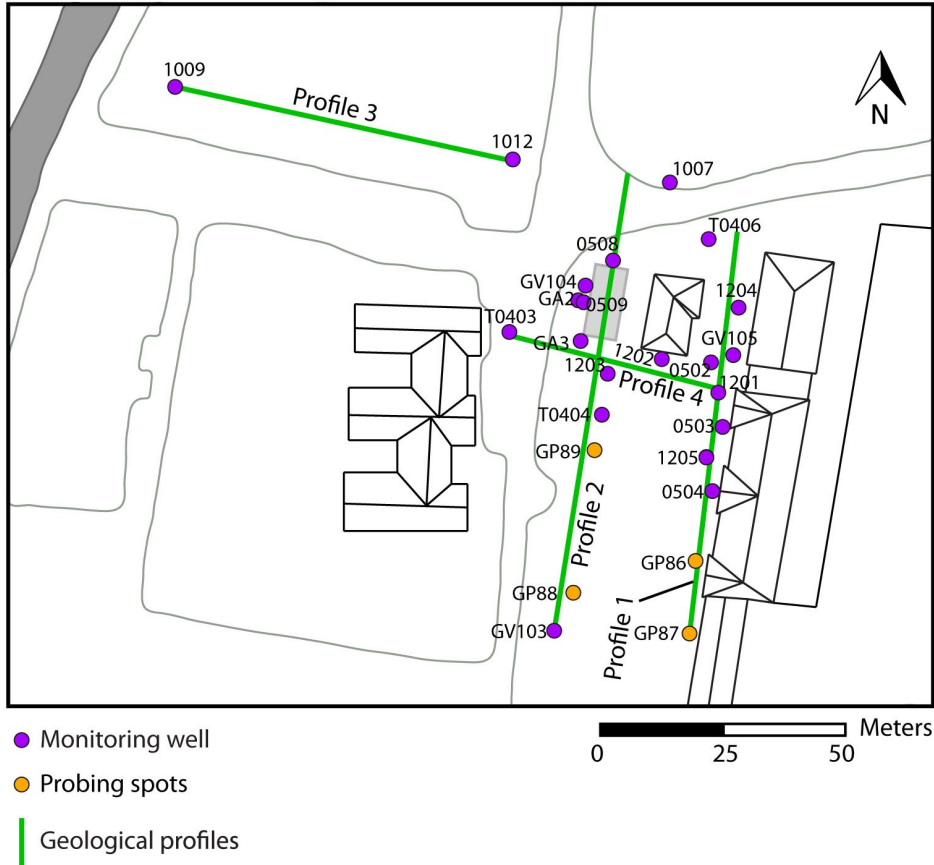
Into Fig. 1 is a detailed view given of the geological profiles location and name of used wells.
