## Meeting the challenges related to material issues in chemical industries

BALDEV RAJ, U KAMACHI MUDALI, T JAYAKUMAR,  
K V KASIVISWANATHAN and R NATARAJAN

Materials, Chemical and Reprocessing Groups, Indira Gandhi Centre for Atomic Research, Kalpakkam 603 102, India  
e-mail: [dmg@igcar.ernet.in](mailto:dmg@igcar.ernet.in)

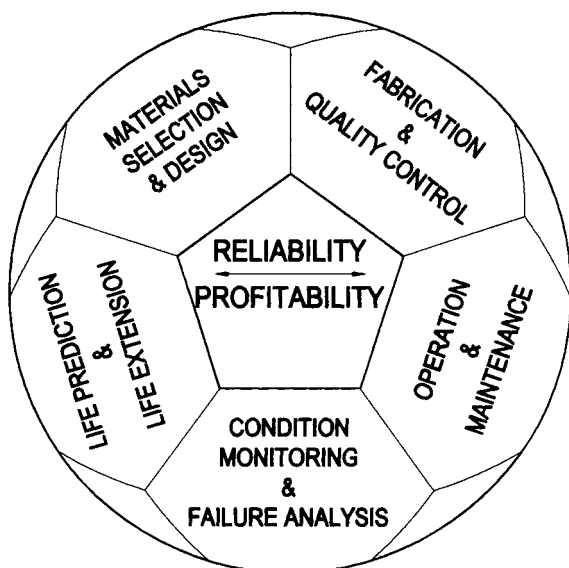
Figure 1. Factors affecting reliability and profitability of chemical industries.

As we enter the new millennium, several chemical industries set up in the past few decades will be subjected to design and technological changes, and associated economic constraints. Addition of larger, more automated, highly sophisticated and complex components will become necessary. Issues of life estimation and extension of existing plants have to be addressed to overcome the loss in production and to conserve raw materials. As new plants are constructed and existing plants modernised and automated, every possible effort is needed to cut costs and increase efficiency, and in this way increase profits. Maintenance of components becomes increasingly expensive and complex due to several advances that have taken place by way of modernisation or for increasing profitability, and for avoidance of unexpected failure of critical components. As a consequence, maintenance is increasingly critical, downtime of the plant is less tolerable and reliability and safety of the equipment/components become increasingly important. Materials, techniques and methodologies that offer greater benefits in the way of higher output, efficiency, improved availability, increased safety and lower maintenance are being constantly incorporated in strategic life-cycle management of several chemical plants. Monitoring the condition of the operating chemical plant is of increasing importance with growing awareness of the need to obtain the best possible financial return by demanding the highest levels of reliability of the components. Reliability is the ability of a component to perform a required function under stated conditions for a stated period of time. It is difficult to separate reliability and maintenance, as there are no components which are perfectly healthy under plant-operating conditions. Every component in the plant undergoes some kind of corrosion, wear, fracture, cracking, surface degradation, loss in conductivity, magnetism etc. during service. Hence, prior knowledge of the reliability of each component/equipment is of paramount importance in scientific maintenance planning. Both reliability and profitability can be achieved by careful attention to a few most important factors, namely, materials selection and design, fabrication and quality control, operation and maintenance, condition monitoring, failure analysis, life prediction and life extension. Judicious and current technology-weighted attention to these factors leads to achieving greater reliability and profitability of chemical plants (figure 1).

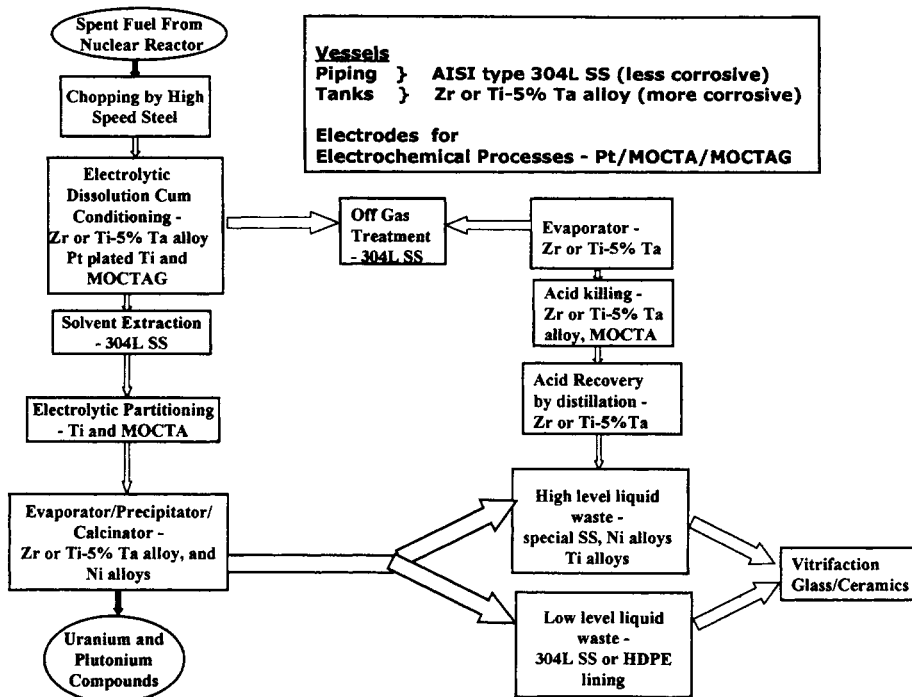
Figure 2. Materials requirement for various unit processes in nuclear fuel reprocessing plants.

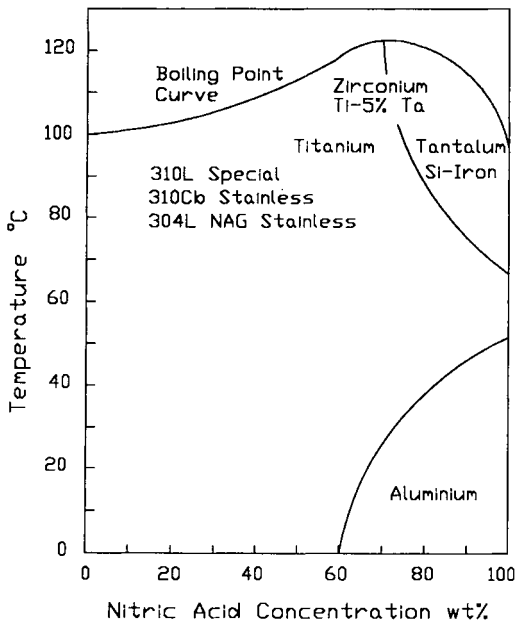
Figure 4. Advanced materials selection for nitric acid service.

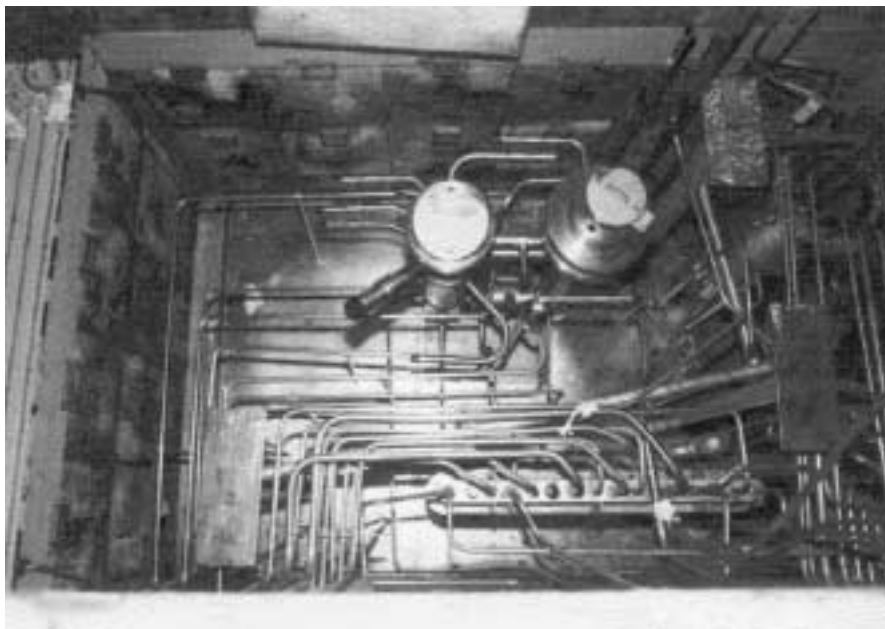
Figure 11. Photograph showing titanium dissolver assembly with piping.

temperature to avoid overheating of the clad portion which otherwise may lead to opening up of the bonded area. A completely fabricated and erected electrolytic dissolver system for the dissolution of the spent fuel from FBTR at the operating area of the Reprocessing Group is shown in figure 11.

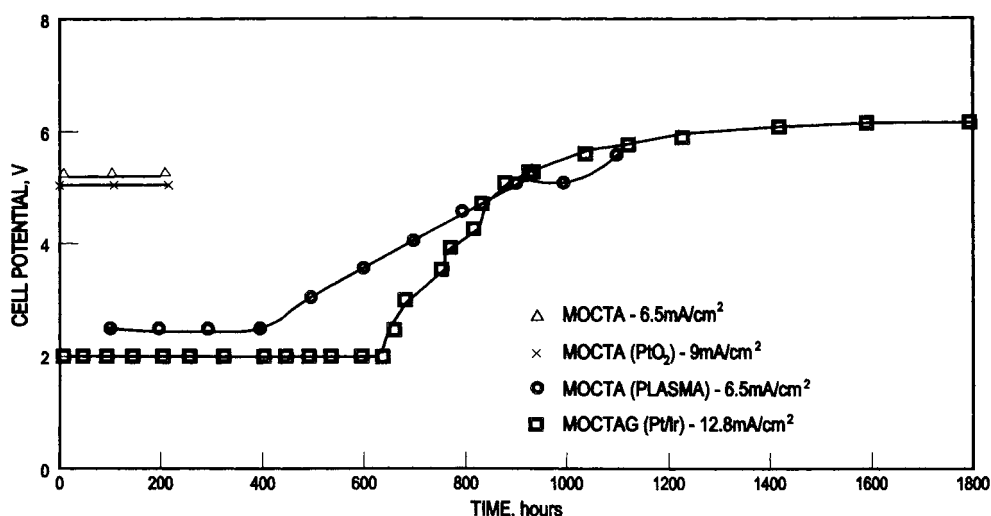
Figure 12. Life evaluation of various electrode materials in simulated boiling reprocessing solution containing nitric acid.

plasma-modified MOCTA (PMMOCTA) electrodes with smooth and compact coating of oxides (figure 13), with an excellent life of 1460 h during electrolysis in a boiling nitric acid solution (figure 12).

reprocessing boiling nitric acid (10 N) test solution containing uranium and other redox ions showed excellent performance of the Pt-Ir layered electrode up to 1850 h at 12.8 mA/cm<sup>2</sup> without any failure (figure 12). 'MOCTAG' electrodes produced by this method possess higher electrocatalytic activity at the surface, with better adherence of the coating in comparison with conventional MOCTA electrodes.

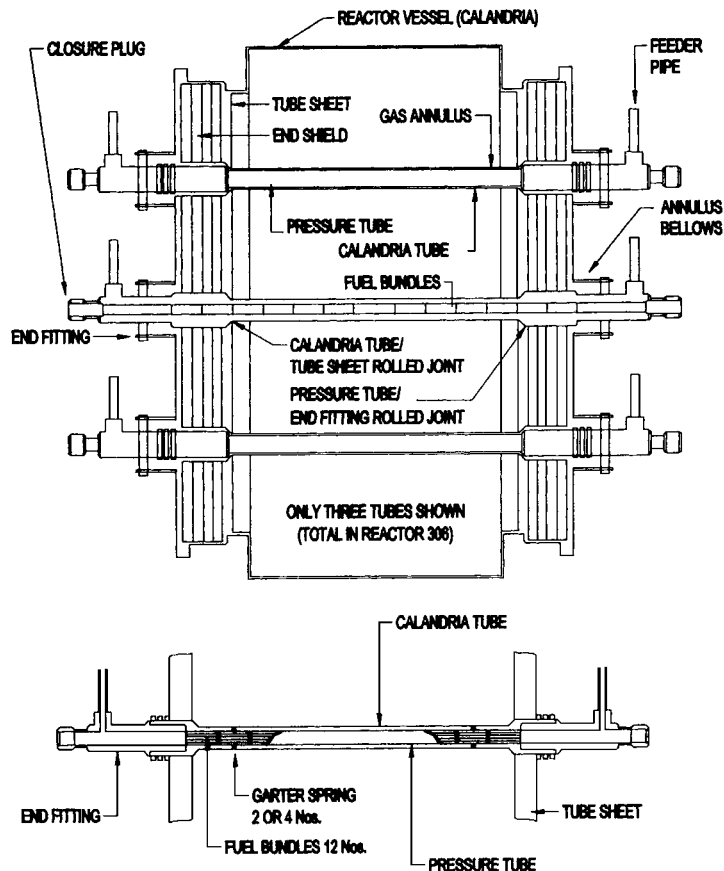
Figure 17. General layout of the coolant channels assembly and the associated components of a PHWR.

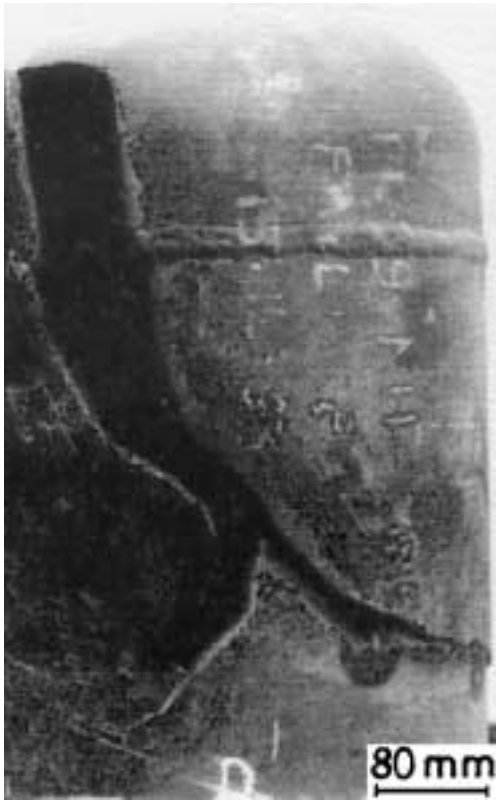
Figure 22. Photograph showing the failed ammonia refrigerant condenser.

Catastrophic failure of an ammonia refrigerant condenser tube (figure 22) was noticed within three hours of its operation in a chemical plant (Kaul et al 1996). The concerned component was a 370 mm diameter pipe (with wall thickness of about 11 mm) with its end welded to a hemispherical dished end (with maximum wall thickness of about 15.9 mm near the weld). The welded component formed the dead end of the pipe line. During its brief operating life, the component was filled with ammonia and the internal pressure dropped from 0.1 MPa to the final pressure of 0.04 MPa while the temperature correspondingly decreased from 270 to 241 K. The pipe was welded to the dished end by SMAW using AWS E 6013 electrodes. The welded pipe was hydrostatically tested at a pressure of 3.2 MPa before putting it into operation. No radiographic examination was carried out on the welds. The materials of construction of the concerned pipe and dished end were reported as API 5L Grade B and A 234 (WPB) (equivalent to A106 Gr. B) respectively. The nominal chemical composition of these materials (in wt.%) is as follows: Pipe: 0.25 C/0.95 Mn/0.06 S (max.)/0.05 P (max.); Dished end: 0.30 C/0.29-1.06 Mn/0.058 S (max)/0.048 P (max).

Visual examination of the failed component revealed that the pipe to dished-end weld was associated with non-uniform penetration. X-radiographic examination of the welded component showed lack of fusion area almost throughout the length of the weld. The weld joint was poorly designed as the tapered transition provided at the joint between sections of

In the light of the evidence gathered during the course of the investigations, it is clear that the failure of the condenser tube started from lack of penetration area of the pipe to the dished end weld. Hydrogen absorbed at the time of welding helped in initiating the crack under the possible influence of weld residual stresses. Welding with AWS E 6013 electrode containing large amounts of cellulose in its coating is primarily responsible for formation and subsequent absorption of hydrogen in the weld puddle. During cooling of the weld metal, hydrogen solubility in matrix drops abruptly and hydrogen, in the supersaturated state, diffuses to the regions of high stress concentration (like a sharp lack of penetration area) where it can initiate a crack. This is believed to take place during storage of the component after welding. Poor weld toughness at the low temperature during start up facilitates easy crack growth and culminates in catastrophic failure as soon as the crack attains the critical length. The cause of this failure is due to improper selection of welding consumables and fabrication procedures.

It is recommended that: (i) low hydrogen electrodes (like AWS E 6016, 6018 etc.) be used for pipe to dished end weld to reduce the risk of hydrogen embrittlement as well as to improve low temperature toughness of the weld metal; (ii) proper design of the weld joint be made to avoid stress concentration when welding sections with different thicknesses; and (iii) radiographic examination of the welded component after fabrication be done to detect weld defects.
