Giourntas, Lampros Gerasimos and Hodgkiess, Trevor and Galloway, Alexander (2015) Comparative study of erosion-corrosion performance on a range of stainless steels. Wear, 332-333. pp. 1051-1058. ISSN 0043-1648 , <http://dx.doi.org/10.1016/j.wear.2014.12.052>

Comparative study of erosion-corrosion performance on a range of stainless steels

L Giourntas^a, T Hodgkiess^b, A M Galloway^a

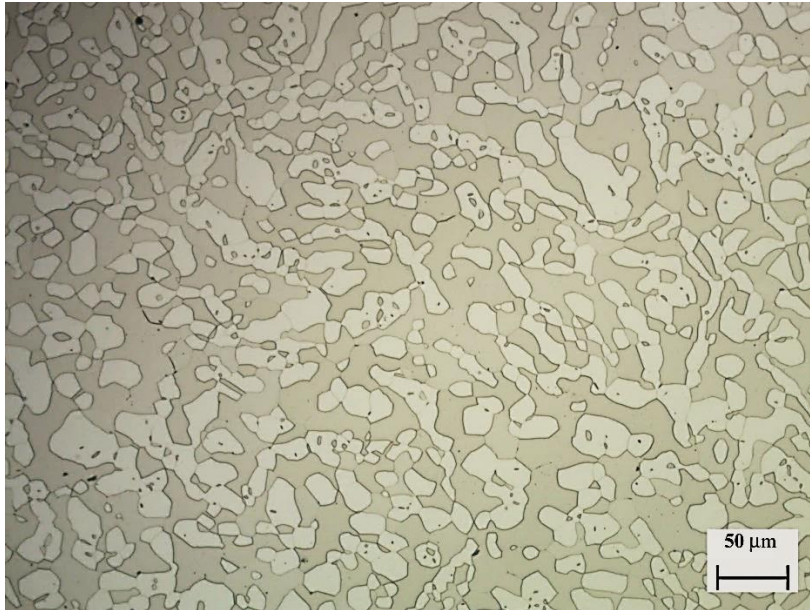
Figure 2. Ferrite matrix and austenite grains in UNS S32760

Micro-structural analysis, with an Olympus GX51 microscope, was completed prior to testing to identify the different structures of the steels. Figures 1-5 display the structures of the steels after polishing to 3 μ m diamond and either etching in Nital (for the carbon steel) or electrolytic etching with 10% oxalic acid for the stainless steels.

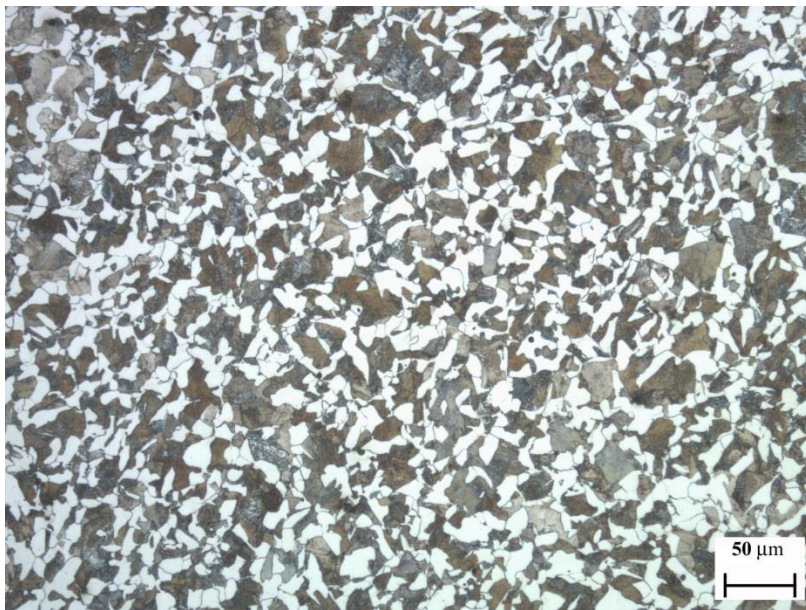
Figure 5. Typical ferrite/pearlite structure of medium carbon steel in UNS G10400

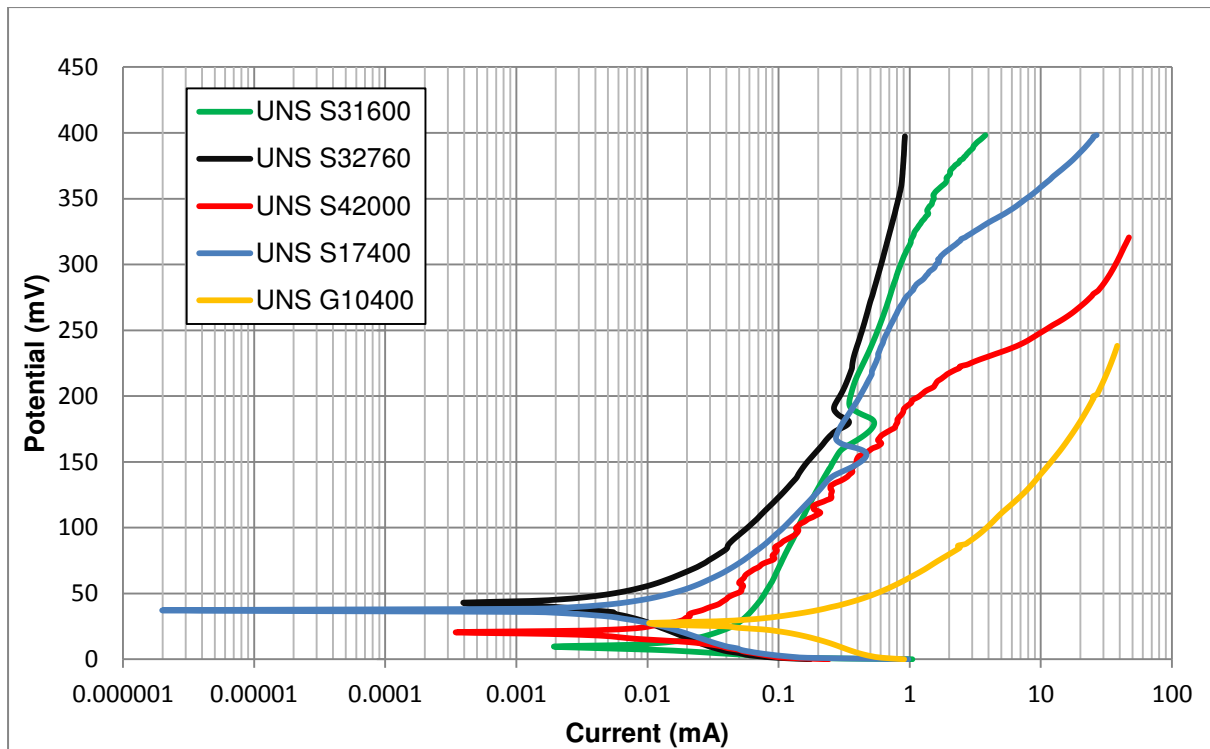
Anodic polarisation scans were conducted on all the tested materials in static corrosion conditions and also in solid/liquid impingement. The results are presented in Figures 9 and 10 in which the starting electrode potentials have been normalized to zero in order to facilitate comparisons between the various alloys. As Figure 9 shows the carbon steel displayed rapidly rising current (typical of active corrosion). In contrast, the stainless steels exhibited much lower currents; this is typical of corrosion resistant materials.

Figure 9. Anodic polarisation sweeps under static corrosion conditions.

Anodic polarisation scans in static conditions show that stainless steels exhibit very low corrosion rates in comparison to the medium carbon steel that was corroding actively at relatively high rates. This is an expected observation, since it is well known that high chromium content (>12% Cr) causes the formation of a passive film that protects the metal against corrosion. With addition of solid particles, the environment becomes more severe and the stainless steels fail to maintain their protective film which results in enhanced corrosion rates but which are, nevertheless, much lower than those of the medium carbon steel. The current fluctuations, as the potential sweeps to more positive values, demonstrate the capacity of the stainless steel to periodically reform its film in between de-passivation events caused by the erosive particles. It is apparent that the improved corrosion resistance of superduplex stainless steel in static conditions is also a feature in erosion corrosion environments. A correspondence between alloy chromium content and corrosion rates in erosion corrosion conditions is evident in Table 4.

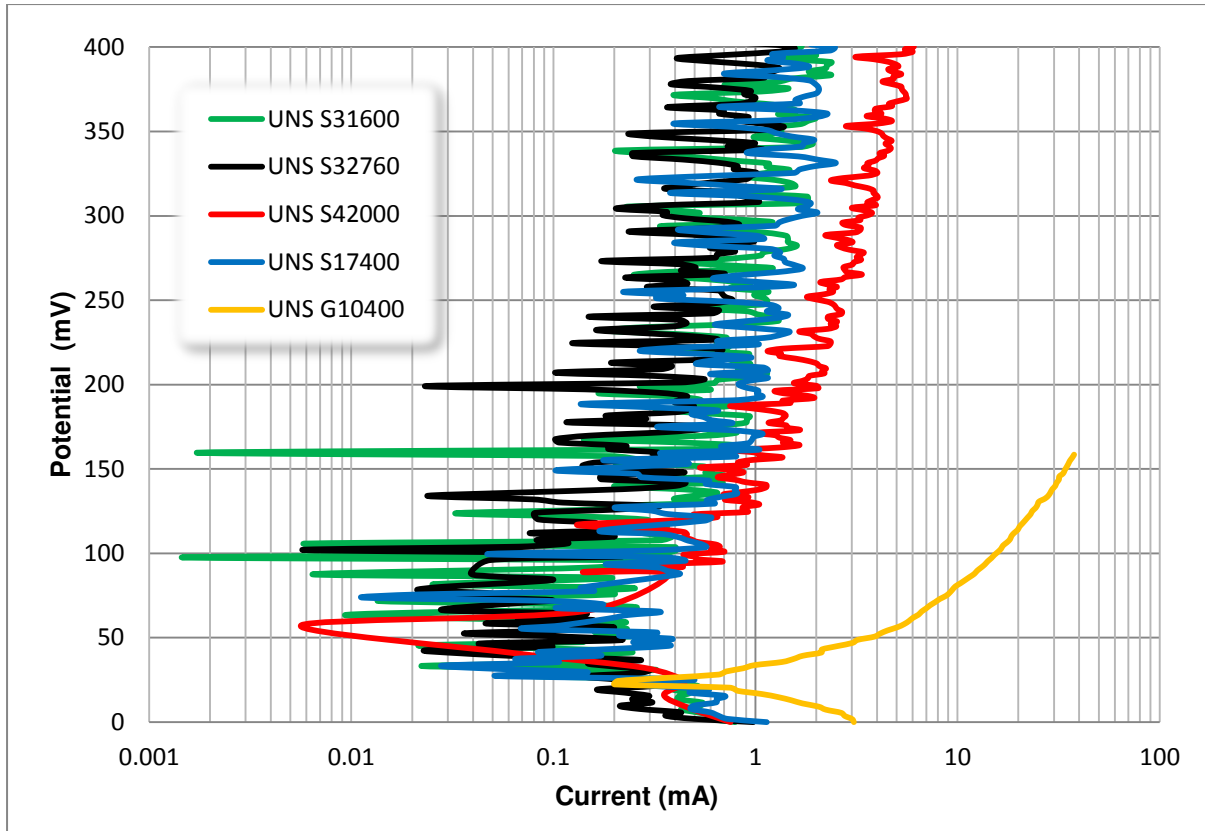
Figure 10 demonstrates the anodic polarisation sweeps of all the materials during solid/liquid impingement. The behaviour of all the materials altered significantly under these conditions. The medium carbon steel sustained its active behaviour but it was corroding at a higher rate. The stainless steels, displayed considerably higher currents than in quiescent water because of the passivity breakdown due to the presence of 200ppm silica sand particles. The rapidly oscillating currents are indicative of periodic de-passivation and re-passivation events.

Figure 10. Anodic polarisation scans under solid/liquid impingement.

Tafel extrapolation was used to generate the corrosion currents for all tested metals under solid/liquid impingement. The extrapolation of the stainless steels' scans involved plotting a straight line running approximately through the maximum of the oscillating currents. The resulting corrosion currents in milliamperes are presented in Table 4.

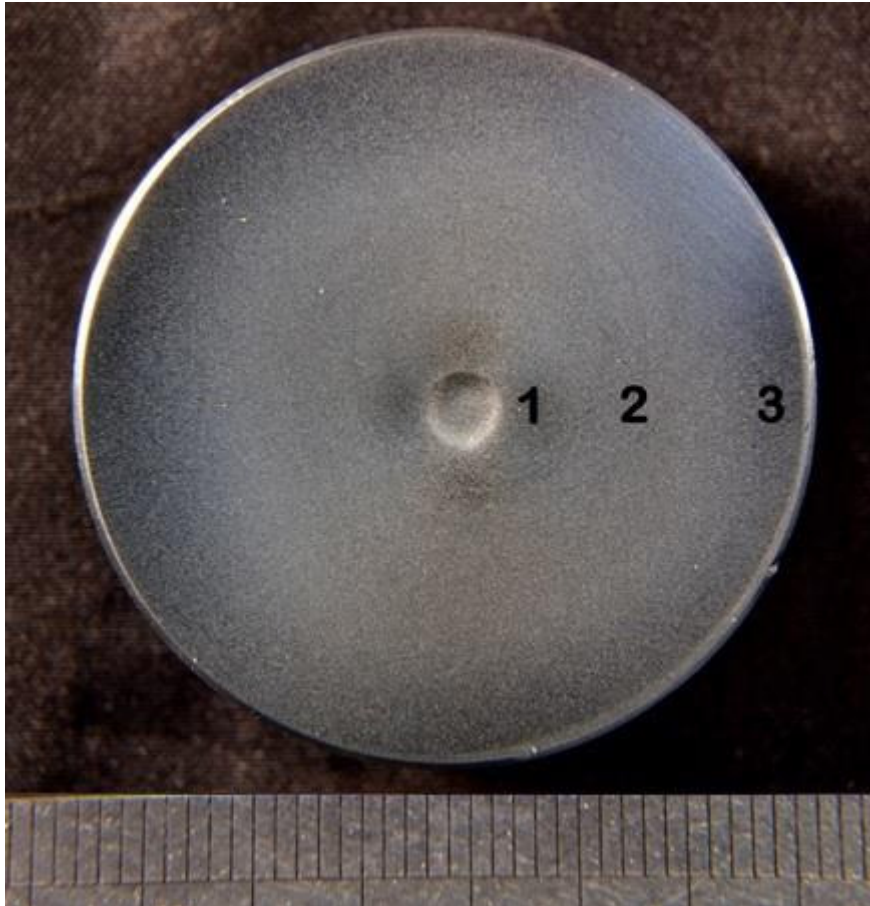
Figure 11 shows the typical post-test surface of all materials. The deep wear scar under the impinging jet is evident together with a number of other surface deterioration regions outside the wear scar. Figures 12-14, representative of all the materials, show the microscopical structure of UNS S31600 of the three zones marked 1, 2, and 3 on Figure 11. The turbulent area was present immediately adjacent to the wear scar. Figure 12 shows that this turbulent zone (marked 1 in Figure 11) results mostly in sliding abrasion as abrasion marks are displayed following the flow direction. Figure 13 demonstrates the region next to the turbulent zone (marked 2 in Figure 11), referred to herein as the severe outer area. The severe outer area exhibited less turbulence which resulted in less abrasion. The outermost region of the specimen (marked 3 in Figure 11) displayed the least surface degradation as is clear from the appearance of the surface preparation grinding scratches, as shown on Figure 14.

Figure 11. Surface of UNS 31600 after solid/liquid impingement with the three different regions beyond the wear scar.

The surface roughness measurements (Table 5) established that the region immediately outside the wear scar (Figure 11) is relatively turbulent in agreement with general opinion of the hydrodynamics of a submerged jet and supported by CFD models [8]. The large diameter of the specimens helped to assess more extensively the wear mechanisms occurring outside the wear scar and exhibited three discrete areas of progressively diminishing roughness starting from the most turbulent region. A particularly interesting feature is that these outer deterioration zones displayed similar roughness in all metals even if they were different in terms of hardness, ductility and strength. It is thus apparent that the mechanical properties of the steels studied herein did not reflect in any significantly different resistances to 0° angle abrasion.

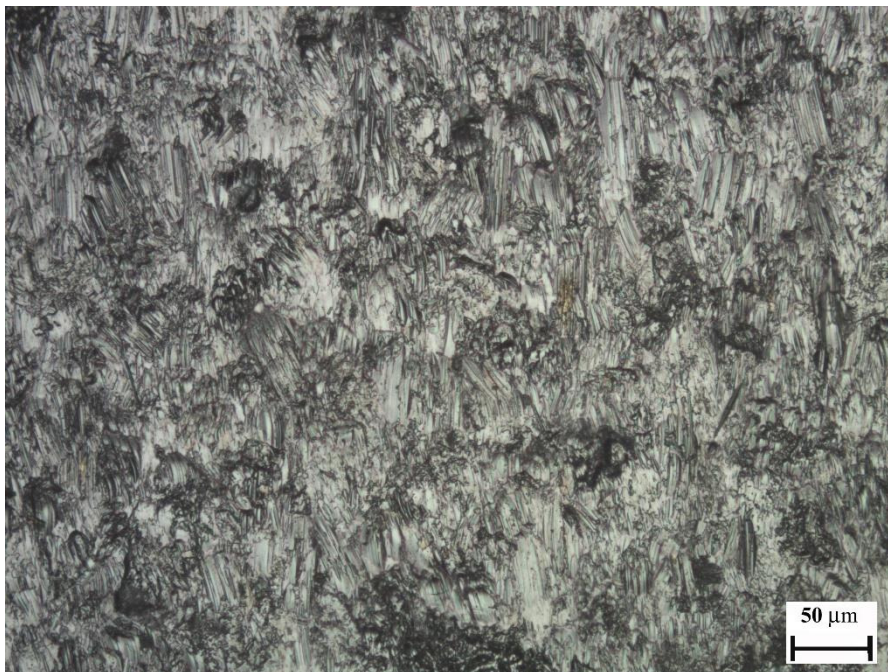
Figure 12. Turbulent area (1) of the UNS S31600 with abrasion marks after solid/liquid impingement.

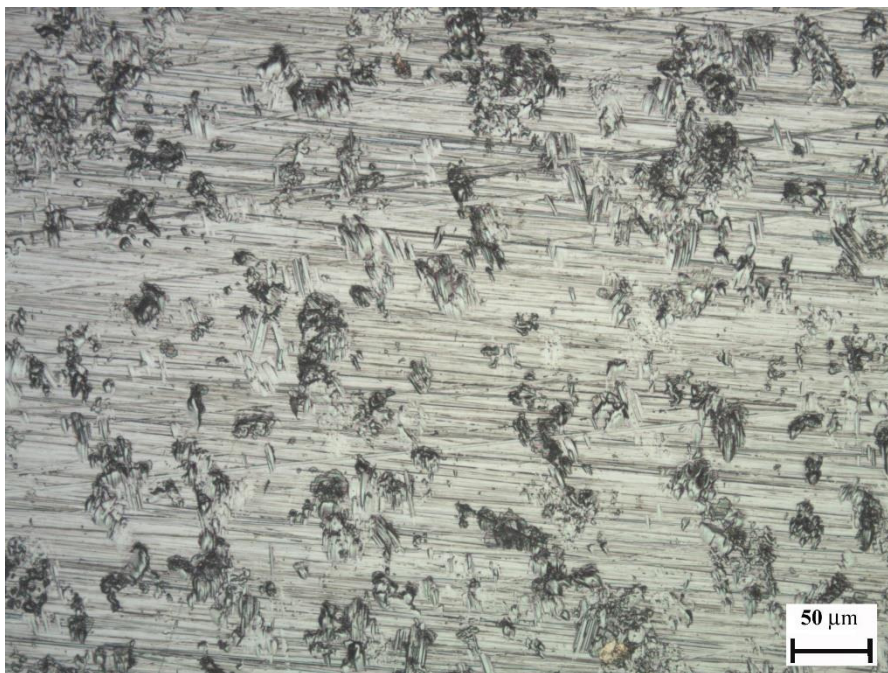
Figure 14. Outermost area (3) of the UNS S31600 after solid/liquid impingement.

An additional feature for the medium carbon steel was the presence of corrosion damage. This is clearly shown by comparison of Figure 14 and Figure 15. The latter shows that the surface preparation scratches have been obliterated by severe surface damage.

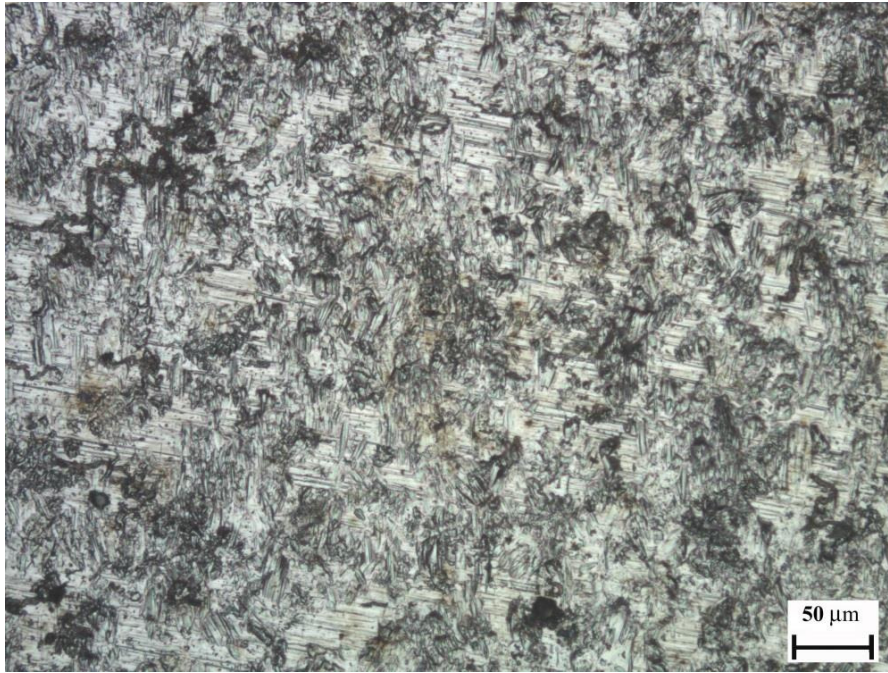
Figure 15. Outermost area (3) of the UNS G1040 after solid/liquid impingement

In regards to the effect of corrosion on the outer areas, the stainless steels behaved as expected with no corrosion products on the surface. On the other hand, the medium carbon steel had poor

performance against corrosion as there were copious corrosion products outside the wear scar. It is clear that the corrosion occurred on the metal surface was mostly general corrosion as there was no evidence of localised corrosion attack.

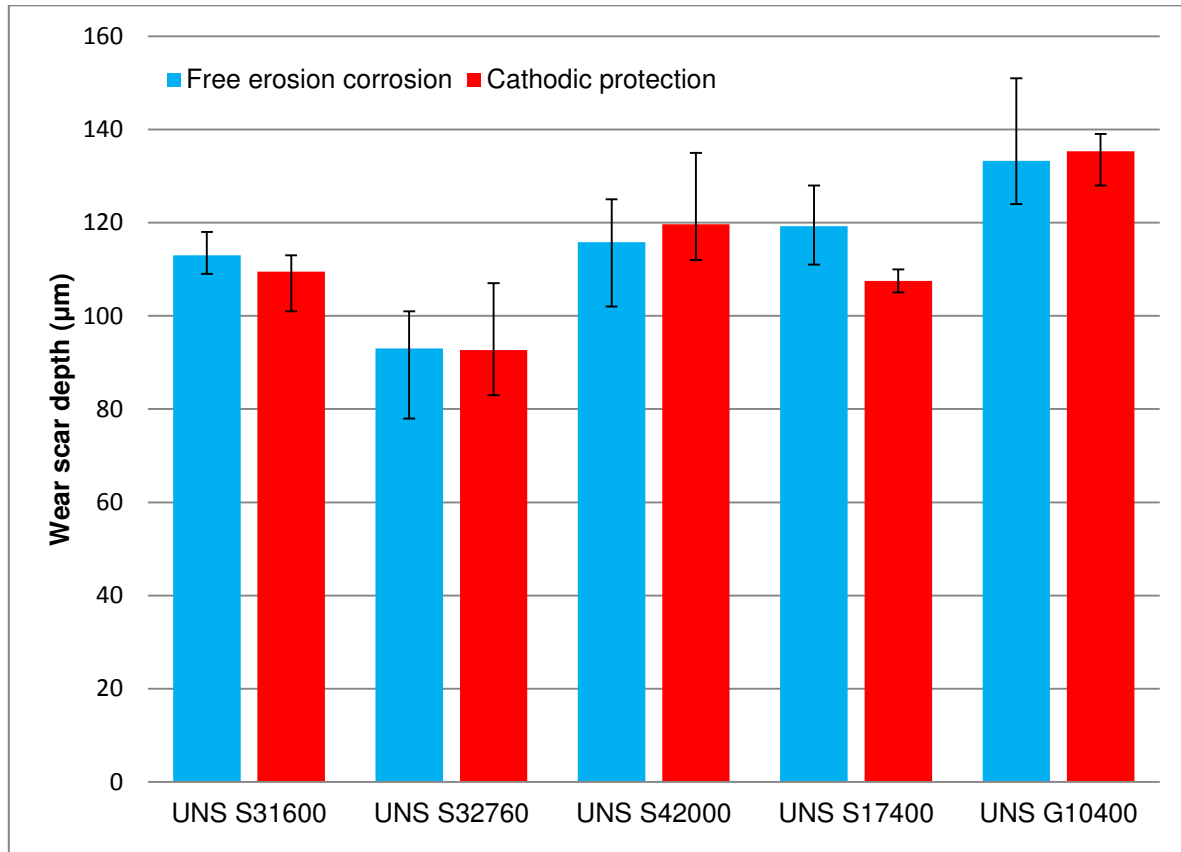
Figure 17 shows the wear scar depths of all the studied materials with and without cathodic protection. It is clear that the superduplex stainless steel exhibits the lowest wear scar depth which implies that it had superior performance. The other comparative materials have similar wear scar depths in both environments. A very interesting feature is that the application of CP has not generally resulted in significant reduction in wear scar depth, which demonstrates that the damage within the direct impinged zone is erosion dominated.

Figure 17. Wear scar depths of the studied materials in erosion corrosion conditions with and without cathodic protection.
