Bezuayehu Tefera and Geert Sterk

# Hydropower-Induced Land Use Change in Fincha'a Watershed, Western Ethiopia: Analysis and Impacts

*The present article analyzes the land use dynamics caused by hydropower dam construction in 1973 in the Fincha'a watershed (1318 km<sup>2</sup>), a tributary of the Blue Nile. Aerial photos (1957 and 1980) and an ASTER satellite*

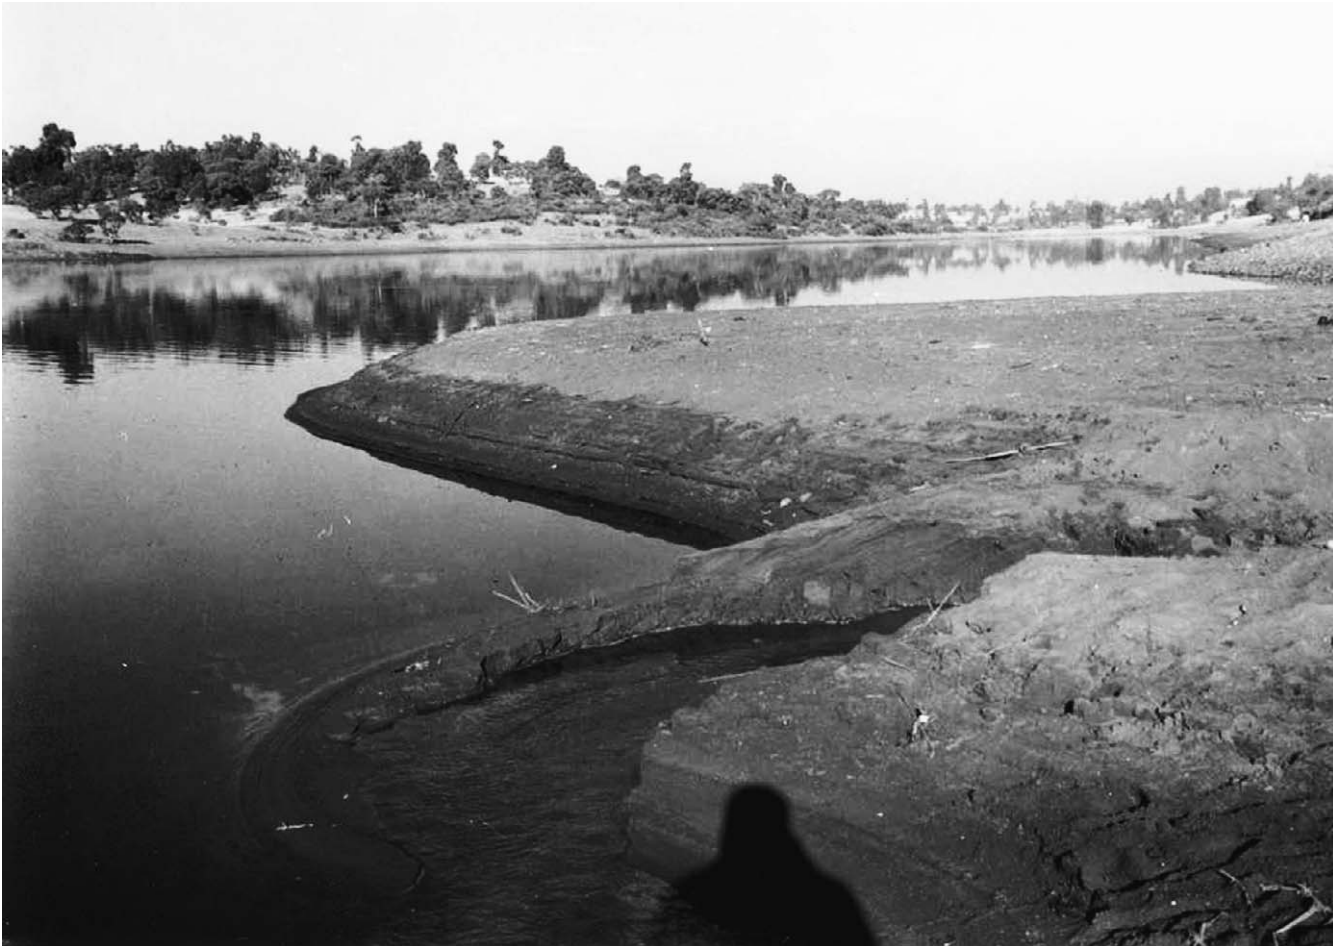
**FIGURE 5** Sediment load transported by a stream into the reservoir in Fincha'a watershed, western Ethiopia, February 2003. (Photo by Bezuayehu Tefera)

Based on susceptibility to erosive rainfall, land use in Fincha'a watershed was categorized in 4 groups: 1) areas that are bare when erosive rain occurs and are exposed to accelerated erosion (ie cropland); 2) areas that have a relatively better vegetation cover but are exposed to indiscriminate tree cutting and overgrazing (ie grazing land); 3) areas with better vegetation cover all year round but subjected to limited encroachment (ie forest); and 4) the water body and swamp. Thus, the proportion of the watershed exposed to possible maximum soil loss was cropland, amounting to 31% in 1957, 36% in 1980 and 46% in 2001. This shows that the area potentially subjected to accelerated erosion increases from time to time. Indeed, rill and gully erosion are abundant forms of erosion on cropland and grazing land. Field observations showed a high sediment influx into the water body (Figure 5), which caused a reduction of the lake's surface area and volume.

Despite these signs of degradation, reforestation and soil and water conservation activities are lacking in the watershed. At the receded parts of the reservoir, many farmers have already started to grow potatoes and maize, and graze their animals. This situation was not detected using the satellite image because these practices must have started after the image was taken. The population of floating grasses growing from the floor of the lake has recently increased, perhaps due to the enhanced sediment influx. This may result in more evapotranspiration losses and reduced electric power generation.
