1 Impact of communal irrigation on the 2018 Palu earthquake-
2 triggered landslides

3 Ian M. Watkinson* & Robert Hall

4 SE Asia Research Group, Department of Earth Sciences, Royal Holloway University of

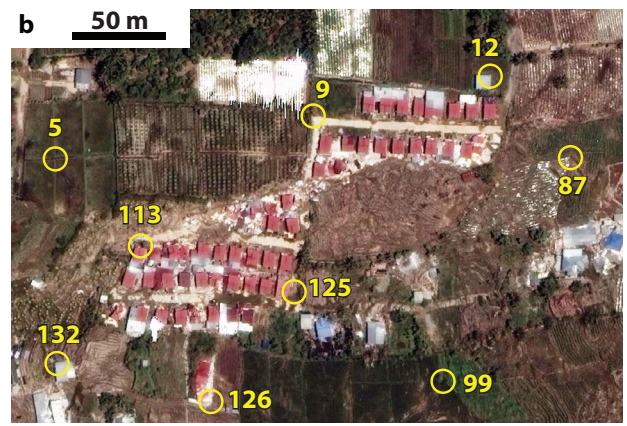
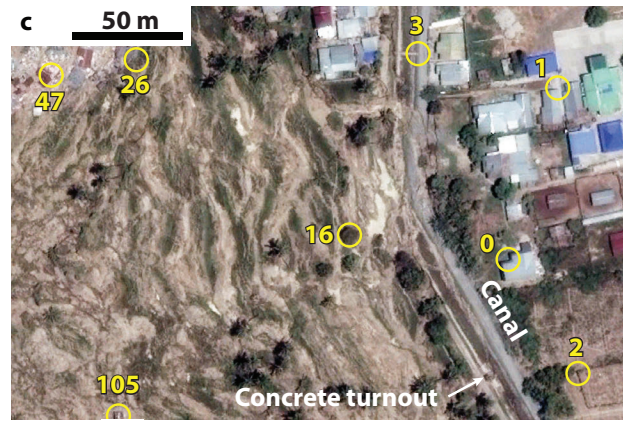
Figure 2

350 **Fig. 2: Landslides and irrigation, eastern Palu valley. a**, Simplified interpretation of
351 landslide domains, landslide-related fractures, urban areas, irrigation channels, topographic
352 contours (from 12.5 m TanDEM-X). Location in Fig. 1c. See Methods for description and
353 Supplementary Fig. 4 for full interpretation. **b**, Northern strike-slip margin, Lolu landslide.
354 Housing estate (red roofs) was originally square in plan. **c**, Extensional domain of Petobo
355 landslide, detaching along the conveyance canal. **d**, Toe thrust system of Petobo landslide,
356 highlighting shortening and coherent thrust slices. Representative tracked objects circled in
357 yellow, displacement in metres. Locations in Figs. 2a. and 3. Imagery ©2018 Google and
358 DigitalGlobe.

120 There is a striking spatial coincidence between the landslides and the irrigation system that
121 supplies Palu valley (Fig. 2, Methods and Supplementary Figs. 9 and 10). Irrigation water is

122 carried northwards along a 15-25 m wide conveyance canal that traverses west-dipping
123 alluvial fans south of Palu. Near Palu airport the canal turns 90° and narrows as it enters the
124 city. Six 3 m wide secondary canals and many smaller channels flow downslope from >21
125 engineered turnouts along the damaged section of the canal. Water enters fields via
126 distribution channels fed by concrete division boxes or artisanal systems. The density of
127 irrigation infrastructure may be a proxy for shallow water infiltration. Vegetation is healthy in
128 the irrigated area and sparse upslope of the canal (Methods and Supplementary Fig. 11).
129 The conveyance canal forms the upslope limit of all significant landslide faults and surface
130 displacements (Fig. 4a), most crown faults are localised within or at most 125 m west of the
131 canal (Fig. 2 and Supplementary Figs. 4 and 10). Average turnout frequency decreases from

132 one per 210 m at Petobo, to one per 320 m at Lolu/Sidera, to just one per 440 m south of
133 Sidera. Additionally, Petobo landslide is localised where a secondary canal from the SE
134 terminates in a distribution system, and along the axis of the canal to the city centre (Fig. 3b).
135 Small fracture systems upslope of the conveyance canal near Biromaru and the airport are not
136 associated with significant surface displacement.
137 Lolu landslide's crown lies 620 m west of the conveyance canal; however, it nucleated along
138 a smaller channel within Lolu village at the termination of a 3 m wide secondary canal (Fig.
139 3a). The crown is delimited by irrigation turnouts and a concrete division box.
