# Development and Validation of NDE Standards for NASA's Advanced Composites Project

K. Elliott Cramer, Daniel F. Perey

## ABSTRACT

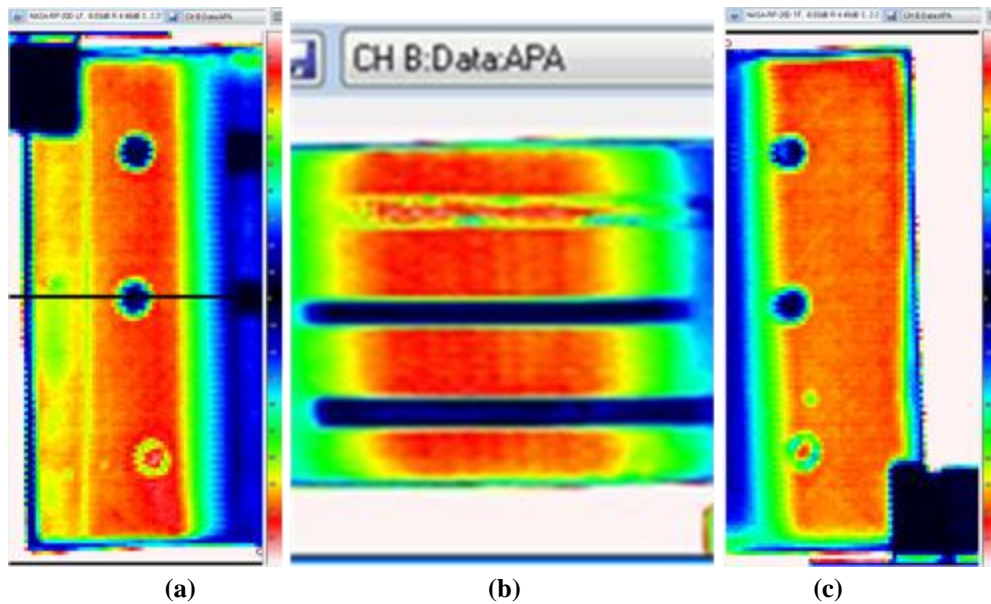
**Figure 2: Ultrasonic c-scan results from the radius corner, delamination standard shown in Figure 1 with the three scan regions indicated.**

Figure 1 shows a drawing and photographs representative of a radius/corner delamination standard, with PTFE inserts, using an IM7/8552 material system. The standard in Figure 1 was fabricated using a quasi-isotropic stacking sequence, [0/90/45/-45]<sub>3s</sub>. Figure 2 shows 3 through-transmission, ultrasonic c-scans of the 3 delamination regions

of the standard in Figure 1. The manufacturer produced the ultrasonic c-scans in Figure 2 using a 1.0 in. (2.5 cm) diameter, 2.0 in. (5.1 cm) focal length, 2.25 MHz transducer with a scan resolution of 0.030 in. (0.076 cm). The manufacturer gated the c-scan to include the back wall reflection, thus revealing the delamination at multiple depths in a single image. Figure 3 provides another example of a delamination standard. This S-curved standard contains 29 simulated delaminations, at different ply locations through the thickness, using three different types of delamination simulators: 0.001in. (0.0025 cm) brass foil coated with Frekote® mold release agent, Air Tech International release ply fabric and American Biltrite 6782 pressure sensitive tape. The standard was fabricated BMS 8-276 carbon fiber composite. The manufacturer performed validation (Figure 3d) of the standard using 1 MHz ultrasonic through transmission inspection with 0.04 in. (0.1 cm) resolution.

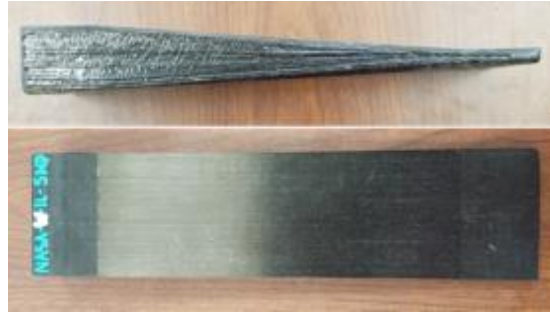
Figure 9: (a) Mechanical drawing and (b) photographs of an example porosity standard with a 5° wedge.

Twenty of the standards produced contained porosity introduced by using a modified cure cycle with either low (1/2 the recommended) or zero autoclave pressure but constant vacuum. Figure 9 shows a drawing and photograph of one of the wedge standards fabricated with process induced porosity. This five degree wedge standard was laid up using a quasi-isotropic stacking sequence,  $[0/90/45/-45]_{ns}$ , where  $n$  varied depending on the thickness. The manufacturer interleaved ply drops forming the wedge along the slope, alternating short plies and longer plies in the stacking sequence, then completed the stack by placing a full set of plies, one complete stacking sequence, as a cover layer over the exposed ply drops. To validate the integrity of the specimen, the manufacturer acquired through-transmission ultrasonic attenuation data (Figure 10) using a 2.25 MHz, 3.0 in. (7.62 cm) focal length transducer that was 1.5 in. (3.81 cm) in diameter. From the ultrasonic validation data shown in Figure 10, the manufacturer calculated the porosity of the standard to be between 2 and 4% by volume.
