Properties of Roman bricks and mortars used in Serapis temple in the city of Pergamon

Özlem Aslan Özkaya, Hasan Böke*

Architectural Restoration Department, İzmir Institute of Technology, 35430 İzmir, Turkey

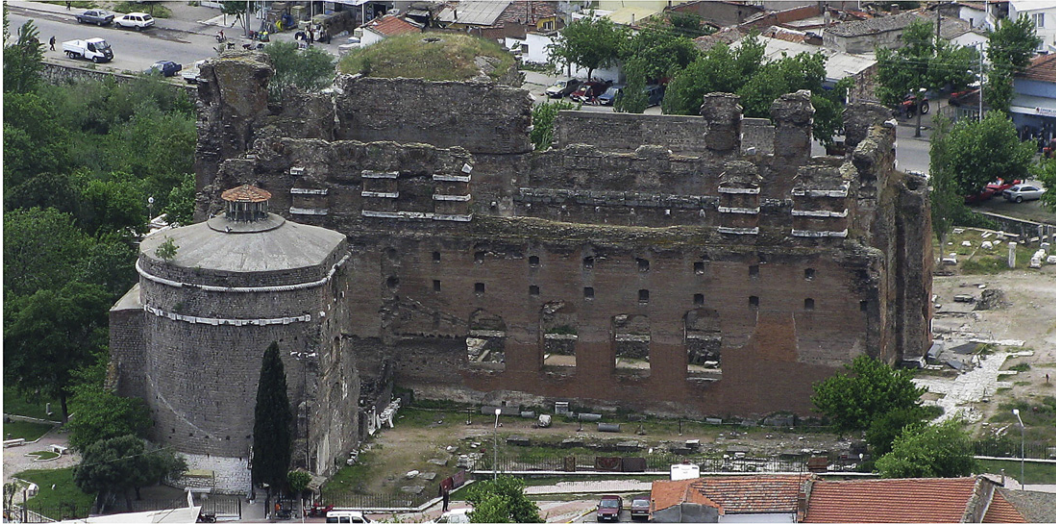
Fig. 1 – A view of the Serapis Temple from acropolis of Pergamon.

The Serapis temple, built in Bergama/Turkey, was the largest Egyptian-style temple structure during the Hellenistic and Roman periods. It is one of the most important monuments of the world heritage (Fig. 1). The main structure of the temple, constructed of red bricks, is 60×26 m. In addition, there are two round structures, one either side, with a square

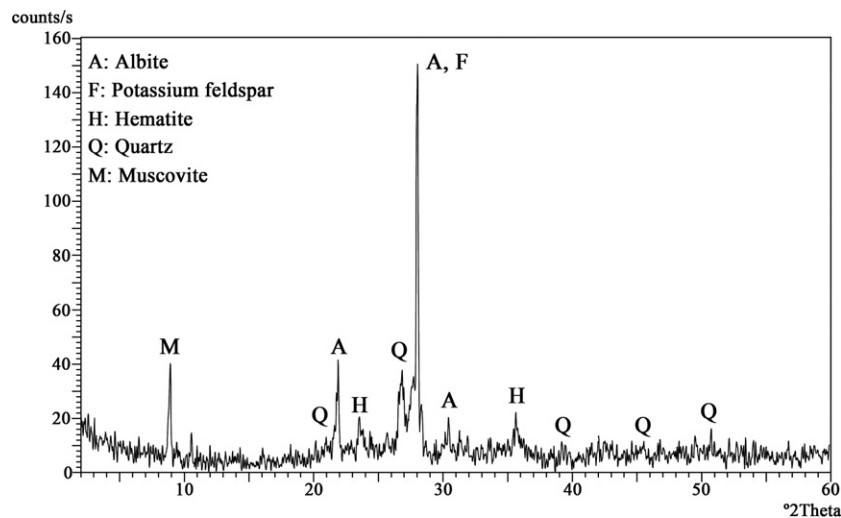
Fig. 2 – XRD pattern of the Roman brick sample (RB-1) with peaks of albite, potassium feldspar, hematite, quartz and muscovite minerals.

Mineralogical analysis conducted by XRD showed that Roman bricks were mainly composed of quartz, albite, potassium feldspar, hematite and muscovite minerals (Fig. 2). Calcium compounds were not observed in the XRD spectrum of the sample. These results show that bricks were produced by earthen materials containing calcium poor clays and low amounts of calcite minerals [8].

The firing temperature ranges of the bricks were estimated by X-ray analysis. The presence of hematite minerals showed that the firing temperature of the bricks was nearly 850 °C [8]. In addition, the absence of high temperature products of clay minerals such as mullite and cristoballite minerals in the XRD patterns indicates the firing temperature of the bricks did not exceed 900 °C [9].

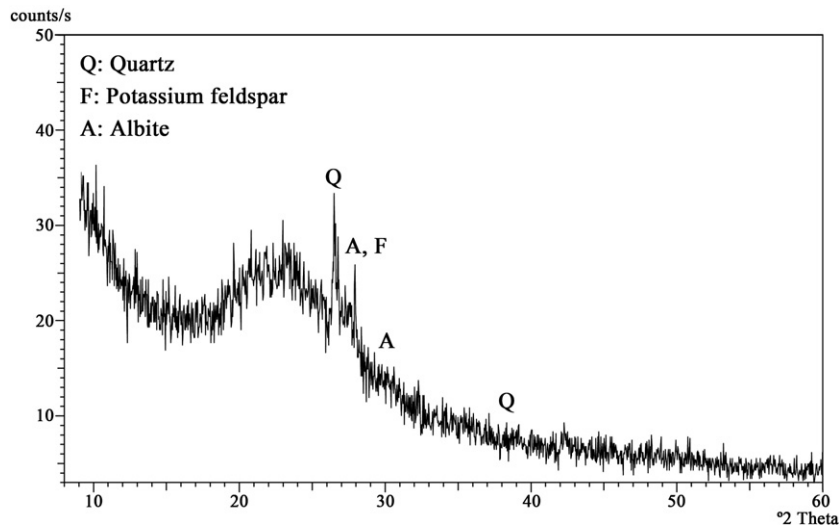
Fig. 6 – XRD pattern of the fine aggregates used in Roman mortar with a broad peak of amorphous silica between 20 and 30°.

XRD patterns of fine aggregates showed that they were composed of albite, K-feldspar, quartz and amorphous minerals indicated by the broad peak between 20 and 30° in the diffraction pattern (Fig. 6). SEM analysis indicated that they were mainly composed of glassy phases of silica (Fig. 7). In electrical conductivity measurements, the high differences in electrical conductivities values (7 mS/cm) of saturated calcium hydroxide solution before and after the addition of aggregates were observed. All these results indicate that the fine aggregates were volcanic with pozzolanic amorphous silica which produces a hydraulic character in the mortar.

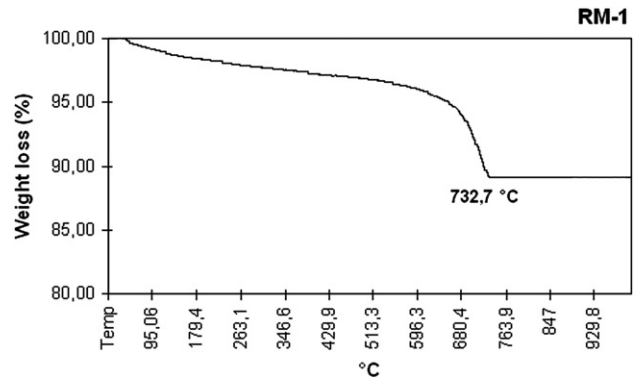
Fig. 9 – TGA graph of the Roman mortar matrix with fine aggregates (RM-1).

The hydraulicity of the Roman mortars was evaluated by thermo gravimetric analyses (TGA). These analyses indicated that the Roman mortar samples contained 2.33% structurally bound water between 200 °C and 600 °C and 6.87% carbon dioxide over 600 °C (Fig. 9). The CO₂/H₂O ratio was 2.95. This

result shows that Roman mortars can be regarded as hydraulic lime mortars [5].
