## Dovecotes in Kayabağ village: an assessment of landscape and architectural characteristics

To cite this article: Ülkü İnceköse (2020) Dovecotes in Kayabağ village: an assessment of landscape and architectural characteristics, Journal of Architectural Conservation, 26:1, 1-21, DOI: [10.1080/13556207.2019.1663647](https://doi.org/10.1080/13556207.2019.1663647)

Department of Architecture, İzmir Institute of Technology, Urla İzmir, Turkey

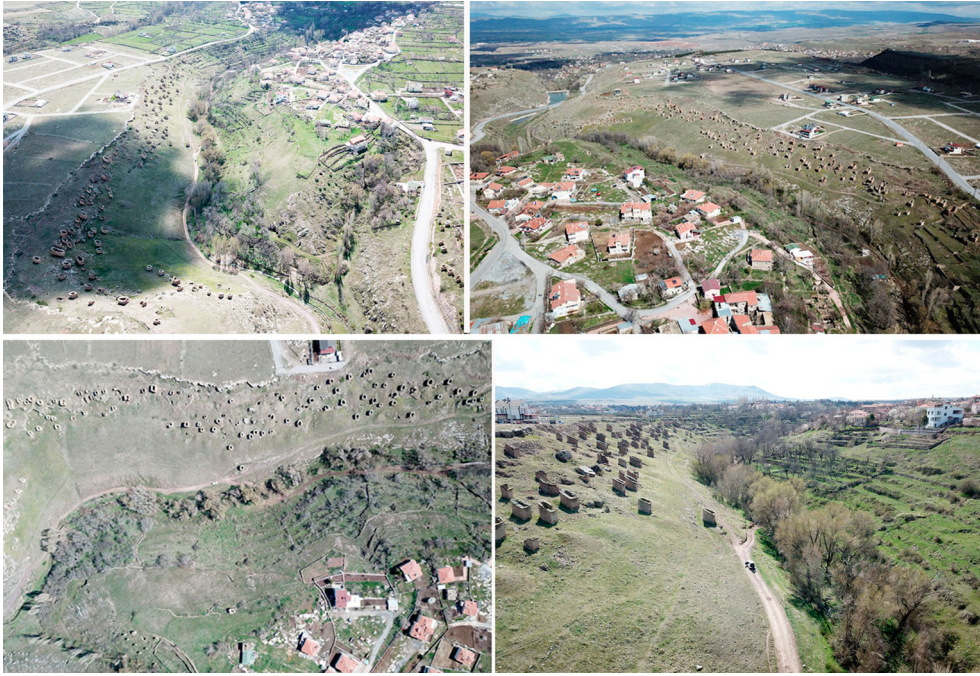
**Figure 2.** (a) The General View: Kayabağ Village and The Değirmendere Valley. (b) Natural Landscape of the Değirmendere Valley.

Kayabağ is located in Değirmendere Valley in which Darsiya Water divides the Village into two parts: the village settlement placed in the south part and dovescotes placed in the north part (Figure 2a). The length of the valley in which dovescotes are placed is about one kilometer and the slope degree is 35–40 degree. There is no other building apart from the dovescotes in the northern slope of the valley, however, the village is placed at the top of the southern slope of the valley. The topography is completely natural in the northern slope of the valley on which the dovescotes are placed. There is no any landscape organization produced by the handiwork of humans. Only the small part in the east was organized gradually.

The northern slope of the valley does also not include any natural entity on the topography that affect the tree-dimensional perception of the dovescotes. Both northern and southern sides of the Darsiya Water in the bottom of the valley and southern slope of valley have rich natural vegetation. Also, the southern slope of valley was organized gradually as vineyards (Figure 2b).

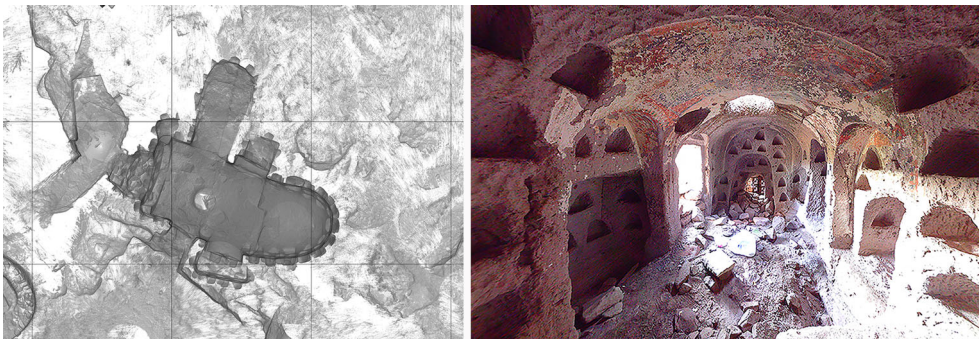
**Figure 3.** An underground church in the site: plan produced by 3D terrestrial laser scanner and spatial organization and the traces of frescos.

Dovecotes are examples of indigenous architecture in the Ottoman Period in Anatolia. They have also traces of historical stratification in Kayabağ. The remains of some underground Byzantine churches are still visible. The ruined walls of these churches are used for some of the dovecotes (Figure 3). The functions of dovecotes provide a detailed information about agricultural and commercial production, and also food culture and human life of the Ottoman Period on a local scale. Dove manure was used in agriculture because of its composition. Specifically, it was used in the cultivation of vineyard and buckthorn [*cehri*], and also, it was known that dove manure was a trade product in the Ottoman period. The cultivation of vineyard was the most important traditional agricultural production of the region, and buckthorn whose fruits were used for dyestuff in the production of silk and wool, was the one of the main trade products of the region in the Ottoman Period. Because the region had an ideal atmosphere in terms of soil structure and climate, buckthorn was cultivated because of the demand for raw materials in industry of some Western countries in the nineteenth century. The trade of buckthorn was the main source of income for the people of Kayseri at the end of the century. The importance of buckthorn in agricultural trade production was clearly understood through the international trade relations between Ottoman Empire and European countries, including England, Holland, France. For example, England established a commercial consular to control the trade of buckthorn in Kayseri. Buckthorn was harvested by locals and sold to Armenian from Tarsus and İzmir, who exported it.<sup>17</sup>

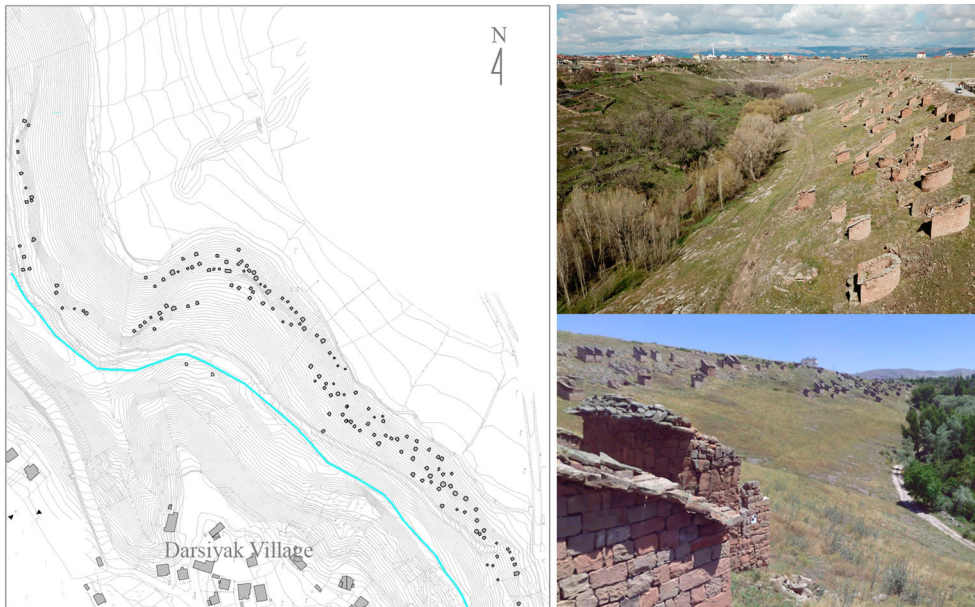
**Figure 4.** Gesi-Darsiyak dovecotes: Site Plan; General view from southern west and northern east of the valley.

A total of 147 dovecotes in Kayabağ have been examined for this study (Figure 4). The dovecotes of the Gesi-Kayabağ region have two main parts: above the ground and the underground parts. The part above the ground is usually named as either ‘tower’ or ‘chimney’ by the researchers. The tower parts of the dovecotes can be defined in terms of conventional architectural interpretations with their defined geometrical features, construction techniques, materials and rational space definitions. On the other hand, the underground part named as ‘nest,’ which is impossible to be observed from outside, has totally different features in terms of spatial organization, practice of construction techniques, and material usage. Each dovecote is unique regarding its interaction with the ground. The same quality of uniqueness complies with the interactions among dovecotes themselves, as well (Figure 5).

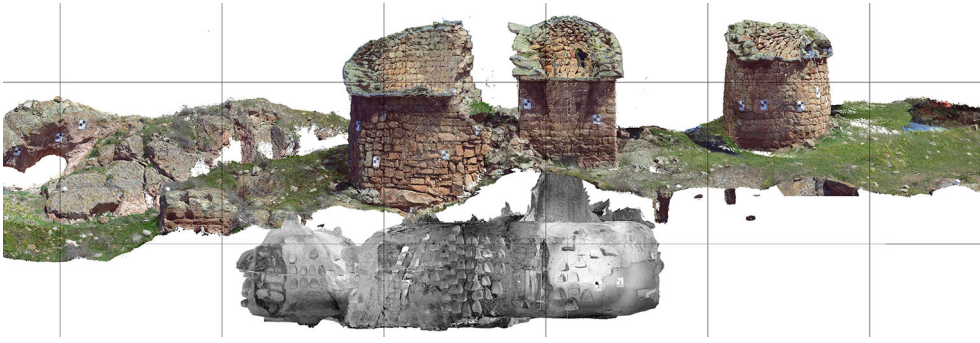
**Figure 5.** Aboveground and underground parts of the dovecotes produced by terrestrial laser scanner.

6. The technical drawings used in the article (in Figure 5), 3D laser data and laboratory analysis is given with a reference to the 'Gesi Kayabağ Dovecotes Renovation and The Valley Landscaping Project' supervised by Melikgazi Municipality and conducted by Demirhanlı Agricultural Products Textile Machinery Project Services Ltd. The related data are used in the article with the approval of the project owner, Master Architect Filiz Hatice Sezer.

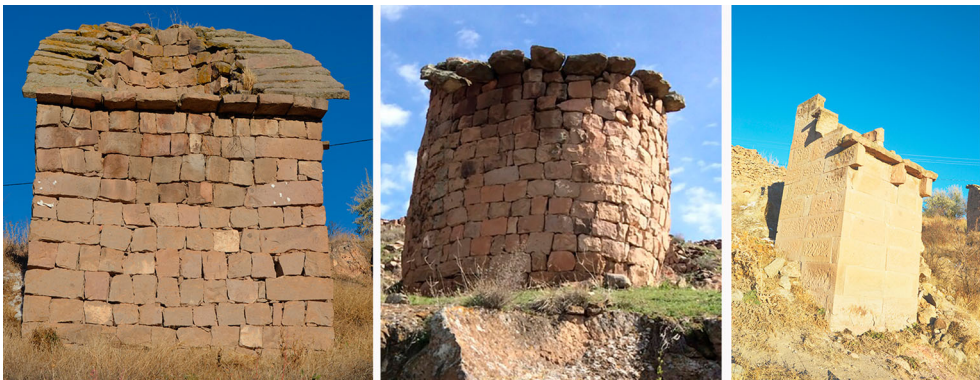
**Figure 8.** Examples for the towers of dovescotes in Kayabağ: U shape plan, circular plan and rectilinear plan.

Ten of the dovecotes display an almost-circular plan geometry. All of the towers with the cut-stone work have a rectangular plan geometry (Figures 7 and 8). The material analysis of mortars shows that two different mortar compositions were used in the walls. Lime mortar was defined in the dovecote display as an almost-circular plan geometry, and lime-cement mortar was defined in the dovecote display as a rectangular plan geometry. According to the material analysis and the construction techniques, the differentiation in plan geometries can be associated with the construction period of the dovecotes. Consequently, it could be accepted that the dovecote display rectangular plan geometry was constructed in a later period. However, this information could not be verified by the interviews with local people.

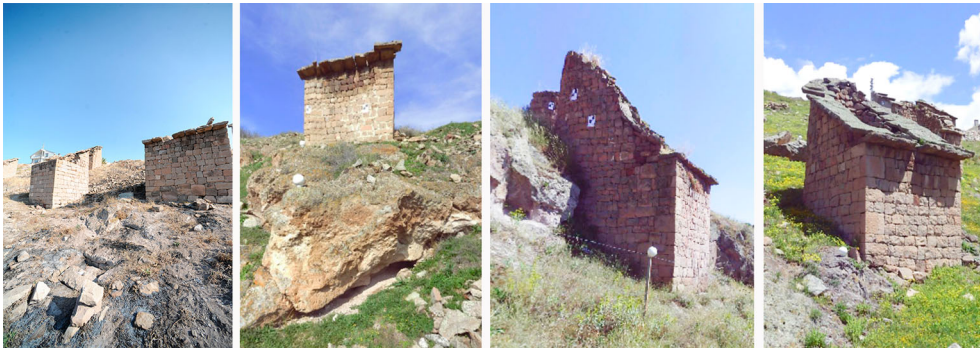
**Figure 9.** Different examples for the tower and topography relation.

Each dovecote is constructed on either side of the valley in full compliance with the features of the topography. Therefore, the interaction between each tower and the topography is unique (Figure 9).

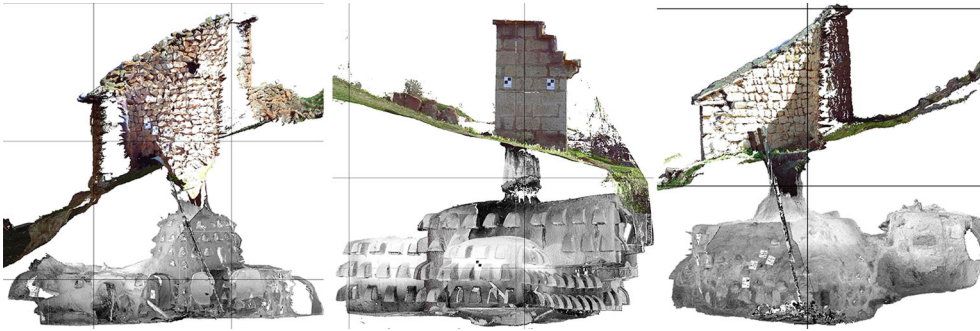
**Figure 10.** Examples for nest (images produced through 3D terrestrial scanner).

The dovecotes are placed on the cliffs at intervals. The towers do not have any spatial interactions among themselves. However, there are some passages between some dovecotes in the nests (Figure 10).

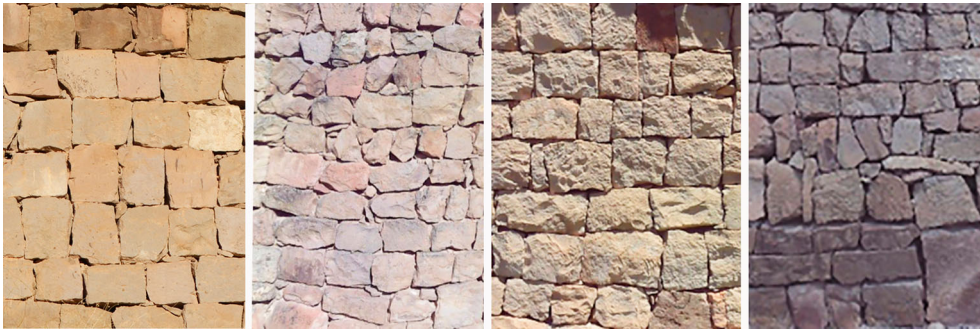
**Figure 11.** Use of stone in the outer leaf of the walls.

Regarding their load-bearing systems, tower walls can be defined as a masonry structure that is traditional construction system used in the region. Even though the walls do not have a standard thickness, the rough-cut stone walls have a width of 60–100 cm. The height of the walls varies between 2.00 and 4.50 m. The width of cut stone walls is about 15 cm. Relating to local geology of the area, the stone material which is used in rough-cut and cut-stone walls is obtained from tuff rocks in the region. In the field observation, different masonry techniques have been observed. In some of the samples, the rough-cut masonry is applied to the inner and outer leaf in the same construction technique. However, in some of the dovecotes, the outer leaf has been constructed with rough-cut masonry, but the inner leaf is the rough-cut rubble masonry. The use of relatively larger-sized and better-shaped stones in the corner of the walls is common for all towers (Figures 11–13).

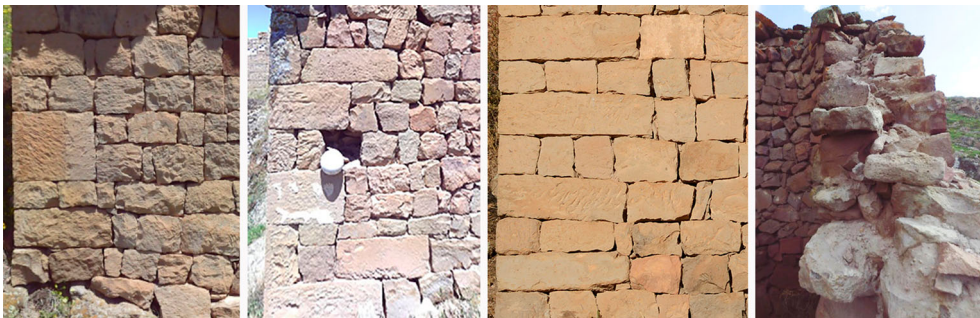
**Figure 12.** The outer stone masonry leaf: Different applications for the edges of tower and a wall with double-leaf.

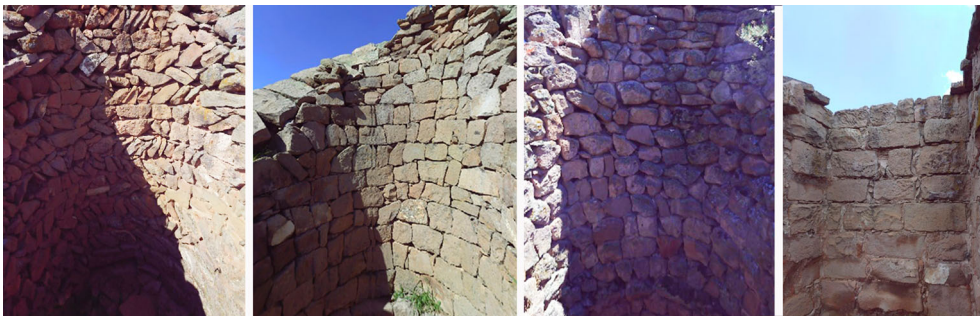
**Figure 13.** The inner stone masonry leaf: rough-cut masonry and cut stone masonry

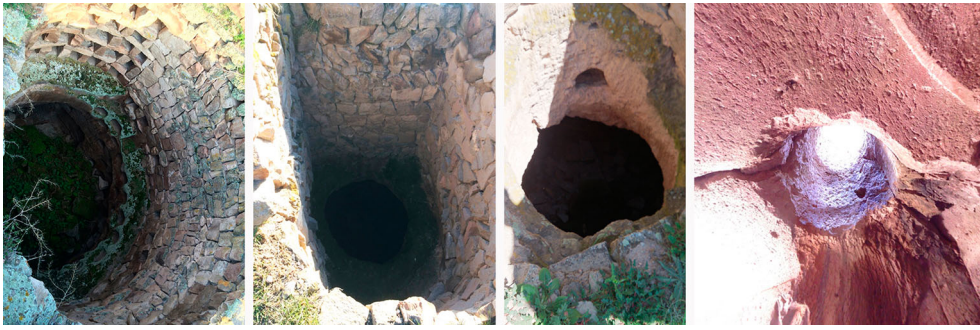
**Figure 14.** Entrance hollow between tower and nest.

The dovecotes have two openings to the outer space, one of which is the ceiling-entrance hole created through carving, which gives an access to the nest for the birds. It does not comply with any strict geometries, and its size varies. The diameter of hole is around 60–150 cm. The entrance hollows begin and continue deeper inside horizontally in an almost cylindrical form. The length varies in all dovecotes, owing to the topographical inclination. While some of them might have a length of 1.5 m, some others might have a height of 3.5 m. The entrance hollow expands gradually deeper inside, and it eventually gets linked to the nest (Figure 14).

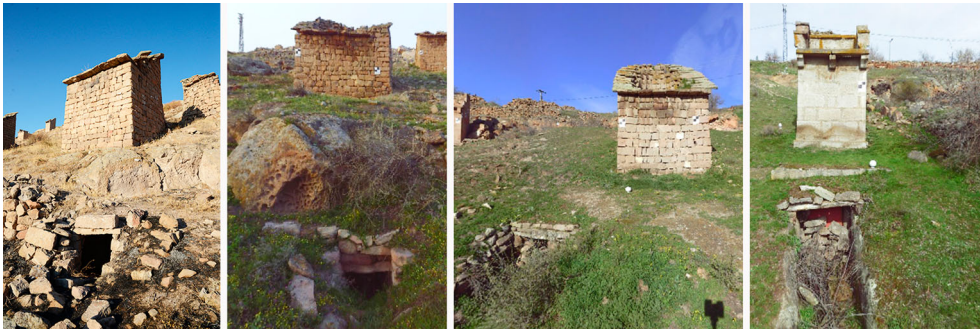
**Figure 15.** Relation types between tower and human entrance.

The other opening is the one used for the human entry. These openings giving access to humans are carved into the rocks away from the tower parts. They might be seen as short tunnels, depending on the topographical inclination. The entry holes are just wide and high enough for crawling into. The entrance part of the opening is framed with a stone

wall. The door opening is spanned with flat stone arch. The doors are simple batten doors that consist of vertical planks (Figure 15).

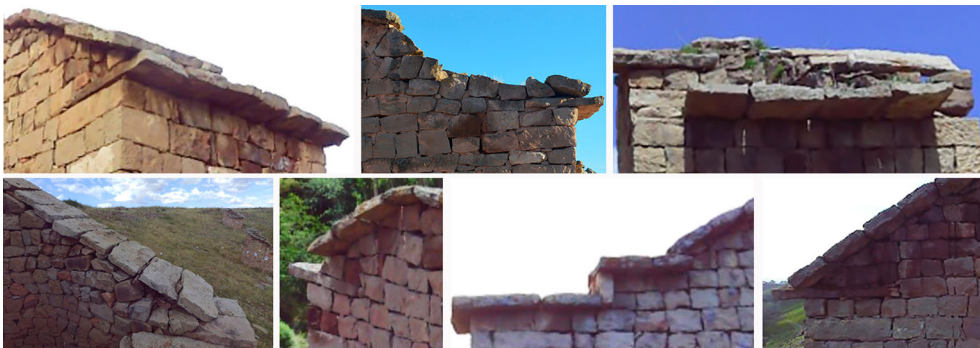
**Figure 16.** Eaves in the dovetails built with rough-cut stone masonry: different applications and special details.

masonry, the flat-cut stones are placed on the inclined walls, and they form a console of 30–35 cm. In the front, the bordering eaves stones on the edges are placed to form a console on the final layer of the wall (Figure 16).

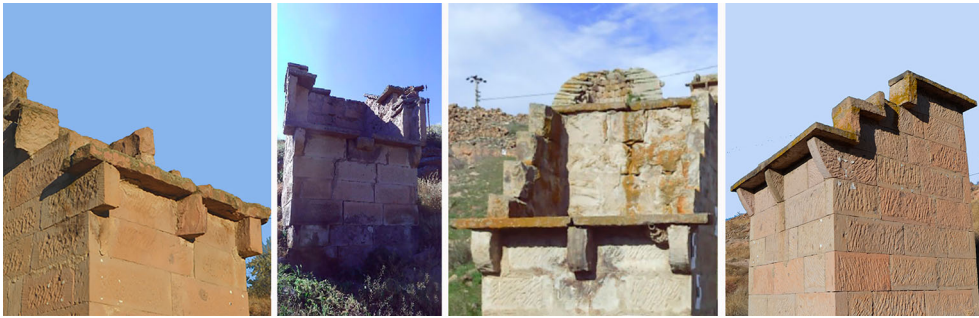
**Figure 17.** Eaves in the dovescotes built with cut-stone masonry: different applications.

In the towers with cut stone masonry, flat stones are placed on the top of the walls which end in steps. While the eaves of the side and back walls are placed as a console of 15–20 cm, the applications onto the front walls differ in details (Figure 17).

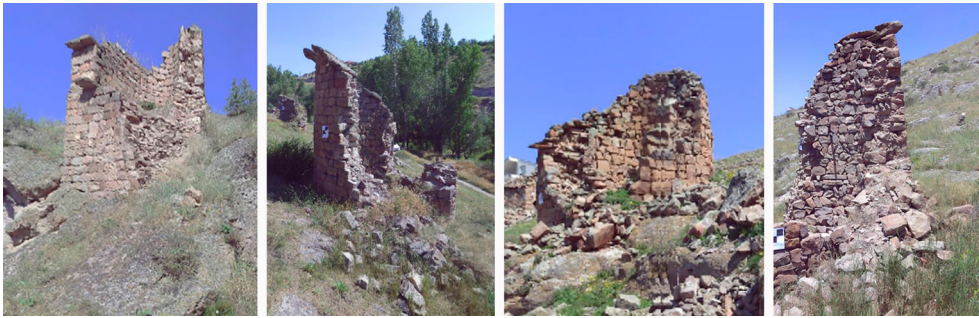
**Figure 18.** Damaged dovecotes in the valley.

The biggest structural problem witnessed in the towers is the collapse of the walls due to some external factors. In some of the dovescotes, the tower walls seem either partly or completely damaged (**Figure 18**).

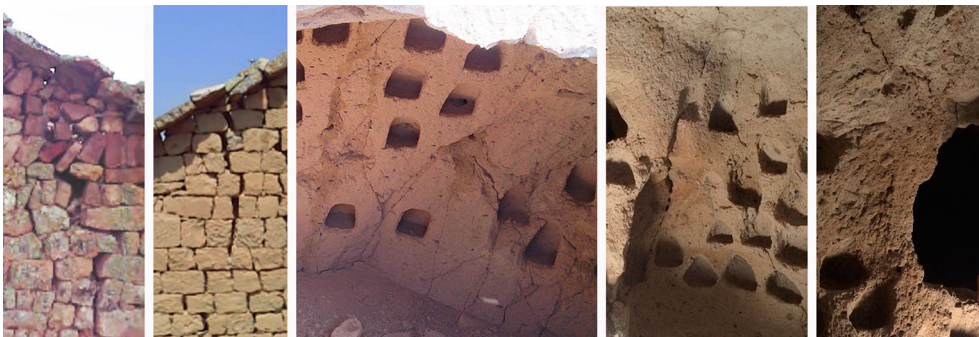
**Figure 19.** Structural failures: Cracks in the walls of the towers and cracks in the walls of the nests and superficial erosion in the rocks.

The deformation in the walls of the nest is to do with the geological structure of the region. The type of the rock, the type of discontinuity, discontinuity tendency, discontinuity intervals, the duration of discontinuity, roughness of the discontinuity surface and the level of roughness, the width of cracks and fills, have an effect on the deformation of rocks. On the other hand, as tuff rocks are not durable types of rocks with a high sensibility to atmospherically factors, their durability is weakened by humidity and other natural factors such as rain, soil accumulation, frost, and sudden changes in temperature.<sup>22</sup> In addition, having a big amount of clay mineral in their formation, tuff rocks absorb water in wet seasons, and this causes the rocks to swell and get heavier (Figures 19 and 20).

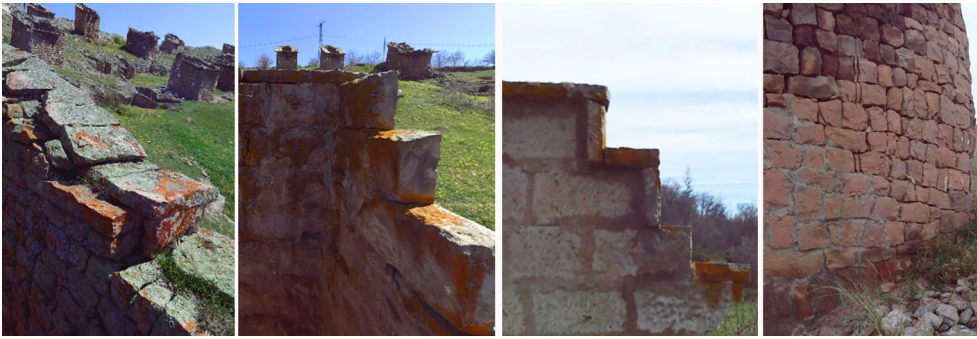
**Figure 20.** Material deteriorations and unqualified repairs in the towers in the masonry walls.

Another important problem observed in the walls is the unqualified repair work. In some towers, unsuitable applications that do not comply with the original masonry techniques are observed. In some other walls, cement-mortar, which is extremely detrimental to natural porous building material, has been used in repair work.<sup>21</sup>
