THREE DIMENSIONAL MODELING VIA PHOTOGRAPHS FOR DOCUMENTATION OF A VILLAGE BATH

H. B. Balta^a, M. Hamamcioglu-Turan^{a*}, O. Ocali^b

^a Izmir Institute of Technology, Department of Architectural Restoration, IYTE, 35430, Urla, Izmir, Turkey – (hamitbalta, mineturan@iyte.edu.tr)

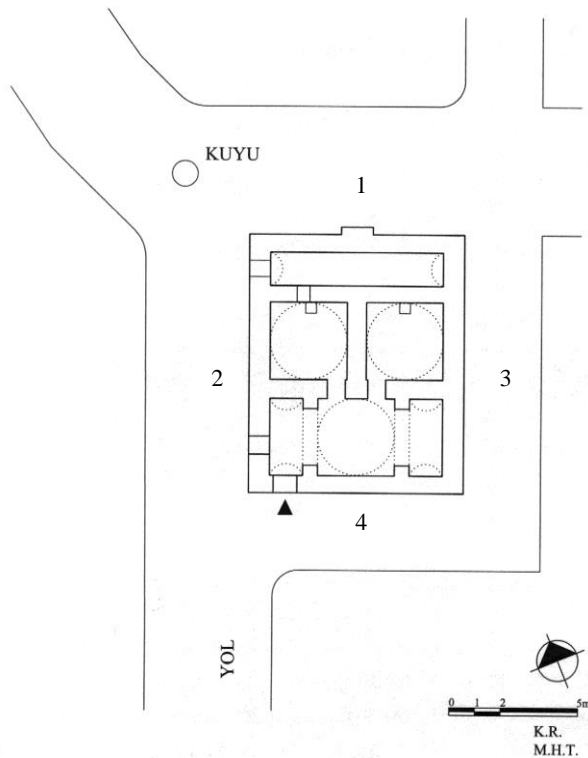
Figure 2 Plan of studied building (Hamamcioglu – Turan, Reyhan, 2005)

The building (8.30 x 10.65 x 3.00) entered from a door at its north side and an irregular opening at its west side is composed of an *iliklik-sicaklik* (tepidarium-caldarium); two *halvets* (hot rooms) and a water tank at present (Figure 2).

As revealed from the characteristic of the entrance door, the ruins of the *soyunmalik* (apodyterium) juxtaposing the *iliklik-sicaklik* should be underneath the street at the 4. The trace of the fireplace underneath the water tank and the well at the 1 of the building indicate that there might be ruins of a woodshed juxtaposing the water tank, and a courtyard at the 2 and 3 of the bath. The rectangular *iliklik-sicaklik* (2.50 x 5.60), running in east direction, is domed at its center and barrel vaulted on its two sides. The *halvets*, juxtaposing the *iliklik-sicaklik* at its south and north, are domed as well. This plan organization can be evaluated among one of the types in Eyice's classification of Turkish bath plans (1960) elongated rectangular *sicaklik* with domed central unit and two *halvets*. The oculi at the domes and vaults elements are the sources of illumination together with the two entrance openings mentioned in the above. In turn, the illumination level is low at the interior. Rubble stone, brick timber and mortar is used in the construction of the walls and brick and mortar is used in the construction of the domes, vaults, pendentives and the drum of the central dome at the *iliklik-sicaklik*. The surfaces of these elements are exposed without plastering at their exterior at present, while they are

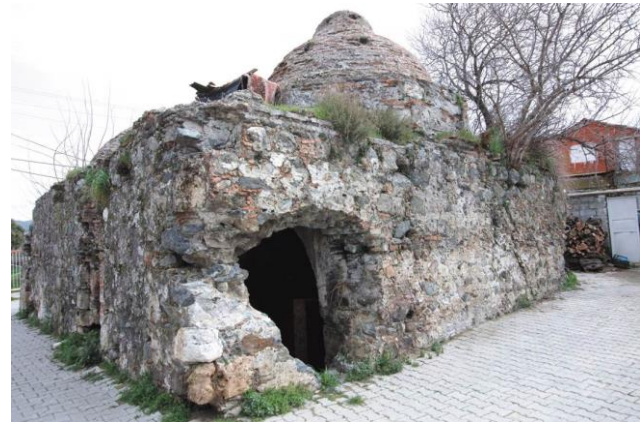
Figure 3 Studied building as viewed from the northwest

plastered at their interior. The monument is in a ruined state as a result of abandonment for years (Figure 3). Fortunately, it has been taken to the restoration program of Seferihisar Municipality, after Seferihisar has declared as a slow city in 2009. (<http://www.cittaslowturkiye.org/eng/>).

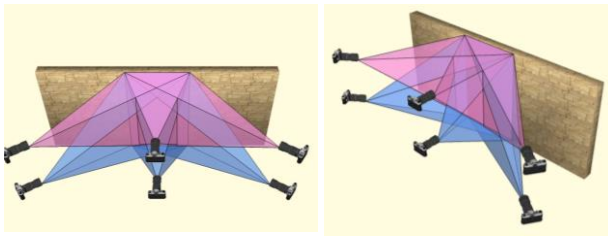
Figure 4. Schemes illustrating camera positions for partial photos

The case study building was photographed in two phases: exterior and interior photographing phases. Each is composed of the design of partial photographs documenting building surfaces and overall photographs documenting the building / space whole from its corners. In both phases, each piece of building surface was documented with six photographs: two taken parallel to the surface with and without ladder; two taken from the right side of the parallel position with and without ladder; and two taken from the left side of the parallel position with and without ladder (Figure 4).

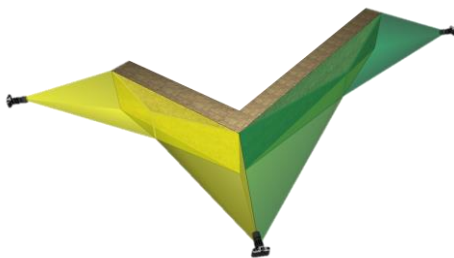
Figure 5. Scheme illustrating camera positions for overall photos

In addition to these partial photographs, overall photographs were shot across the four corners of the bath, both from street and from second story of the neighboring building (Figure 5), if possible. For the interior, photos from the corners of the spaces, with and without ladder were provided.

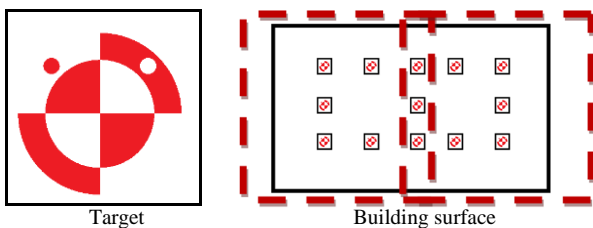
Figure 6. Paper target (a), organization of targets in succeeding partial photos

The partial photograph of the neighboring building surface piece always slightly overlapped with the previous one. The marker patterns were pasted to the facades and domes of building by using glazier's putty. In the positioning of the markers, which would act like control points in the evaluation phase; a gridal order was preferred in the facades. A homogeneous network of markers was also achieved on the domes. In each photo, eight control points were provided. For subsequent photos, minimum calibrated number of control points is three (Figure 6). But for an exact calibration; more than three control points should be viewed in a frame.

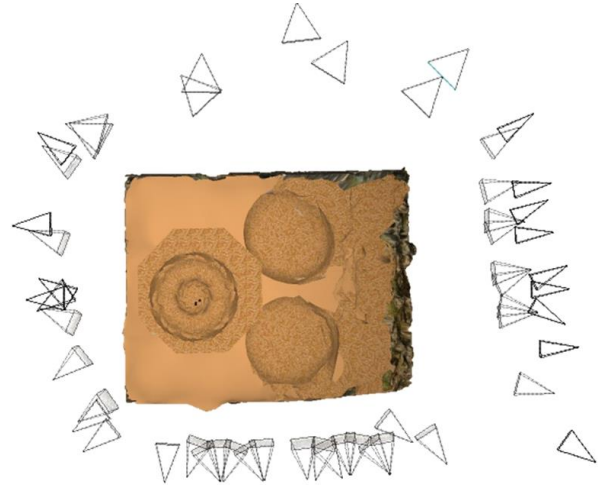
Figure 7. Placement of cameras for the exterior surfaces of the walls

Since the shooting distances for southern and western façades are limited (max. 1.5 m and 2 m, respectively) because of the neighboring houses, smaller focal lengths (wide angles) were

preferred and the numbers of photographs were increased. For northern and eastern façades, the focal length was relatively larger (Figure 7).

The maximum shooting distance for 1 / 50 presentations was calculated according to the below formula in relation with the constraints on each street and on the roof.

$$\text{Negative scale of } 1/50 = 1 / 200 = \text{Focal Length} / \text{Distance}$$

$$\text{Distance} = 200 \times \text{Focal Length} \text{ (Swallow, et al., 2004)}$$

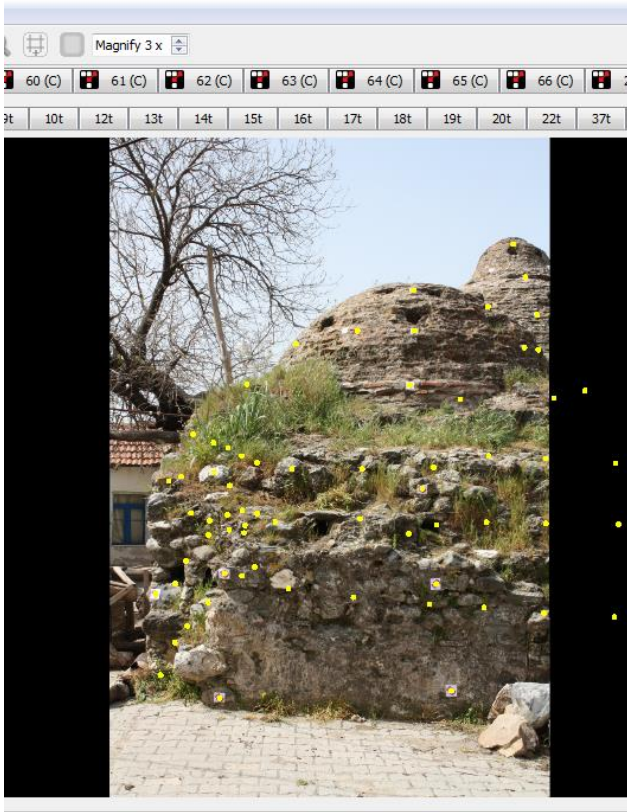
Figure 8. Point cloud indicated with yellow dots

After the photogrammetric model composed of the 3d point cloud of the calibrated points was scaled by entering a single value measured at the site, it was exported to Trimble Sketch-up version 8 together with the related photographs (Figure 8).

The photographs were linked to each other with maximum 8 and minimum 3 calibration points, which were identified with paper targets. Minimization of calibration points was considered in case of short shooting distances. 2 pixels error is taken as equivalent to 2 cm error. Maximum 2 pixels error was accepted in the calibrations considering the fact that human eye will have difficulty in detecting errors less than half of a millimeter in the presentations (20mm/50= 0.4mm).

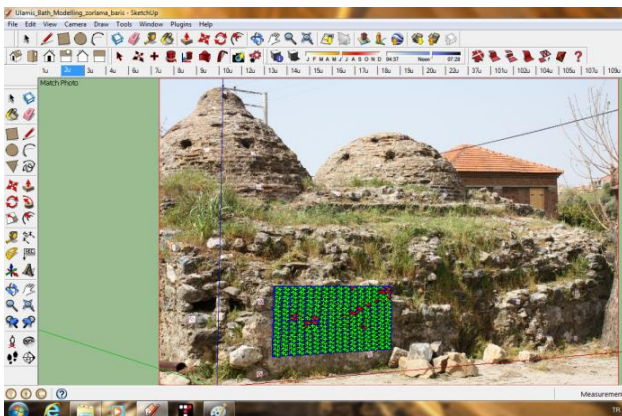
Figure 9. Up sampling of a mesh group

Building surfaces visible on each photo were modeled one by one in counter clockwise order. The photo with highest number of successful meshes for the same building surface was selected among the views taken from different positions. If none of the views provides successful meshing (Figure 9), then calibration was repeated. As a result, a mesh system for the bath whole was constituted. The photos shot parallel to the related building surfaces were projected onto the meshes in order to provide texture.

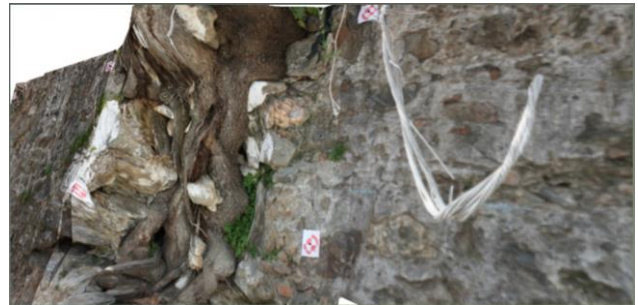
Figure 10. Presentation of photorealistic details of historical morphologies.

historical building. The end result model based on experiments with targets presents photorealistic details of the studied Ottoman bath. The accuracy is measurable with the error data provided by the software. The exterior surfaces including those of the walls and the vaults of the *iliklik-sicaklik*, the drum of the major dome, and bottom zones of all domes were modeled successfully (Figure 10). These positive results were achieved in the presence of the conditions mentioned in the below:

- Providing targets on the building surfaces prior to shooting
- Coordinating scale – lens – distance relations
- Designing shooting angles
- Providing sufficient illumination during shooting
- Providing a parallel shot to each piece of building surface

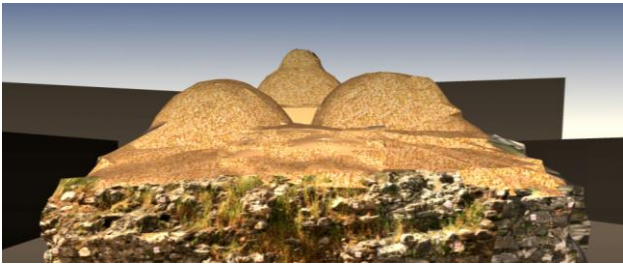
Figure 12. Eastern elevation

Systematic shooting of dome surfaces could not be made especially at their top zones because it was impossible to stand up in an appropriate position. In turn, the geometry and/or the surface texture were documented partially. The model was completed with comparative study within the building. That is to say, the documented piece was copied to the undocumented parts of the dome (Figure 12). These areas were indicated with beige color and dots on the presentation model. The areas with correct geometry, but insufficient texture quality were differentiated with beige render without dots. Utilization of an unmanned aerial vehicle for shooting in these zones may be helpful.

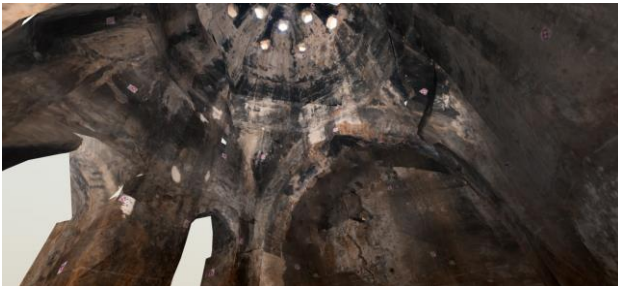
Figure 13. *İtiklik / sıcaklık*, perspective view from the model.

In case of limited illumination, as in the interior of the bath, the model could not be completed (Figure 13). So, the photographs should be repeated after provision of an artificial illumination system.

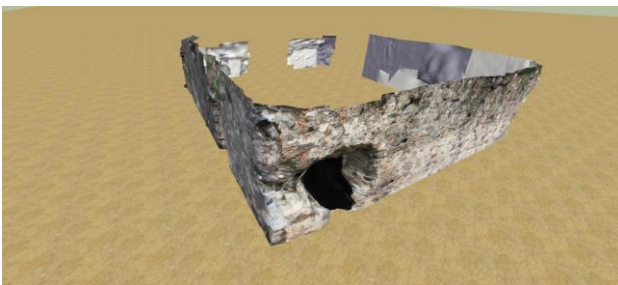
Figure 14. Modeling without targets

In case of lack of targets, the exterior surfaces of majority of the walls could be modeled, but the wall on the narrow street at the south and the superstructure could not be modeled (Figure 14).
