Flash flood simulation of the Toga River caused by localized torrential rain in urbanized area

ABSTRACT: In the afternoon of July 28 in 2008, a flash flood occurred suddenly in water-friendly reach of the Toga River in Kobe City and tragically, five people were drowned by the flood. They were among about fifty people enjoying the river environment at the site. The flash flood was caused by a sudden localized torrential rain in the urbanized area of the river basin. Noteworthy fact with this flood is the flow image was successfully captured by a river monitoring camera installed by the local government and it was made clear that the sudden water rise occurred at least within two minutes, indicating that the flood entering the accident site was like a tsunami flowing down the river. The flow was almost supercritical and water level rose locally by transverse steps installed in a steep bed slope of about 1/20. In order to investigate the flow feature more in detail, we conducted a two-dimensional flow simulation using laser-scanned data as bathymetry information, from which distribution of hydrodynamic force acting on the people in the river was estimated, demonstrating the difficult

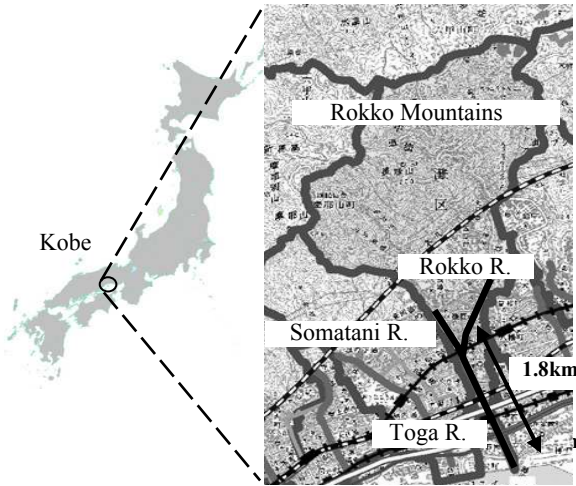
Figure 1. Toga River Basin

The main reach of the Toga River is located in Kobe City with two small tributary streams, the Rokko River and the Somatani River, as indicated in Figure 1. The length of the main river is 1.79km and the drainage area is 8.57 km², which is roughly a common scale of the rivers flowing in Kobe City. One of the outstanding features of the Toga River is its bed slope; the slope is 1/200 even at the river mouth and more than 1/20 at the

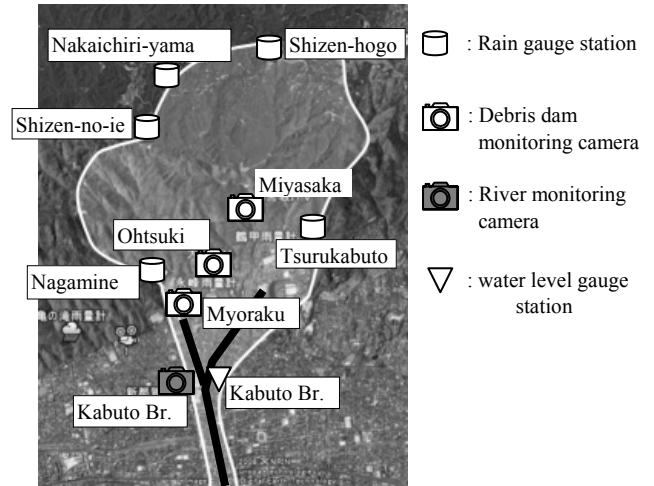
Figure 3. River monitoring systems

gauge station, c) a river monitoring camera, and d) three debris dam monitoring cameras. Figure 3 shows the location of the respective stations. The rain and water gauges collect data every ten minutes, while the river monitoring camera installed at the Kabuto Bridge captures a still image every two minutes. On the other hand, the debris dam cameras intend to record video images of the flow over the dam crest. In addition to the above monitoring systems, the Japan Meteorological Agency provides rainfall information with a resolution of 1 km by 1 km measured by a weather radar system every ten minutes.

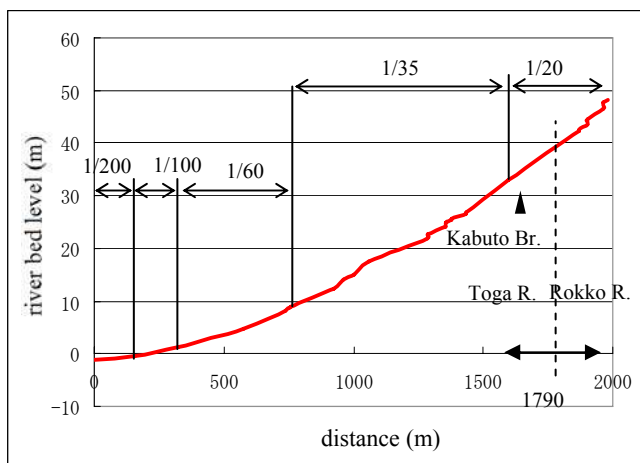
Figure 2. River bed profile

upstream end of the main river as shown in Figure 2. The channel cross section is trapezoid with a bottom width of about fifteen meters at most of the sections. The side walls and the bottom is fixed by concrete, however, small meandering lower stream with efficient fish ladder is installed in the center of the channel. In addition, side stairs are installed at many locations for improving the accessibility to the riverfront. The lower river basin is mostly occupied by residential houses and paved streets developed up to the foot of the mountainous area. Therefore, a storm drainage system is installed for preventing inland flood. Most of the inland water is conveyed to the main river through pipes or ducts.

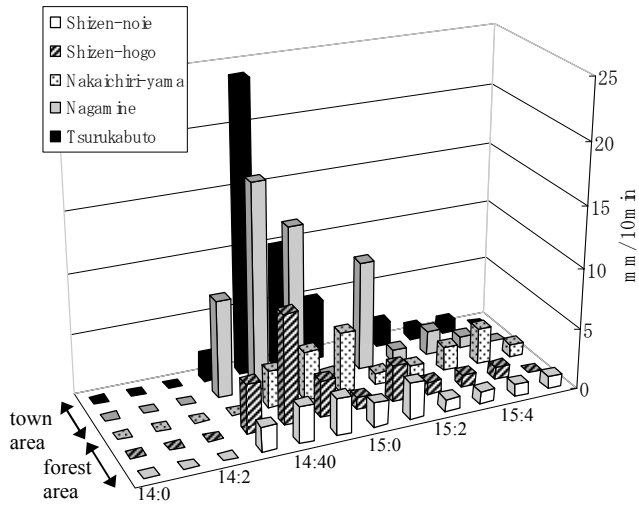
Figure 4. Hyetographs at rain gauge stations

Hyetographs at each rain gauge station are provided in Figure 4. It is obvious that rainfall intensity is stronger in the downstream urban area than in the upstream forest area. Surprisingly, at the Tsurukabuto station, the rainfall increases suddenly up to 24mm per ten minutes from almost no rain condition. The rainfall continued for about an hour, rapidly decreasing its intensity after the peak.

As has already been shown in Figure 4, the rain distribution is concentrated on the urbanized town area rather than the forest area. The inflow from

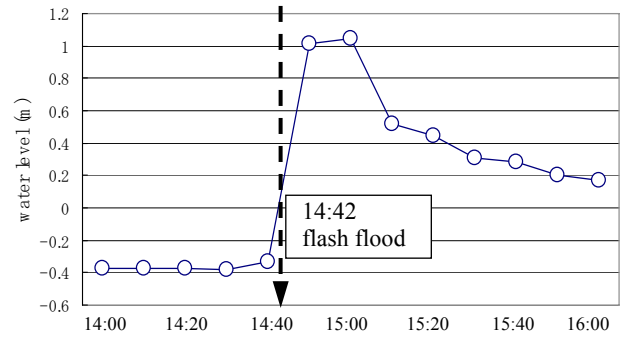
Figure 5. Water level hydrograph at Kabuto Bridge

According to the water level hydrograph shown in Figure 5, the water level at the Kabuto station rose 1.34m in ten minutes. The peak water level condition continued for about ten minutes followed by gradual decrease of water depth. The water depth before the flash flood is about ten centimeters, which is a normal flow condition of this river.

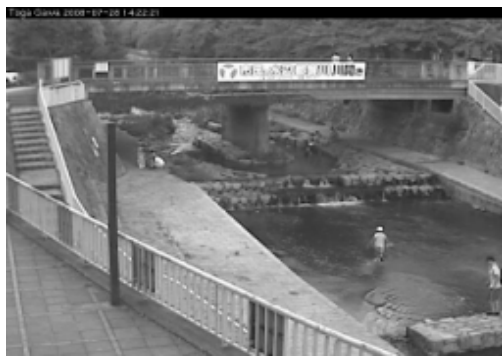
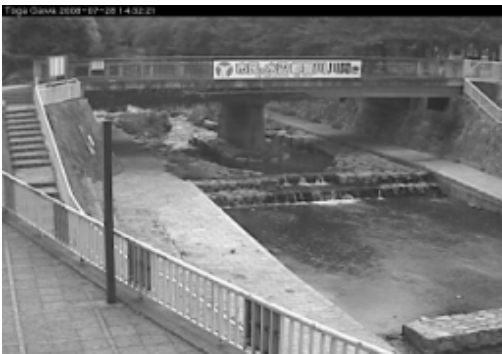
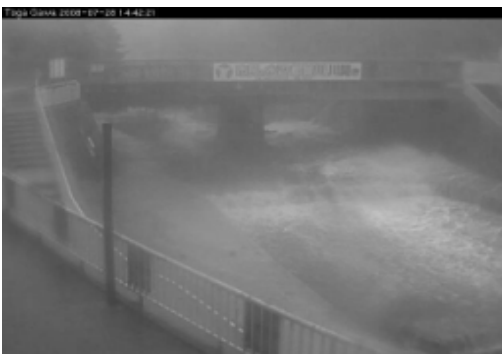
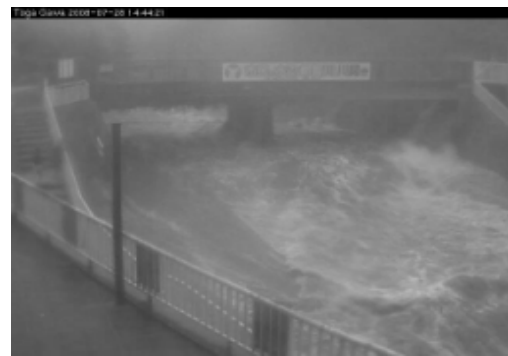
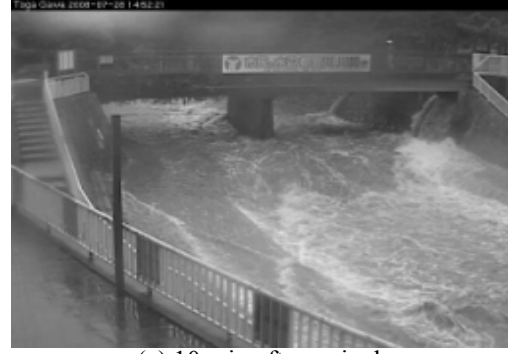
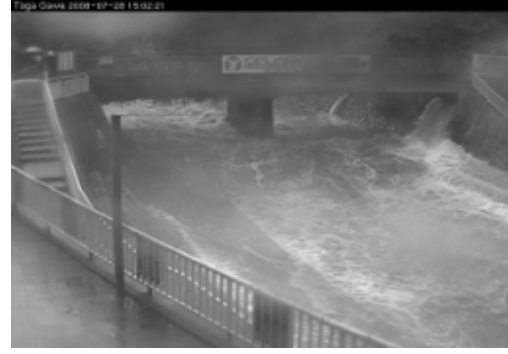
Figure 6. River monitoring images before and after arrival of flash flood

The river monitoring camera installed downstream of the Kabuto Bridge successfully captured what had happened during the flash flood. Figure 6 displays several consecutive images before and after

the flash flood. Figure 6(a) is the image twenty minutes before the arrival of the flash flood. As

can be observed, there are several people including children enjoying the river. It has been re-

(a) 20 min before flash flood

(d) 2 min after arrival

(b) 10 min before flash flood

(e) 10 min after arrival

(c) flash flood just arrived

(f) 20 min after arrival

ported that more than fifty people were playing in the river at the time. The weather is fine with no rain. Actually, the weather in this area had been fine for a month before the flash flood occurred. The rain caused by the development of cumulonimbus clouds started ten minutes before the event. Figure 6(b) is the image ten minutes before the flash flood, at which time the torrential rain began to fall and people within the image have evacuated from the river. However, there were still many people left in the river downstream of the section. Figure 6(c) shows the image just when the flash flood arrived at the site. It is apparent that the water depth increases significantly with large water surface undulation. The side walking ways are also covered with water. It has to be mentioned from these images that the sudden increase of water depth occurred almost within two minutes and not in ten minutes as indicated in Figure 5 in terms of the water level hydrograph. This discrepancy is attributed to the fact that the water level information is transmitted to the local government office via a telemeter after averaging ten minutes of data. This flow situation continues for more than twenty minutes as can be seen from Figure 6(e) and Figure 6(f).

In order to simulate the complicated flash flood features evidenced by the river monitoring camera previously demonstrated in Figure 6, it is necessary to obtain detailed bathymetry information, basically composed of walkways, fish ways and stepping stones. For this purpose, we used a ground laser instrument capable to measure the 3D ground data with a spatial resolution of several centimeters. Data for submerged river bed difficult to measure with this instrument are replaced by the manually measured values. With this procedure, a detailed bathymetry data of 1.8km of the Toga River are obtained. An example of the measurement data is indicated in Figure 9. The dots corresponding to the respective measured data represent the bathymetry information quite precisely.

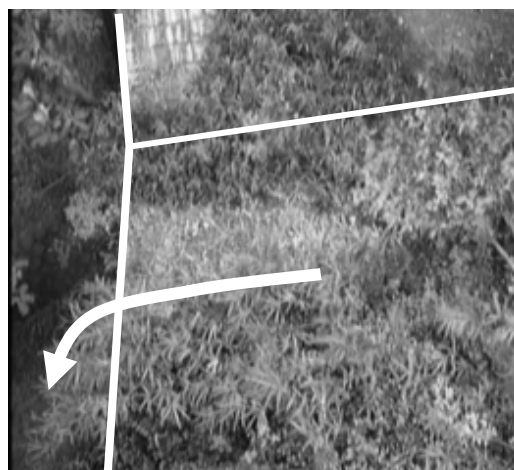
Figure 7. Image of debris dam monitoring camera at Ohtsuki

the forest area was examined by debris dam monitoring cameras. Figure 7 is an image of the Ohtsuki camera installed just upstream of the urban area at the time of the peak rainfall. It is obvious there occurs no inflow from the forest area through this dam, i.e. even a water surface cannot be detected from the image. This condition continues even after the peak rainfall. Since the other two cameras provided similar surface situations as well, we can conclude that the water catchment area contributing to the present flash flood is restricted only to the urbanized residential area with little influence from the rainfall in the forest area. From this information, we made a rough estimate of the peak discharge from the rational formula using the residential area, peak rainfall intensity and the runoff coefficient assumed to be unity. The calculated result, about $40\text{m}^3/\text{s}$, will be examined in the 2D simulation in the following chapter.

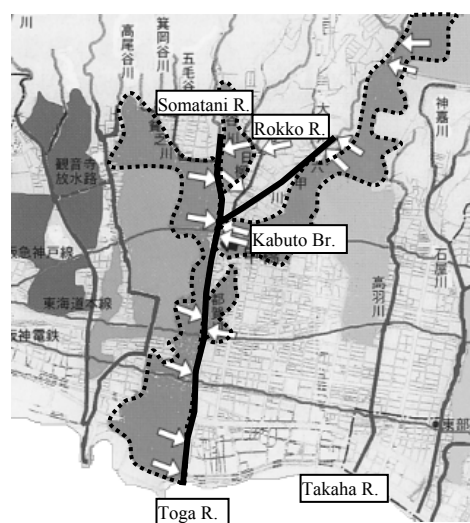
Figure 8. Stormwater drainage system of the Toga River

The residential area has a stormwater drainage system in addition to small-scale tributary channels as illustrated in Figure 8. The shadowed area bounded by dotted line corresponds to the drained area of the system. The drained water enters the major river channels through ducts or pipes at seventeen exits indicated by arrows in Figure 8, out of which twelve exits are located upstream of the Kabuto Bridge. It has been reported that the stormwater inflow to the river is extremely high like a jet at the exit. This indicates that the installed stormwater drainage system rapidly accumulated the stormwater and drained the water to the nearest river quite efficiently. This is however one of the causes of the present flash flood. The problem was there were people still left within the water course.

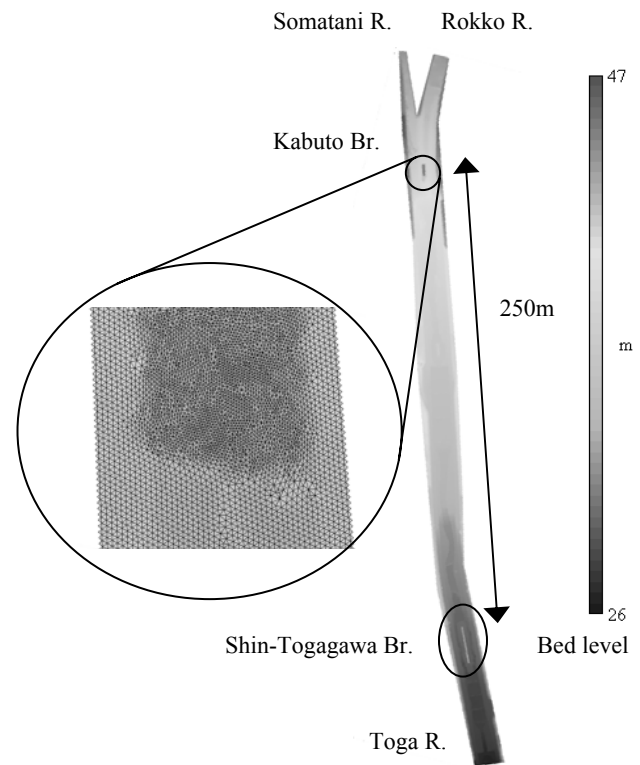
Figure 10. Range of simulation and grid arrangement

Since it is impossible to use all of the measured bathymetry data in the simulation, the data is rearranged into a set of triangular unstructured grid. The maximum size of the grid is set at 0.6m since the size of the cubic stepping stone is about 0.6m. Smaller grid size is used near the bridge pier as shown in Figure 10. The total number of grid is about 80000 in the present simulation. The simulation model used is based on the two-dimensional shallow water equations with turbulence terms as follows:

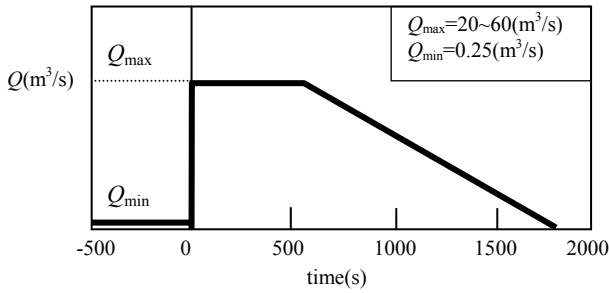
Figure 11. Input hydrograph

The above equations are discretized by a finite volume method using the flux difference scheme (FDS) for the solution of the equations (Fujita and Tsubaki, 2003, Hoffman and Chiang, 1993). Initially, small discharge Q_{min} , 0.25 cubic meters per second, is applied at the upstream tributary channels until the flow becomes stable. Then, a sudden increase of flow with a peak discharge of Q_{max} is supplied to simulate the flash flood as shown in Figure 11. The input discharge is divided in half and supplied at the upstream two tributary channels. The effect of the respective drainage channels were not taken into account in the present simulation.

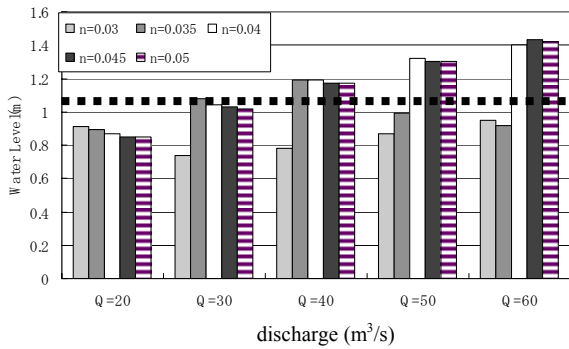
Figure 12. Comparison of water level at Kabuto Br.

Figure 12 presents comparison for the condition (a). The horizontal broken line indicates the measured data. The simulated water depth increases with the increase of input discharge. The irregular variation of roughness effect is due to the local variation of the bathymetry at the site. Figure 13 is the results for the condition (b). The horizontal shadowed zone is the estimated range of water depth. Figure 14 is the same expression for the condition (c).

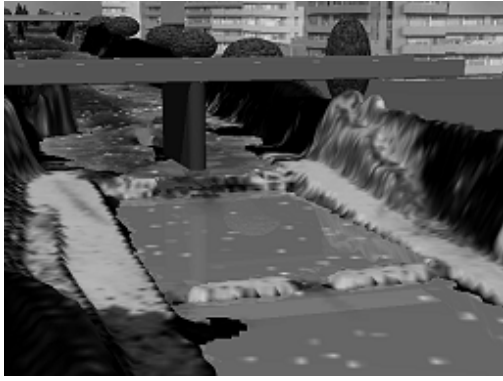
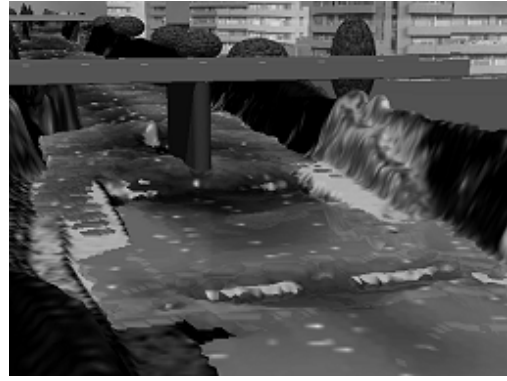
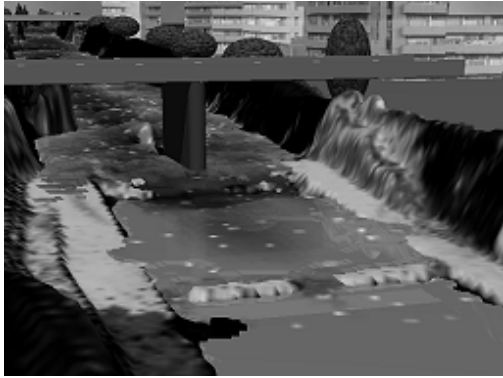
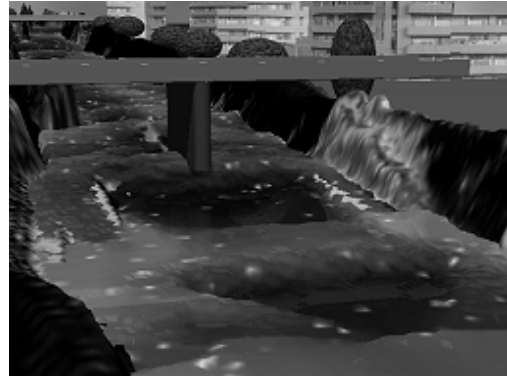
Figure 15. Three-dimensional expression of simulated results near Kabuto Br.

The simulated results of water surface patterns downstream of the Kabuto Br. at several time steps are demonstrated in Figure 15 in a form of 3D expression with an angle similar to the river monitoring camera. It is clearly seen that the flow is initially obstructed by the stepping stones in the lower channel. Then the elevated water gradually spreads upstream on the side walkways. However the backwater effect is restricted to a small region because most of flow region becomes supercritical as will be shown later in this chapter. The water surface displays significant undulation when the peak flow arrives at the section as shown in Figure 15(d). The simulated water surface configuration agrees fairly well with the image of the monitoring camera previously shown in Figure 6, except the side inflow from the drainage system. Figure 16 presents 3-D images from a viewing angle by a person left on the side walkway before and after the flash flood's arrival. Obviously the side walkways are fully covered by the water with considerable depth. The simulated results are presented by 3-D expressions from other viewing angles in a similar fashion to build animation movies, which will be distributed as an educational material for the people trying to utilize the water-friendly river environment in relatively small steep rivers.

(a) flash flood just arrived

(c) flow obstructed by steps

(b) lower channel overflow

(d) flow undulates at peak dis-

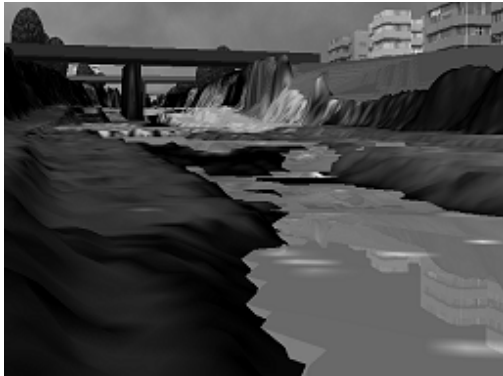
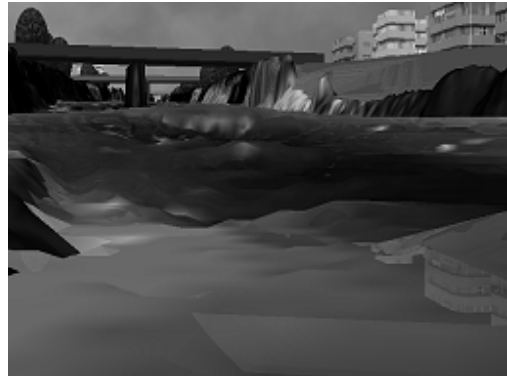
Figure 16. Three-dimensional expression from a side walkway downstream of Kabuto Br.

(a) before the arrival of flash

(b) at peak flow

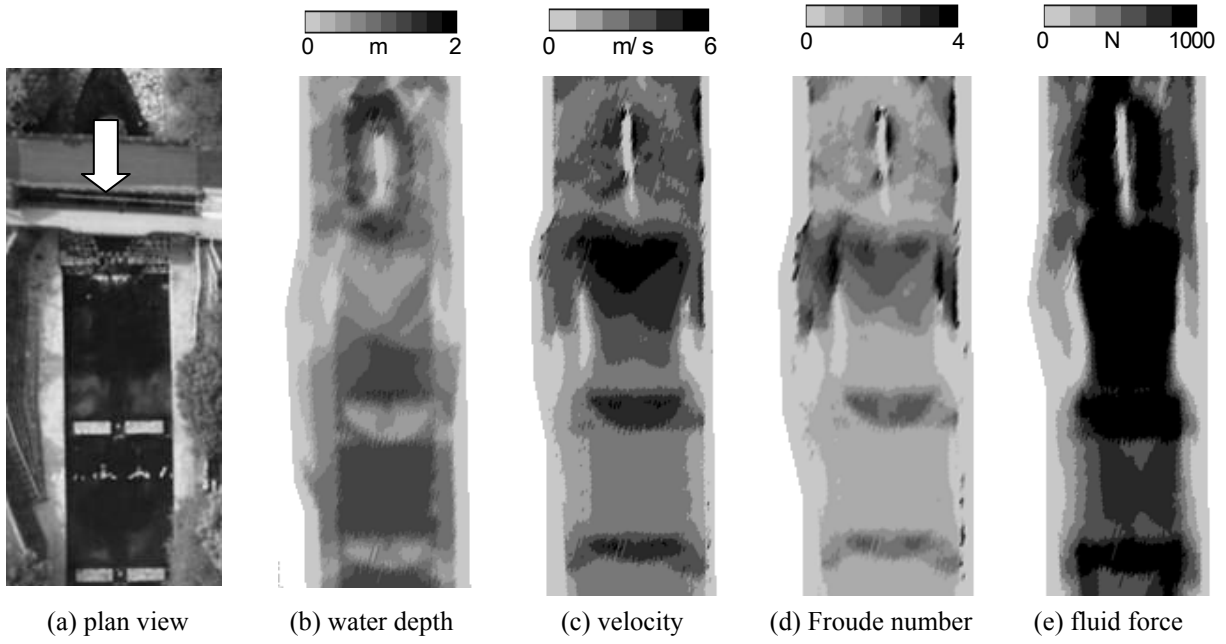
Figure 17. Distribution of hydraulic parameters at Kabuto Br.

Several hydraulic parameters in the channel downstream of the Kabuto Br. are provided in Figure 17 for the flow condition at the peak discharge together with a plan view of the site in normal condition. Figure 17(b) demonstrates that the water depth varies significantly from place to place with crossing shock waves just downstream of the bridge pier. It should be noted that local water depth becomes more than fifty centimetres even on the side walkways. Velocity distribution provided in Figure 17(c) shows that lower channel velocity becomes greater than five meters per second, while the velocity is still more than one meter per second even on the side walkways. It can be pointed out from Figure 17(d) that the Froude number distribution varies significantly from subcritical to supercritical with the maximum value of about four.

In order to examine the force acting on the people at the time of the river accident, we calculated the distribution of hydrodynamic force from water depth and velocity distributions. The shape of the human body is assumed to be two cylinders when the flow depth is smaller than 0.5 meters and a larger cylinder for a deeper flow. The drag coefficient is assumed to be one in the calculation. The distribution of the hydrodynamic force thus calculated is shown in Figure 17(e). It is obvious that people on the side walkways are subjected to the local fluid force of more than 200N. This force level is almost equivalent to the force under which people are difficult to take even a step forward in the stream (Kunita et al., 2009).

The two dimensional simulation of the flash flood occurred in the Toga River due to torrential rain is conducted to reveal the cause of the water accident. It was made clear from the distribution of hydrodynamic force acting on human body in the river that people left on the side walkways must have been difficult to evacuate after the arrival of the flash flood because of the irresistible force acting on them. Therefore, an efficient alarming system for the flash flood is required for preventing those water accidents, occasionally have occurred in Japan in the past few years.
