## Crush responses of composite cylinder under quasi-static and dynamic loading

**Published in:**  
Composite Structures

# **Crush responses of composite cylinder under quasi-static and dynamic loading**

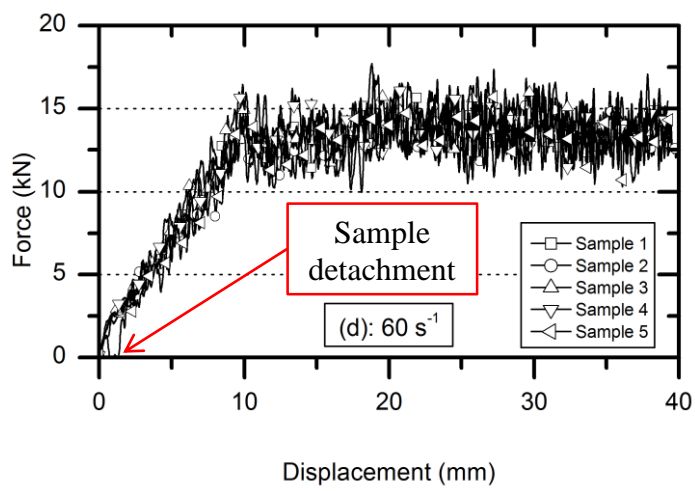
Figure 6: Force response of specimens loaded at (a)  $2.1 \times 10^{-4}$ , (b) 0.2, (c) 30, (d) 60 and (e)  $100 \text{ s}^{-1}$ , with initial specimen detachment evident in (d) and (e).

Figure 6 shows the force-displacement response recorded for each set of specimens tested at different strain rates. Due to the controlled crushing of the tulip triggers, the first 10 mm of the stroke saw a smooth, linear increase in the reaction force. This is followed by a transition to steady-state crushing of the bulk cylinder where a slight peak was observed. Once the steady-state crushing was established at approximately 15 mm of stroke, the force level remained constant until the end of the test. All response curves took on a similar form. The increasing test rate increased high frequency noise but did not change the shape of the response curve.

Some oscillatory noise can be observed in the force response, particularly in the plateau phase where steady-state crushing occurs. The magnitude of this vibration increased with increasing test rate. The adhesive used to hold the specimen to the platen, as it accelerated to the desired speed, was not sufficiently strong in some cases, particularly at the higher rates. This caused detachment of these specimens, allowing them to hit the other platen prematurely. This detachment caused the gap in the initial stages of the measured force-displacement curve (Figure 6(d) and (e)). Removing this gap yielded a force response that was indistinguishable from the force response of specimens that did not experience detachment, hence these results were retained.

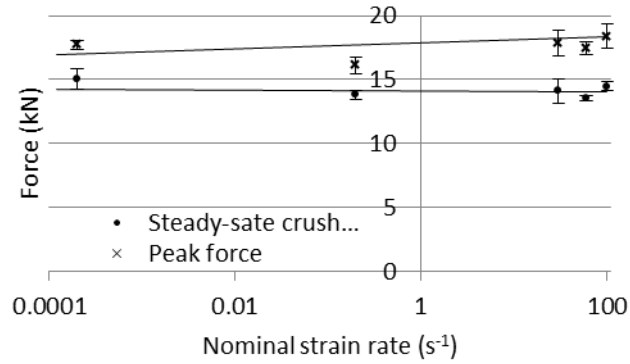
Figure 8: Averaged peak and steady-state crush load at different strain rates.

The SEA,  $F_{peak}$ ,  $F_{SS}$  and CE were calculated for each test. Figure 7 shows the averaged SEA for each strain rate along with its standard deviation. The averaged  $F_{peak}$  and  $F_{SS}$  are plotted in Figure 8 for each strain rate. The progression of CE is plotted in Figure 9.

state crush region in the high rate tests. This suggests that the increasing oscillatory noise is the cause of the increase in observed  $F_{peak}$ . The average amplitude of these high frequency oscillations increased from 4.7 kN for the  $2 \times 10^{-4} \text{ s}^{-1}$  test to 8.1 kN for the  $100 \text{ s}^{-1}$  test, which corresponded well to the apparent increase in  $F_{peak}$ . Therefore, the increase in  $F_{peak}$  with strain rate is likely a result of the vibrations in experimental testing rather than a change in the intrinsic material property. The crush efficiency falls into two distinct groups. The specimens tested on a screw-driven testing machine have higher crush efficiencies than those tested on the hydraulic testing machine. Again, the difference can be attributed to the testing method rather than changes in the underlying material properties.

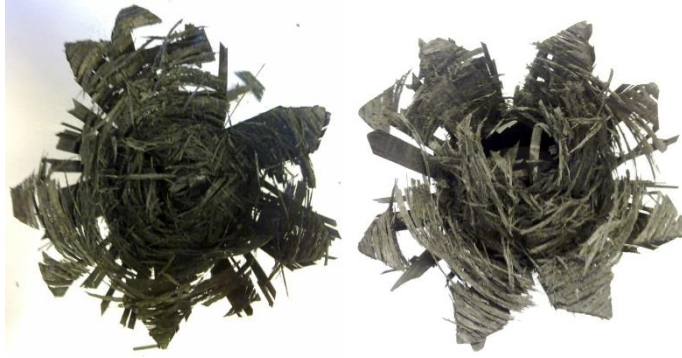
Figure 10: Typical specimens from the  $2.1 \times 10^{-4} \text{ s}^{-1}$  test.

The specimens in the present study produced reliable results under the reported testing methods. Pre-test measurement confirmed the consistency in the geometry of specimens. The responses observed between different samples within a batch for each testing condition was also very consistent in terms of the force response as well as the damage pattern. Two typical specimens in the low rate test shown in Figure 10, demonstrate their similarity. Post-test inspections showed that specimens tested under the same conditions were largely indistinguishable from each other and exhibited the same damage modes.
