THÈSE PAR ARTICLES PRÉSENTÉE À  
L'ÉCOLE DE TECHNOLOGIE SUPÉRIEURE

COMME EXIGENCE PARTIELLE  
À L'OBTENTION DU  
DOCTORAT EN GÉNIE  
Ph. D.

PAR  
Mélanie LÉVESQUE

ÉTUDE DES FACTEURS INFLUENÇANT LE MÉCANISME DES DÉCHARGES  
PARTIELLES D'ENCOCHE

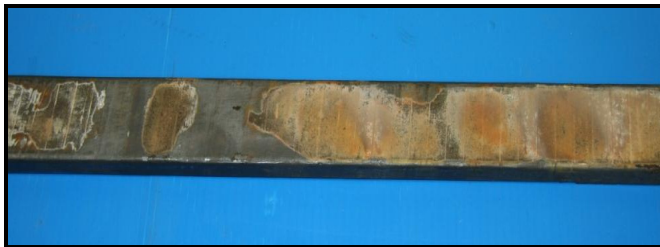
Figure 1.3 Une barre ayant été soumise à des DP d'encoche de nature purement électrique

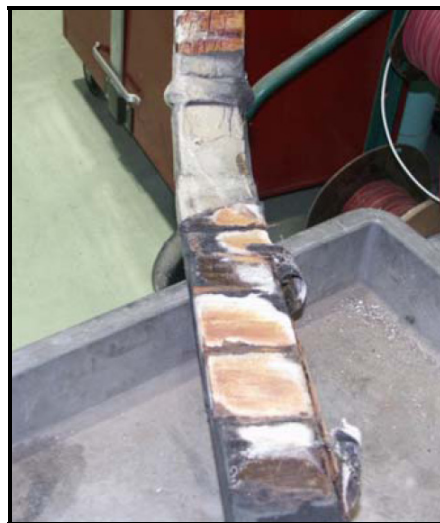
Figure 1.4 Une barre soumise à des DP d'encoche avec de la vibration mécanique

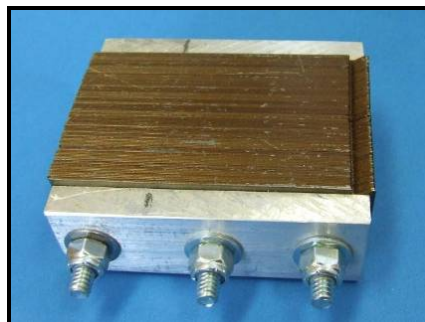
Figure 2.2 Lamination stack used for mechanical abrasion

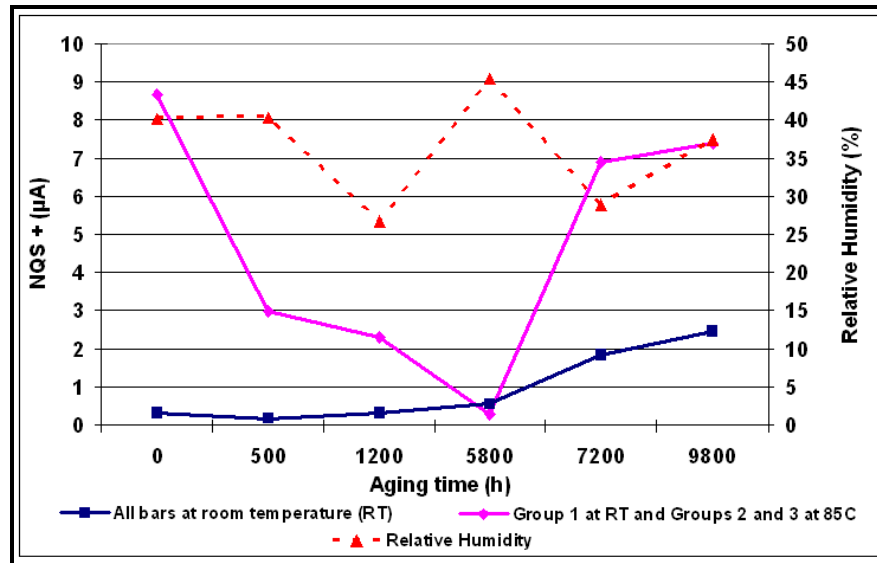
Figure 2.10 Evolution of the NQS + of all six bars in parallel measured with the capacitive coupler at room temperature and with bars of groups 2 and 3 at 85°C

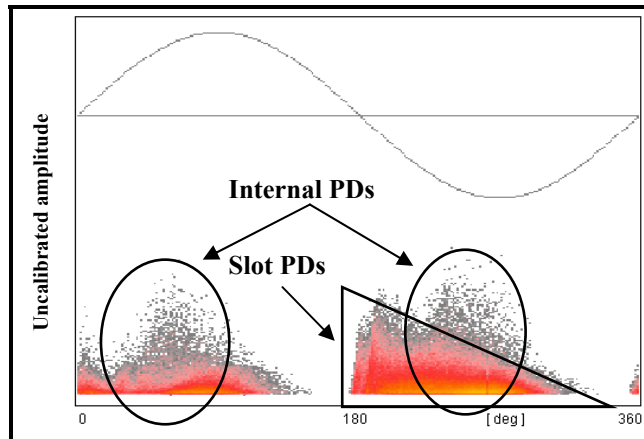
Figure 2.13 PRPD pattern measured at 8 kV in front of one slot PD site of bar 2A with the directional antenna at 85°C after 9800 h of aging time

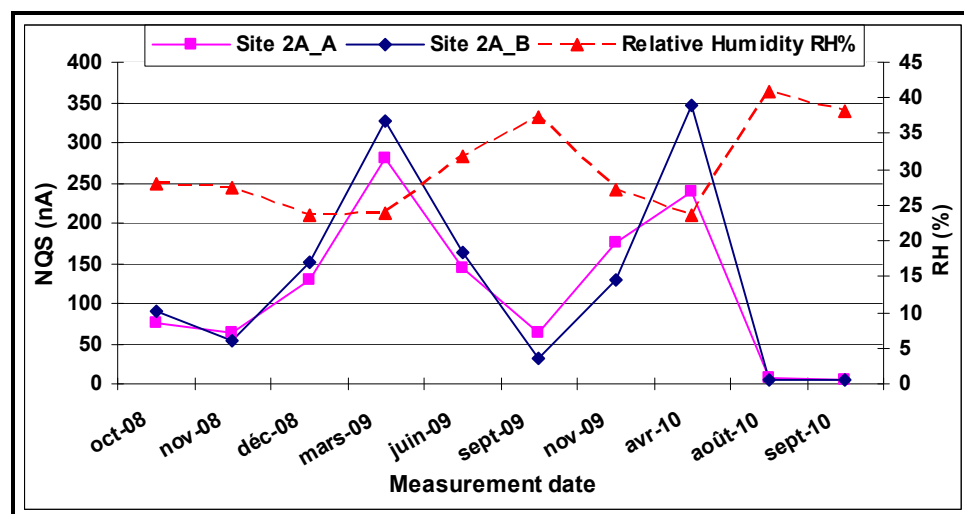
Figure 3.1 Evolution of the slot PD activity measured in front of two slot PD sites with a directional antenna at 8 kV and 85°C over a period of two years

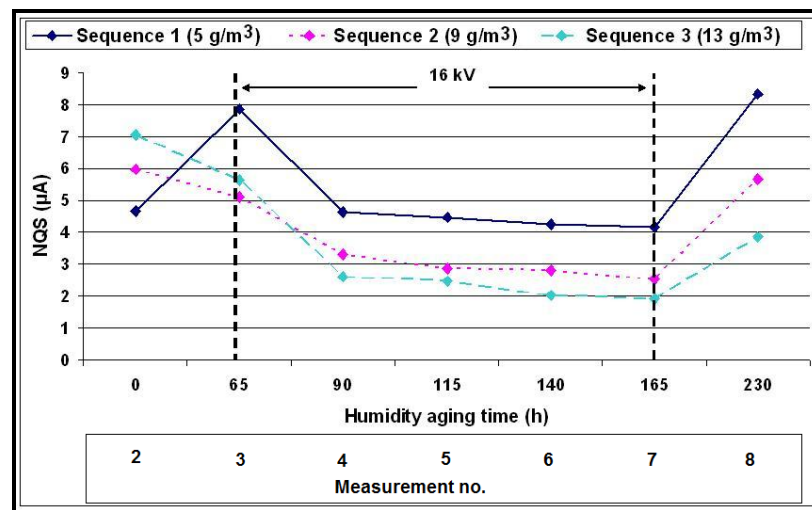
Figure 3.14 Evolution of the NQS of the slot PD site of bar B measured at 8 kV and 85°C for all aging sequences

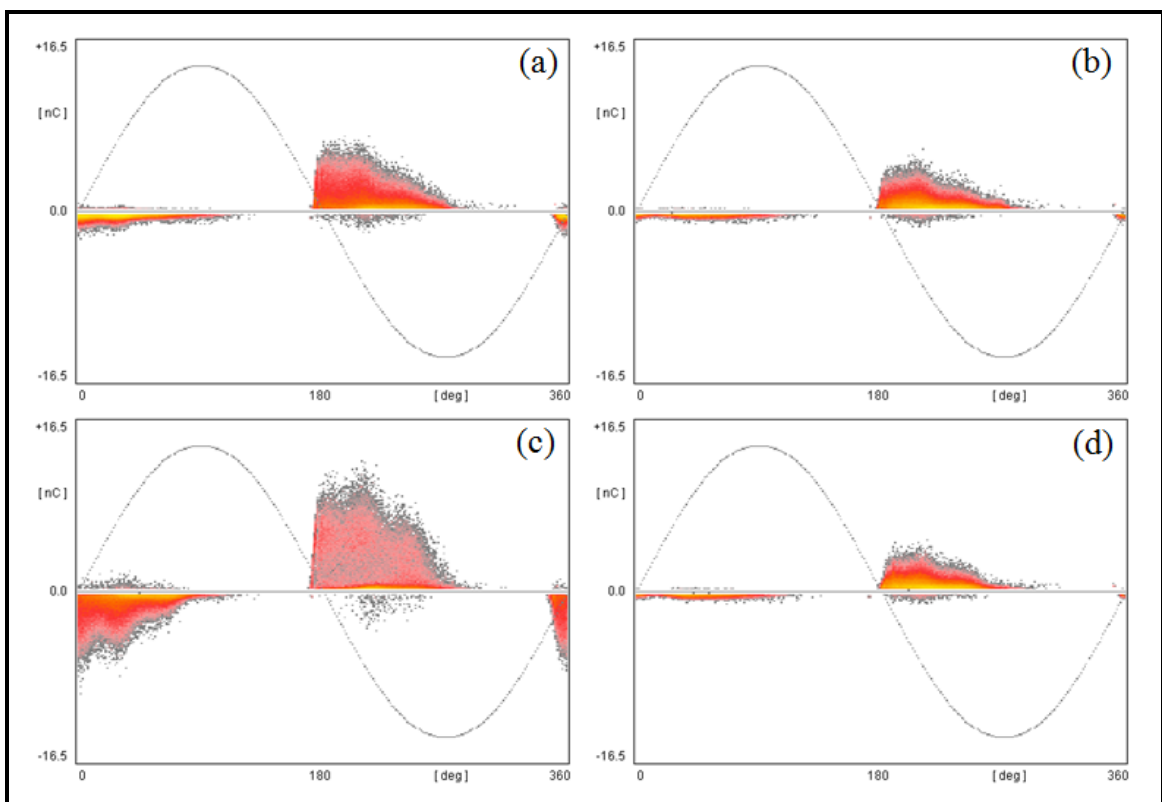
Figure 3.17 PRPD patterns measured at 8 kV and 85°C on bar B at the end of aging sequence 2, measurement 8, in all humidity conditions (a) 9 g/m<sup>3</sup>, (b) 13 g/m<sup>3</sup>, (c) 5 g/m<sup>3</sup> and (d) 13 g/m<sup>3</sup>

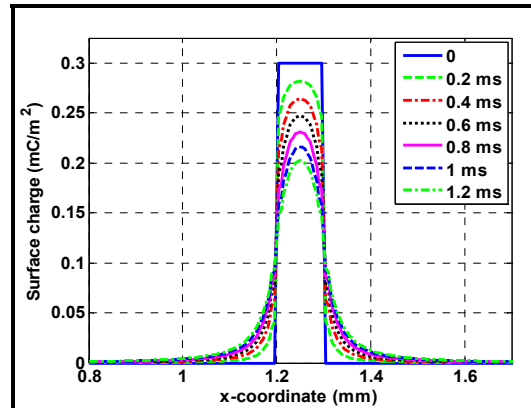
Figure 4.9 Surface charges decay for insulation surface conductivity of  $10^{-12}$  S per square

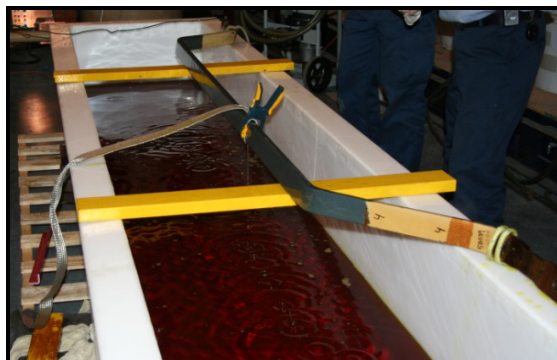
Figure 5.14 Le montage utilisé lors de l'essai de rupture diélectrique
