THESIS PRESENTED TO  
ÉCOLE DE TECHNOLOGIE SUPÉRIEURE

BY  
Abbasali SABOKTAKIN RIZI

INTEGRITY ASSESSMENT OF PREFORMS AND THICK TEXTILE REINFORCED  
COMPOSITES FOR AEROSPACE APPLICATIONS

MONTREAL, DECEMBER 20, 2013

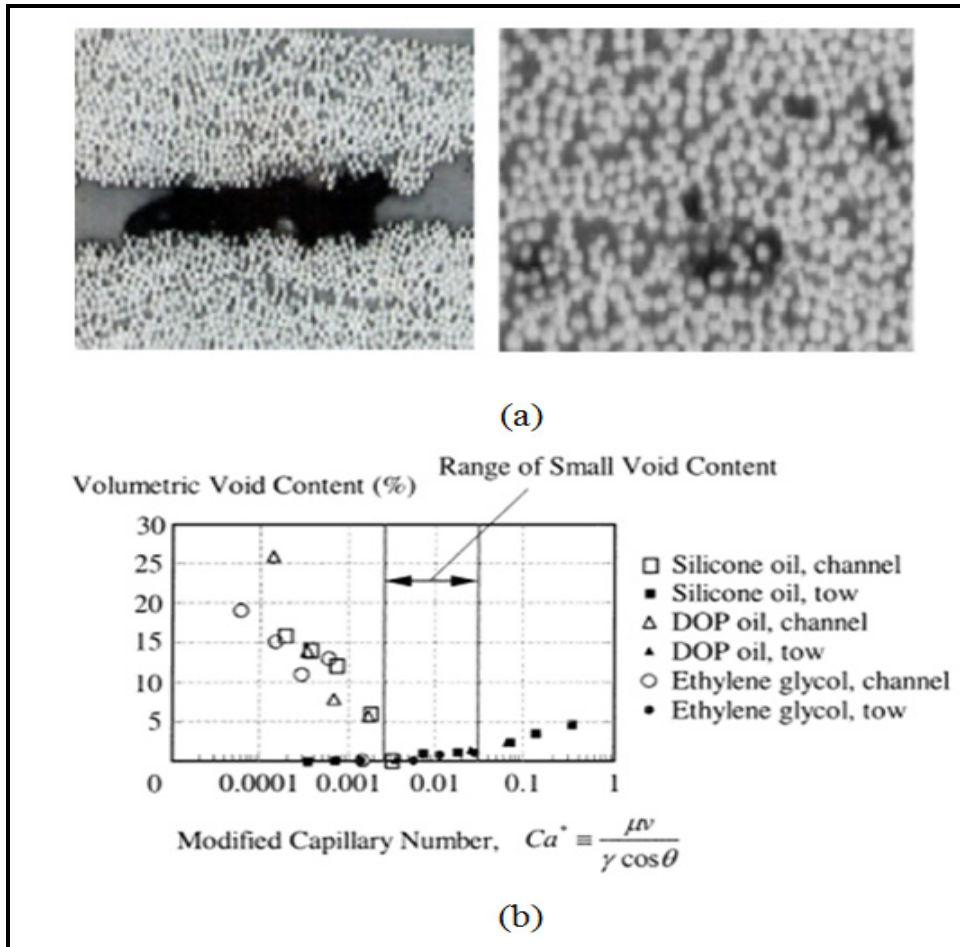
Figure 1.28. (a) Example images of void in textile composite: macrovoid (left) and microvoid (right)  
 (b) Void content vs. capillary number.  
 (Hamidi Y.K., Aktas L. and Altan M. C. , 2009)

Preform permeability: permeability which includes the characteristics of fiber dimensions and arrangement is significant parameters in resin infusion. This parameter allows controlling the fiber impregnation, complete fiber wetting and ensuring high quality textile composite structure. Non-uniform permeability because of preform inhomogeneity causes the resin velocity to change from point to point at micro scale. Differences in permeability result in either bubbles inside fibre bundles, or in the space between fibre bundles (see Fig.1.28).
