Effectiveness of Seismic Retrofitting of a Historical Masonry Structure: Kütahya Kurşunlu Mosque, Turkey

Abstract A seismic performance assessment of historical Kütahya Kurşunlu Mosque in Turkey is presented before and after it has been retrofitted. Site investigations were carried out to identify structural conditions, in which severe cracks, especially on the dome, were mapped. Regarding damage conditions, the Mosque has undergone several interventions, including retrofitting actions, in order to improve its seismic performance and global structural behavior. Effectiveness of seismic retrofitting of the Mosque was investigated by using the finite element method. Two representative structural models of the Mosque, namely non-retrofitted and retrofitted, were generated as a three-dimensional finite element model using an advanced structural analysis software. Ambient vibration measurements were performed to identify modal properties of the Mosque. Thus, the finite element model was calibrated and improved according to the experimental modal data. Nonlinear pushover and dynamic analyses were conducted to evaluate the seismic performance of the historical Mosque. This paper aims to

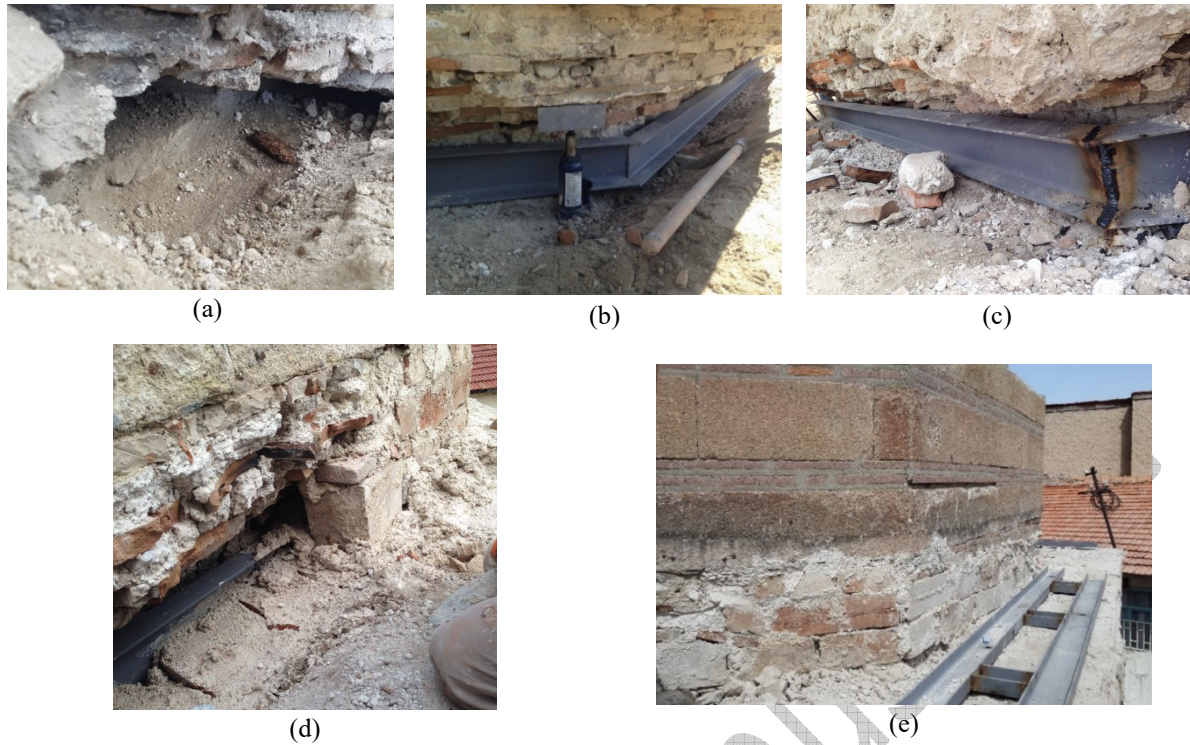
Fig. 6. Implementation of the steel girders at the bottom level of the drum, (a) loss of wooden beams, (b) steel girder elements placed at the bottom section of the drum, (c) welded connection of steel girder elements, (d) hydraulic lime-based injection and covering, (e) covering the elements with new masonry material

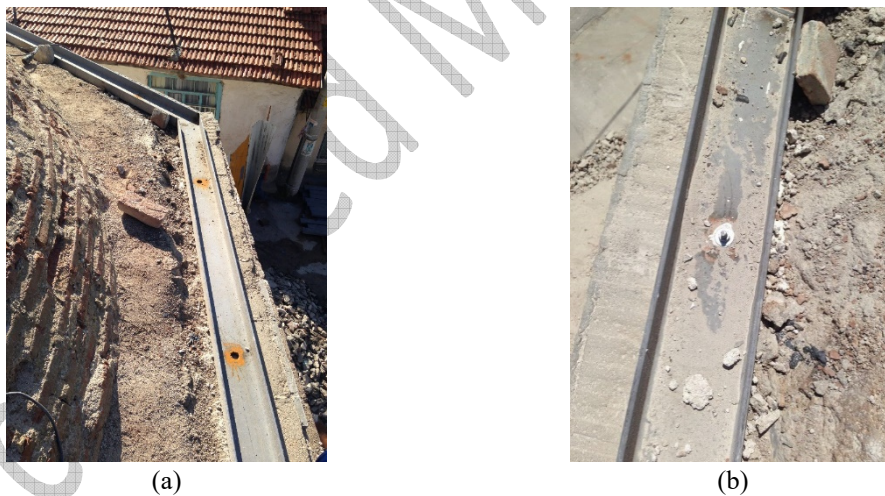
Fig. 7. Steel girder elements at the top of the drum, (a) single U160 elements, (b) steel anchor connection

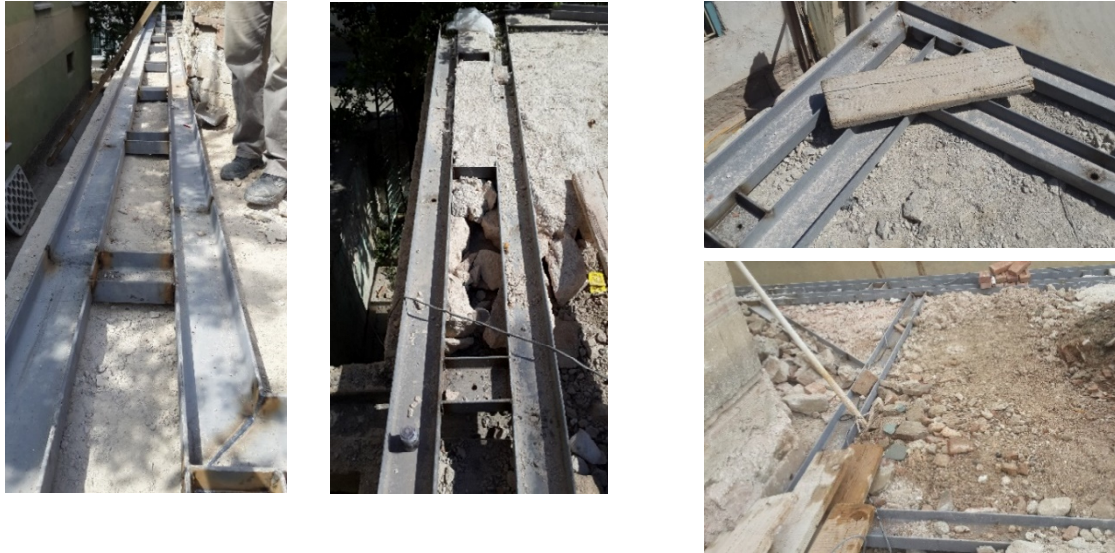
Fig. 8. Application of double steel girder (2U160) on the load-bearing walls

The steel girders were anchored at the top level of the load-bearing walls aiming to provide interaction of the structural walls (Fig. 8). Single U160 was anchored on the north wall, whereas double U160 steel elements were implemented to the rest of the load-bearing walls (see Fig. 5). All steel elements were fixed to the walls using steel anchors after hydraulic lime-based injection was applied to the anchor holes. Additionally, parallel double steel profiles were connected using U160 every meter (Fig. 8). Finally, steel girders were covered with mortar, and the dome top surface and portico was coated with lead, as shown in Fig. 9.

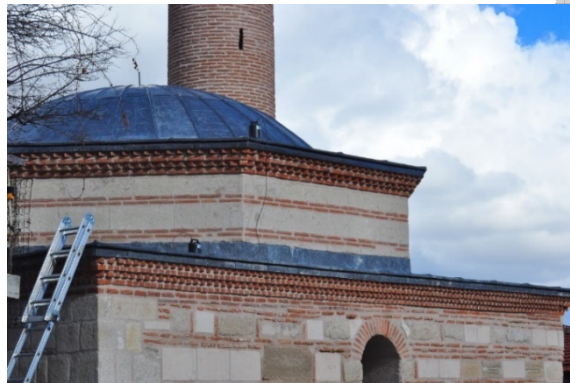
Fig. 9. Lead covering after steel girder retrofitting

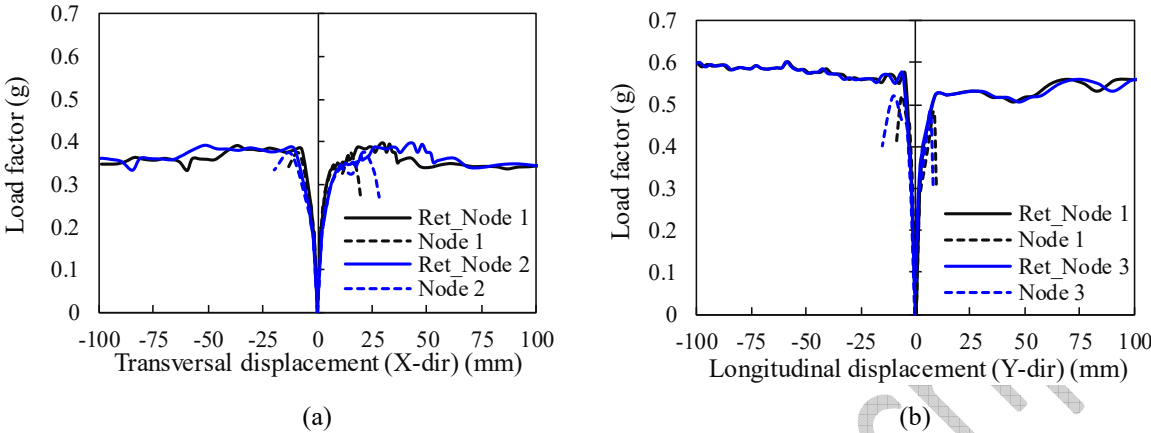
Fig. 16. The pushover curves of the non-retrofitted and retrofitted model in, (a) transversal direction, (b) longitudinal direction

The capacity curve of the Mosque was computed by considering three different control points—Nodes 1 and 2 for the transversal direction and Nodes 1 and 3 for the longitudinal direction. The control points were located on the top point of the dome, the highest level of the portico and the south wall, namely Nodes 1, 2, and 3, respectively (see Fig. 15). In Fig. 16(a), the pushover curves depict that the first crack initiates when a value of 0.18g horizontal load acted on the structure in the transversal direction. A similar cracking load was achieved for the non-retrofitted and retrofitted models, whereas the maximum lateral load in the x-direction was observed to be nearly 0.38g and 0.4g, respectively. The peak horizontal displacements are, for the non-retrofitted model, lower than the retrofitted one in the x-direction, and the post-peak ductility is much increased by the retrofitting.

A higher lateral load capacity was observed for the y-direction when compared to the x-direction. The results were expected since the area of the load-bearing walls is larger in this direction. Fig. 16(b) illustrates that the non-retrofitted representative scheme can resist a lateral load up to half of its total weight, and the capacity in the (-) y-direction increases to nearly 0.6g when the steel elements are introduced. Also, the retrofitting allowed increasing the lateral load capacity from a value of 0.48g to 0.56g for the (+) y-direction. Again, the ductility is increased enormously with the retrofitting.

Fig. 16 shows that the non-retrofitted model has a low capacity to dissipate energy—expected in historical masonry structures due to the quasi-brittle nature of the masonry. Likewise, the final loading step of the presented pushover curves do not represent the global failure of the historical Mosque, but the curves are sufficient to characterize and reproduce the local damage. On the contrary, the retrofitted model has a higher energy dissipation capacity. As the adopted seismic retrofitting improves the global response of the structure by achieving the so-called box-behavior, in-plane failure mechanisms dominate the global response and, therefore, allow a better redistribution of the imposed stresses and failure to be controlled by in-plane shear mechanisms. Similar conclusions have already been noted in different studies performed on historical structures—for instance, in Karanikoloudis and Lourenço (2018), Ciocci, Sharma, and Lourenço (2018), and Silva, Mendes, Lourenço, and Ingham (2018). It is stressed that the adopted modeling approach is unable to capture disintegration of the masonry walls during seismic loading, meaning that the designer must decide on the adequacy of the masonry arrangement to prevent disintegration or

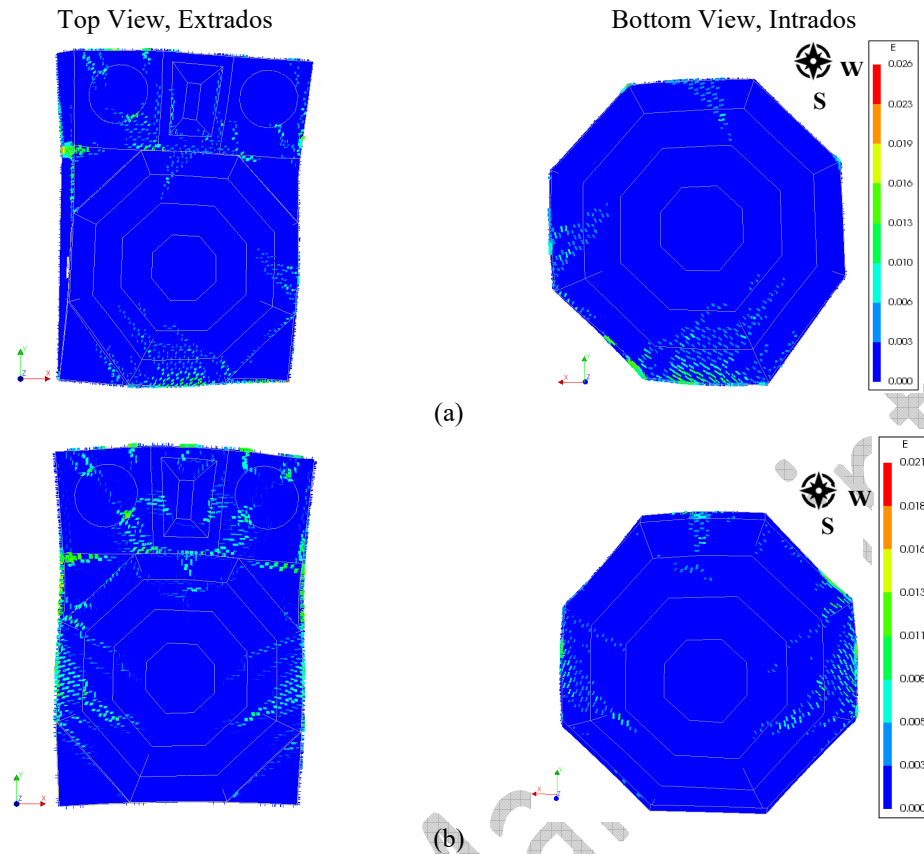
Fig. 19. Numerical damage on the dome of the non-retrofitted case in terms of maximum principal strain distribution (a) at load factor 0.27g in (+) x-direction, (b) at load factor 0.3g in (+) y-direction

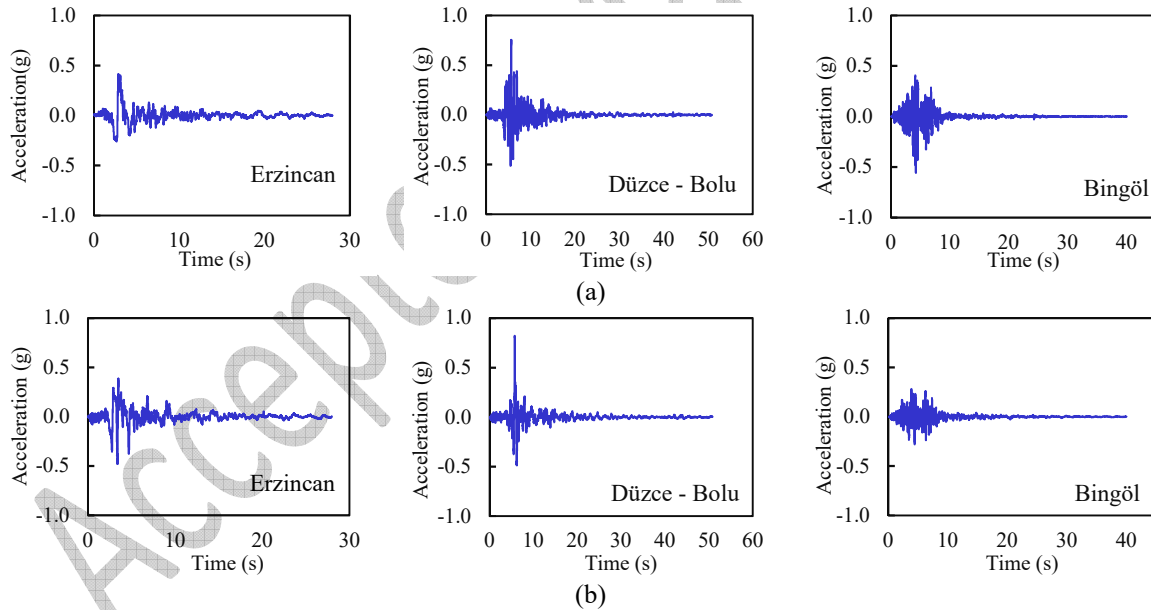
Fig. 20. Acceleration-time series of each record (TR-NSMN), (a) longitudinal component (N-S), (b) transversal component (E-W)

Since nonlinear response history analyses require high computational efforts, only a part of strong ground motion was considered in this study, aiming to speed-up the analyses. Thus, the duration of each record was shortened according to the cumulative energy duration that is proposed by Trifunac and Brady (1975), meaning that the time period under interest is in between the 5% and 95% of the total arias intensity energy. In this case, for the time instant of 20 s, the energy content of the motion reaches almost 100% of the total, and, therefore, only the first 20 s of each acceleration-time series was considered in the dynamic analyses.

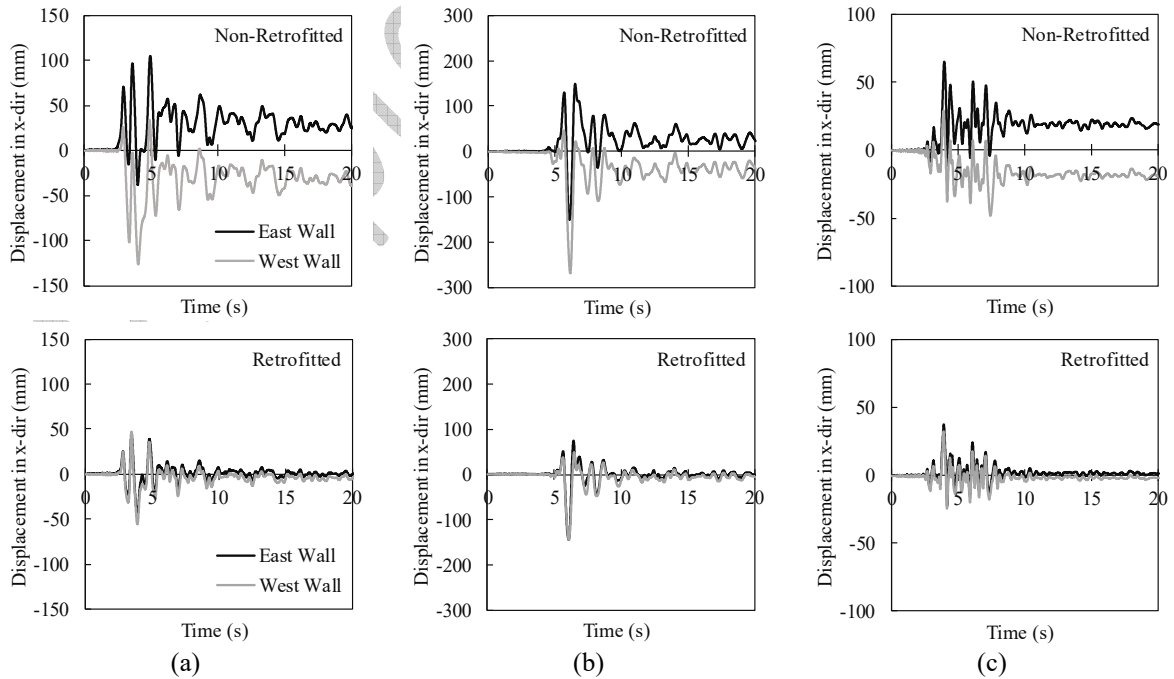
Fig. 22. Displacement-time series of control nodes at east wall and west walls for three ground motions in x-direction, (a) Erzincan, (b) Düzce – Bolu, (c) Bingöl

The change in the out-of-plane displacement with respect to time at each control node is given in Fig. 22 and Fig. 23 for both transversal (x) and longitudinal (y) directions, respectively. These figures consider parallel walls on the same plot to identify the movement direction of the components whether they are involved in a global structural behavior. The response at the two control points on the east and west walls have similar trends, but both control nodes present residual displacements in the opposite direction, as shown in Fig. 22. It is obvious that the steel girder retrofitting mitigates residual displacements. The displacements history of the nodes has a similar trend and amplitude, which can be an indication of the global structural behavior improvement. In general, a considerable decrease in the peak displacement was observed in the Erzincan and Bingöl cases. Although a reduction in the peak displacement was observed in Fig. 22(b) and Fig. 23(b), the imposed displacement values are still high and can be an indication of structural damage.

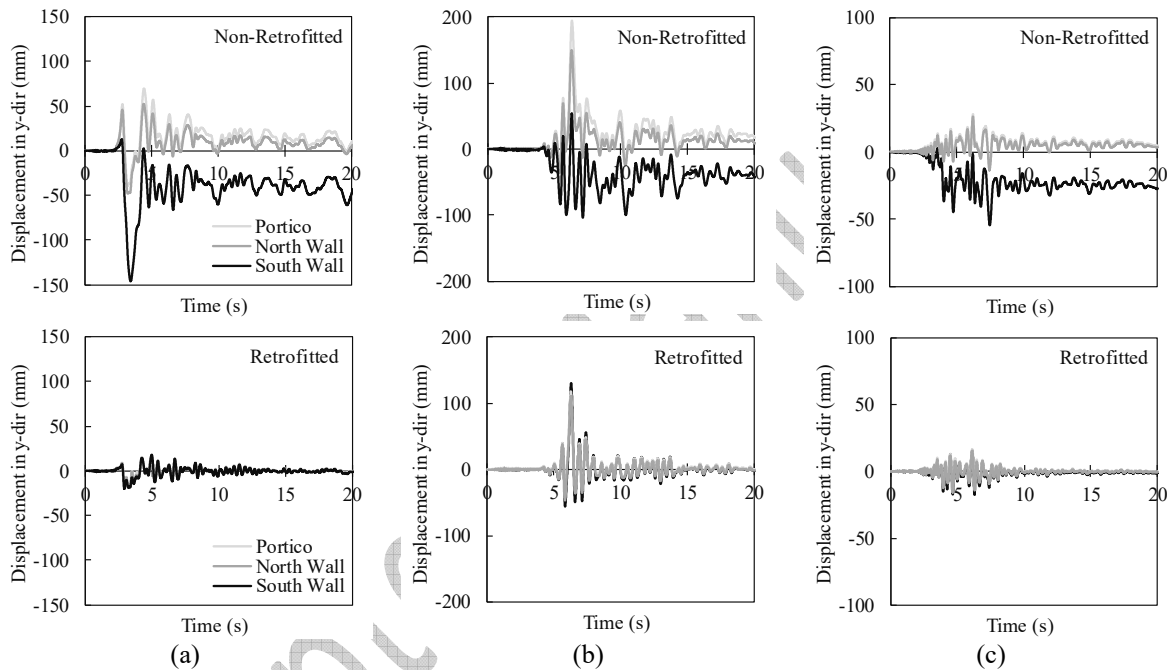
Fig. 23. Displacement-time series of control nodes at north and south walls and portico for three ground motions in y-direction, (a) Erzincan, (b) Düzce – Bolu, (c) Bingöl

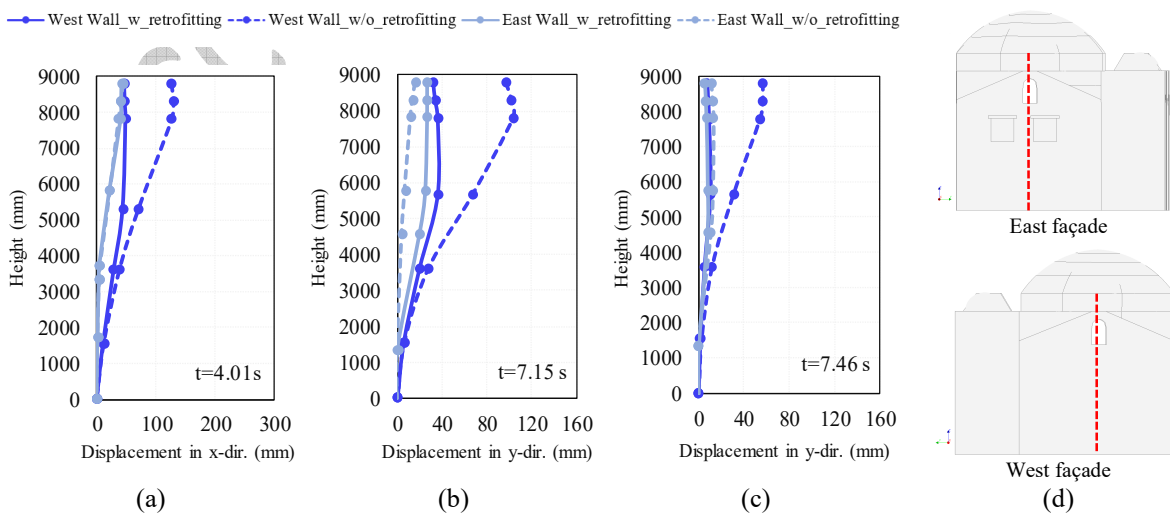
Fig. 24. Change in out-of-plane behavior in terms of absolute displacement at time-step when west wall has peak displacement, (a) Erzincan, (b) Düzce - Bolu, (c) Bingöl, (d) location of the section cuts

Displacement-time series and peak displacement at each control point at the top level of the walls may not be representative of the change in response. Therefore, the displacement response in the out-of-plane direction along the height of the structural walls (west/east), for transverse action, were plotted as an example. In order to plot these curves, a time-step of the peak displacement response which occurred at the control point on the non-retrofitted model was considered, and the vertical section of the mid-length of the wall was considered as the section cut (Fig. 24(d)). In all plots, the section above 7.8 m represents the drum where the dome is supported. However, there is no significant change in relative displacement on the drum section. Due to the fact that two parallel walls do not have maximum out-of-plane displacements at the same time-step, only the time-step when the west wall has the maximum displacement were presented in this paper, as given in Fig. 24. Again, it is clearly seen that implementing steel girders allow reducing the observed out-of-plane displacement of the walls along the height.

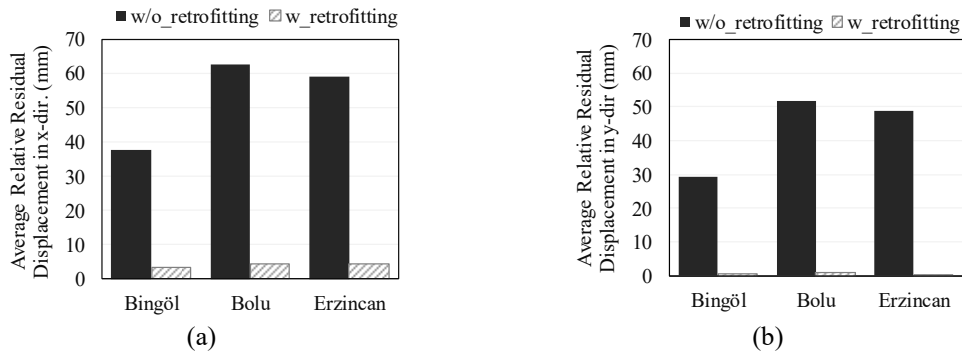
Fig. 27. Variation in the average relative residual displacement with respect to each ground motion, (a) transversal direction, (b) longitudinal direction

Additionally, relative residual displacements were computed by taking the average of the displacement in the time interval after the ground motion reaches nearly 90% energy, which corresponds to 10 s to 20 s of each record in Fig. 22. Relative out-of-plane displacement in the non-retrofitted model is high, which leads to expansion of the dome and results in high tensile stresses. As stated before, severe damage in the form of large cracks was observed on the dome during the site investigations. It can be concluded that the high relative displacements in the out-of-plane directions contributed to the severe cracks observed on the dome. On the contrary, an improvement in the response for the retrofitted model is clear and is presented in Fig. 27 for both directions. A limited expansion of the dome in both orthogonal directions can be addressed due to presence of steel girders.

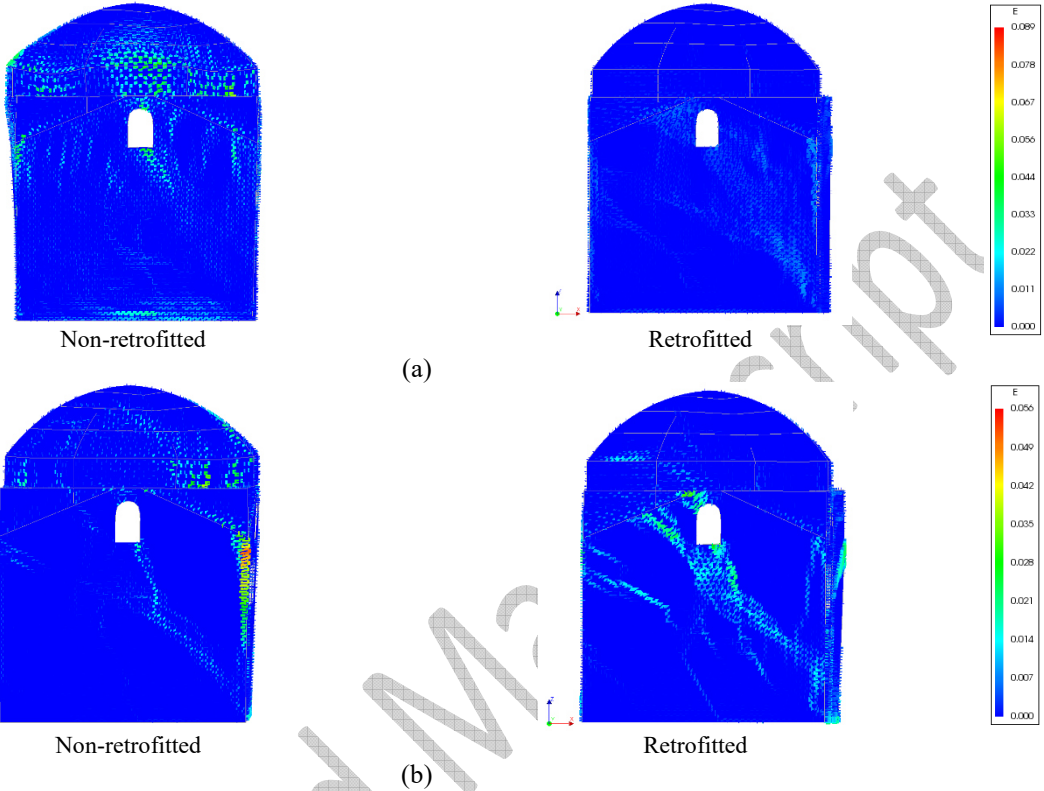
Fig. 29. Total principal tensile strain distribution on the south façade of the numerical models due to dynamic loading, (a) Erzincan Earthquake at time-step 3.43s, (b) Bingöl Earthquake at time-step 3.99s

Fig. 29, Fig. 30, and Fig. 31—the strain distribution on the south, west, and east façades presented similar damage pattern to Fig. 17, respectively, when numerical model subjected to different dynamic loadings. In fact, the strain pattern obtained from the retrofitted case shows that the structure was dominated by in-plane behavior, whereas out-of-plane movement was observed in the non-retrofitted case (see Fig. 29).

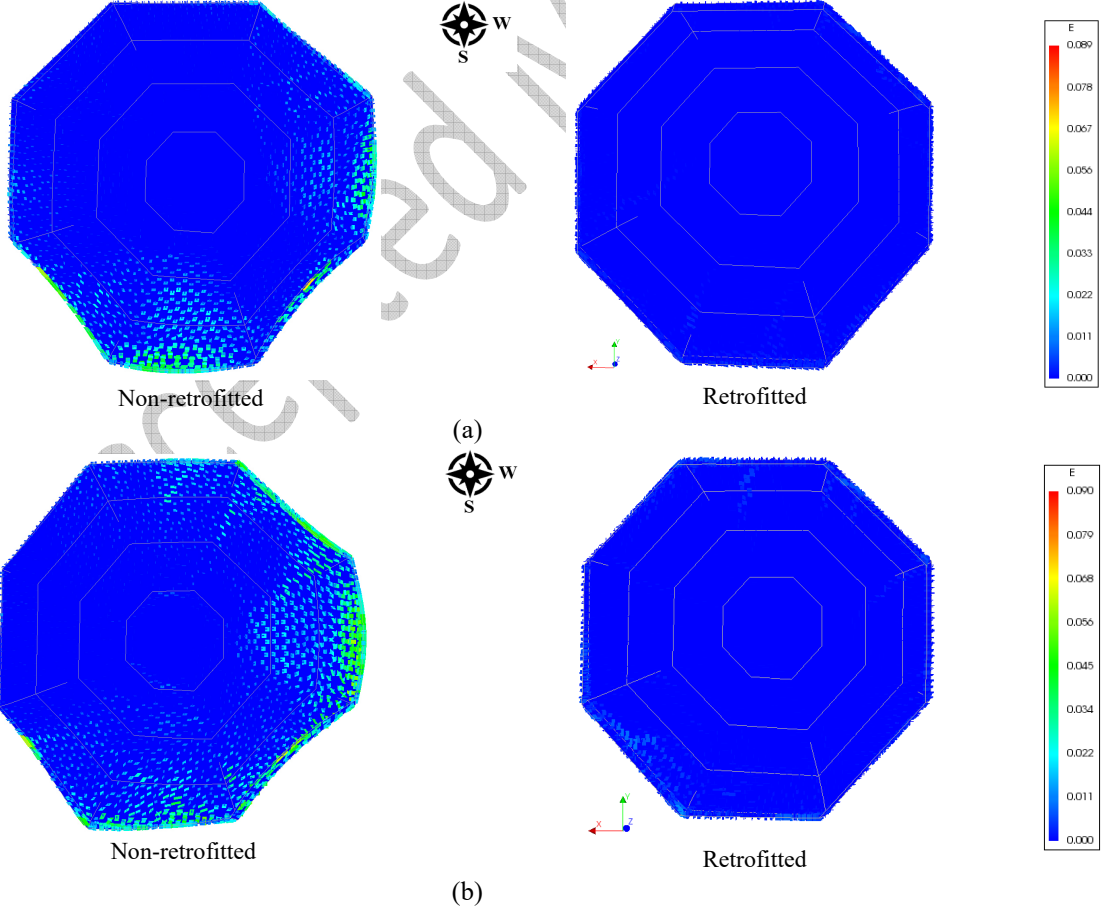
Fig. 32. Total principal tensile strain distribution on the dome of the numerical models subjected to (a) the Erzincan Earthquake at time-step 3.43s, (b) the Bolu Earthquake at time-step 6.12s

Moreover, nonlinear dynamic analyses satisfactorily reproduce the damage observed on the dome, in which the orientation of the parallel cracks shown in Fig. 3 and Fig. 4 are compatible with the principal tensile strain distribution (Fig. 32). Fig. 3 illustrates that both parallel cracks propagate until the drum section, which was also observed on the non-retrofitted numerical model, and the concentration of the tensile strains corresponds to the location of the real damage.
