A preliminary assessment of the state of preservation of the wreck of the *Belgica*

David Gregory¹, Poul Jensen², Kristiane Strætkevørn³,
Tom Lenaerts⁴ & Marnix Pieters⁵

Such a pre-disturbance survey of the state of preservation of the wreck of the *Belgica* was carried out in connection with proposals to raise her. The aims of the assessment were fourfold:

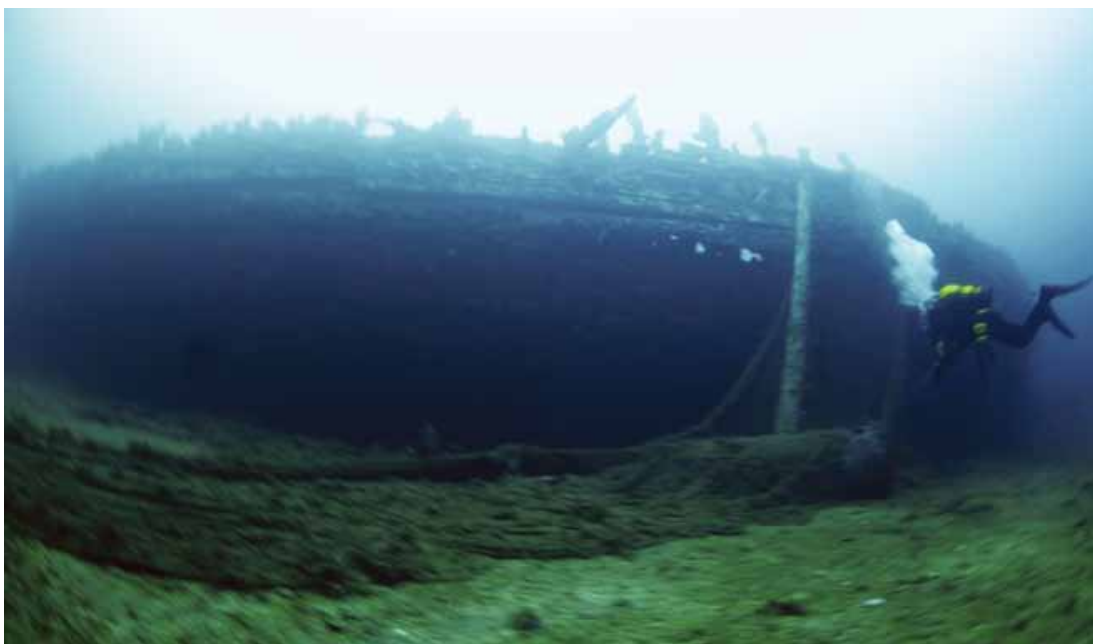
FIG. 4 The wreck of the *Belgica* lying on the seabed, view on starboard side (Courtesy Tom Leys).

In order to obtain the necessary field data for the assessment of the state of the preservation of the *Belgica* two successive field campaigns were organised in the first half of 2008. The aim of the first campaign was to make a comprehensive photographic record of the wreck. This was carried out in February to ensure maximum underwater visibility due to limited algae in the water during winter months. In order to facilitate this documentation, a large fishing net that had been colonised with seaweed and was covering the central and lower parts of the wreck, was removed. A photomosaic of the wreck was taken (fig. 8) with overlapping pictures for the mosaic being taken along the longitudinal axis of the wreck, more or less at the same level above the wreck. This photomosaic allowed for the first time a visual overview of the entire wreck and was subsequently used to locate the samples taken for assessing the structural strength of the wood. The mosaic will also be used for the further archaeological analysis of the wreck. During this campaign, details as well as overviews, such as fig. 4, showing the starboard side of the wreck were also taken.

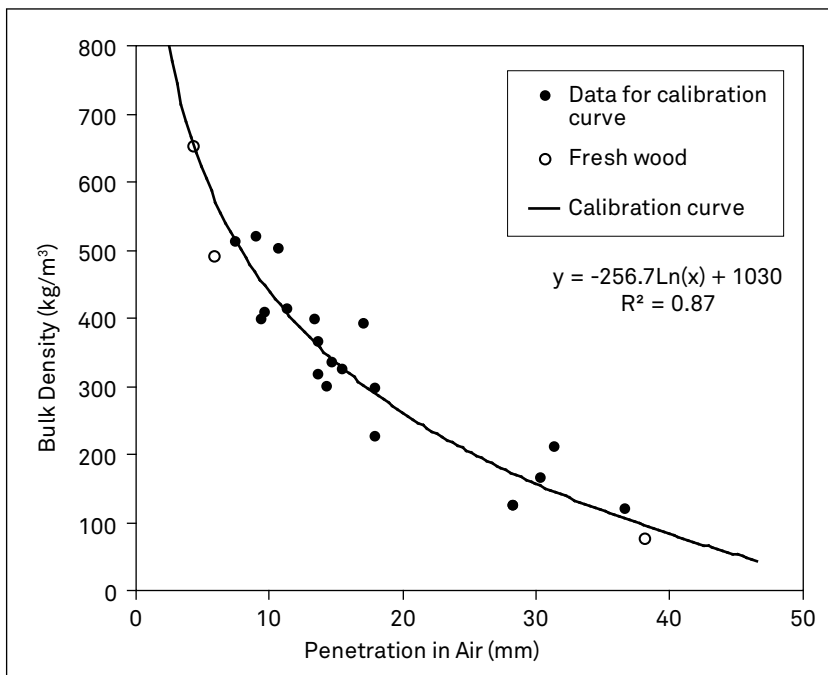
FIG. 12 Correlation between the depth of pin penetration and bulk density of waterlogged archaeological wood.
Correlatie tussen de penetratiediepte van de pin en de schijnbare dichtheid van het waterverzadigde archeologische hout.

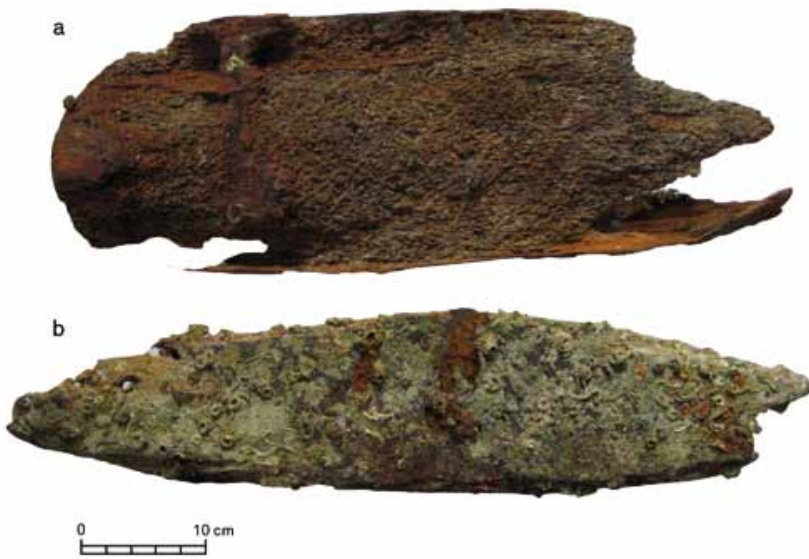
Figure 13 shows the two samples of oak wood taken to assess the activity of wood boring organisms. There were definite signs of colonisation by fouling organisms. These organisms tend to live on the surface of the wood rather than bore in to the wood (figures 14 and 15).

FIG. 13 Two samples of wood taken from the wreck of the *Belgica*.
Twee houtstalen van het scheepswrak van de Belgica.

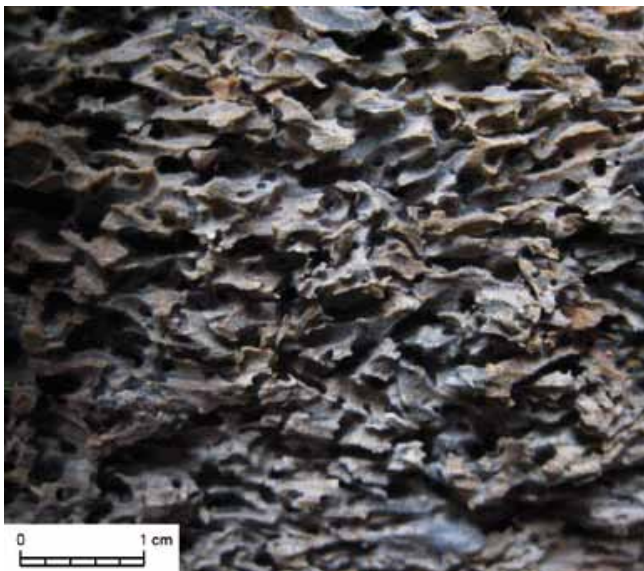
FIG. 14 Surface of wood sample (figure 13a) extensively degraded by gribble.
*Oppervlak van een houtstaal (figuur 13a) dat in sterke mate is aange-
tast door paalpissebed.*

The surfaces of both wood samples were heavily degraded by the activity of wood boring crustacea (figure 14). Although there were no signs of living organisms on the wood, it should not necessarily be concluded that they are not present and active on other parts of the wreck.

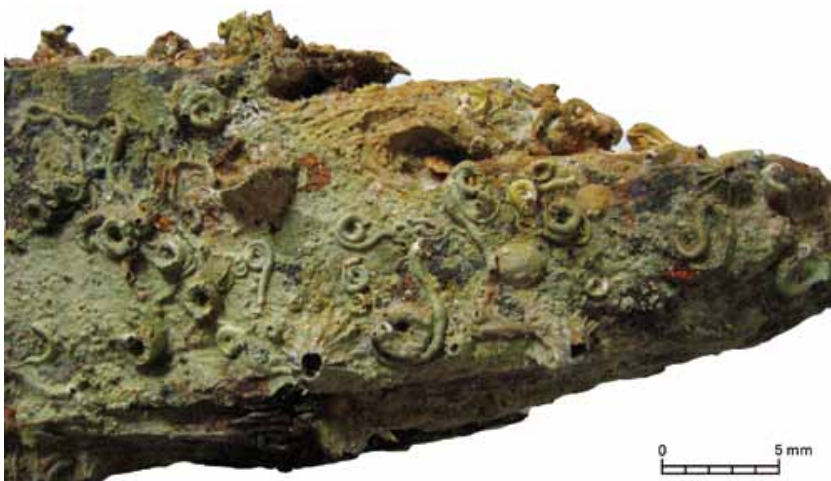
FIG. 15 Close up of biofouling organisms on the surface of wood (figure 13b), including calcareous tubeworms and barnacles.
Detailopname van biologische aangroei op het houtoppervlak (figuur 13b) met inbegrip van kalkhoudende buiswormen en zeepokken.
