Characterization of an HY-130 steel weldment by
transmission electron microscopy.

THESIS

CHARACTERIZATION OF AN HY-130 STEEL WELDMENT
BY TRANSMISSION ELECTRON MICROSCOPY

December 1981

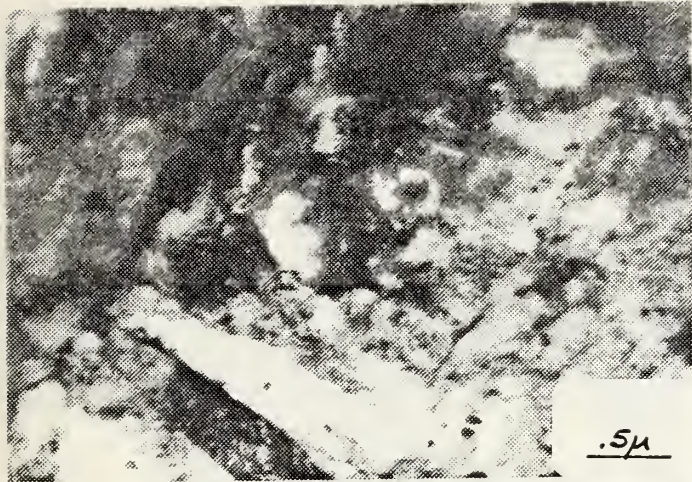
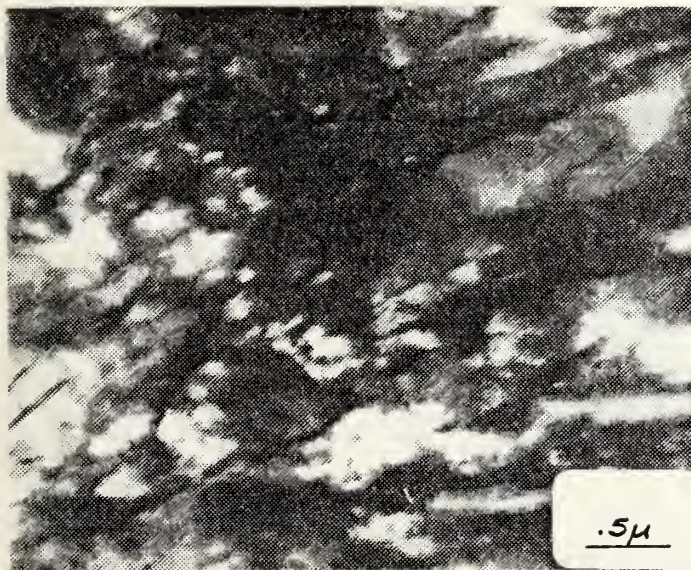
Figure 12

MICROSTRUCTURES AT
3.25mm. DISTANCE FROM
FUSION LINE, ALL
PHOTOGRAPHS AT 22,000X
WITH TEM

heavily dislocated martensitic microstructure, but the large carbides are still visible, the hardness of all the regions show that they represent the HAZ region nearest the base metal.

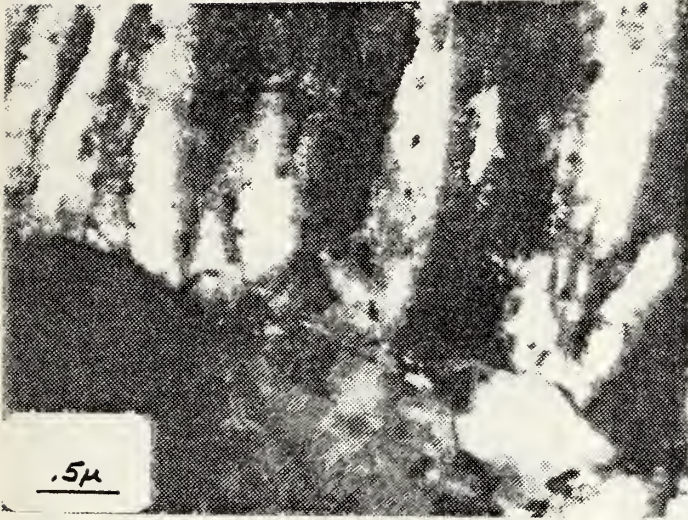
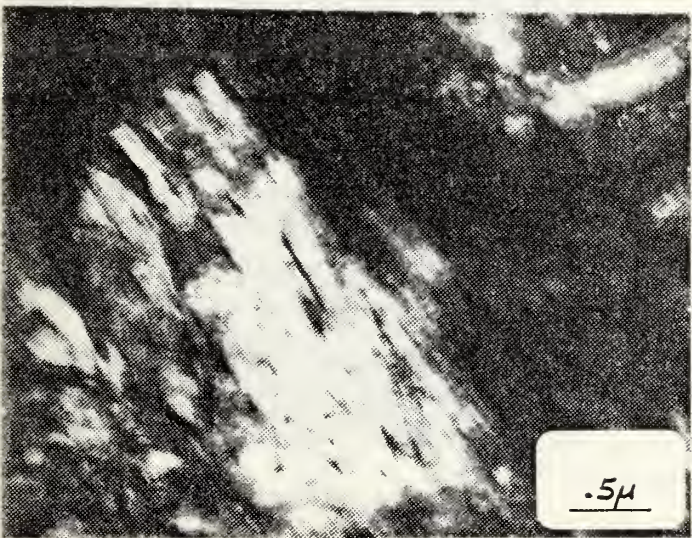
Figure 13

Changes begin to appear in the next region which represents the HAZ at a distance of 2.5mm. away from the fusion line, figure (13). Although the predominant microstructure is still martensite, very few large carbides are visible, and region 3 shows bainite I (upper bainite) with Widmanstatten carbides in a wide bainitic lath as sharply contrasted to the narrow lath spacing of the martensitic microstructure. Region 4 shows some granular bainitic microstructure within a predominantly martensite and bainite I field. Region 2 shows martensite with an occasional ferrite region bordering the martensite-bainite interface. Large carbides encircle the ferrite, and retained austenite is also suspected in this region. Figure (14) shows a ferrite, and typical microstructure of region 3 with the wide bainite I laths shown in contrast to the martensitic microstructure. Within the bainite, large regions of rod-shaped Widmanstatten carbides are present along with martensite. The photo at the right is an enlarged view of the Widmanstatten carbides within an upper bainite region. The corresponding diffraction pattern is shown in figure (14) with the very faint carbide reflections present near the central spot.

MICROSTRUCTURES AT 2.5mm.
DISTANCE FROM FUSION
LINE ALL
PHOTOGRAPHS AT 22,000X
WITH TEM

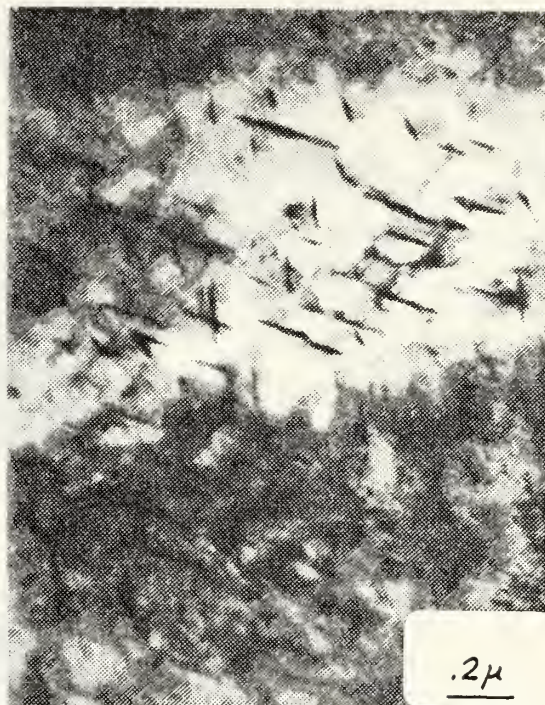
Figure 14

MICROSTRUCTURE AT 2.5mm. AWAY FROM THE FUSION LINE IN REGION 3 WITH THE PHOTO ON THE RIGHT AN ENLARGEMENT OF THE ROD-SHAPED WIDMANSTATTEN CARBIDES PRECIPITATED IN THE UPPER BAINITE ON THE LEFT

SELECTED AREA
DIFFRACTION PATTERN
SHOWING CARBIDES IN
ENLARGED PHOTO AT
RIGHT

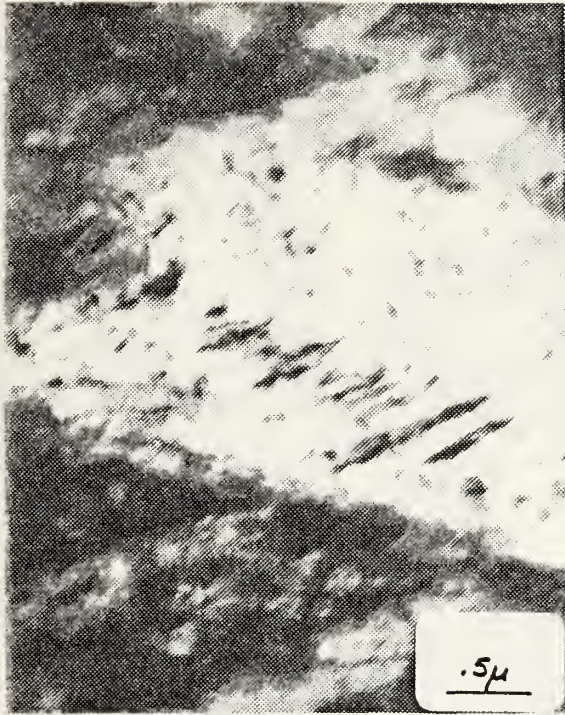
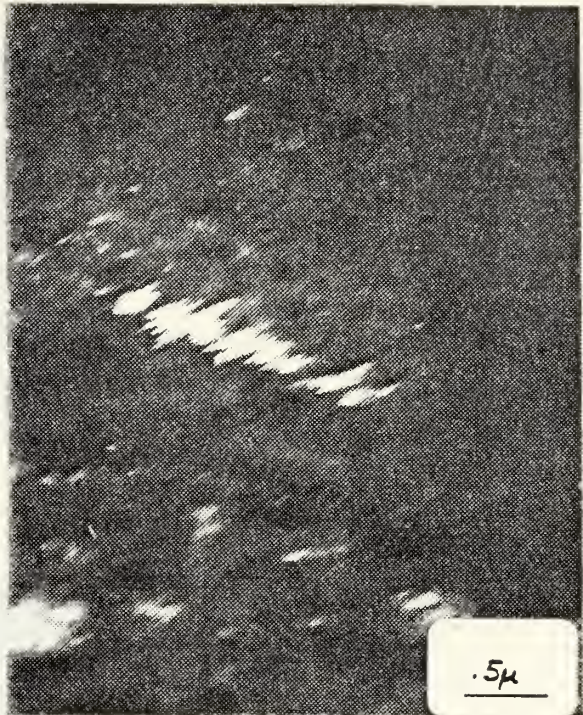
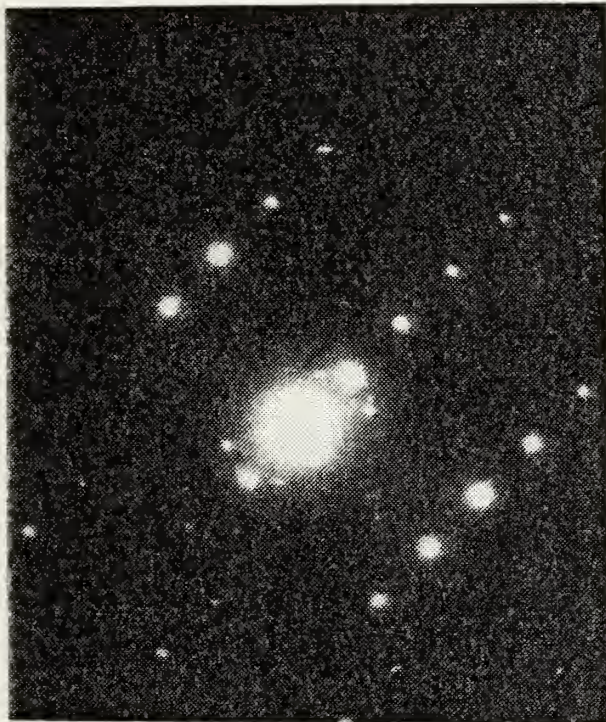
Figure 17

the wide bainite I laths. Figure (17) shows the dark field-bright field microstructures from a region of section 4 with the presence of twinned martensite in the wide laths encompassing the Widmanstätten carbides. This twinning is not characteristic of such a slow cooled weldment, but is known to occur in bainite I as a result of alloy segregation. [Ref. 11] The associated selected area diffraction pattern reveals this twinned martensite and is shown in the same figure.

MICROSTRUCTURE SHOWING TWINNED MARTENSITE IN THE UPPER
BAINITE OF REGION 4

SELECTED AREA
DIFFRACTION OF ABOVE
SHOWING TWINNED
MARTENSITE

carbides appear in the narrow martensite laths, indicating some autotempering may have occurred. Twinned martensite was occasionally found in this region, probably due to alloy segregation, figure (17). There is some retained austenite suspected in this region, which is reasonable when the rapid cooling rate from 1170°C experienced by this region is considered. Chen and Thompson [Ref. 12] illustrate similar micrographs of retained austenite in their work, especially in regions of upper bainite.

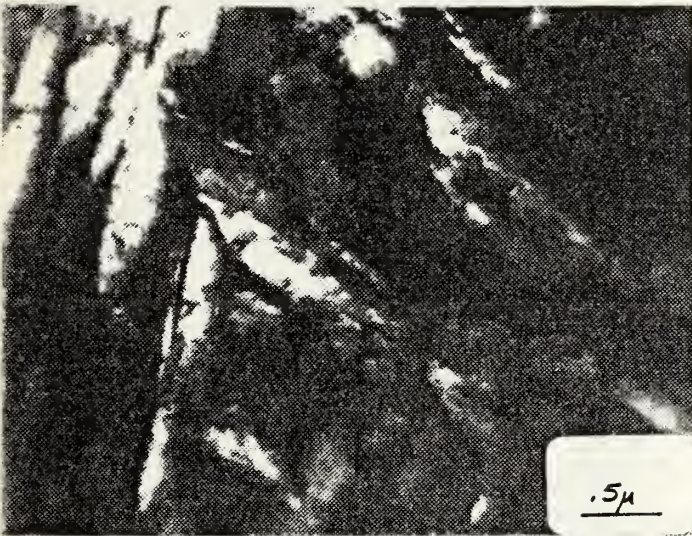
Figure 18

The fusion line region is shown in figure (18) and for the first time. Bainite III (lower bainite) is observed. The acicular bainite laths show some carbides at boundaries and interior regions. The amount of carbides visible has greatly decreased from those seen in other regions of the HAZ, and the laths are narrower and shorter than those of bainite I.

MICROSTRUCTURES AT
FUSION LINE, ALL
PHOTOGRAPHS AT 22,000X

The sections representing the fusion line, as shown in figure (18), are subjected to a temperature of approximately 1536°C. The microstructure consists of primarily lower bainite. Carbides are not visible and, since the temperature (1536°C) would be high enough to ensure complete solutioning of the carbon and the possibility of some mixing with weld metal, the M_s temperature would be lower at the fusion line than for any other region of the HAZ, thus allowing lower bainite to form. The cooling rate in this region is fairly rapid, and is at least 17°C per second given by Sorek, [Ref. 9] which exceeds the 8°C per second cooling rate required for martensite formation as discussed by Holsberg. [Ref. 15] Another explanation for the lower bainite present at the fusion line is that dilution of the base metal (5% nickel) probably occurred, mixing with the weld metal (2.76%nickel) producing a lower hardenability and
