METHODS & TECHNIQUES FOR THE ANTI-EROSION AND ANTI-FLOODING PROTECTION IN MOUNTAINOUS DRAINAGE BASINS IN EVRYTANIA (GREECE)

A. Mertzanis¹, S. Kosmas², A. Papadopoulos¹, A. Kosmas³ and F. Marabini⁴

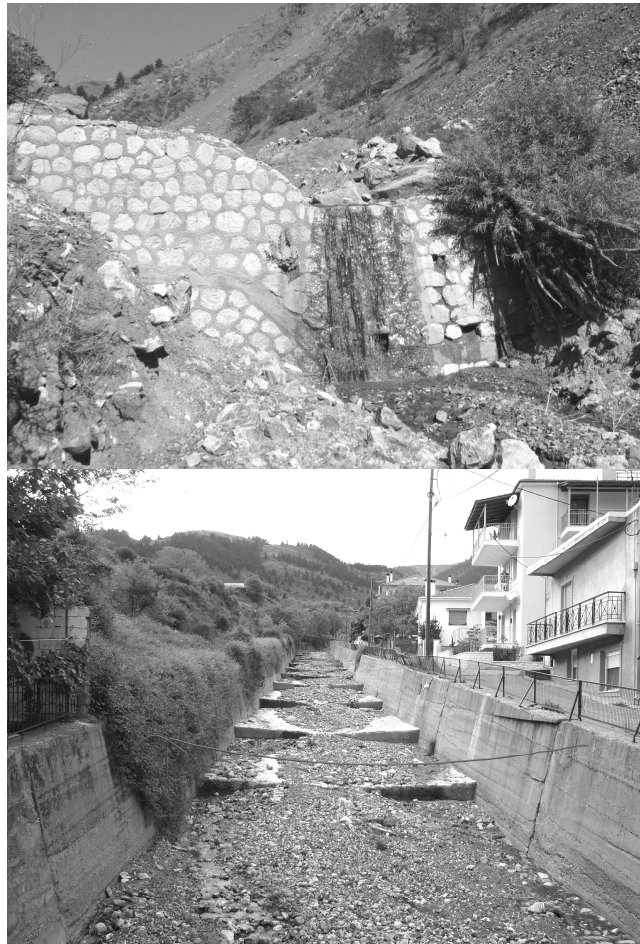
Fig. 1a & 1b - Works for the settlement of the torrent Klarotos. Stone dam for the settlement of branch Kotronakia (1a). Picture 1a shows the extra elevation of the dam in order to make it more efficient. Artificial sheeting of the bed of the torrent Klarotos in the town of Karpenisi (1b). (Source: A. Mertzanis)

The works for the re-direction of the torrent Klarotos the first of which were constructed already since 1956, by the Forest Authority, were successful. The streambed was “secured” since it acquired fixed points the ravine and gradient erosion and the sliding and land sliding were put under control and until recently the torrent did not create any flooding problems in the town of Karpenisi, given that, that from time to time the initial works were enforced with complementary smaller scale works which were constructed during the 1971, 1980, 1984, 1987, 1997 and 1998 (Figures 1a & 1b). The works for the re-direction of the torrent were constructed only up to the base of the steep slope, due to technical difficulties and also due to the coarseness of the relief (Kosmas S., et al. 2009).
