**National Oceanography Centre
Research & Consultancy Report No. 11**

NOC turbulence glider deployment report
for the Liverpool Bay Coastal Observatory
June 2011 Deployment

C Balfour, P Knight & D McLaughlin

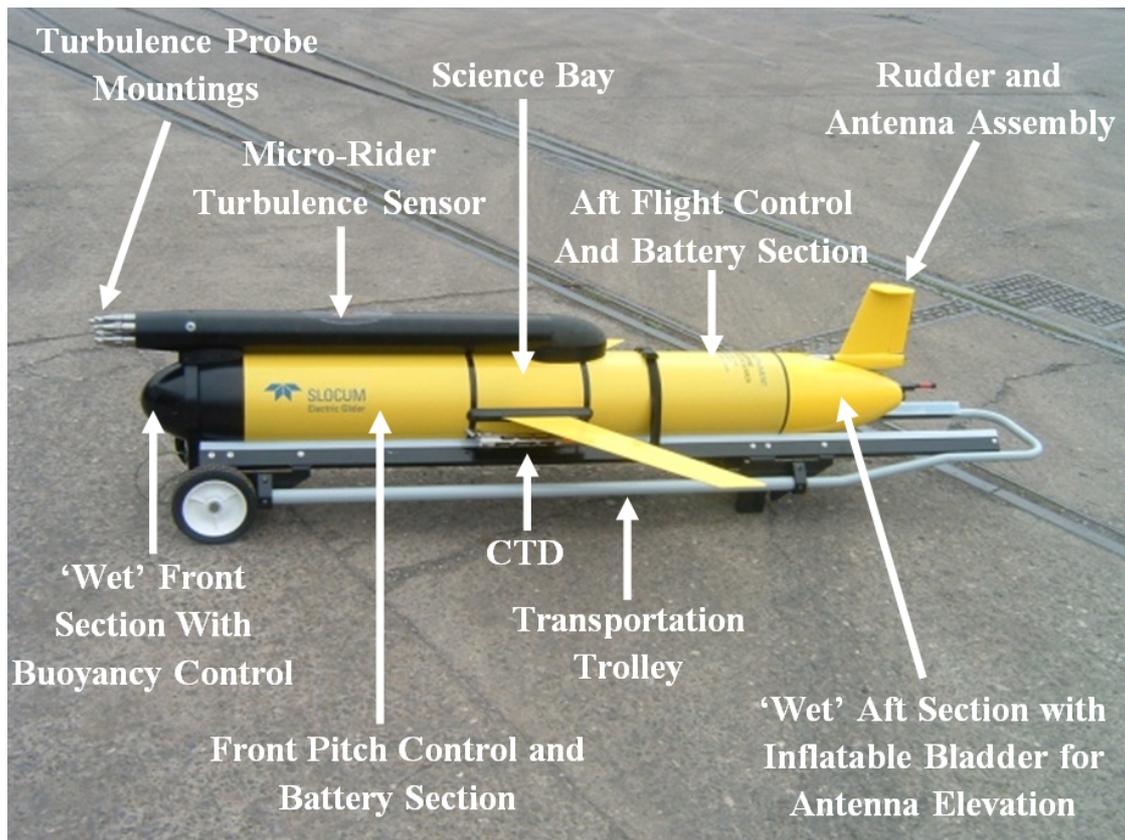
Fig. 1. Turbulence Glider configuration

This report describes the key features of the turbulence glider deployment undertaken by the National Oceanography Centre, Liverpool (NOCL) from Tuesday 28th June and Monday 4th July 2011. The key features of the NOCL turbulence glider are shown in Fig. 1. The general objective of the deployment described in this document was to evaluate the performance of the turbulence glider for an extended period of time. In addition to this the CTD and turbulence measurements undertaken by the glider were compared with data recorded by a seabed based recoverable instrumentation frame.

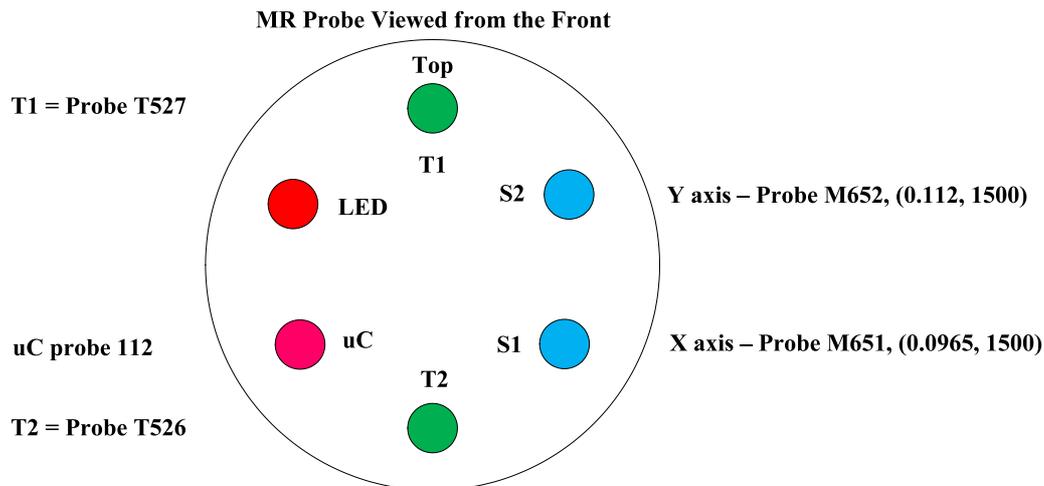
Fig. 3 RSI micro-Rider – Glider Mounted Microstructure Probe Configuration

The Glider, ADCP frame, Seabird 19+ CTD Carousel etc were loaded onto the ship and initial checks performed on the glider communications and instrument setup. The glider based turbulence probe was configured as shown in Fig. 3.

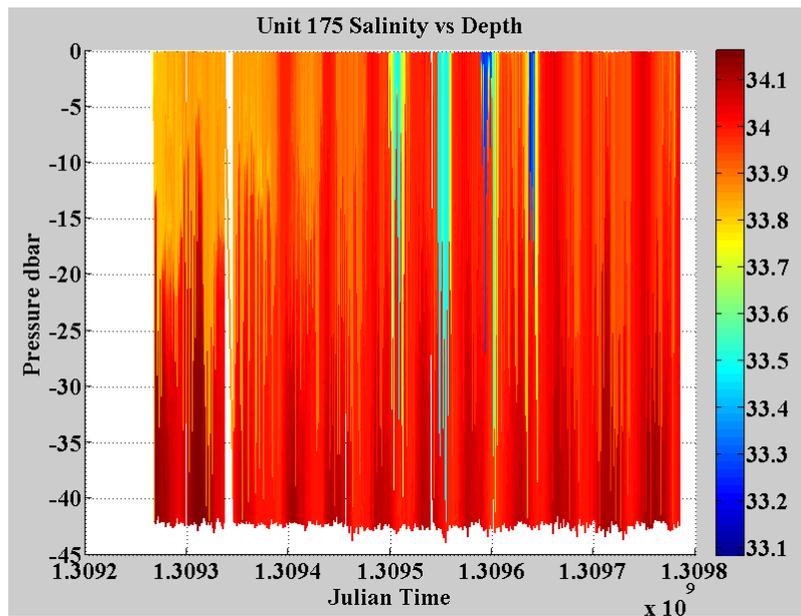
Fig. 4 CTD Salinity profile for the microstructure glider deployment from 28th June to 4th July 2011

The microstructure glider has been programmed to record CTD data during glider climbs. As indicated by the plots in Figs 4 to 6 a comprehensive record of CTD data has been achieved throughout the deployment, which lasted approximately 6 days. There is evidence of some of the raw measured CTD values for temperature, conductivity and pressure occasionally resetting to zero. This is most probably occurring during system restarts after problems such as mission aborts, glider surfacing for dialog etc, as shown in Fig. 7. Filtering was used to remove these values during the initial CTD data analysis.

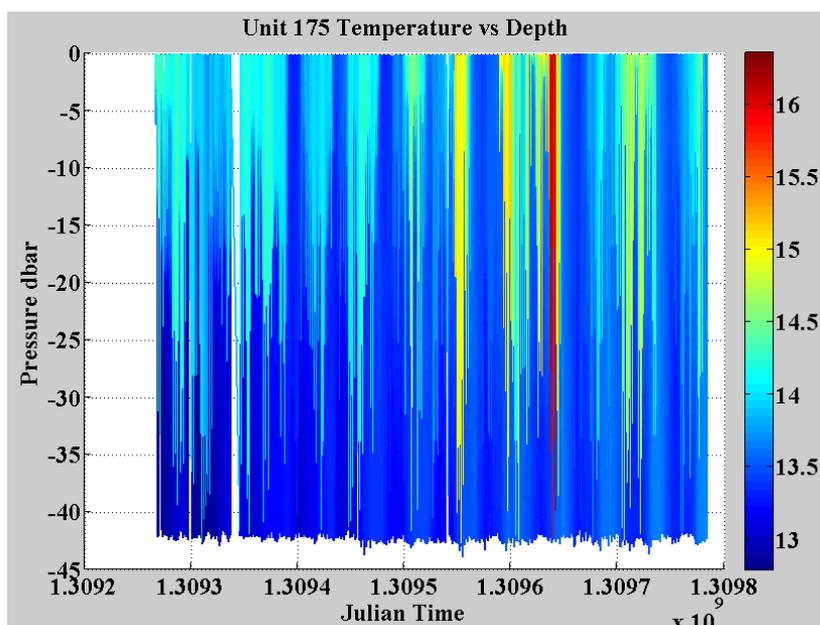
Fig. 5 CTD Temperature profile for the microstructure glider deployment from 28th June to 4th July 2011

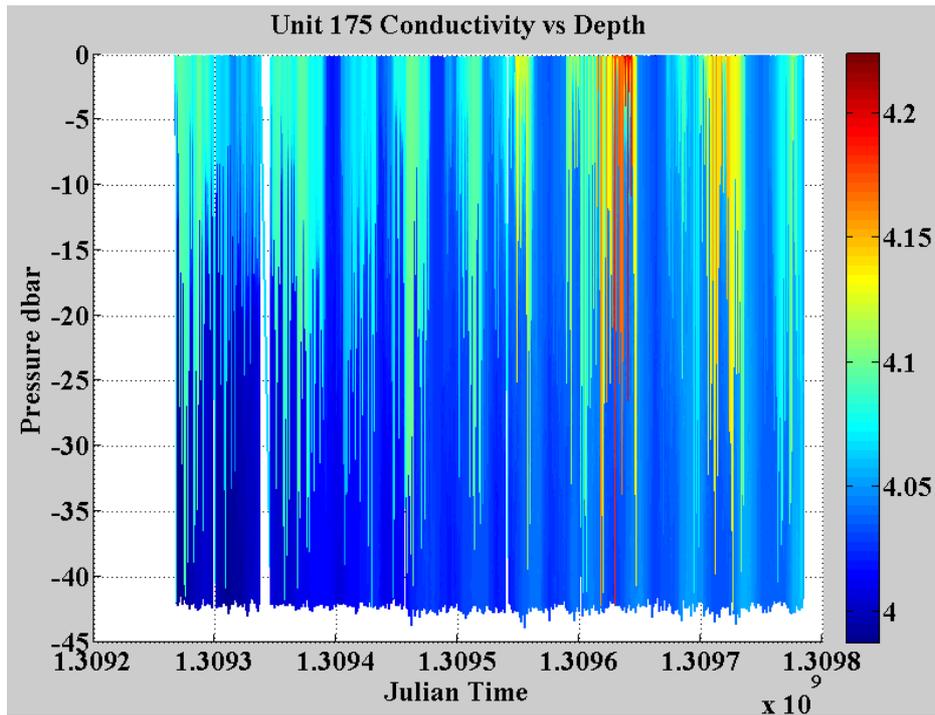
Fig. 6 CTD Conductivity profile for the microstructure glider deployment from 28th June to 4th July 2011

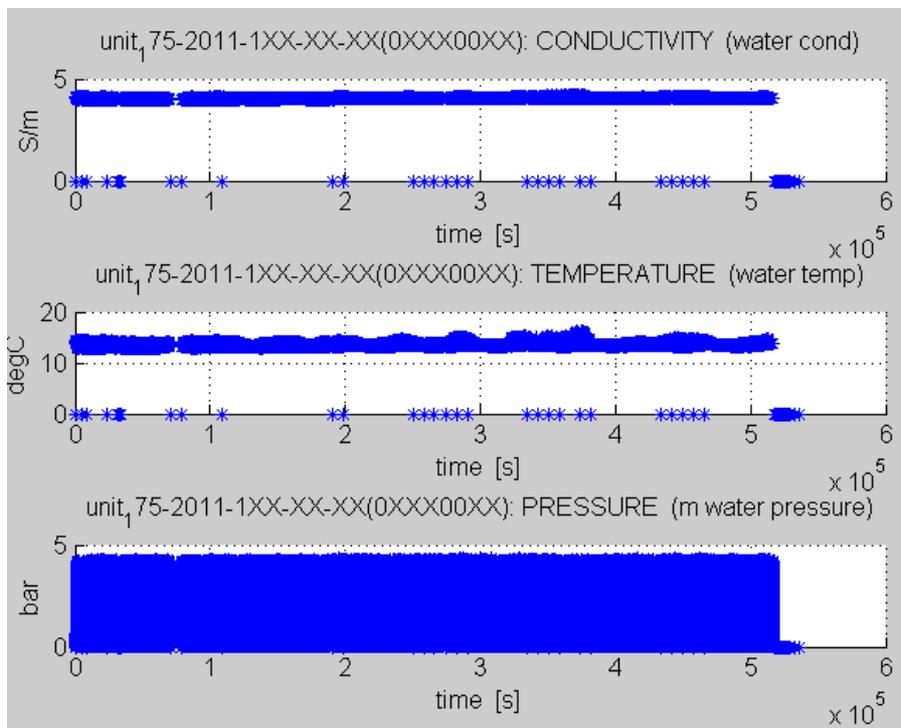
Fig. 7 Plot of the recorded raw glider data

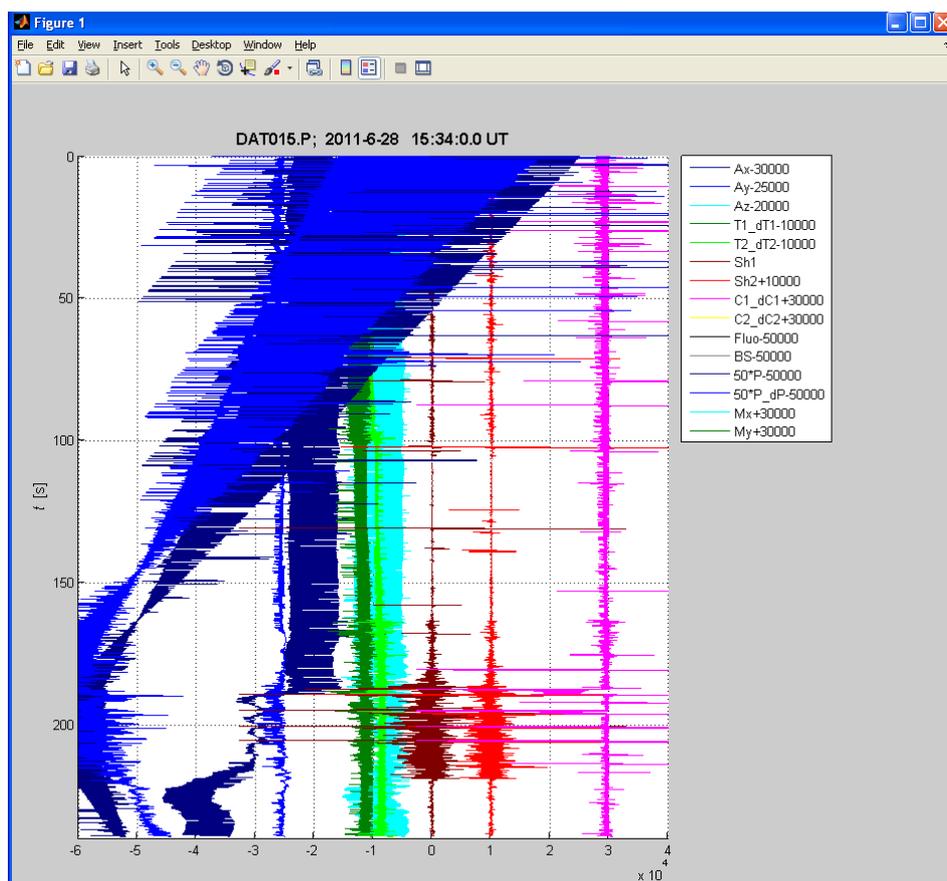
**Fig. 8 DAT015.P – One of the First Up Cast Measurements
When The Mission Started**
(date and time stamped at 16:34 on 28th June 2011)

The data plots in this appendix present a series of normalised plots of the raw microstructure data on a common scale. The general intention is to provide a graphical aid that acts as an initial review of the quality of the turbulence measurements. The pressure record in Figs. 8 to 10 shows an up cast and then inflection at the surface and there seems to be signal activity on all channels indicating the microstructure probes are all recording data. What is evident in all of the turbulence measurements that were recorded is that there is a high degree of noise and spiking in the data. Regular and sudden excursions to high amplitude values are occurring in each channel across the full recorded data set. The glider ‘comatose’ mode was used periodically during the deployment. This mode is used to shut down the glider actuators during dives and climbs to limit mechanical and electrical noise affecting the quality of the turbulence measurements. Noise and spiking was still evident when the comatose mode was used (fig. 9) indicating a potential problem with the RSI micro-Rider turbulence probe. RSI were contacted for advice and it appears that this spiking and data quality problem affected all of the turbulence data recorded during the deployment. After consultation with RSI the micro-Rider turbulence probe was returned to Canada for evaluation and repair.

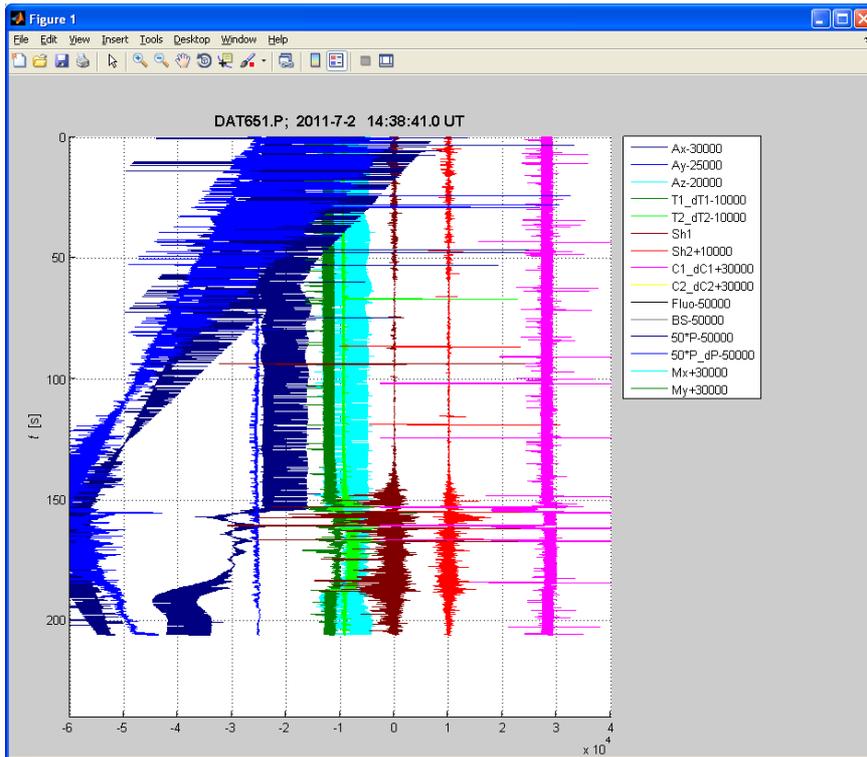
Fig. 9 DAT651.P – Recorded With The Comatose Mode (glider motors and fin silent) Enabled
 (date and time stamped at 14:38 on 2nd July 2011)

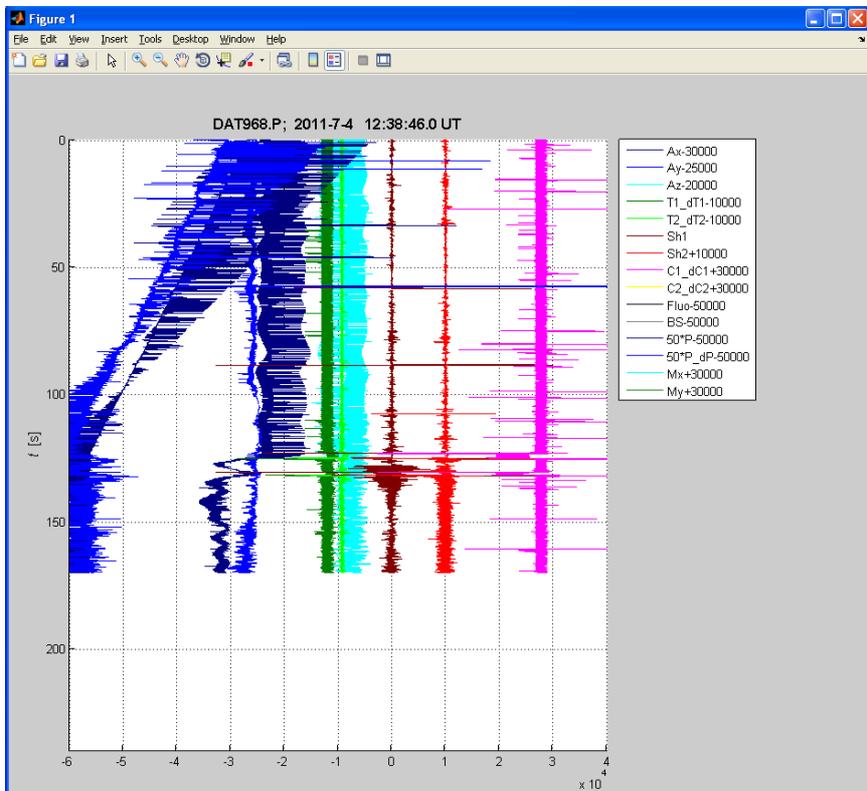
Fig. 10 DAT968.P – The Last Recorded Data File During the Deployment.
 (date and time stamped at 12:38 on 4th July 2011)

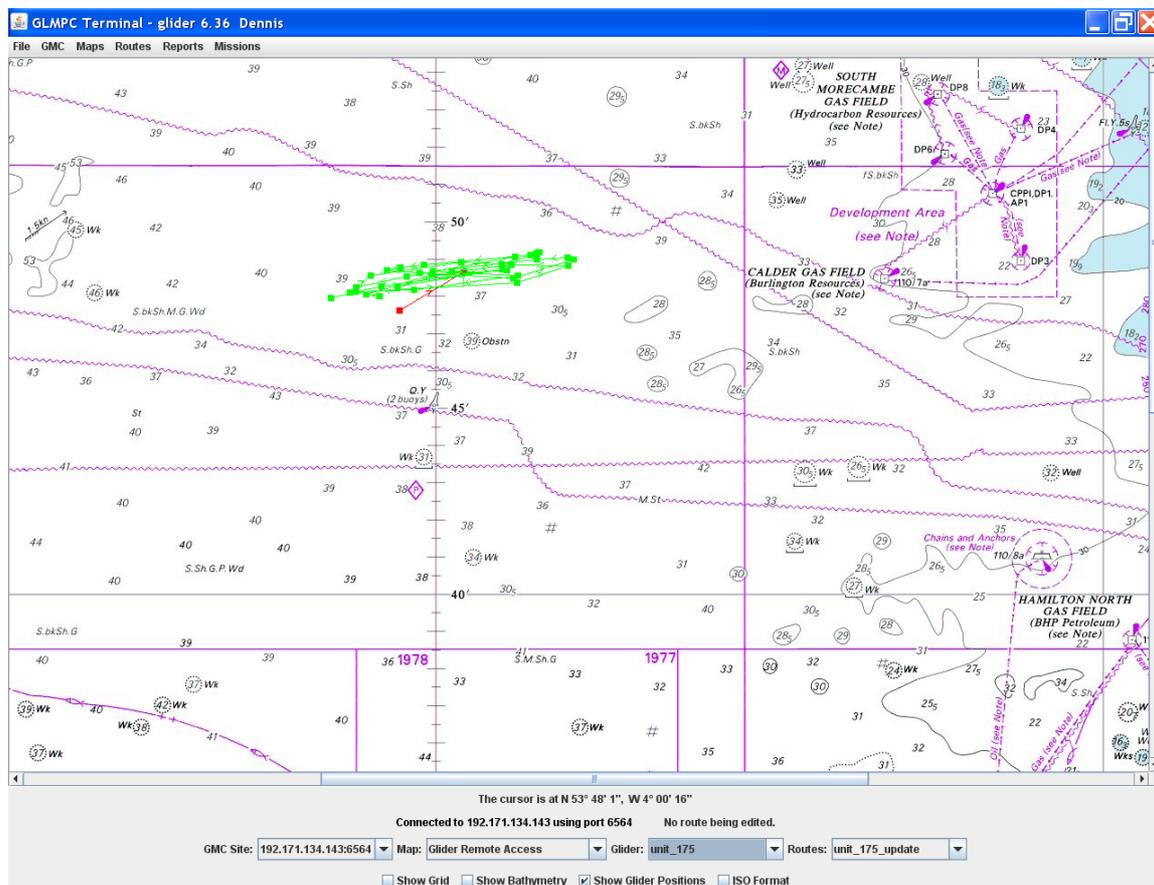
Fig. 11 - GLMPC Glider Position Plotting Software – Screen Capture From 1st July 2011

A plot from the glider ‘GLMPC’ visualisation software is shown in Fig. 11. This image illustrates the reported glider positions from the deployment on 28th June until this plot was generated on 1st July 2011. The red line links the two target waypoints (red rectangles) either side of the ADCP seabed instrumentation frame position. The green rectangles represent the reported glider positions during the deployment. The glider is being cyclically driven from east to west and then west to east in tandem with the phase of the tidal current. Although the tidal currents will affect the navigational abilities of the glider the area of operation has been successfully confined to within several kilometres of the instrumentation frame deployment site. This presented a good opportunity to generate the required collocated glider and seabed instrumentation frame based measurements, as required.

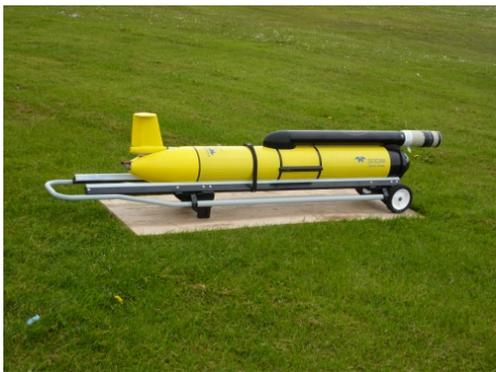
Glider on the Transportation Trolley with the Probe Cover On for Compass Testing

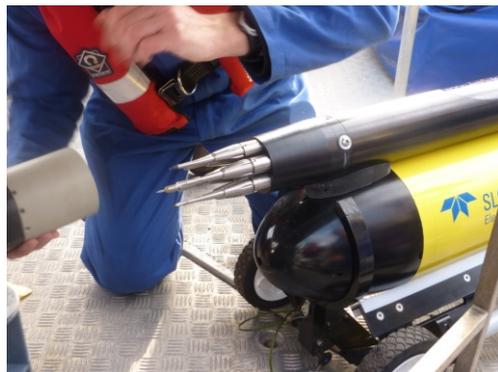
Fragile Microstructure Probes Close Up

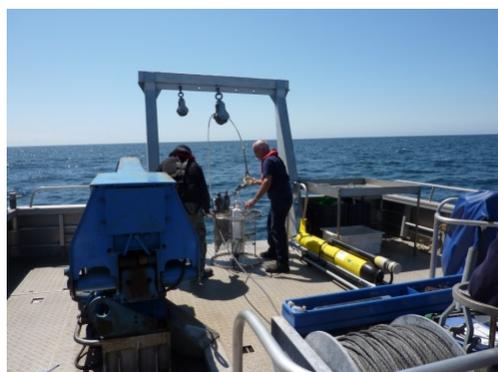
Recovered CTD Carousel

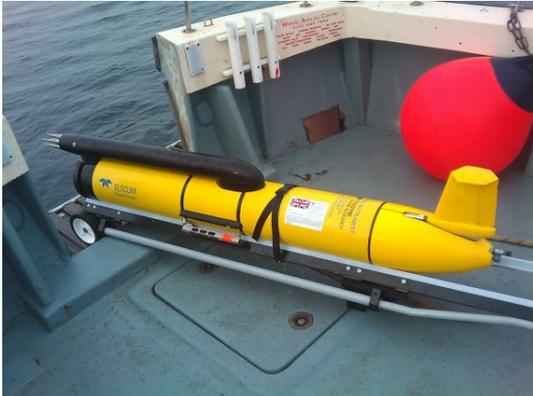
Turbulences glider just after recovery without the probe cover in place

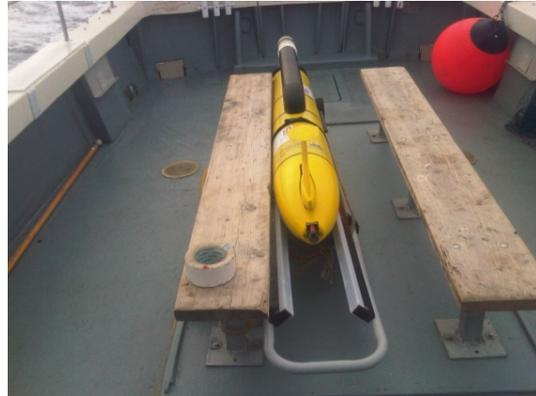
Turbulences glider stowed for the return to the NOCL Vittoria Dock Store at Birkenhead

Subsequent testing of the glider after the recovery revealed that the pitch motor (fore) battery connector had vibrated loose during glider transportation. The glider runs with the fore and aft battery packs wired in parallel. These battery packs are monitored with one common voltage measurement that results in difficulties determining the source of accelerated battery depletion problem. The disconnection of the pitch battery pack resulted in a reduction in the glider battery capacity of ~60% and accounts for the faster than anticipated reduction in the glider battery voltage during the deployment. This problem has been reported to TWR and a temporary repair has been installed to encourage the pitch battery connector to remain seated during glider transportation. The glider (unit 175) has been updated to the latest available firmware release to deal with the problems that occurred with the internal measurement of the charge drawn from the glider batteries. Post deployment analysis of the micro-Rider turbulence probe data showed that there was a problem with this sensor during the deployment. Noise and spiking were evident in the recorded data that ultimately compromised the quality of the turbulence measurements that were recorded. RSI were consulted and the micro-Rider was sent back to the manufacturer in Canada for repair.
