Nondestructive Structure Characterization by Laser-Ultrasonics

ALAIN BLOUIN, CHRISTIAN NERON, LOUIS-PHILIPPE LEFEBVRE

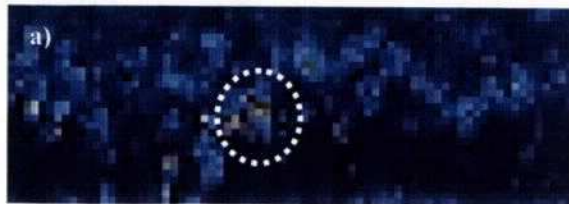
Figure 9 presents images obtained on the acetabular cups by both laser-ultrasonic pulse echo and laser tapping techniques. Laser excitation and detection beams were impinging on the porous surface of the cups. As expected, the signals were highly affected by the foam microstructure, dominated by the pore size. The large pore foam strongly attenuated the ultrasound in the MHz range and, not surprisingly, no significant signals were obtained with the laser-ultrasonic pulse echo technique. Figure 9a shows the laser tapping image obtained on the large pore foam coated cup with the artificially unbond area. Indeed, the upper portion of the scan shows many bright spots coming from the large pores in the structure, while the lower portion is much more uniform and corresponds to a uniform structure with a smaller pore size. The area encircled in Figure 9a represents the portion where the BN coating was applied. A contrast is observed, but is not very good. This low contrast may however be due to the reaction between BN and titanium during sintering that could have restored a sufficiently good bonding.

Figure 9b and 9c shows the laser tapping and laser-ultrasonic pulse-echo images obtained on the cup with uniformly distributed fine pores. A small defect seen with both techniques is indicated by an arrow on the images. The contrast is however better in the laser tapping image. This defect is not visible on the surface of the cup. It can be attributed to an area of larger pores in the coating, to a badly bonded area or to metallurgical artifacts. Additional measurements should however be done with other techniques or by destructive metallography to properly identify the nature of the defect.

Figure 9: a) Laser tapping image on the large pore non-uniform coating. The dotted circle indicates the artificially produced unbonded area. b) Laser tapping and c) laser-ultrasonic images on the fine pore uniform coating.
