*Nondestructive Testing and Evaluation*,  
Vol. 23, No. 2, June 2008, 109–120

## **Nondestructive testing of open microscopic cracks in plasma-sprayed-coatings using ultrasound excited vibrothermography**

JEAN-MARC PIAU<sup>†\*</sup>, ABDELHAKIM BENDADA<sup>†</sup>, XAVIER MALDAGUE<sup>†</sup> and  
JEAN-GABRIEL LEGOUX<sup>‡</sup>

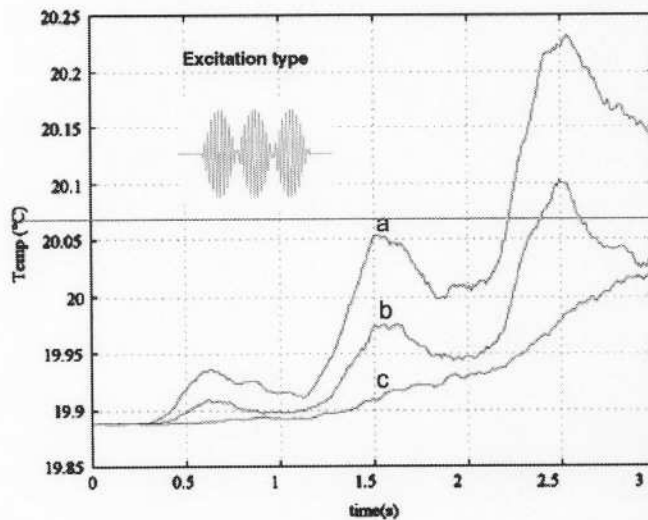
drawbacks. The experiments performed differ from the conventional lock-in, the acquisition is done during the transient regime and the stimulation only lasts three periods. The amplitude modulation frequency was set to 2 Hz. Figure 7 presents two typical crack surface gradient profiles (a,b) and the bottom curve (c) is a sound region gradient profile taken between two cracks. One can see the transient regime with the three pseudo sinusoidal periods ramping up followed by the cooling down which has not been recorded entirely.

Figure 7. Temperature versus time transients (modulation at 2 Hz). (a,b) Temperature versus time transients on two different cracks. (c) Temperature versus time transient in between two cracks.
