**AN APPLICATION OF EMS98 IN A MEDIUM-SIZED CITY:  
THE CASE OF L'AQUILA (CENTRAL ITALY) AFTER THE APRIL 6, 2009  
Mw 6.3 EARTHQUAKE**

**Abstract** This paper describes the damage survey in the city of L'Aquila after the 6 April 2009 earthquake. The earthquake, whose magnitude and intensity reached Mw=6.3 and I<sub>max</sub>=10 MCS, struck the Abruzzi region of Central Italy producing severe damage in L'Aquila and in many villages along the Middle Aterno River valley. After the event, a building-to-building survey was performed in L'Aquila downtown aiming to collect data in order to perform a strict evaluation of the damage. The survey was carried out under the European Macroseismic Scale (EMS98) to evaluate the local macroseismic intensity. This damage survey represents the most complex application of the EMS98 in Italy since it became effective. More than 1700 buildings (99% of the building stock) were taken into account during the survey at L'Aquila downtown, highlighting the difficult application of the macroseismic scale in a large urban context. The EMS98 revealed itself to be the best tool to perform such kind of analysis in urban settings. The complete survey displayed evi

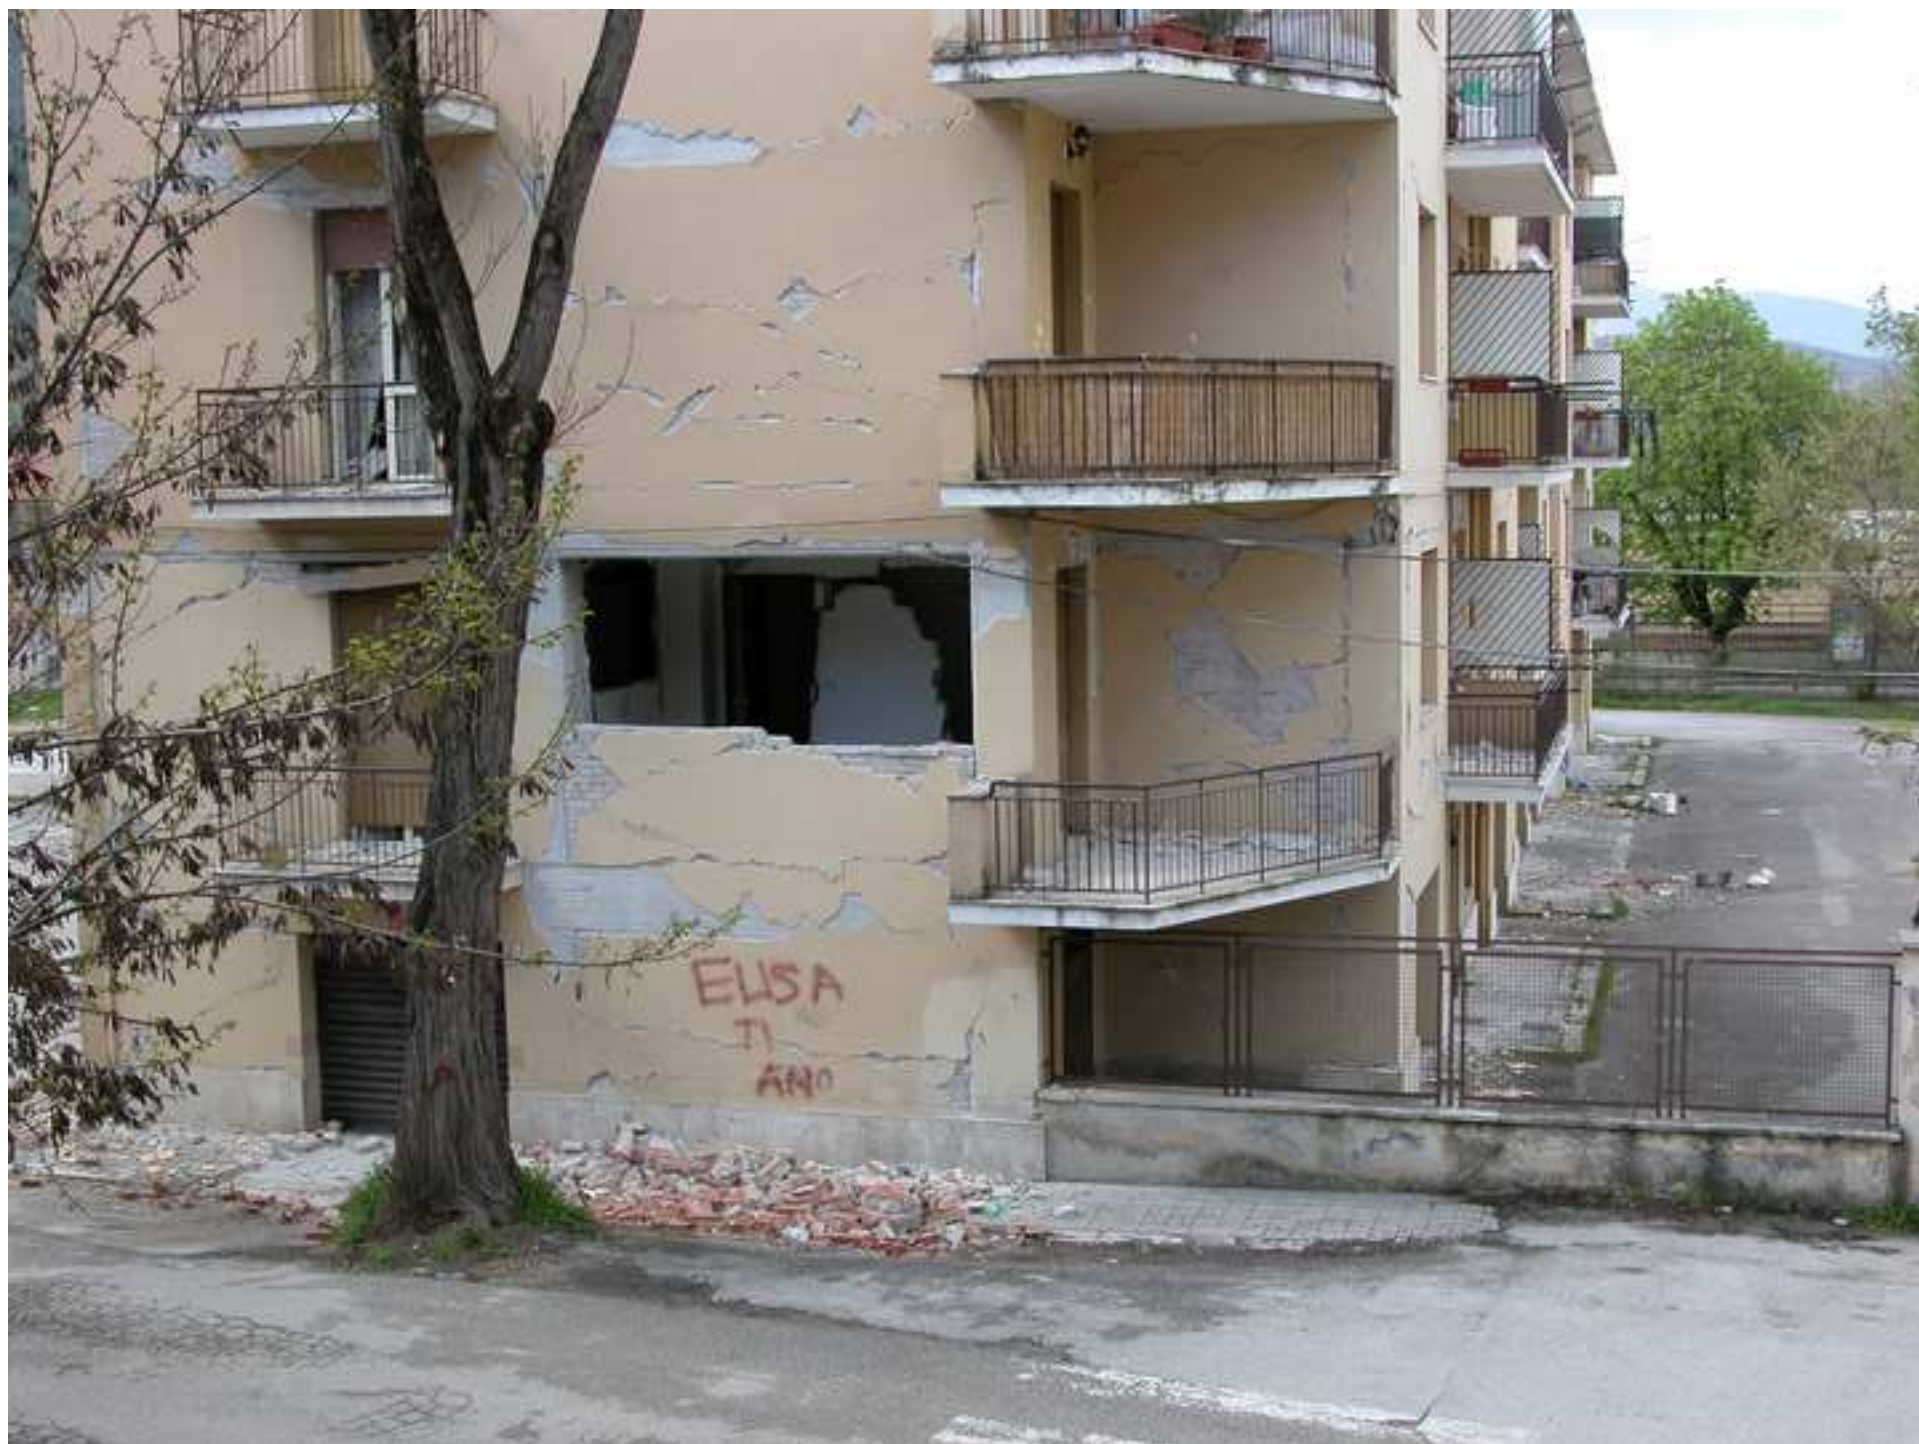
5. - Map of the buildings' vulnerability (all classes) surveyed in downtown of L'Aquila
6. – Graph of the frequency of the vulnerability classes A to D. C&M is for Special Buildings (monuments, churches etc...), NS is for Not Surveyed.

Figure 5 shows the general distribution of the vulnerability classes within the surveyed area. The low number of buildings corresponding to class A (Fig. 6) can be explained with the relative

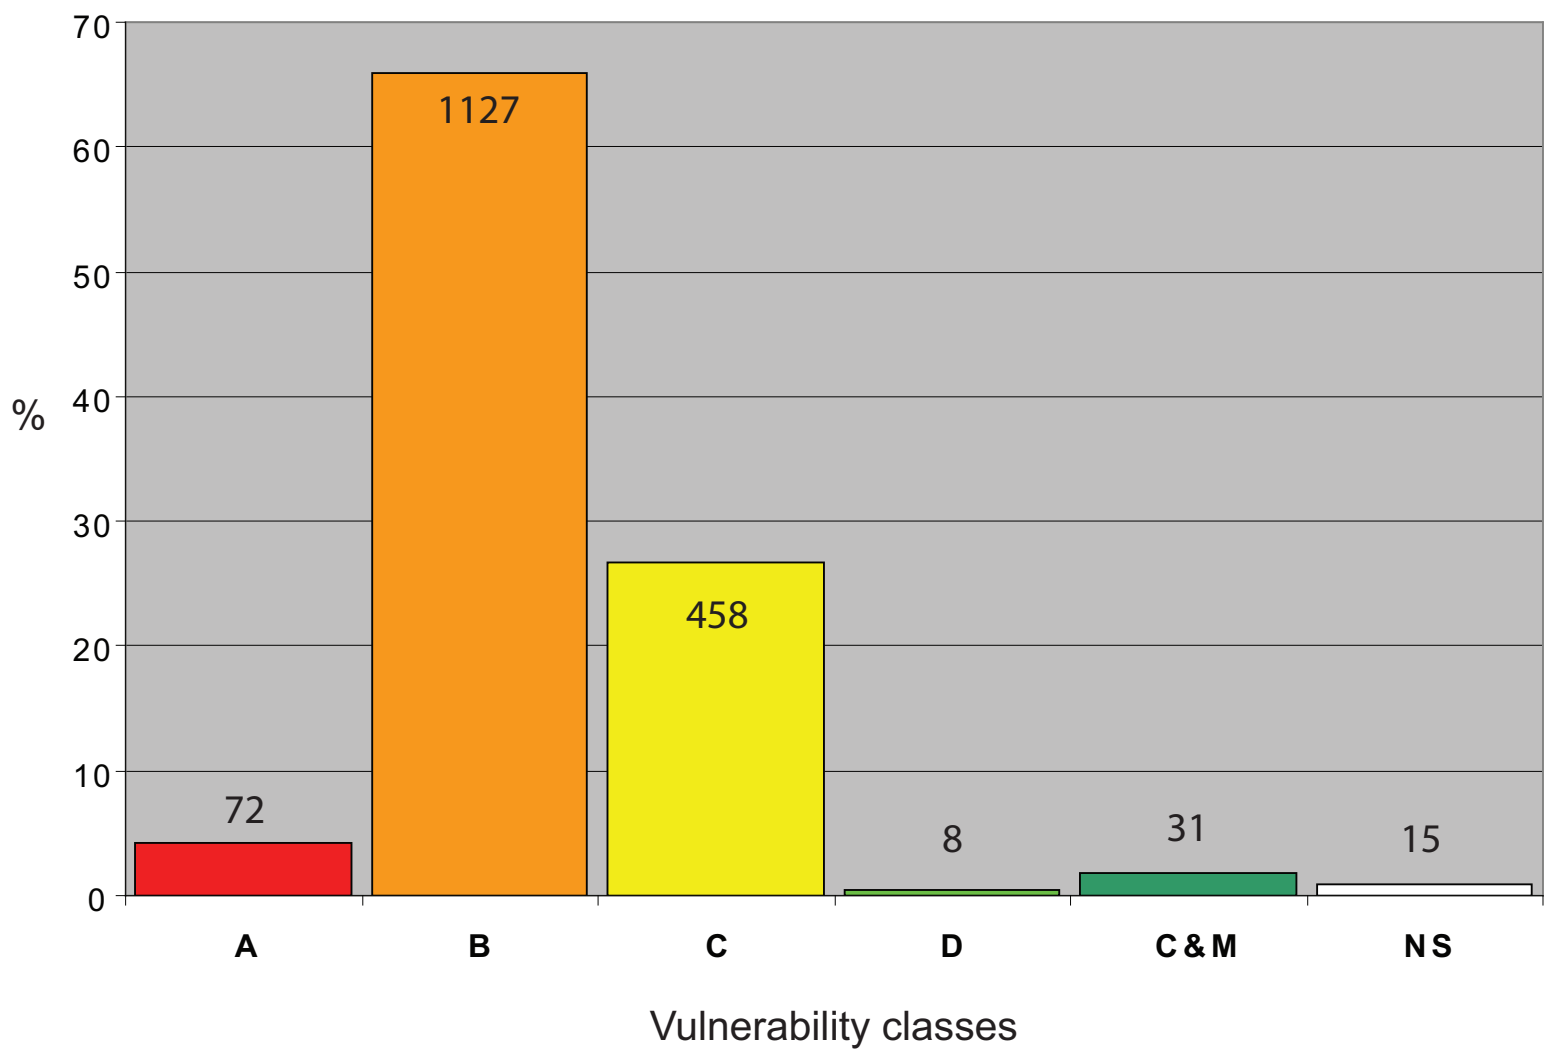
7. – Graph and table of the percentage of damage grades for each vulnerability class
8. – Map of damage grades (all grades together). Red circle indicates the most damaged sector

A grade of damage, varying from DG0 (no damage) to DG5 (collapse) was assigned to each building according to the damage description shown in table 2 (Grünthal 1998). The result is a database containing all useful information to assess the macroseismic intensity (Fig. 7).

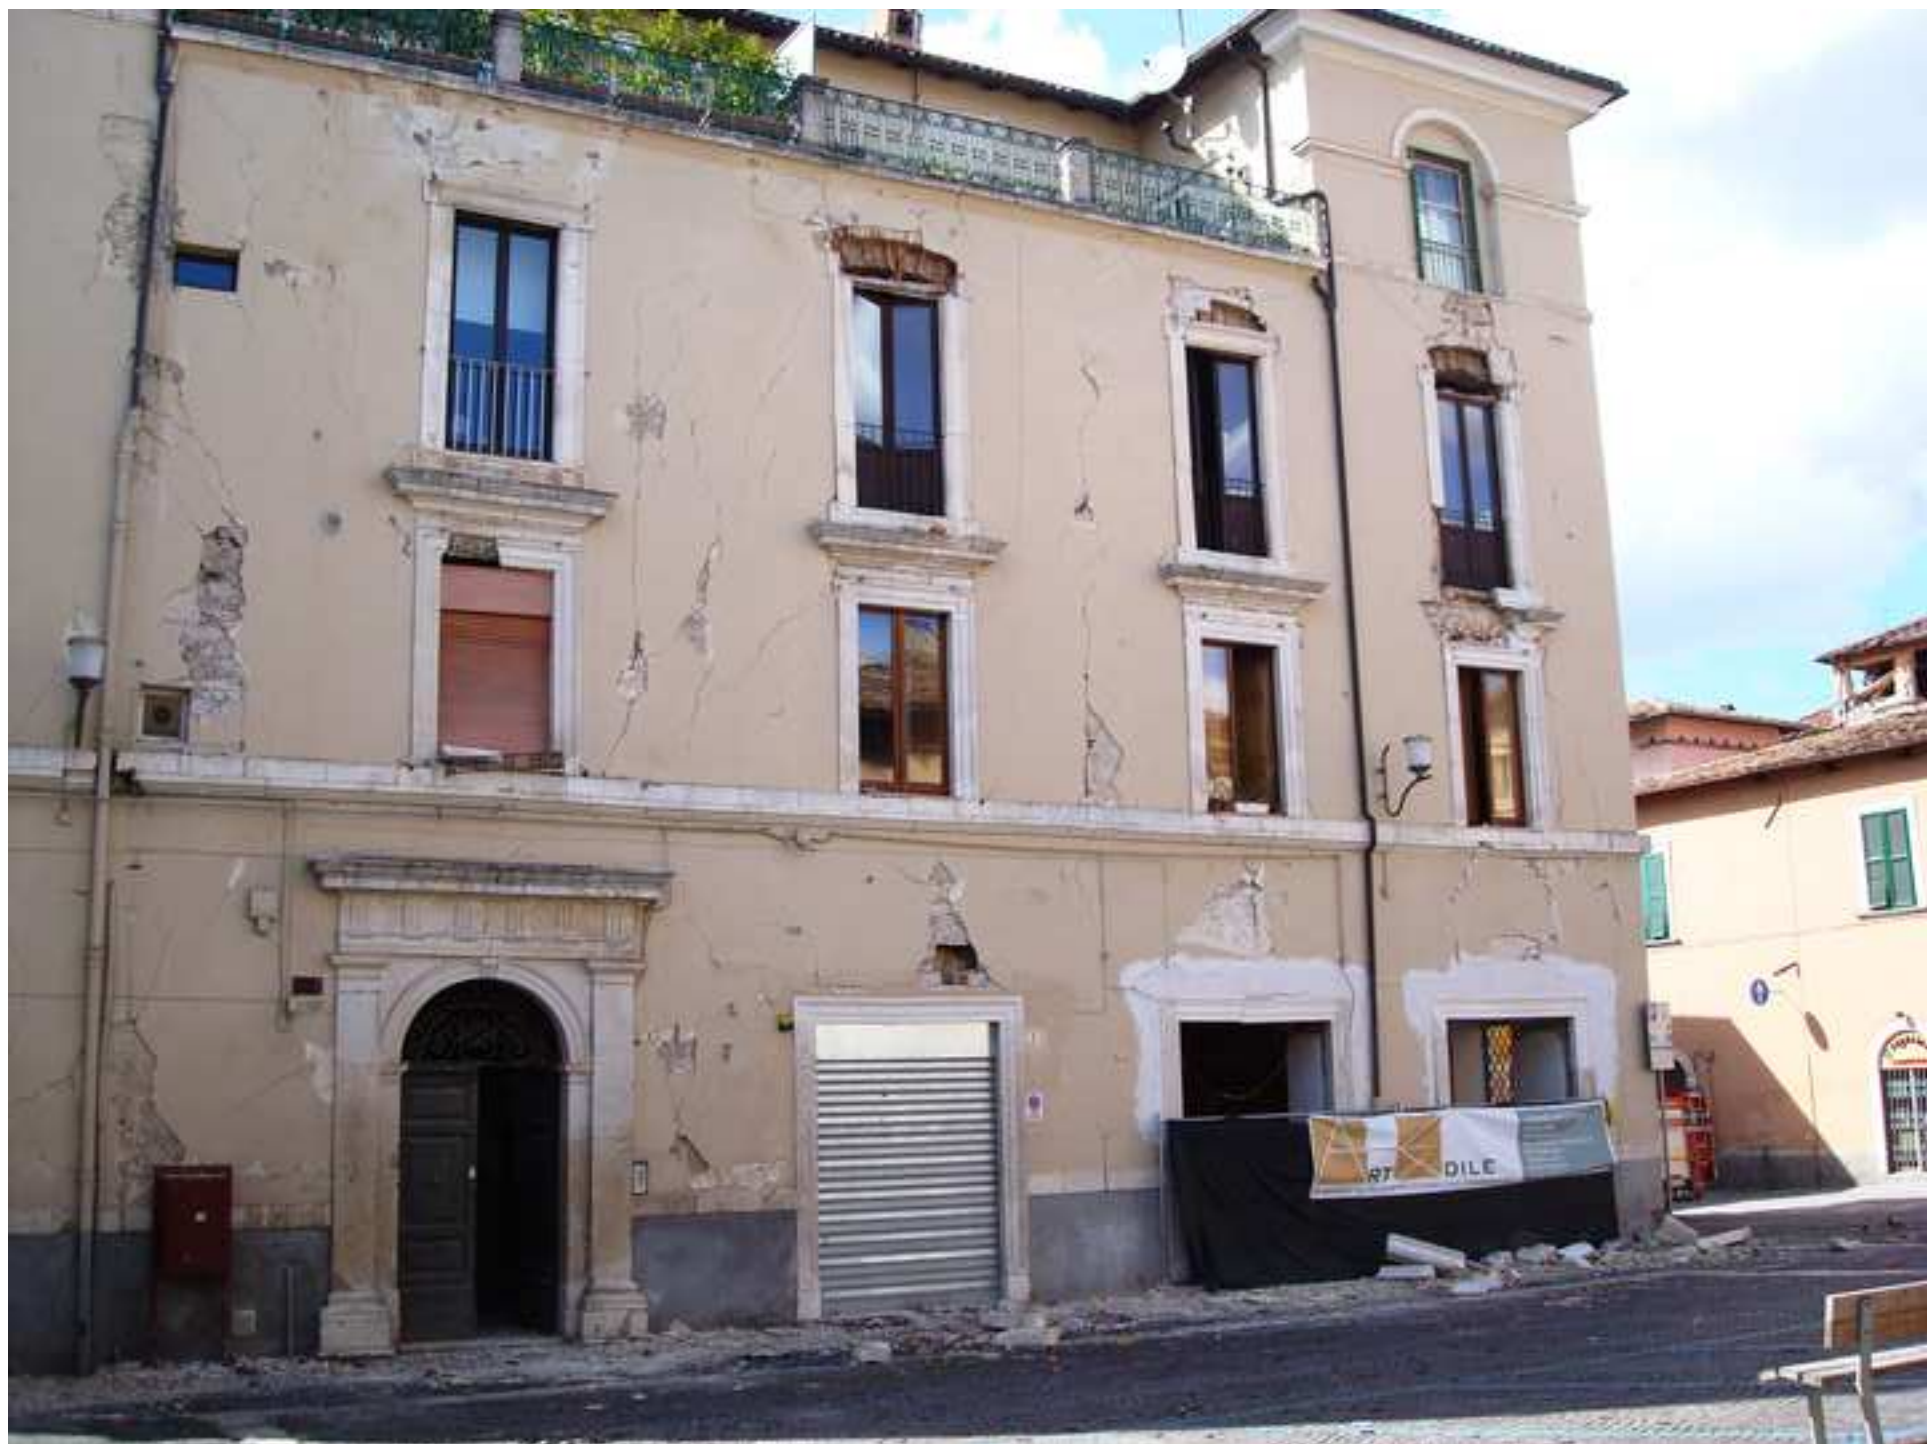
The survey has also found out that the masonry structures suffered severe damage especially in the upper parts (roofs, cornices, and in general upper floors) (Fig. 10), while buildings in RC were severely damaged (DG3 or DG4) (Fig. 11) at the lower floors. In many masonry houses, despite their undamaged external walls, the collapse of internal floors was observed (DG4).

10. – Partial collapse of the roof (DG4) in masonry building (Class B) located on via dei Giardini (photo QUEST INGV)
11. – Destruction of concrete and protrusion of reinforcing rods (DG4) in RC building (Class C) (photo QUEST INGV).

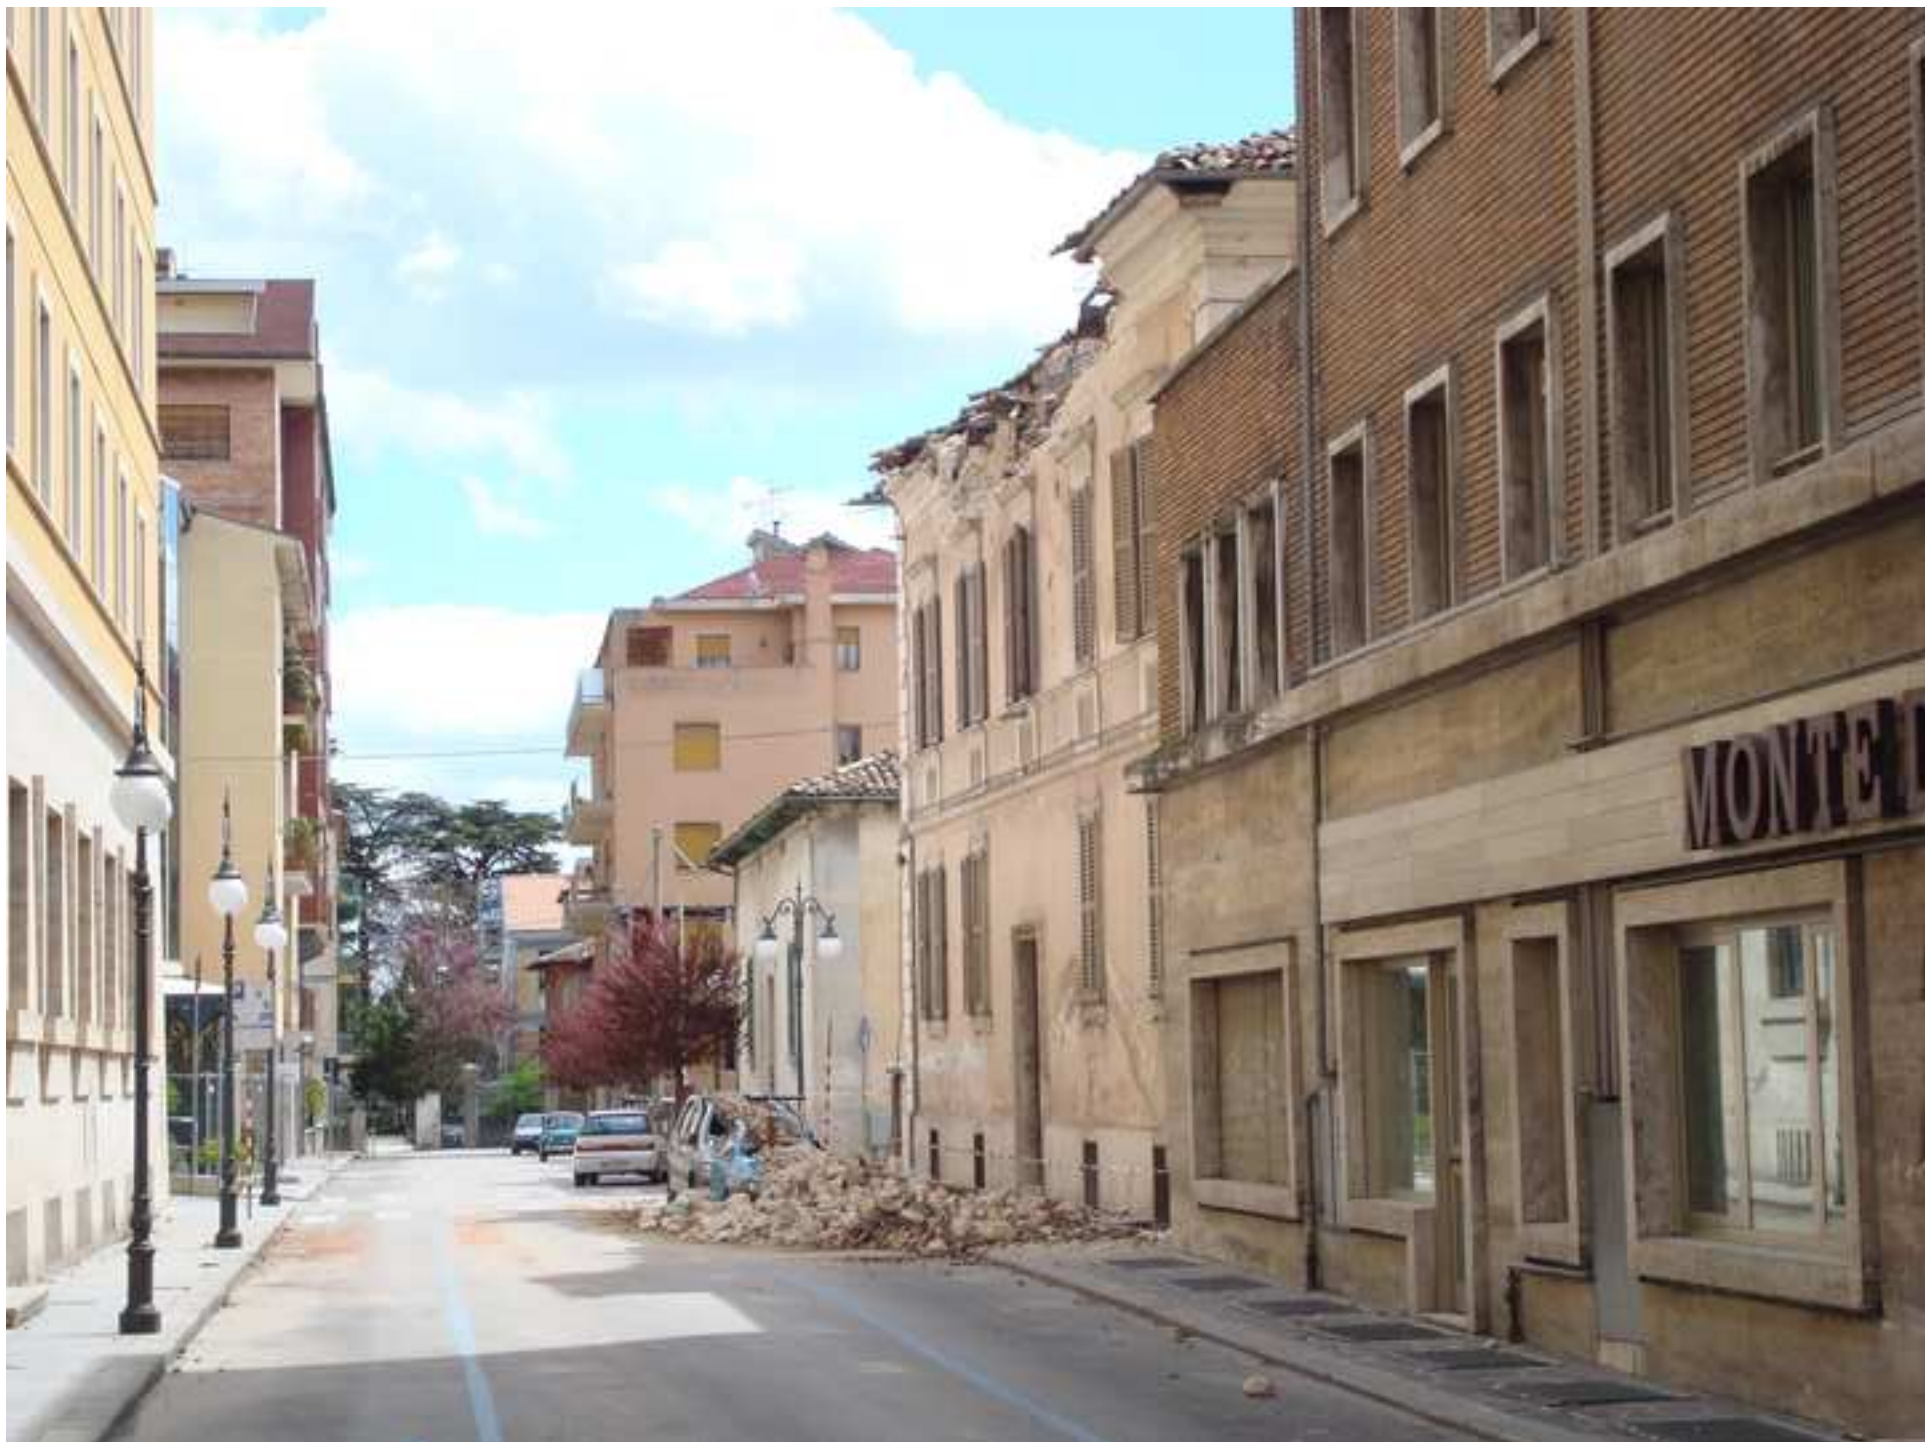
12. - Image of Via Roma, in the western parte of historical centre (photo QUEST INGV).
13. – Distribution of the grades of damage for class A only
14. – Distribution of the grades of damage for class C only

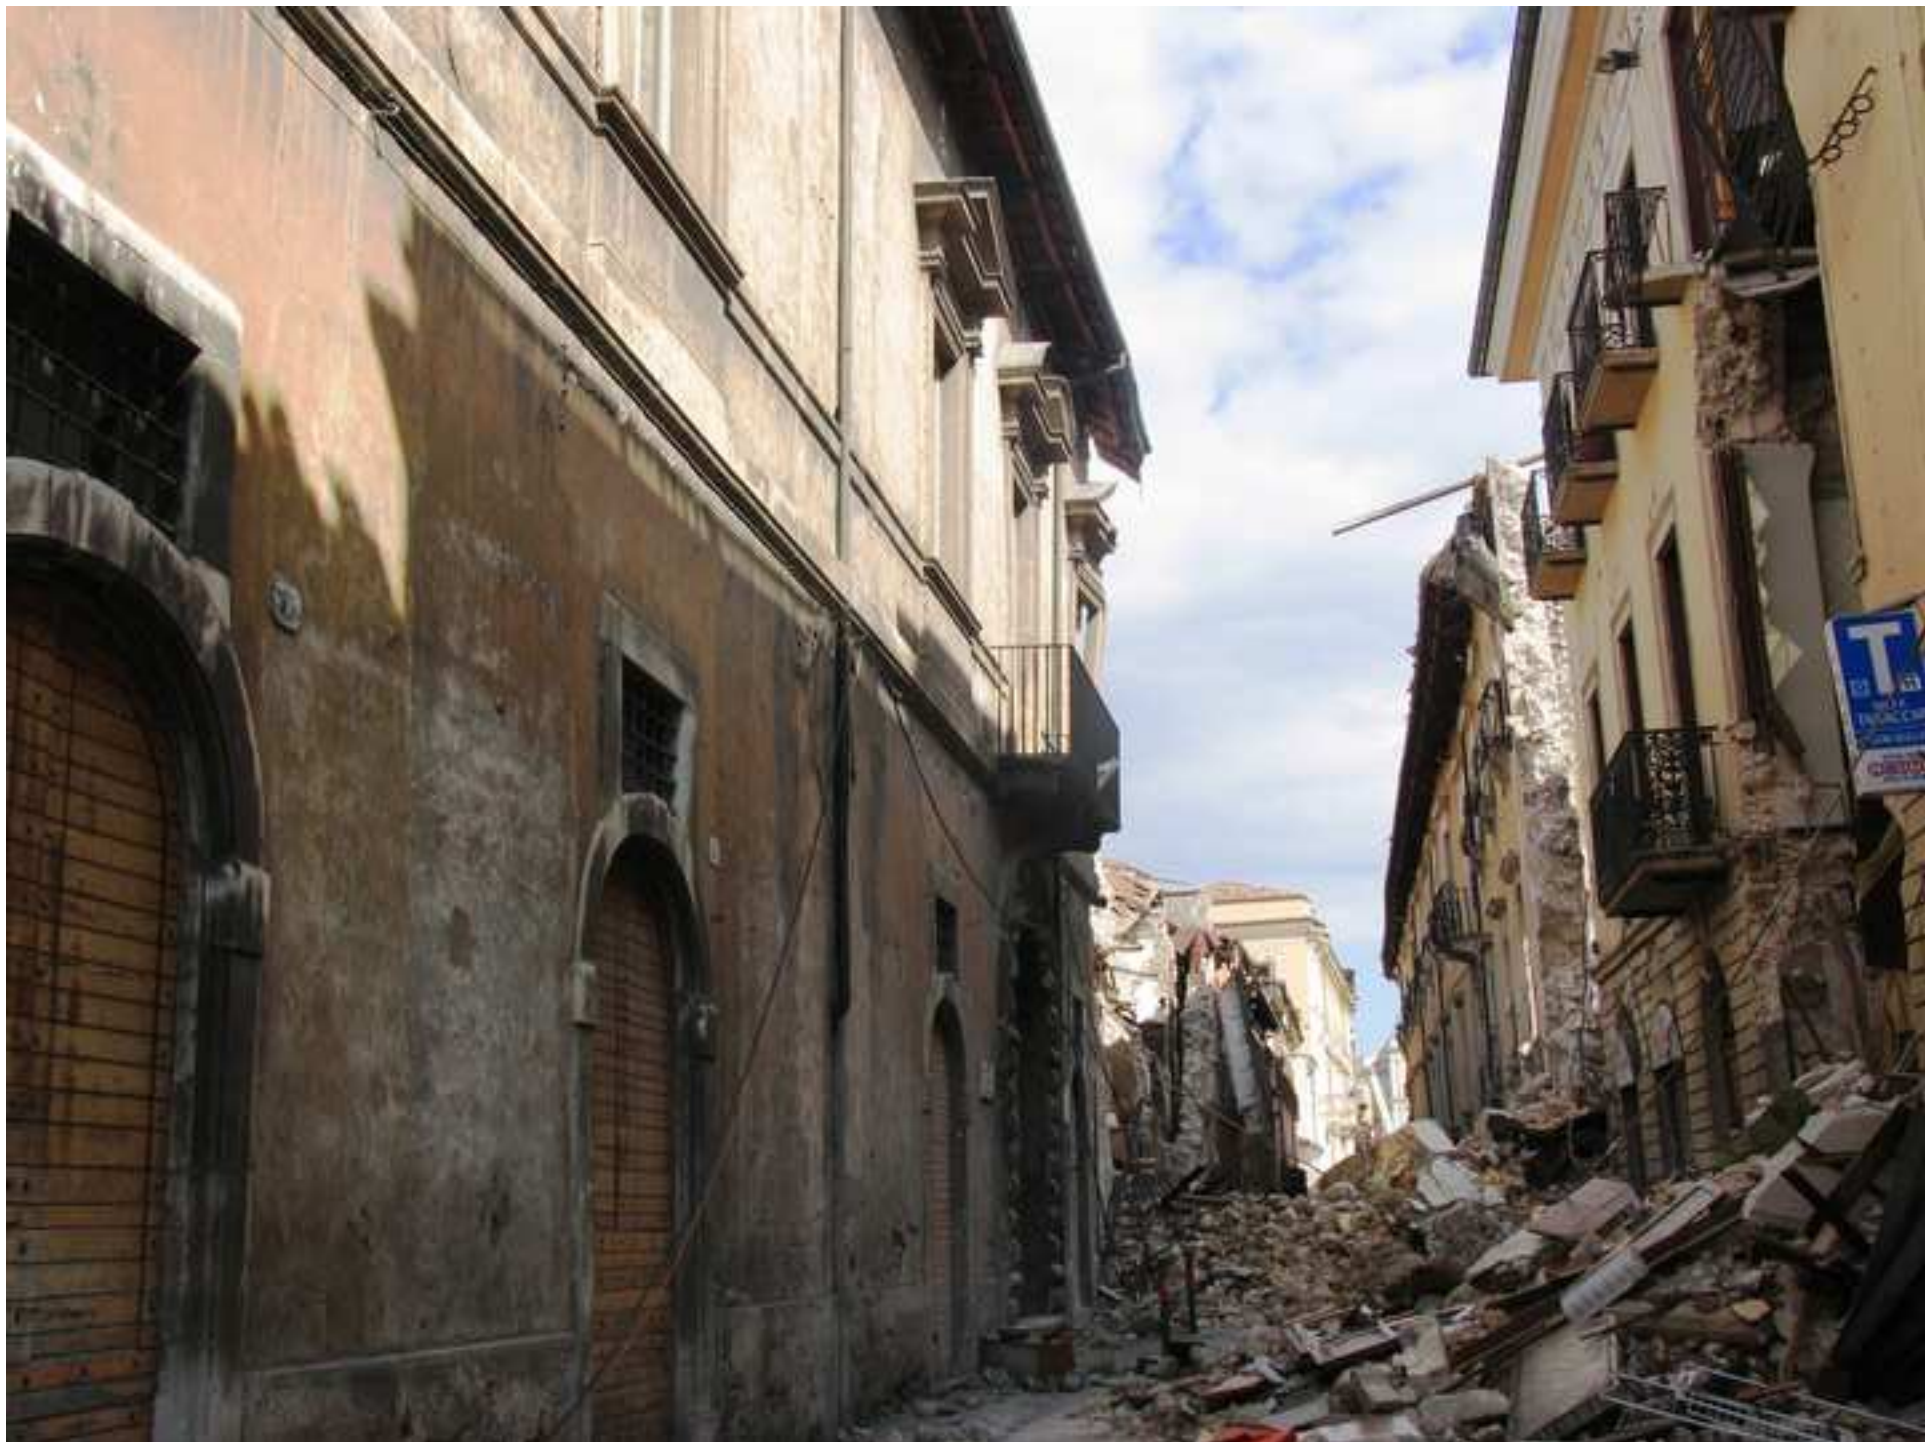
15. - Distribution of grades of damage 4 and 5
16. - Distribution of the grades of damage 4 and 5 in buildings of class C.
