Rain–wind-induced cable vibrations in the Alamillo cable-stayed bridge (Sevilla, Spain). Assessment and remedial action

Joan R. Casas* and Angel C. Aparicio

Rain combined with wind action provoking vibration has been observed in the longest stays of the Alamillo cable-stayed bridge in Sevilla (Spain). The maximum displacements observed are in the order of magnitude of 0.5 m and have caused discomfort problems to the pedestrian circulation across the bridge. The paper shows the analytical and experimental studies carried out to analyse the possible solutions and also the steps developed to stop the vibration phenomenon. In 2004, a dynamic test in the cables was envisaged to measure the actual damping in the cables. It became clear that damping in the cables was very low and the solution required the installation of dampers. The damping devices had to be in accordance with the relevant aesthetic constraints of the structure. The installation of the damping devices took place during 2007. After the installation of the damping devices, a new dynamic test was carried out in February of 2008 to check if the level of damping introduced by the dampers was appropriate. During the tests pe

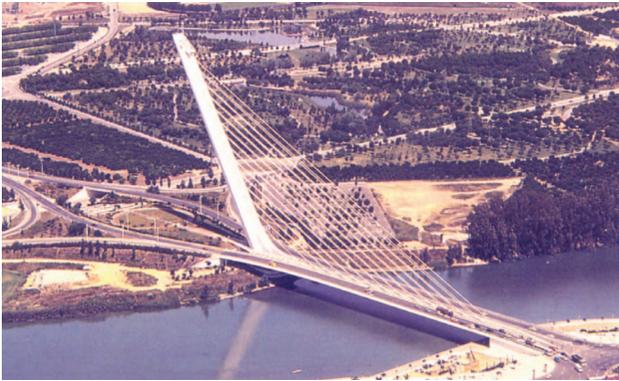
Figure 1. View of the Alamillo bridge.

The Alamillo cable-stayed bridge (Figure 1) was open to traffic in 1992 during the EXPO-92 world exhibition in Sevilla (Spain). The span length is 200 m and the deck is composed of a hexagonal steel box girder of 4.40 m depth. The width of the steel box is variable, and every 4 m, two lateral cantilevers 13.20 m in width, formed of steel ribs, support a reinforced concrete slab of 23 cm thickness, forming the traffic carriageway. The pedestrians pass over the upper flange of the steel box. The deck is connected to the pylon via 13 pairs of parallel stays, each pair consisting of 60 strands that are 15.24 mm in diameter, except for the last pair, which are 292 m in length and which consist of 45 strands that are 15.24 mm in diameter. The pylon is a composite (steel–concrete) structure. Its variable cross section contains a circular void, 4 m in diameter up to a level of 76.15 m, reduced to 2 m diameter from the 76.15 m level to the 132.25 m level. The total height of the pylon from the pedestal base (7.0 m level) to the crown is 134.25 m. The pylon has an inclination of 32° to the vertical, which makes it possible to balance the forces in the cable stays without the use of back-stays. Both structures, pylon and deck,

Cable notation: 1 refers to the shortest and 13 to the longest cables. The right (R) and left (L) is related to a pedestrian walking from the end of the deck towards the tower (see Figure 1).

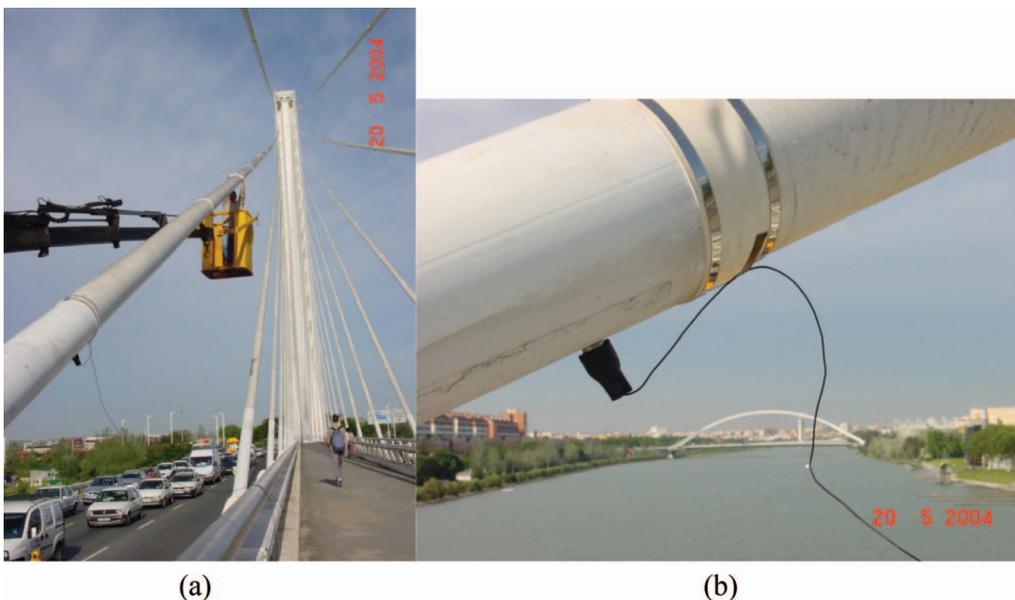
Figure 2. (a) Excitation by hanging from a crane and (b) view of the accelerometer attached to the cable.

Because the wind–rain-induced vibration phenomena is highly dependent on the damping level of the cables, a dynamic test of all stays was carried out in 2004 to measure the level of critical damping in each stay as the first step to analyse and attempt to solve the problem. In the dynamic test, the excitation of the cable was achieved by hanging on the cable and moving it upward and downward with a frequency close to the natural frequency of the cable (see Figure 2). Once the amplitude of the vibration was large enough, the cable was released and then the free-damped vibration of the cable was recorded with a piezoelectric-type accelerometer that was located at the lower part of the cable (Figure 2). The acceleration records (Figure 3), after being conditioned by an accelerometer preamplifier and recorded on a portable computer were then used to obtain the natural frequencies via fast Fourier transforms (FFTs), as presented in Figure 4. Damping ratios were also obtained. The method used to derive damping was the logarithmic decrement using the free-damped

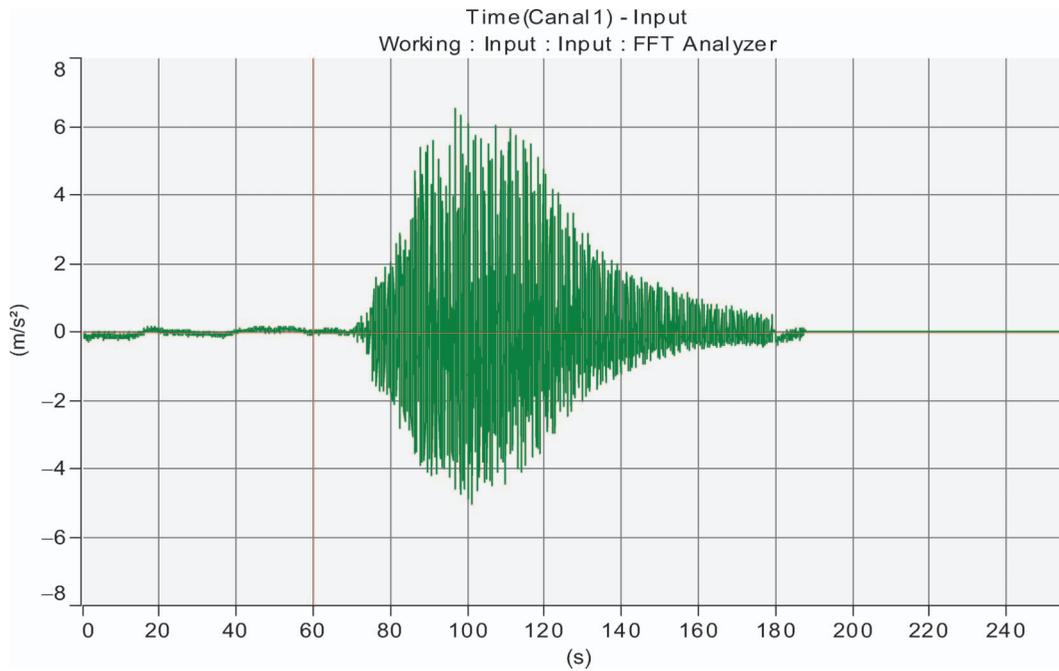
Figure 3. Acceleration record of cable 6L. The forced and the free-damped parts should be noted.

vibration part of the total recorded signal. Because the total acceleration signal has contributions from several vibration modes, first the signal was divided into the different mode components by selective digital filtering and then, the logarithmic decrement and the

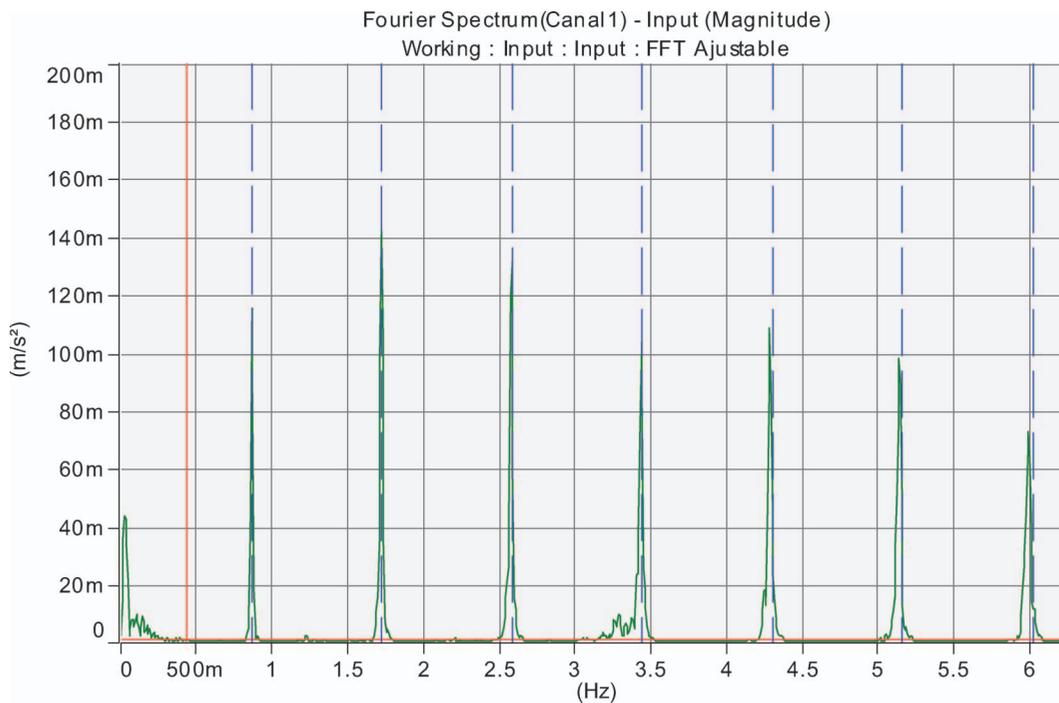
Figure 4. FFT of vibration recorded in accelerometer in cable number 6.

As can be seen, the damping in each mode is lower than the damping obtained with the complete signal. Of course, the most accurate results are those obtained through signal decomposition. In addition, it can be deduced, from Table 1 and the FFT obtained for the different cables, that the highest contribution to the total vibration comes from vibration modes 2 and higher. The dominance of mode 2 in the vibration was also confirmed by visual observation (monitored by video) of the vibration of the cables during an episode of stormy weather with heavy rain and wind. FIB (2003) and CEN (1993) recommend a percentage of critical damping higher than 0.5% (logarithmic decrement higher than 0.03) in cables longer than 80 m to avoid the rain-induced vibration. As can be seen in Table 1, none of the long cables accomplishes this requirement.

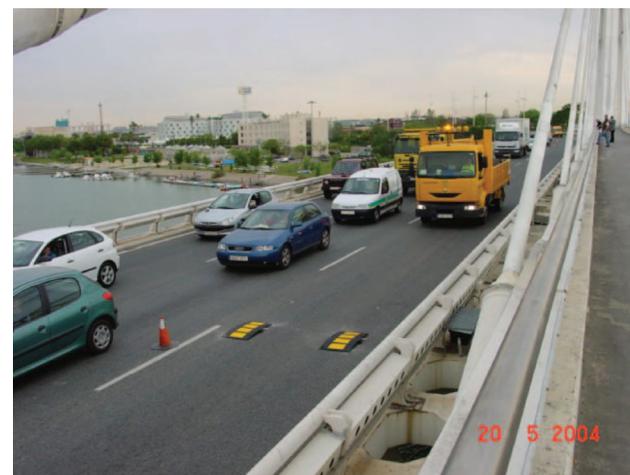
Figure 5. Excitation of deck and cables by traffic and truck over an obstacle.

In order to get a significant level of vibration in the cables, a truck going over artificial unevenness in the pavement was immersed in the traffic flow (Figure 5).

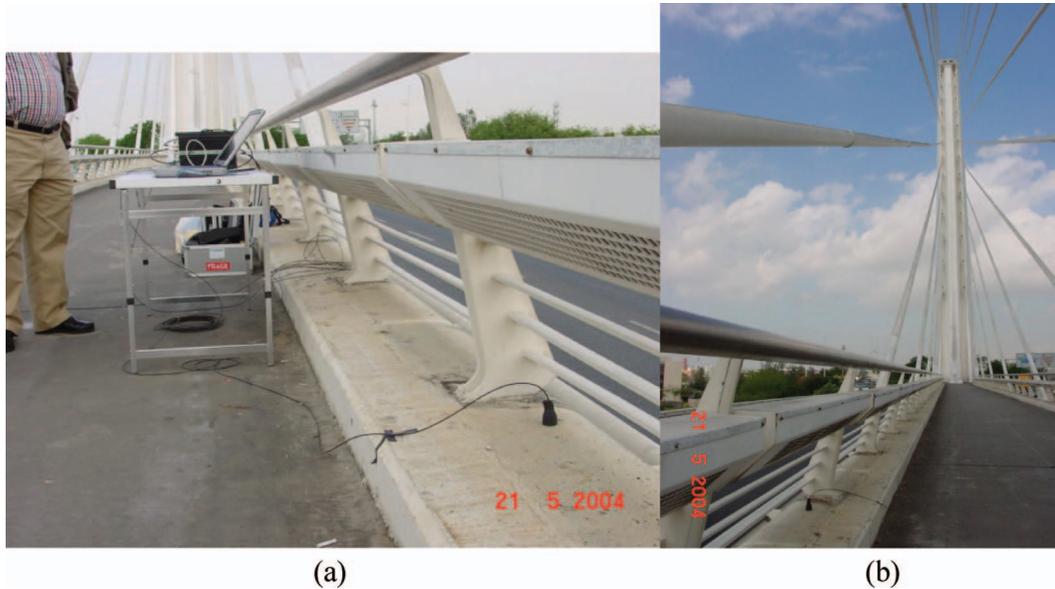
Figure 6. (a) Eccentric situation to record flexural and torsional vibrations and (b) the accelerometer in the deck.

In this case, the attachment of accelerometers in the bridge deck (Figure 6) allowed the vibration of the deck to be obtained, and the natural frequencies could be derived according to the methodology presented in Casas (1995), based on the analysis of the Fourier spectra obtained by FFT of the time signals. From the vibration records, the values in Table 4 were deduced. The values in Table 4 are also compared with the values obtained in the dynamic tests carried out in 1992 after bridge completion and before opening to the traffic (Aparicio and Casas 1992, Casas 1995).

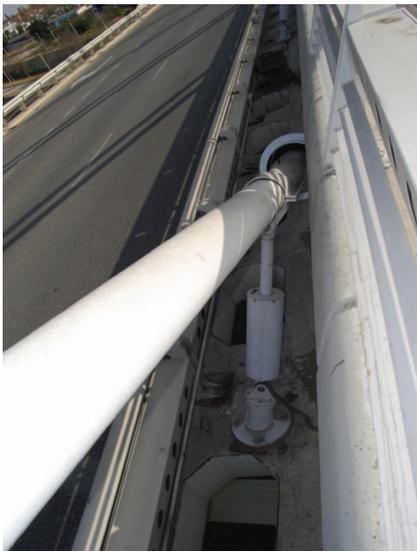
Figure 7. View of the dampers.

The solution of additional dampers was finally chosen and was installed in the bridge during 2007. The dampers are of the magneto-rheological type. The damping values in Table 5 should be guaranteed for a maximum distance of the damper to the anchorage lower than 3% of the cable length. Due to aesthetic constraints, one of the main requirements in the case of external dampers is that the location of the damper should not be above the pedestrian handrail. As a general rule, the damping devices to be installed should have a minimum visual impact on the global appearance of the bridge. As can be seen in Figure 7, where one of the installed dampers can be seen, these requirements were successfully fulfilled, and the dampers are hardly noticeable.
