Giourntas, Lampros Gerasimos and Hodgkiess, Trevor and Galloway, Alexander (2015) Enhanced approach of assessing the corrosive wear of engineering materials under impingement. *Wear*, 338-339. pp. 155-163. ISSN 0043-1648 , <http://dx.doi.org/10.1016/j.wear.2015.06.004>

“Enhanced approach of assessing the corrosive wear of engineering materials under impingement”

Corrosive wear phenomena are apparent in hydraulic machinery that handle slurries. This study focuses on the development of an integrated methodology of material assessment that is employed to understand the mechanisms of deterioration and effectively compare materials' performance under impinging slurry. The technique involves mass loss measurements and post-test analysis of the surface, which comprises measurement of wear scar depths and volumes, that yield the quantification of the various material degradation processes that occur directly under, and adjacent to, the impinging jet. A medium carbon steel and a stainless steel have been investigated, since they exhibit different corrosive wear behaviour.

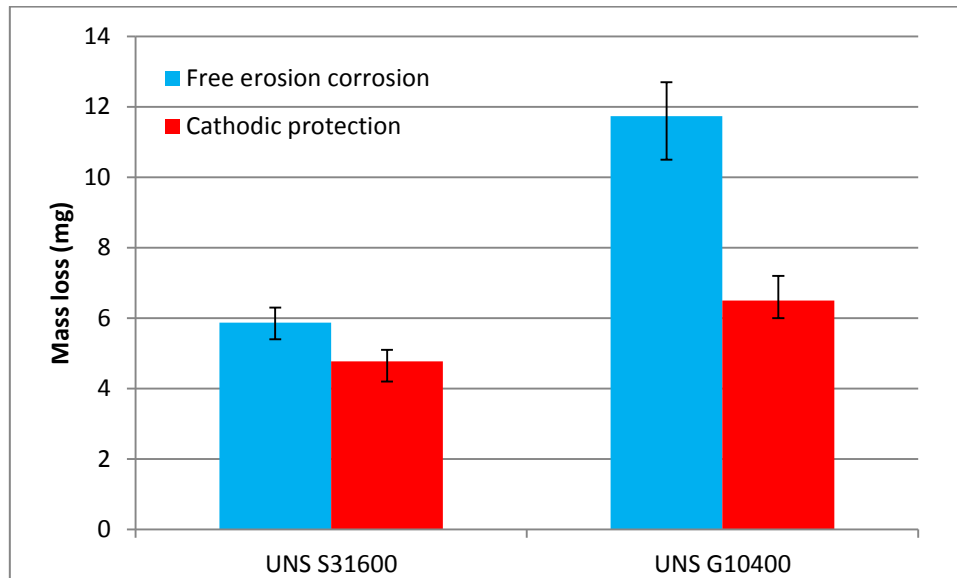
Figure 3 demonstrates the mass loss measurements as averages with error bars showing the scatter from the three replicates under free erosion-corrosion and also with the application of cathodic protection. The erosion-corrosion performance of the UNS S31600 was superior compared with the carbon steel UNS G10400. The discrimination of these two steels was evident in both conditions as the UNS S31600 sustained its superior resistance even when the cathodic protection was applied. It is also apparent that the UNS G10400 suffers severely by the corrosion factor, as its mass loss with the CP applied is almost half when no electrochemical processes are taking place (CP).

Figure 3. Mass loss of the steels in solid/liquid impingement with and without cathodic protection application

The total mass losses were measured directly, see Figure 3. The overall mass loss of the UNS S31600 was substantially lower than the UNS G10400 in free erosion corrosion conditions, which demonstrates the superiority of the stainless steels against carbon steels. This feature is mostly related with the nature of the stainless steels, which are well known corrosion resistant alloys (CRA's), and they form a passive film that protects them from corrosion.

The total mass losses with cathodic protection of the steels were measured directly from the experiments (see Figure 3). The application of CP resulted in reductions in the overall material mass loss of both materials. It is clear that the mass loss on the UNS G10400, when the cathodic current was applied, was decreased from 11.7 mg to 6.5 mg (68 %), whereas the UNS S31600 mass loss dropped by 18 %. This signifies that the corrosion related component (C+S) is playing a more substantial role on the material degradation of the medium carbon steel and it has far less influence on the stainless steel. Thus, the important factor is likely to be that the solid particles break down the surface protective film of the stainless steel but the reformation rate is high.

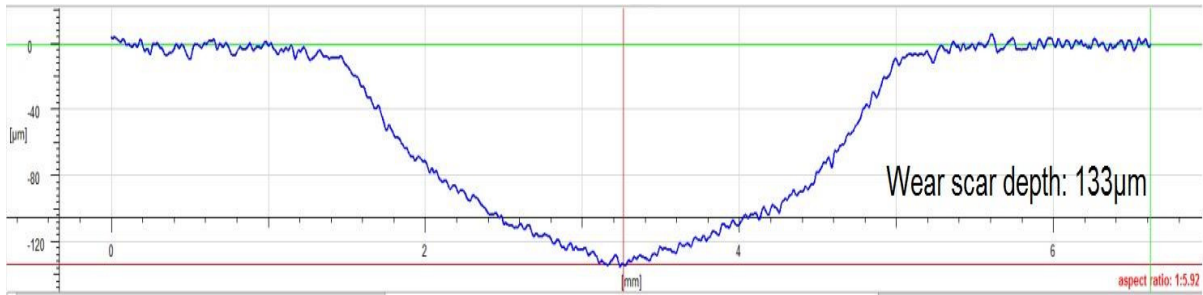
To evaluate, more extensively, the behaviour of these two different metals in the zone directly under the impinging jet (wear scar), surface profile scans were completed on all specimens. Figures 4 and 5 show examples of U-shaped wear scar profiles of the stainless steel and the carbon steel respectively, after test in free erosion-corrosion conditions. It should be mentioned that the wear scar diameter corresponds approximately to the diameter of the nozzle.

Figure 5. Surface profile scan of the wear scar of the medium carbon steel UNS G10400 after solid/liquid impingement.

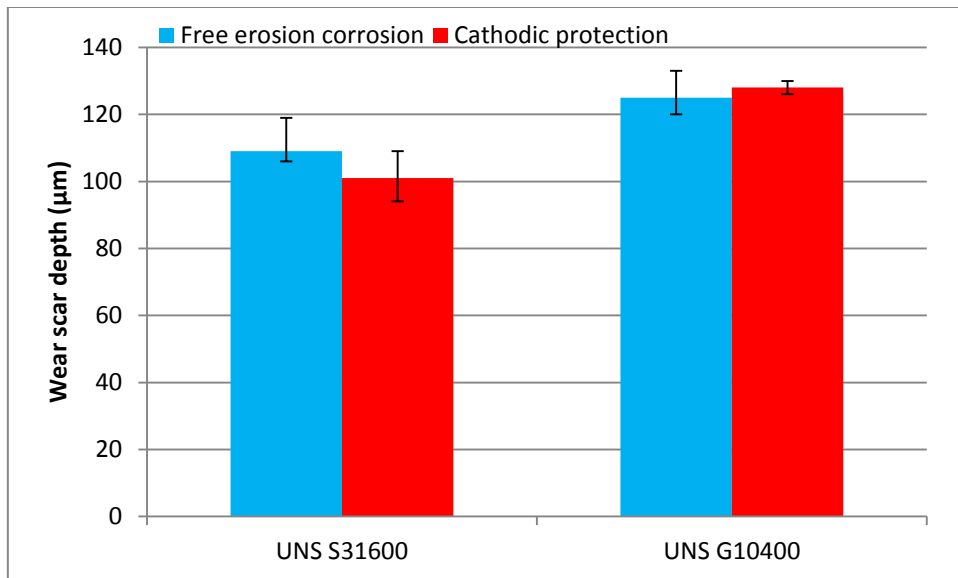
Figure 6 shows the wear scar depths of the two steels with and without cathodic protection. There is a clear correlation between the mass losses and the wear scar depths, as the UNS G10400 has deeper wear scars than the UNS S31600. It is also evident, that the application of CP has not generally resulted in significant reduction in wear scar depth on either material.

Figure 6. Wear scar depths of the studied materials in erosion corrosion conditions with and without cathodic protection.

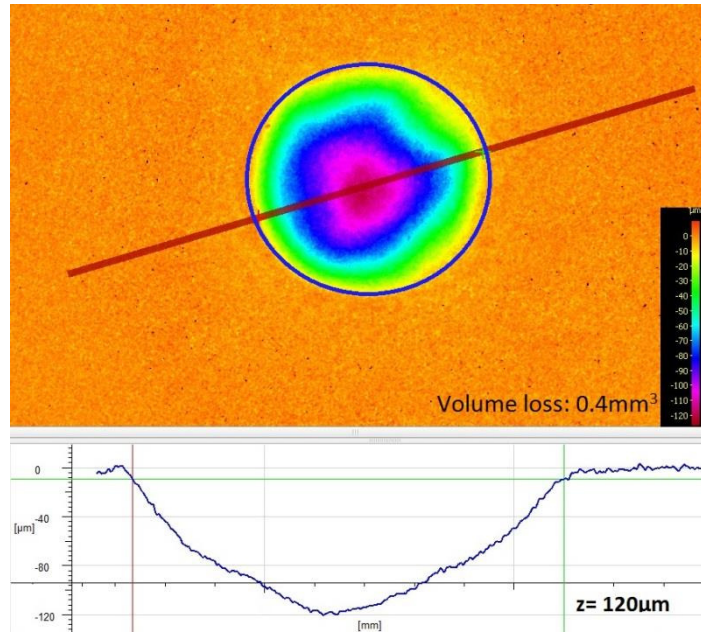
Figure 7 shows the volume measurement of the direct impinged zone of the UNS S31600. The volumetric analysis was executed on the region inside the blue ring, which represents the area under the jet. It is clear, from the surface profile scan below, that the volume loss has been determined accurately within the wear scar. Also, several volume assessments have been undertaken by increasing the diameter of the blue ring and the differences in the resulting volume values were minimal. Possible inaccuracies/errors in the measured wear scar volume due to general thickness loss of the specimen surface during the 1hour experiment were calculated to be negligible.

Figure 7. Volumetric analysis and surface scan on the direct impinged zone of the UNS S31600 surface after solid/liquid impingement without CP.

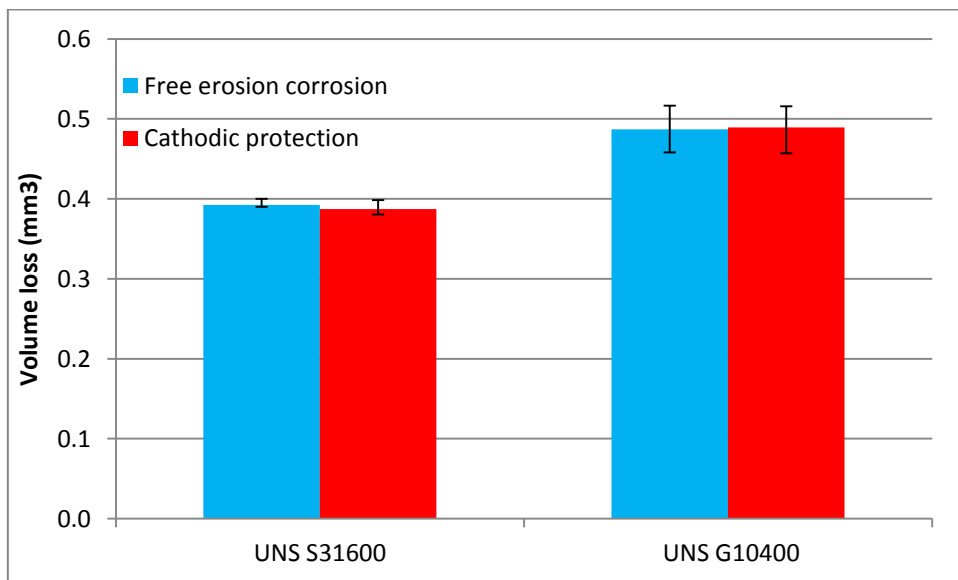
Figure 8 illustrates the volume losses within the wear scar during solid/liquid impingement with and without cathodic protection. The volume loss of the UNS G10400 steel was 20% higher than UNS S31600 in both conditions, which shows the benefit of the stainless steel over the medium carbon steel within the direct impinged zone. It is also evident that the volume losses remain stable, even if the cathodic protection current is applied to the specimens. This trend demonstrates that the volume loss on the direct impingement is mostly associated with erosion damage.

Figure 8. Comparison of the average volume losses within the wear scar of the UNS S31600 and UNS G10400 with and without cathodic protection.

According to Figure 8, the volumetric losses, in the wear scars on both materials with and without the application of CP were similar. This means that, in the material/testing conditions of this study, the material loss on the direct impinged region is purely by mechanical action and the corrosion related component is negligible on the direct impinged zone. The properties of the erodent should

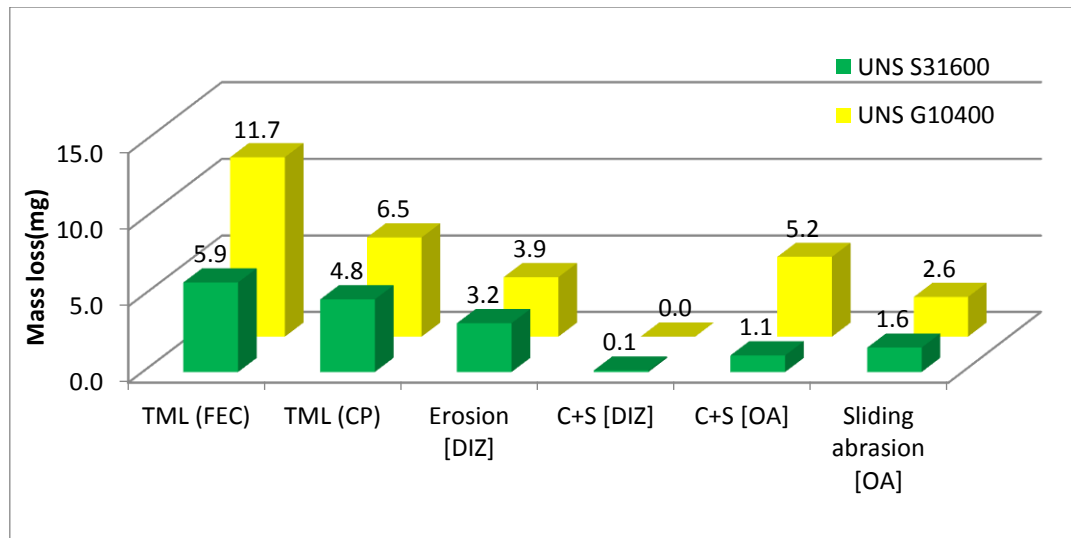
A comparison of the relative magnitudes of the various deterioration mechanisms taking place on both materials is represented in Figure 9. The separation of the various mechanisms is based on the recognized contributors to corrosive wear damage;

The quantitative material losses, shown in Figure 9, demonstrate the substantial benefits of the expanded assessment of erosion-corrosion testing that forms the basis of this paper.

Figure 9. Discrimination of the different material degradation processes on the UNS S31600 and UNS G10400 steels.

The values of Figure 9 have been obtained as described in the sections below.

The findings have facilitated quantification of the effect of the extreme angles of impingement, i.e. 90° and 0° from one jet impingement test and also, isolation of the mass losses taking place on the direct impinged zone and the outer area. They have also demonstrated the differentiation between the mechanical deterioration mechanisms of erosion and sliding abrasion and shown that sliding abrasion contributes significantly to the mechanical damage resulting from the action of an impinging jet on the large component.
