# Effects of Damage on Long-term Displacement Data of Woven Fabric Webbing Under Constant Load for Inflatable Structures

**NASA LaRC**

AIAA SciTech 2016, January 3-8, 2016

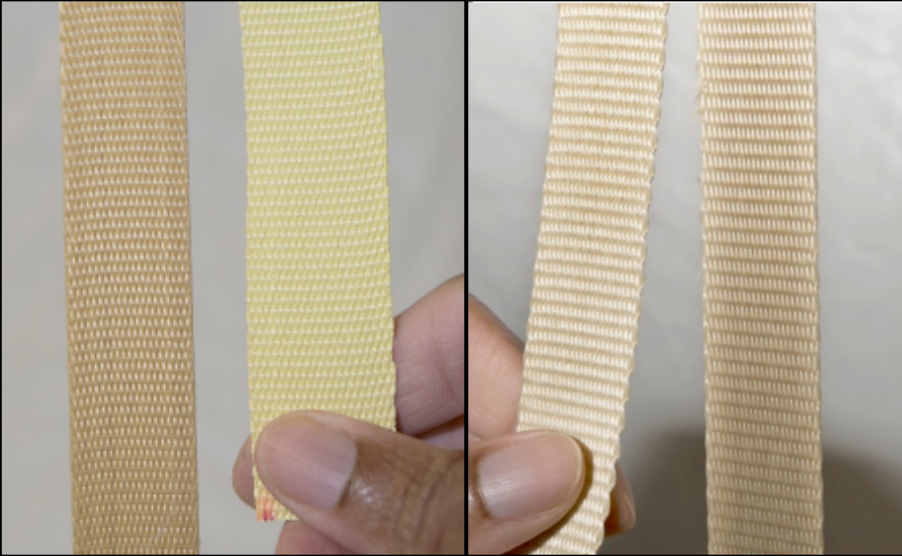
Typical Roll of Webbing Material  
(Flexible Structural Restraint Layer)

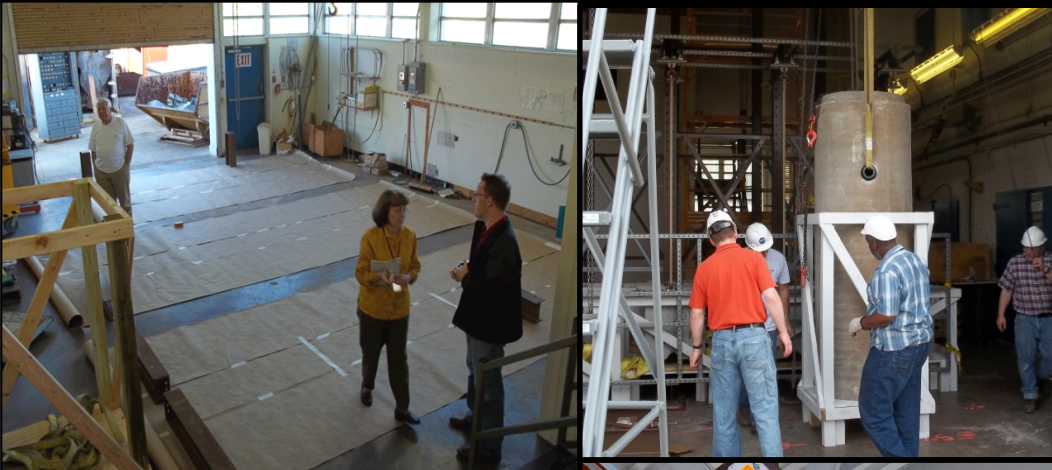
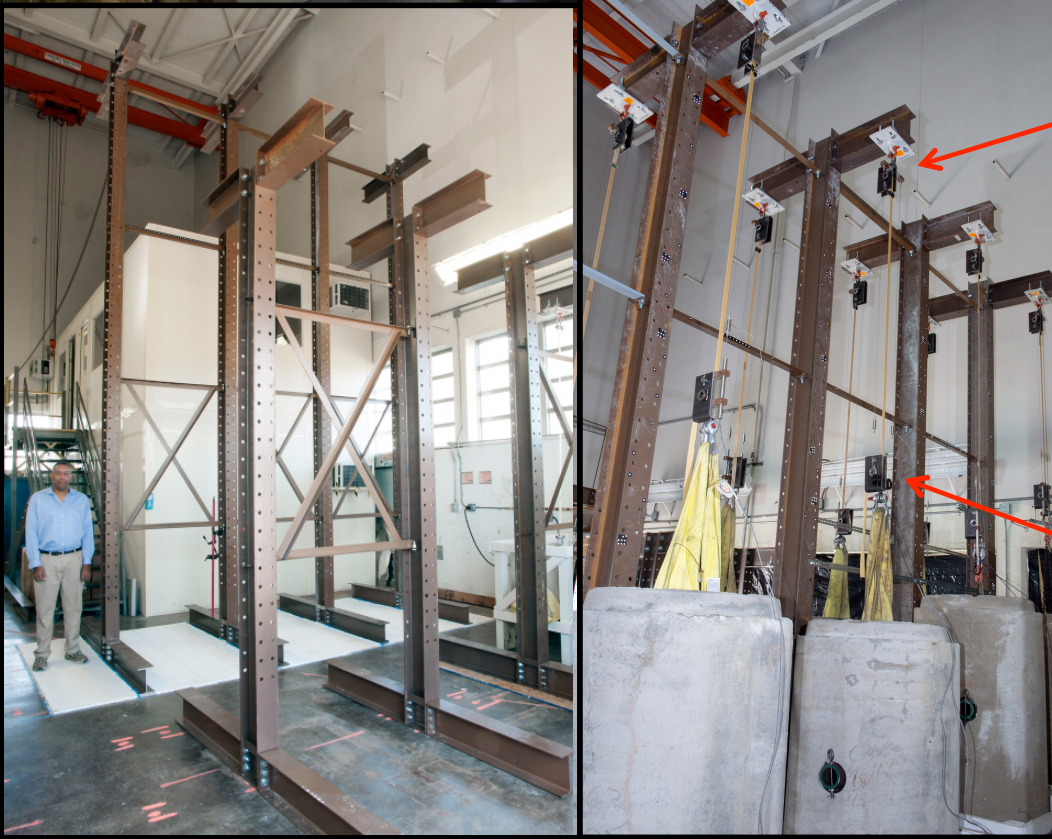
# Creep Test Facility

- Initial creep test, Feb 2012
- Creep test hardware (3 rows)
  - I-beam structures
  - Concrete weights
- Typical displacement sensor

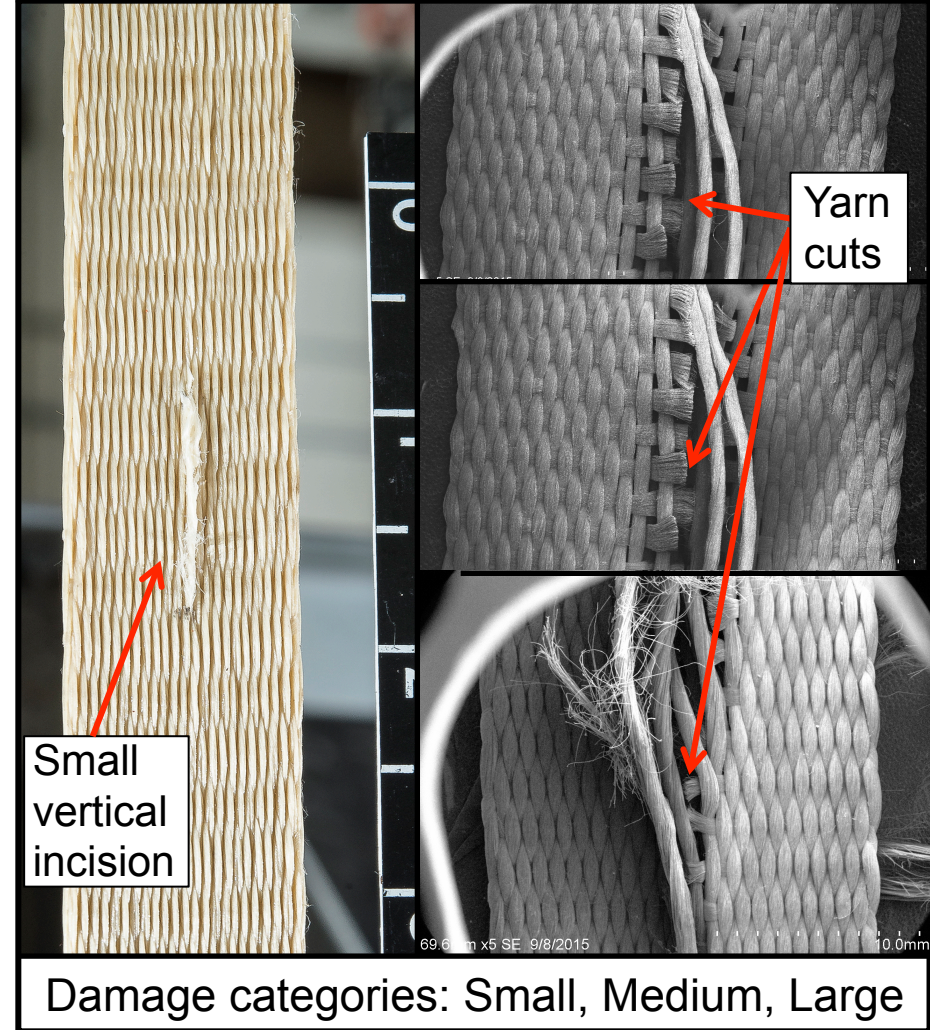
## Damaged Webbing

Damage categories: Small, Medium, Large

- Eleven test groups defined by test material, applied load, and damage
- Horizontal incision: Known to have an adverse effect on strength proportional to length

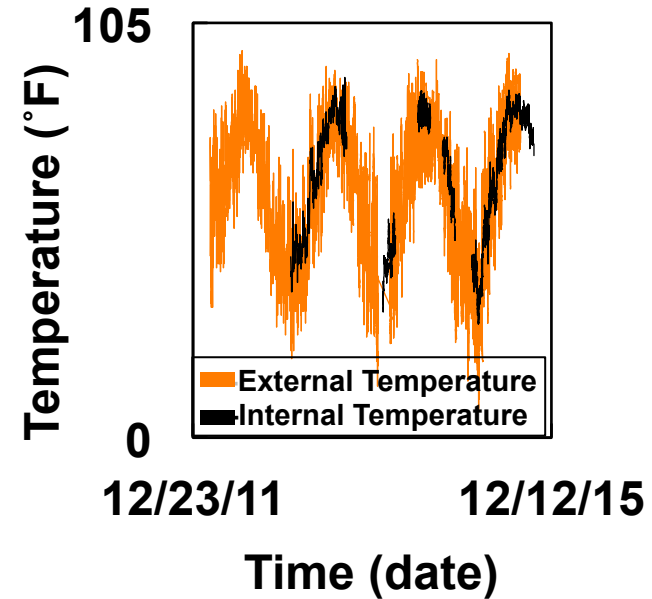
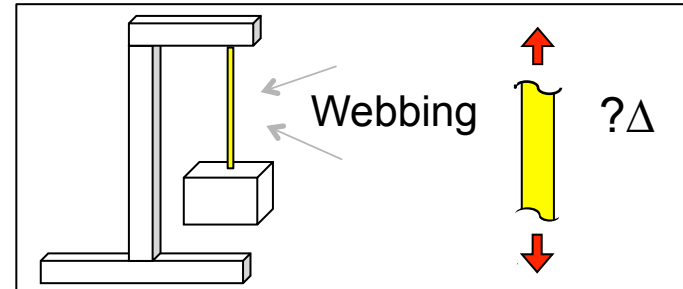
## Temperature Data

- Daily, seasonal, and yearly temperature and humidity effects influence the creep displacement curve
- Webbing exhibits negative coefficient of thermal expansion (CTE)

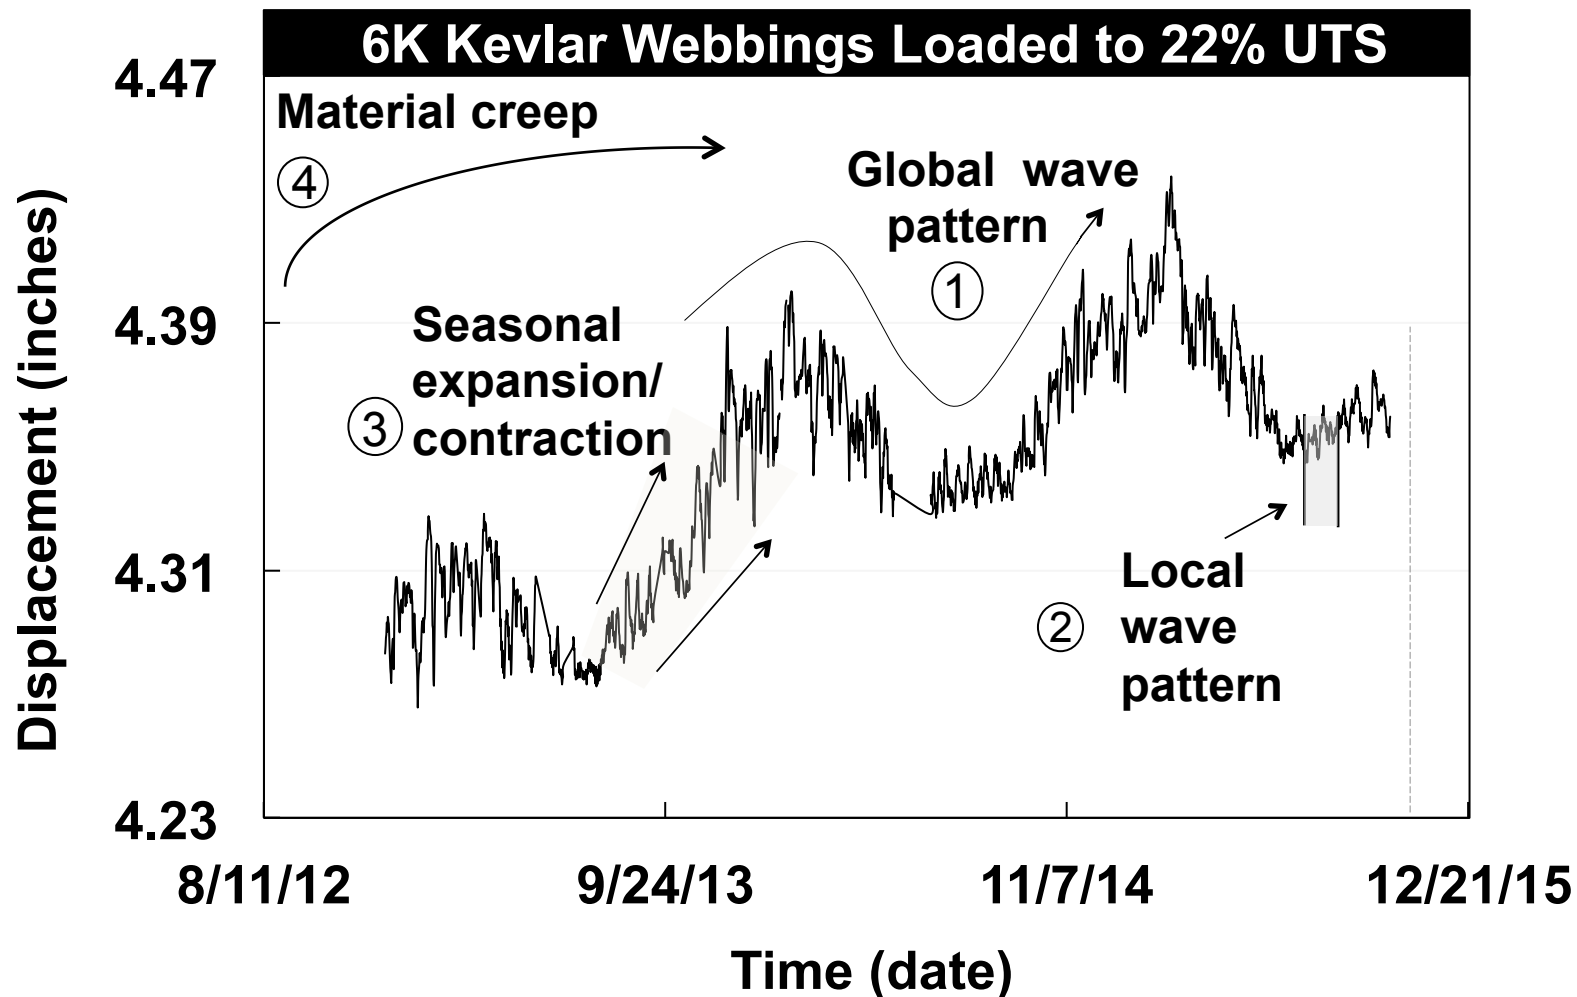
# Characteristics of Displacement Curve

- 3-year time period
- Four characteristic curve patterns
- Failure experienced above 50% UTS

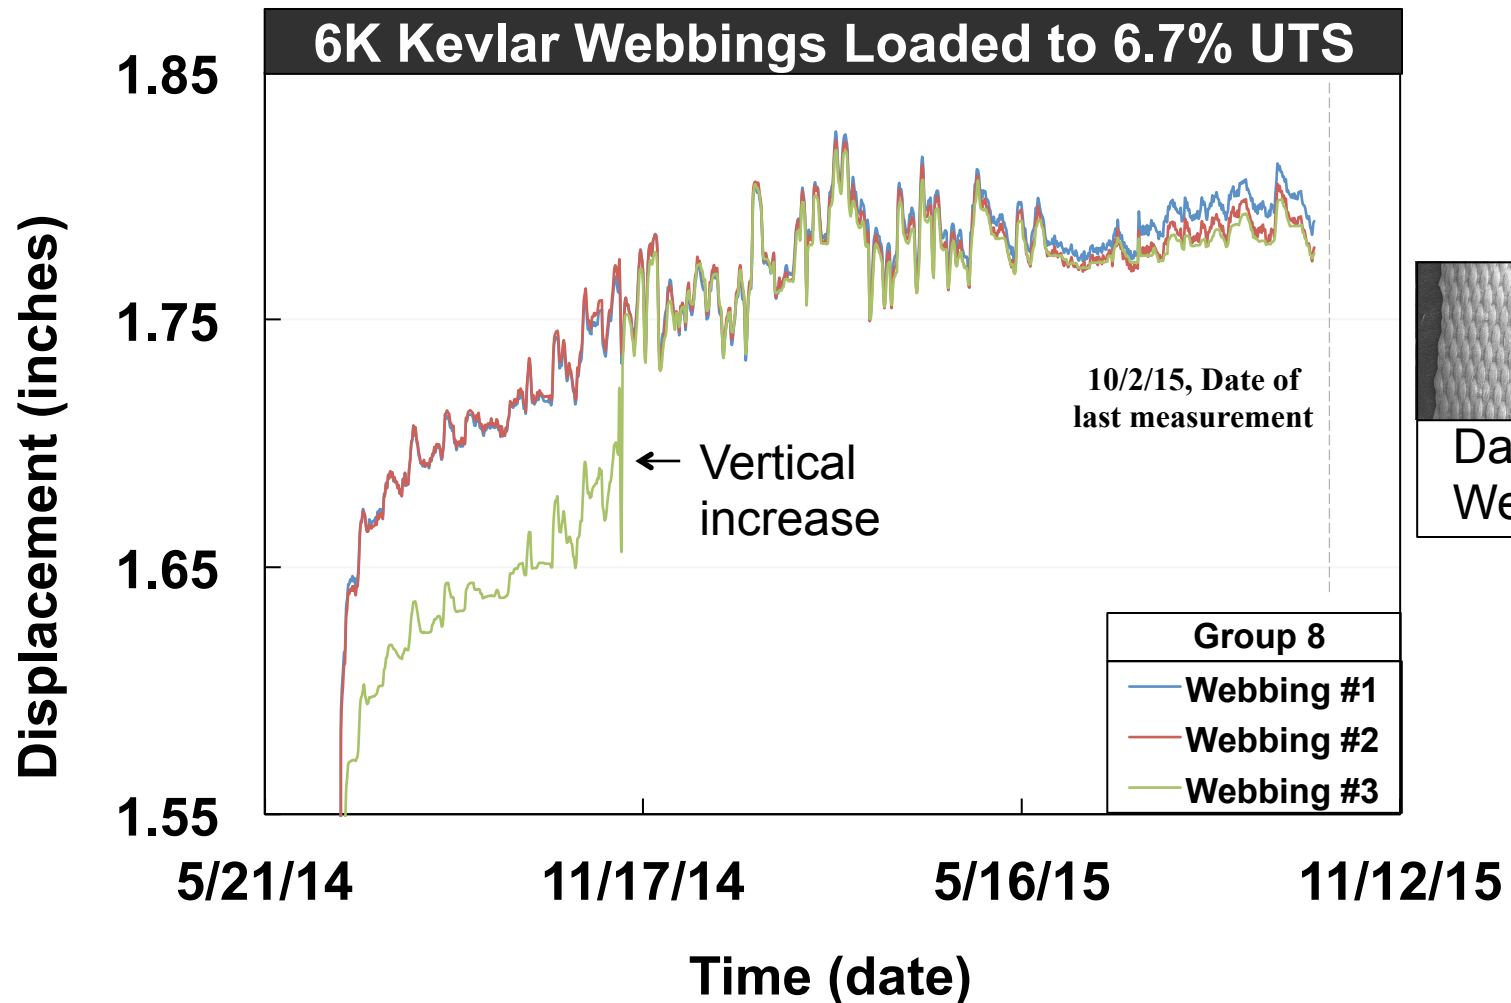
# Effects of Damage

- Damage introduces vertical spikes into local wave pattern
- Damage doesn't effect strength over time

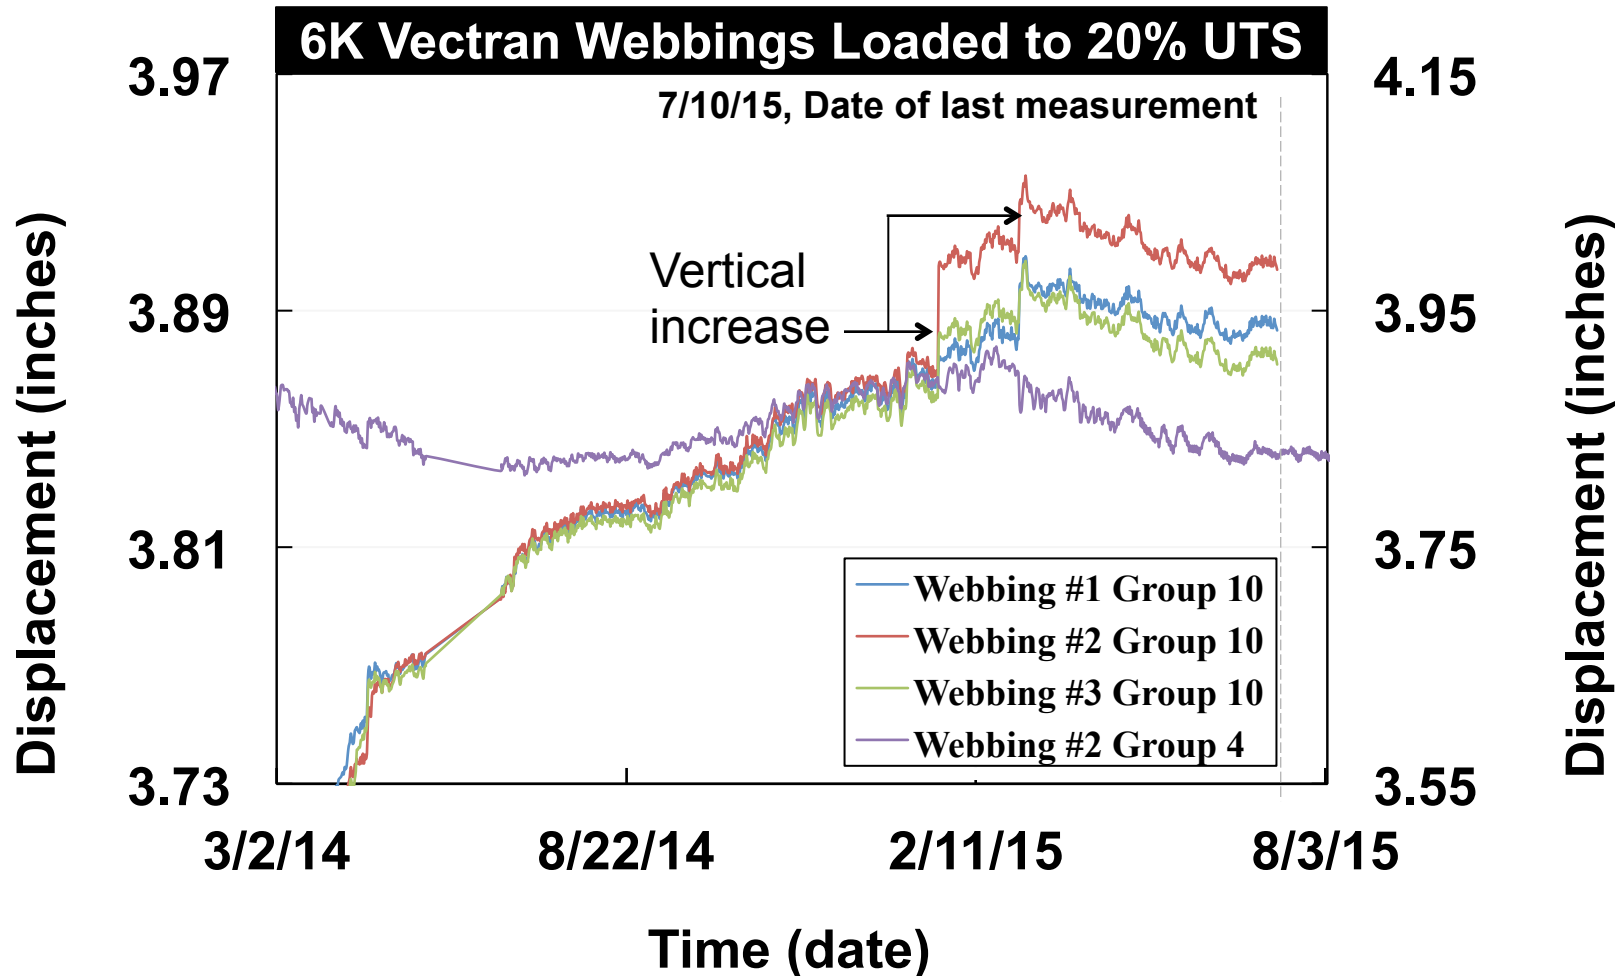
# Effects of Damage

- **Vertical spikes are due to transfer of load from damaged to pristine warp yarns**
- **Cut fill yarns have little effect on webbing strength**

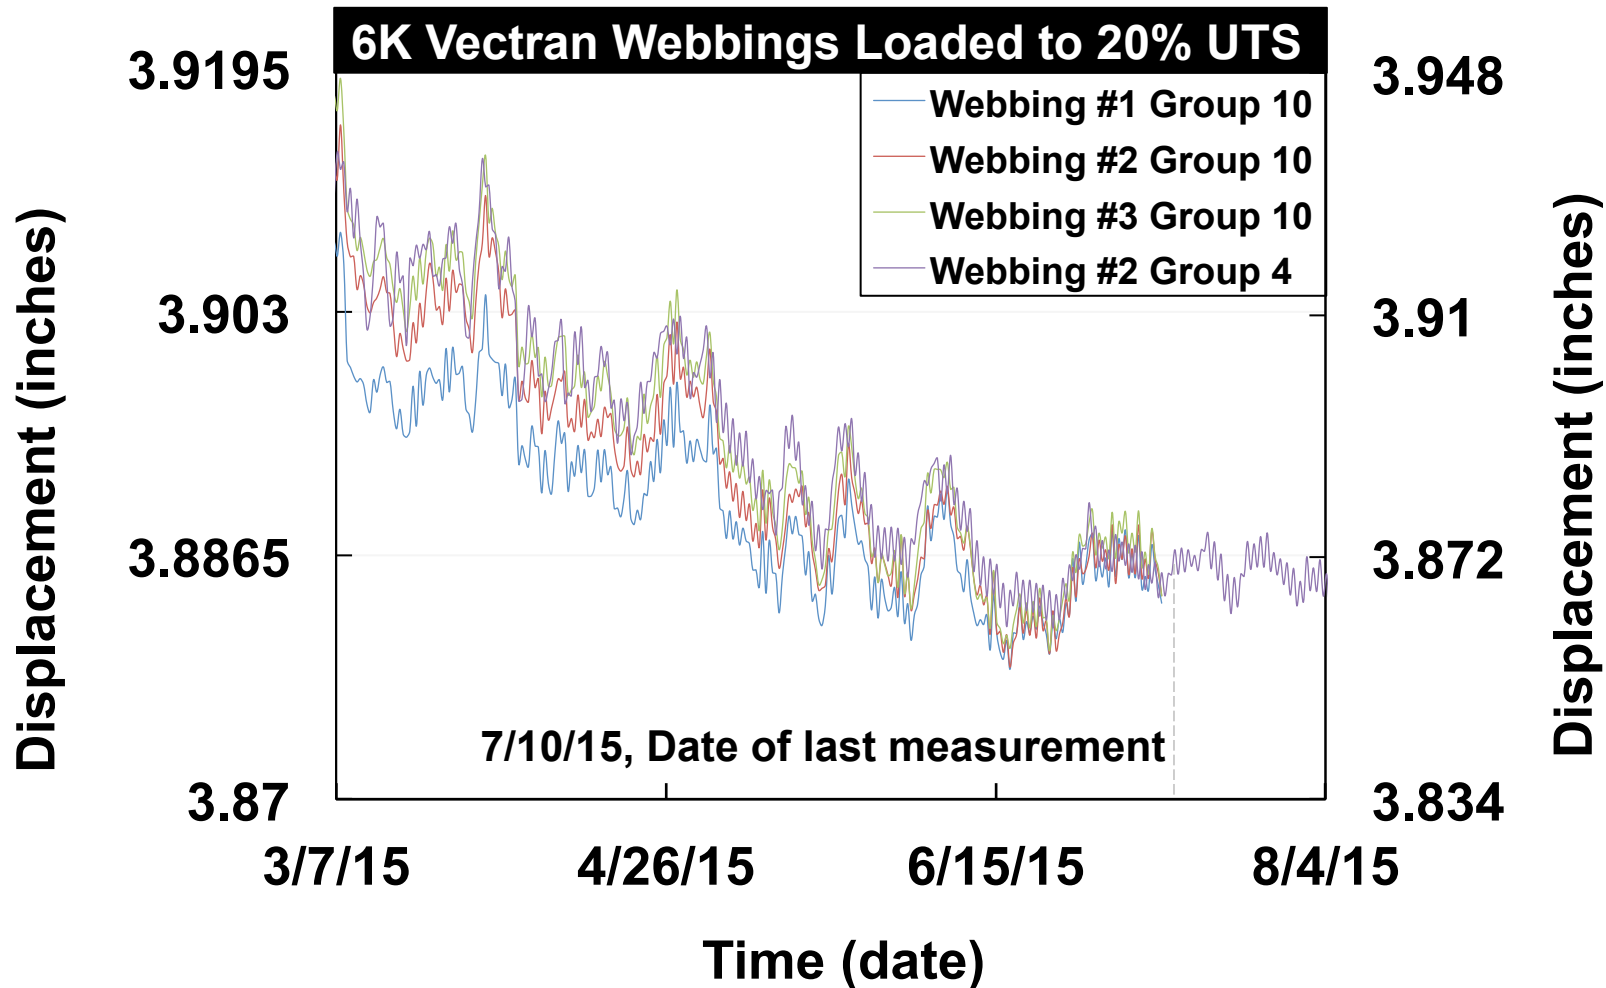
# Effects of Damage

- Magnified view of damaged webbing wave patterns relative to baseline pattern indicates insignificant effect of damage

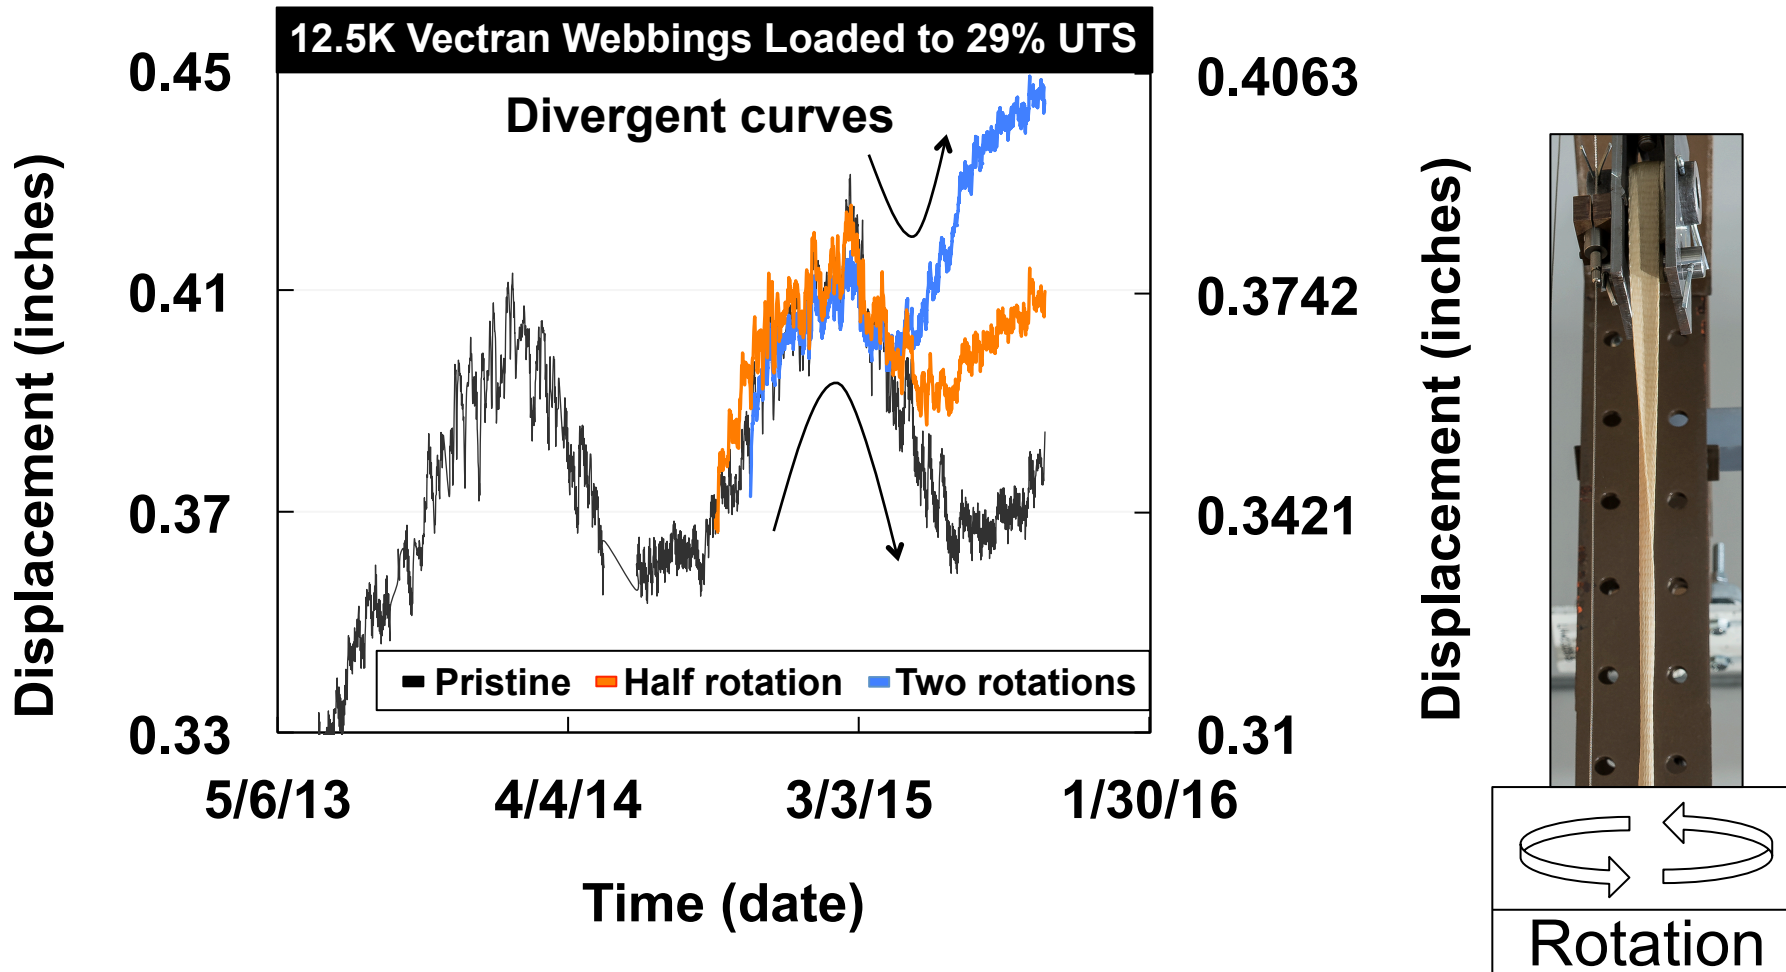
# Effects of Rotation

- Rotation introduces a divergent global wave pattern
- Rotation has a significant effect on strength over time

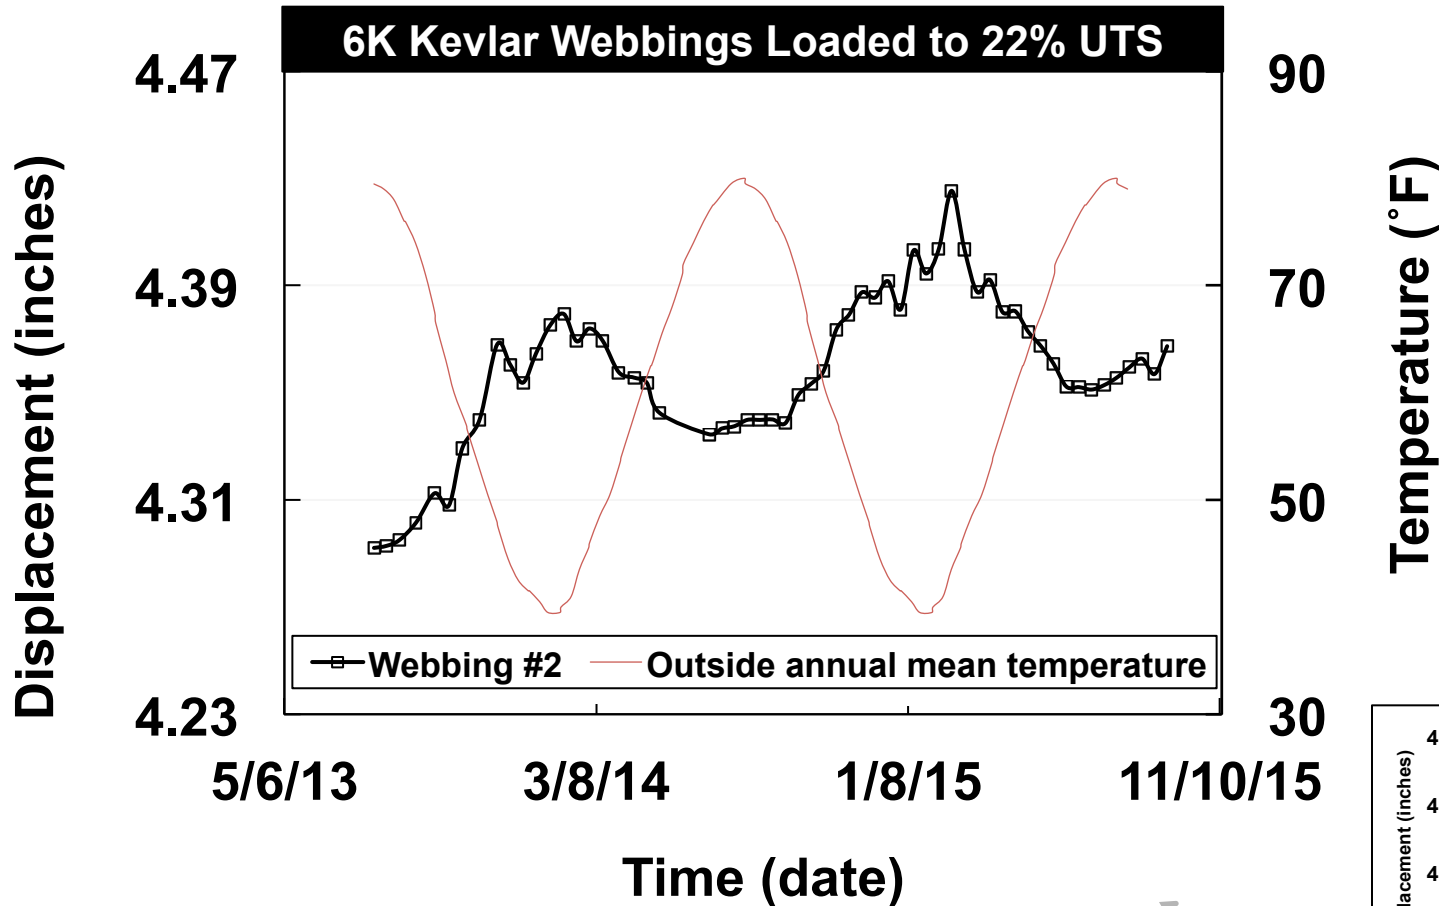
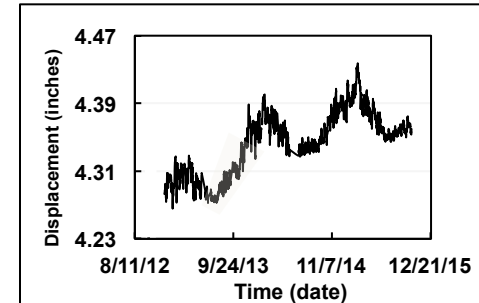
# Running Sum Calculation

- Local wave patterns can be eliminated and global wave patterns highlighted through the use of running sum data
- Each data point in presented graph consist of 20 days of data

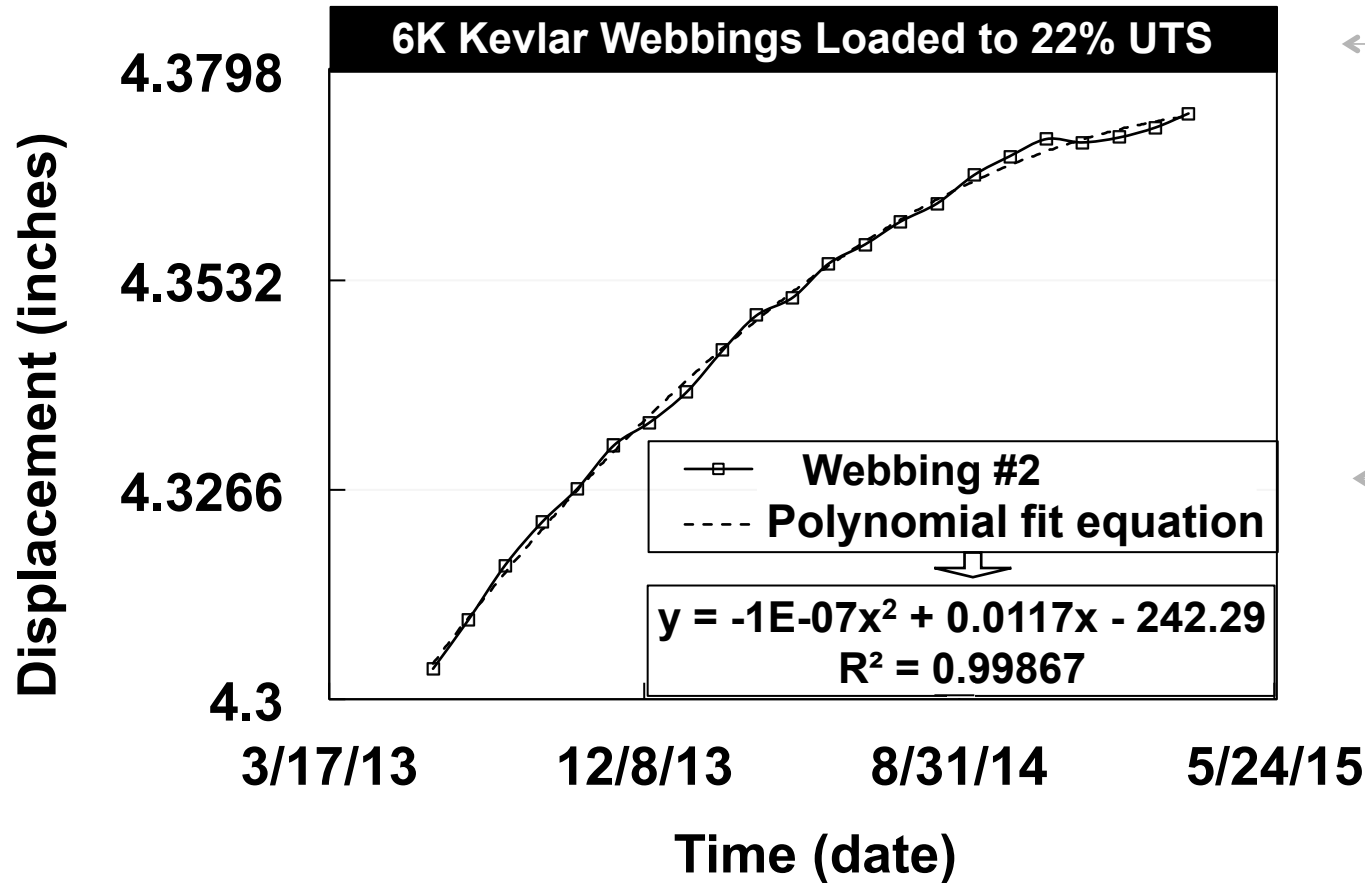
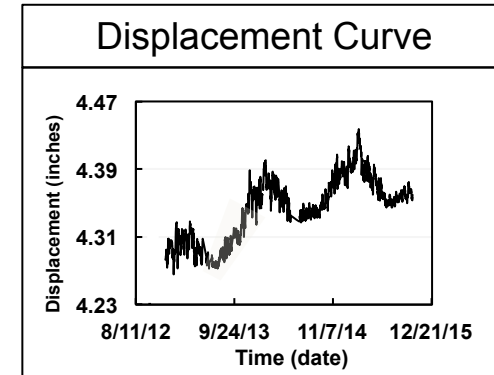
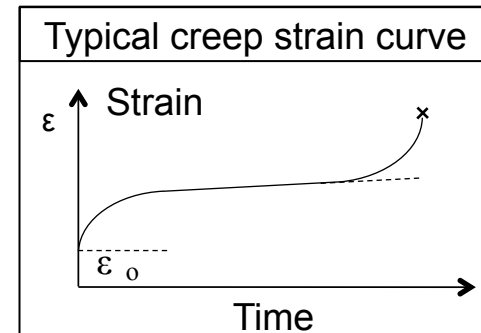
# Running Sum Calculation

- All wave patterns can be eliminated and a continuous curve generated through the use of running sum calculations
- Each data point in presented graph consist of 1 year of data
- Running sum curve is comparable to a classic creep curve
